On-scene Investigation / Vehicle to Vehicle
Dynamic Science, Inc. / Case Number: DS01-008
2001 Chevrolet 1500 series 4x4 pickup
Arizona
March, 2001

1. Report No. DS01-008		2. Government Accession No.		3. Recipient Catalog No.	
4. Title and Subtitle In-Depth Accident Investigation				5. Report Date April 16, 2002

Dynamic Science, Inc.
Accident Investigation
Case Number: DS01-008

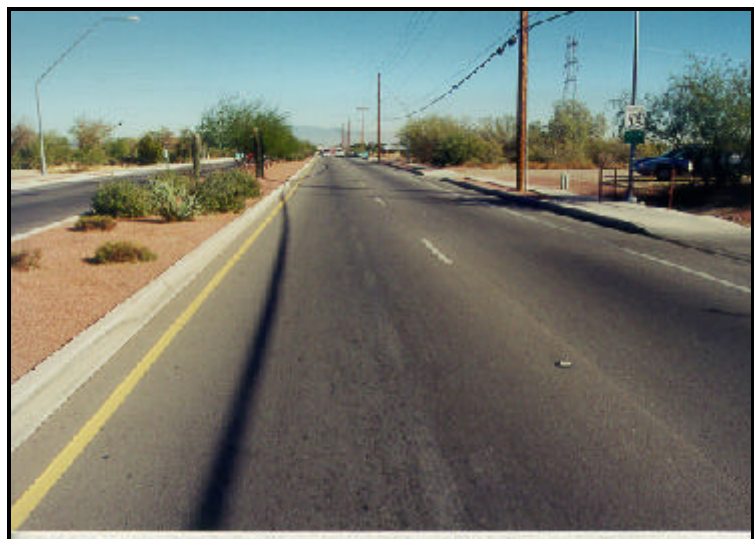
Figure 1. Area of impact–east

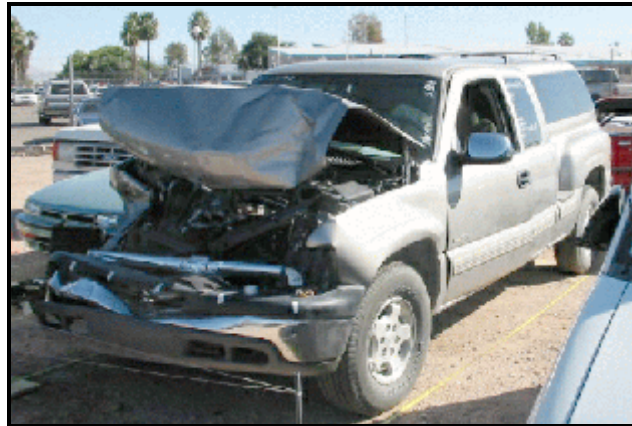
Figure 2. Front left, case vehicle

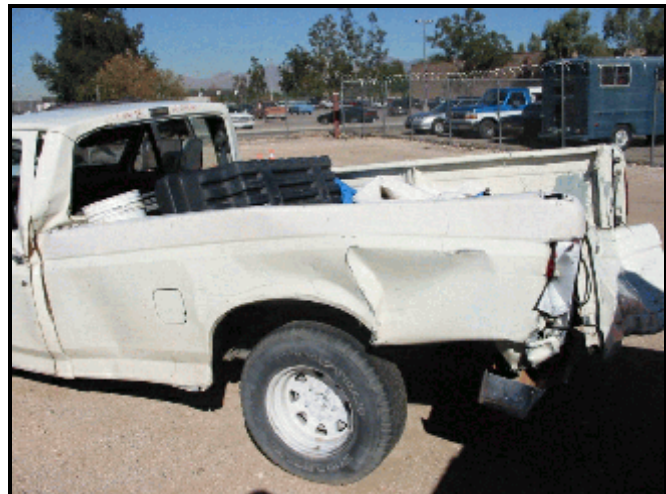
Figure 3. Left side, other vehicle

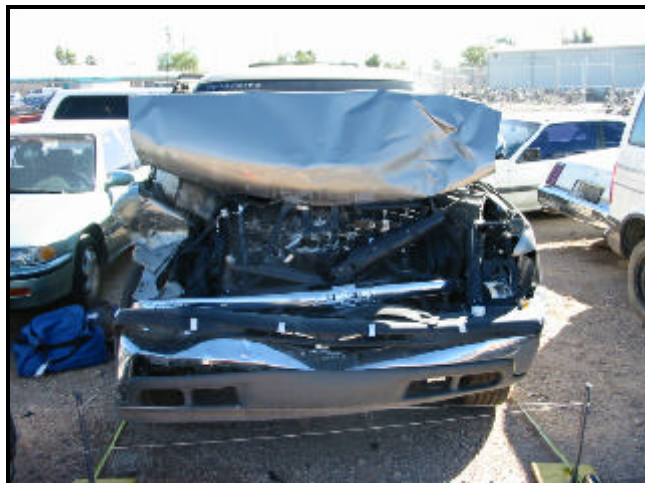
Description:	2001 Chevrolet 1500 series 4x4 pickup	
VIN:	2GCEK19T511xxxxxx	
Odometer:	Unknown	
Engine:	5.3l V8	
Reported Defects:	None	
Cargo:	Unknown	
Damage Description:	Moderate frontal crush. Above bumper crush to grille and hood.	
CDC:	12FDMW2	
Delta V ³ :	Total	25.4 km/h (15.8 mph)
	Longitudinal	-25.4 km/h (-15.8 mph)
	Latitudinal	0 km/h (0 mph)
	Energy	87,671 joules (64,687 ft-lbs)

Figure 5. Front of vehicle

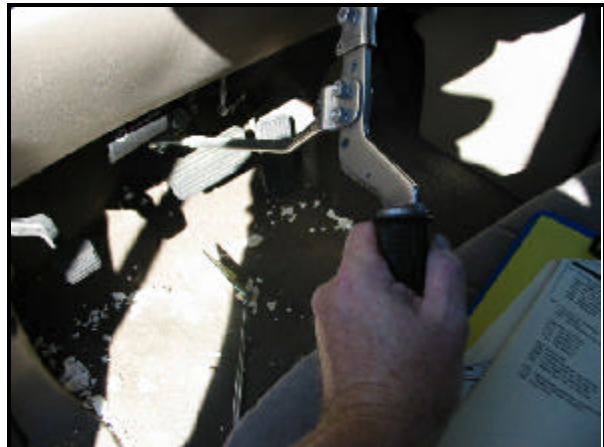
The case vehicle was equipped with a Monarch Mark 1-A mechanical gas and brake hand control system. The brake is operated by pushing the operating handle towards the brake pedal; the accelerator is operated by moving the operating handle towards the driver's seat at a right angle to the brake movement. The brake and accelerator can be used separately or simultaneously. The hand control does not require an automatic transmission, and must only be installed on vehicles with power steering and power brakes. The hand control system in this case was set up for left hand operation, but can be adjusted for right hand operation. It does not appear that the mechanical hand control factored into either the crash or injuries sustained during the crash.

Figure 6. Mark 1-A mechanical hand control

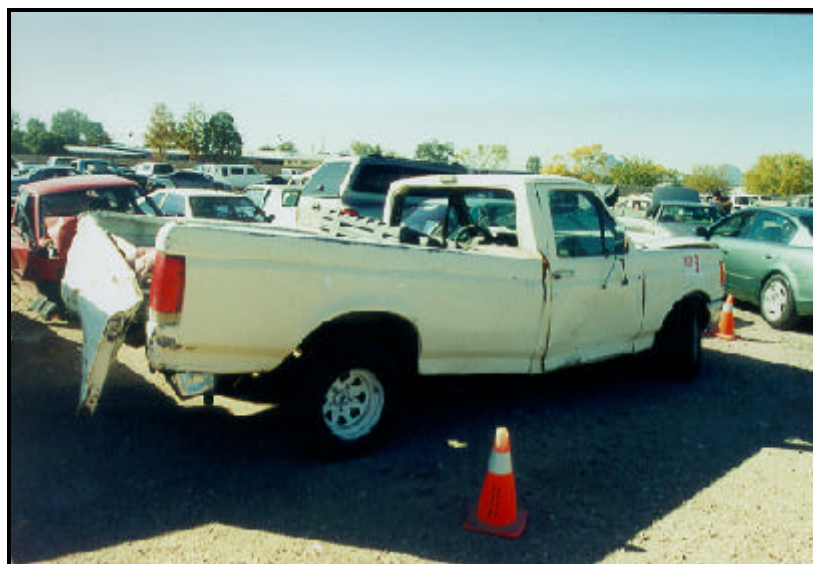
Damage Description: Under-ride type damage to bumper area. Pickup bed forced into back of cab.

Figure 9. Right rear side, other vehicle

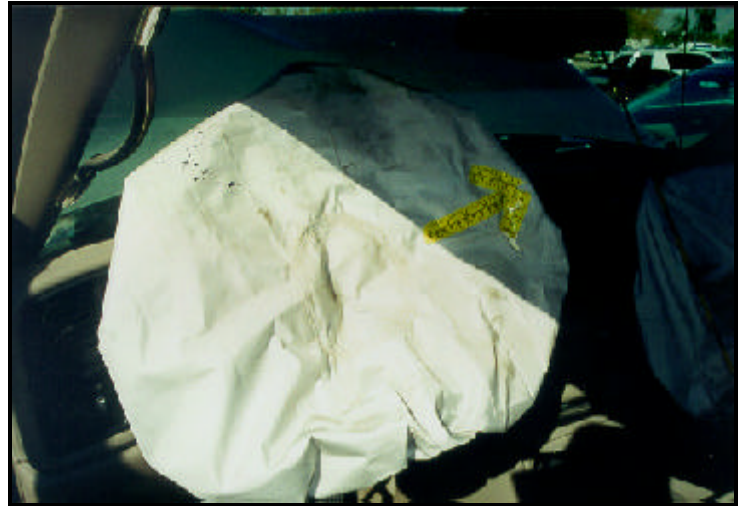
Figure 10. Driver's air bag

At impact, the driver and child occupant responded to the 0 degree direction of force by pitching forward. It is reasonably clear that since there was no contact to the module cover, all the injuries came as a result of interaction between the air bag and the driver. This occupant died essentially due to a fractured skull due to forces from the deploying air bag and the driver's forward torso movement. She would likely have been injured to some degree whether or not the vehicle had been equipped with an air bag. However, the injuries would not have been as severe. The unrestrained driver's forward movement was being limited to some degree by the driver's left and right arms as she braced prior to the crash. This was relatively soft crash as evidenced by the significant front end under-ride. It should also be noted that there were no indications of steering wheel deformation or loading. The majority of the injuries are air bag related. As the right side of the child's face was being struck by the deploying air bag the child's head was in contact with the driver, leaving no opportunity for significant rearward movement of the child's head.

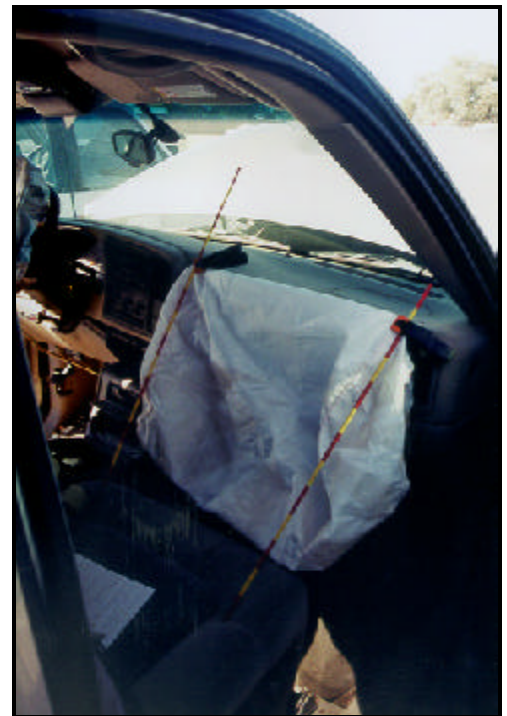
The unrestrained front right occupant of the case vehicle pitched forward in response to the initial braking and then engaged the passenger air bag as it deployed. There was no contact to the module cover or the instrument panel. According to the investigating officer, he sustained a number of contusions and abrasions but was not seriously injured.

Figure 11. Front right passenger air bag

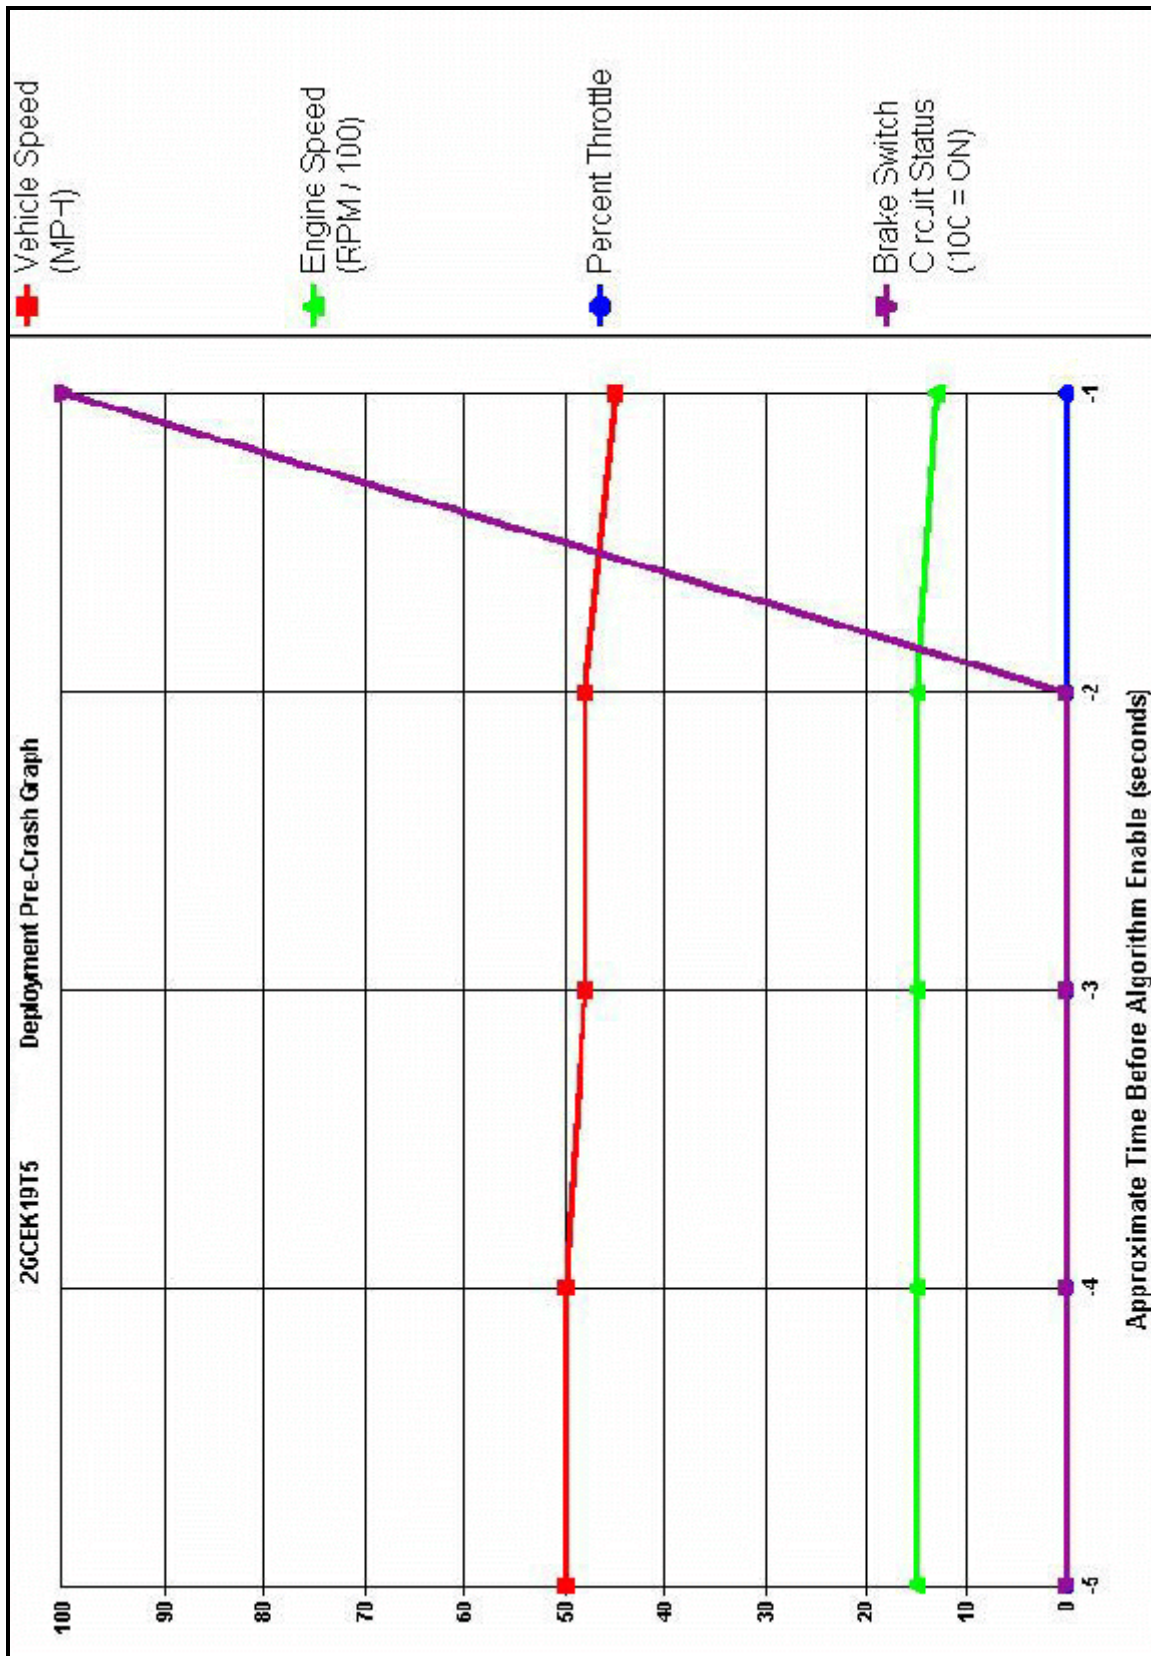
The driver of the case vehicle saw the other vehicle brake. The throttle was not engaged at this time and the vehicle had decelerated to 77 km/h (48 mph). Two seconds before algorithm enable, the driver of the case vehicle began braking (the brake switch circuit status was ON). The case vehicle deposited 10.3 m (34 ft) of locked wheel skids. One second prior to algorithm enable, the EDR reported a vehicle speed of 72 km/h (45 mph). The driver was unable to stop in time and the front of the case vehicle (12FDMW2) struck and under-rode the rear of the Ford (06BDEW1). The case vehicle had a maximum crush of 58 cm (22.8 in) above bumper, 14 cm (5.5 in) at the bumper, and a maximum average crush of 33 cm (12.9 in). The case vehicle sustained a longitudinal delta v of -28.0 km/h (-17.4 mph) at the 120 ms mark as recorded by the EDR. WinSmash was run using averaged crush measurements for the case vehicle. The results were slightly lower for the case vehicle and should be considered borderline. According to the WinSmash run the case vehicle sustained a longitudinal delta v of -25.4 km/h (-15.8 mph)² and the other vehicle sustained a longitudinal delta v of 30.6 km/h (19.0 mph). Both frontal air bags in the case vehicle deployed during the impact.

Figure 12. Pre-Crash Graph

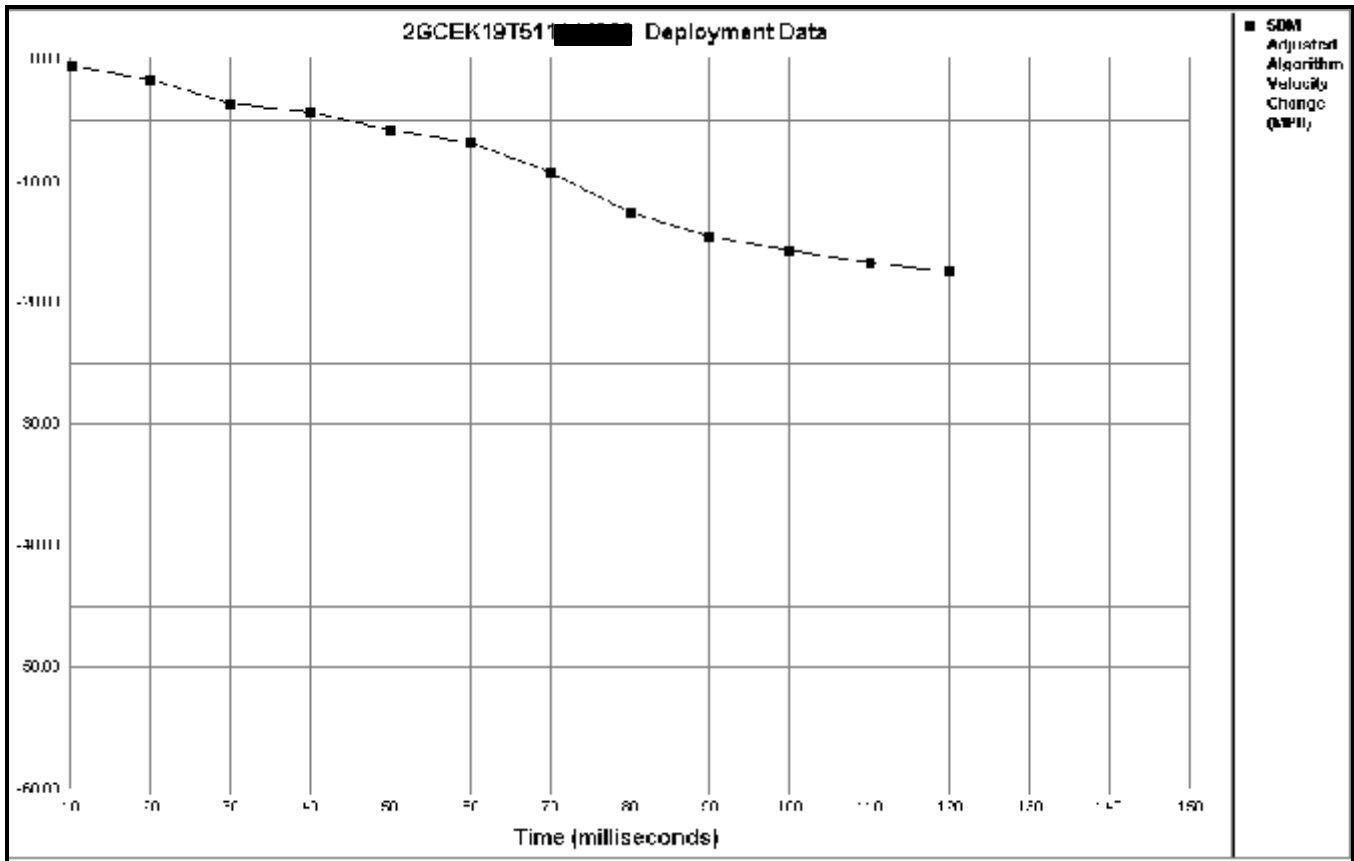
Figure 14. Post-Crash Graph: SDM Adjusted Algorithm Velocity Change
