REMOTE AIR BAG INVESTIGATION

CASE NUMBER - IN01-011

VEHICLE - 1996 GEO METRO LSI

CRASH DATE - September 2000

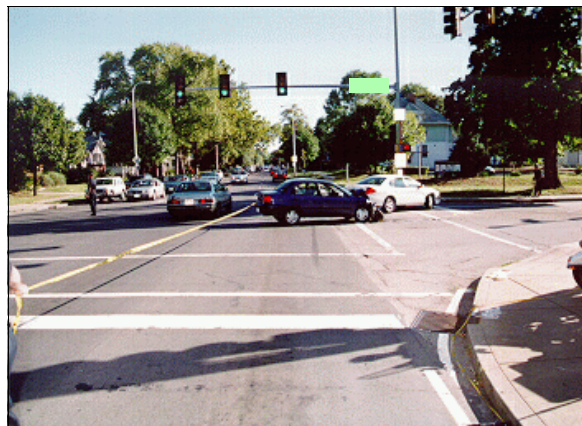
The front of the case vehicle impacted the Ford's right fender and right front wheel, causing the case vehicle's driver and front right passenger air bags to deploy. After impacting the Ford, the case vehicle rotated approximately 75 degrees clockwise, coming to rest in the outside southbound lane, heading west-southwest. The Ford rotated approximately 60 degrees counterclockwise and came to rest on the west leg of the intersection, in the outside eastbound lane, straddling the north-south crosswalk, heading southwest (**Figure 1**).

Figure 1: On-scene view looking south along case vehicle's travel path into intersection; Note: final rest positions of case vehicle (foreground) and other vehicle (background) and case vehicle's right tire skid mark (case photo #02)

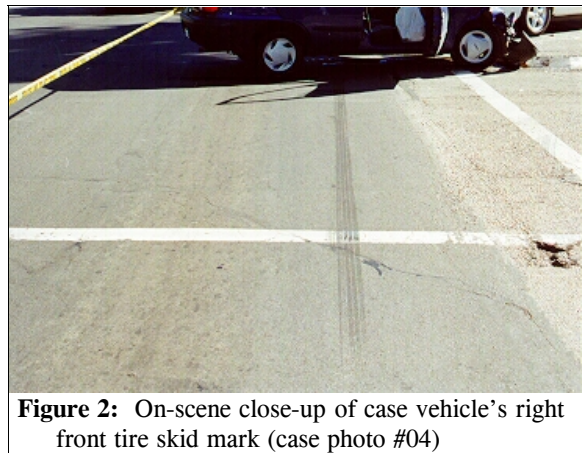
The case vehicle was traveling south in the outside southbound lane of a five-lane, undivided, city street and was approaching a controlled four-leg intersection, intending to continue traveling southward (i.e., there were two through lanes for both directions and a center left turn lane on the north and south legs of the intersection). The other vehicle had been traveling north in the left turn lane of the same city street and turned left, intending to travel westward (**Figure 1**). According to witness statements, the automatic signals had changed to red as the case vehicle entered the intersection while the other vehicle completed the left turn. The case vehicle's driver braked, depositing approximately 9.1 meters [29.7 feet] of front tire skid marks, in an attempt to avoid the crash (**Figure 2**). The crash occurred within the intersection of the two roadways.

Figure 2: On-scene close-up of case vehicle's right front tire skid mark (case photo #04)

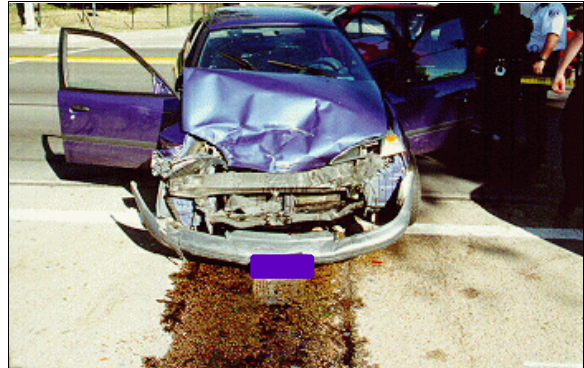
Based on a police inspection and photographs of the case vehicle, the case vehicle's initial contact with the Ford involved the entire front (**Figure 3**). Direct damage extended from the right bumper corner to the left bumper corner. Maximum crush was estimated as approximately 45.7 centimeters [18 inches] at the front right corner of the engine hood. The case vehicle's front was shifted slightly to the right. The windshield glazing was cracked due to impact stress, suspected contact by the passenger's air bag and suspected contact by the back right passenger (**Figure 4**). The hood was buckled back and upward, and the right fender was crushed rearward, restricting the right front tire.

Figure 3: On-scene view of case vehicle's front damage at final rest; Note: front bumper fascia on ground and radiator fluid spill (case photo #07)

Based on the available photographs, the CDC for the case vehicle was estimated as: **11-FDEW-3 (330)**. The WinSMASH reconstruction program, CDC-only algorithm based on estimated CDCs for the two vehicles, was used. The Total, Longitudinal, and Lateral Delta Vs are, respectively: 38 km.p.h. [23.6 m.p.h.], -33 km.p.h. [-20.5 m.p.h.], and +19 km.p.h. [+11.8 m.p.h.]. Based on the Police Crash Report and the case vehicle's driver, the case vehicle was going approximately 56 km.p.h. [35 m.p.h.] prior to braking.

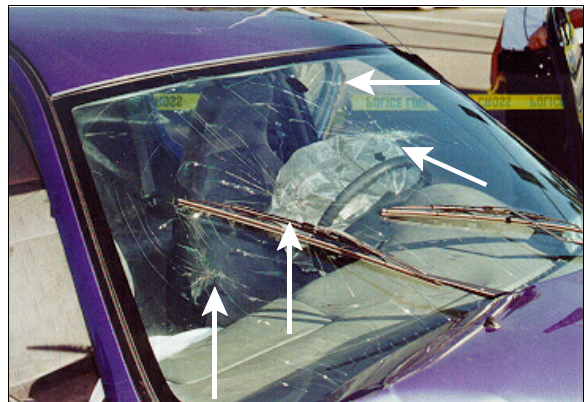
Figure 4: On-scene view of cracks in case vehicle's windshield glazing (case photo #16)

A review of the police photographs of the case vehicle's interior revealed that there were several spider web-type impacts in the windshield's glazing (**Figure 4**). The uppermost contact to the center of the windshield was probably a result of the windshield being impacted by the back of the rearview mirror when it was contacted by the front right passenger's air bag. The sources of the two apparent contacts towards the right side of the windshield are unclear. Finally, the impact to the upper part of the center windshield is probably a result of impact by the case vehicle's back right passenger. There was also damage to the case vehicle's center instrument panel, including deformation to a center vent and displacement in the center instrument panel's plastic trim pieces (**Figure 8**).

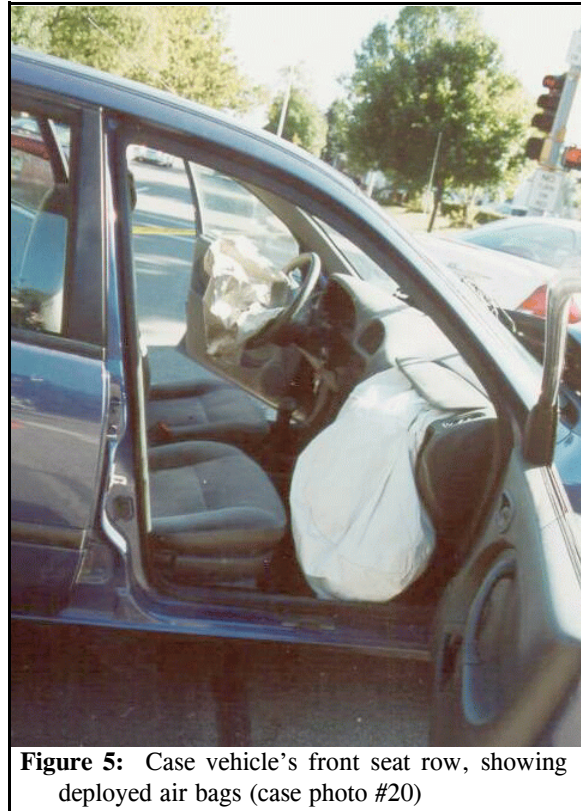
The front right passenger air bag was located in the top of the right instrument panel (**Figure 5**). Police photographs of the front right passenger air bag revealed that the cover flap opened at the designated tear points and there was no visible evidence of damage to the air bag, but the cover flap appears to have evidence of contact (i.e., cloth or skin transfers) from interaction with the out-of-position front right occupant (**Figure 6**). The investigating police officer made no mention of any evidence of contact or damage to the air bag's fabric.

Figure 5: Case vehicle's front seat row, showing deployed air bags (case photo #20)

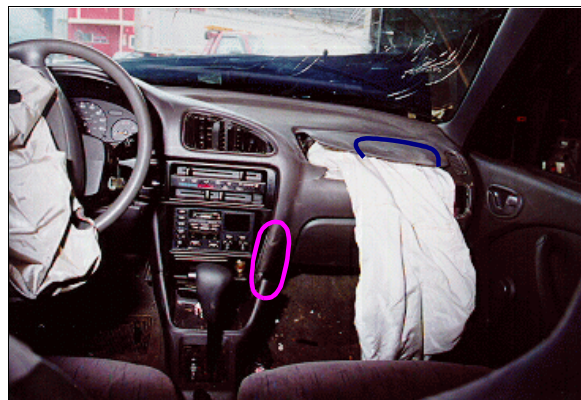
Figure 6: Case vehicle's instrument panel, deployed air bags and center console; Note: scuffs on front right air bag module's cover flap and scuffed and cracked center console (case photo #19)

vehicle's impact with the Ford caused the child passenger to continue forward, upward, and slightly leftward, toward the 330 degree direction of force. The deploying front right air bag module's cover flap contacted the child in the neck area, lifting him slightly upward and hyper-extending his neck, causing: dislocations at the atlanto-occipital junction and between C1-C2; a laceration of the brain stem; lacerations of the spinal cord just below the medulla and between C1-C2; subarachnoid hemorrhage at the base of the brain; lacerations of the vertebral arteries at the C1-C2 level; laceration of the larynx; laceration of the trachea; contusions on his chin, left mandible and neck; and causing him to bite his tongue. As the front right passenger air bag expanded, the air bag's fabric contacted the occupant's face, neck, chest, and arms, causing: contusions of his right lung; and abrasions on the right side of his forehead, near his right eye, anterior neck bilaterally, left shoulder, upper chest and his right and left arms. The expanding air bag lifted him further upward and pushed him rearward against the adult front right passenger. The child passenger's torso was most likely compressed between the air bag and the adult front right passenger, who was moving forward into the child's back. This compression caused: fractures of right ribs 1 - 10 posteriorly, adjacent to the vertebrae; laceration of the right pleura with fractured rib edges protruding into the pleural cavity; a laceration of the liver; a laceration of the splenic capsule; and a broad band of contusion across his lower neck posteriorly. The case vehicle rotated approximately 75 degrees clockwise to final rest. Although the exact posture of the child at final rest is unknown, presumably the out-of-position front right passenger either remained within the front right adult passenger's grasp or was "grabbed" by the front right passenger shortly thereafter. In either case, according to the statements on the Police Crash Report, the child was removed from the vehicle and laid on the pavement.

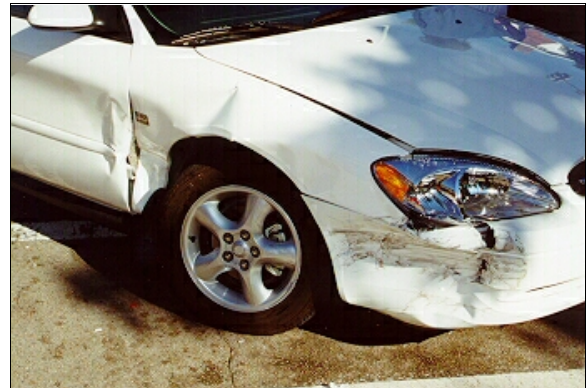
Based on a police inspection of the Ford and police photographs, the case vehicle's initial contact with the Ford involved the front fender and forward most edge of the front right passenger door (**Figures 7 and 8**). Direct damage extended from the left front bumper corner rearward to the right front door. Based on the available photographs, the CDC for the Ford is estimated as: **01-RFEW-2 (040)**. The WinSMASH reconstruction program, CDC only algorithm based on the estimated CDCs for the two vehicles, was used. The Total, Longitudinal, and Lateral Delta Vs are, respectively: 25 km.p.h. [15.5 m.p.h.], -19 km.p.h. [-11.8 m.p.h.], and -16 km.p.h. [-9.9 m.p.h.].

Figure 7: On-scene front of left view of damage to Ford's right front from impact with case vehicle; Note: direct damage begins near right front corner (case photo #31)

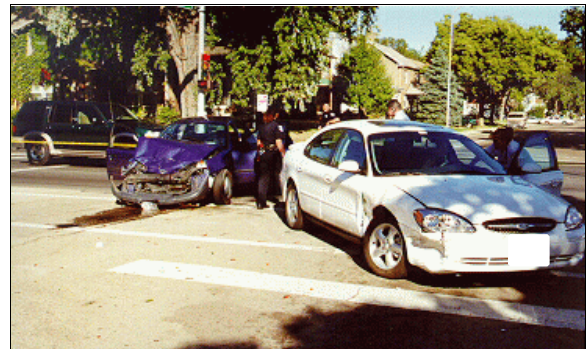
Figure 8: On-scene view looking east-northeast at case vehicle's (left) and Ford's (foreground, right) final rest positions (case photo #06)
