## ON-SITE ADVANCED OCCUPANT PROTECTION SYSTEM INVESTIGATION

CASE NUMBER - IN01-012  
LOCATION - MISSOURI  
VEHICLE - 2001 FORD TAURUS SES  
CRASH DATE - April, 2001

September 19, 2002

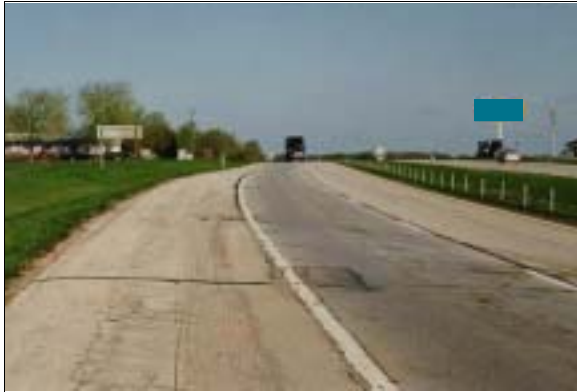
The case vehicle was traveling east in a left-hand curve in the outside eastbound lane of a four-lane, divided, U.S. Interstate trafficway (**Figure 1** below) and presumably intended to

**Figure 1:** On-scene westerly view from front of where Peterbilt truck-tractor was stopped and disabled showing case vehicle's pre-crash travel path in left-hand curve; Note: evidence indicates that case vehicle's driver failed to negotiate the curve (case photo #51)

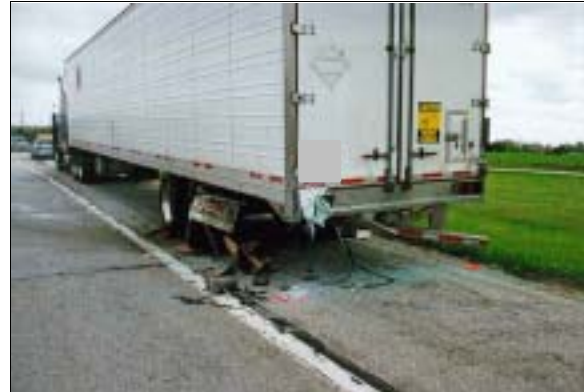
**Figure 2:** On-scene view looking southeastward at damage to trailer portion of tractor-trailer that was stopped and disabled along south shoulder; Note: windshield glazing hanging from trailer's left rear door (case photo #42)

The front (**Figure 3** above) of the case vehicle impacted the back left of the Wabash semi-trailer (**Figure 2** above), causing the case vehicle's driver and front right passenger supplemental restraints (air bags) to deploy. The case vehicle's front end initially contacted the trailer's underride guard, bending it under (**Figure 4**), before continuing under the trailer and impacting the rear tandem wheels. Upon impacting the left rear tandem wheels, the case vehicle rotated approximately 35 degrees clockwise off the trailer and moved in a east-northeasterly direction before coming to rest (**Figures 5 and 6**) in the inside eastbound through lane, heading southeastward.

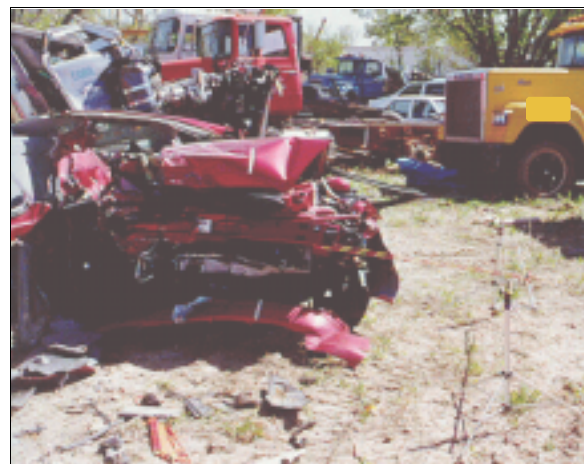
**Figure 3:** Reference line view from right showing case vehicle's severe frontal deformation and rightward end displacement (case photo #11)

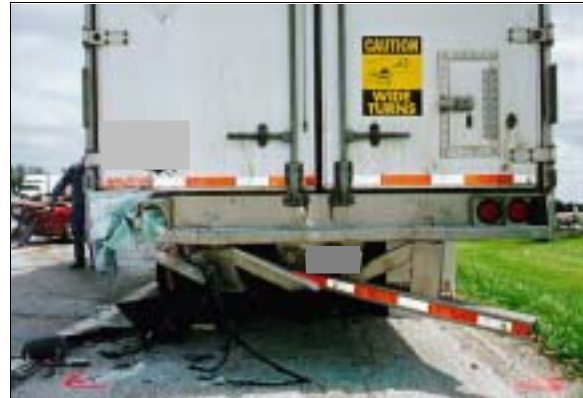
**Figure 4:** On-scene view looking east at damage to stopped trailer's back surface and underride guard (case photo #43)

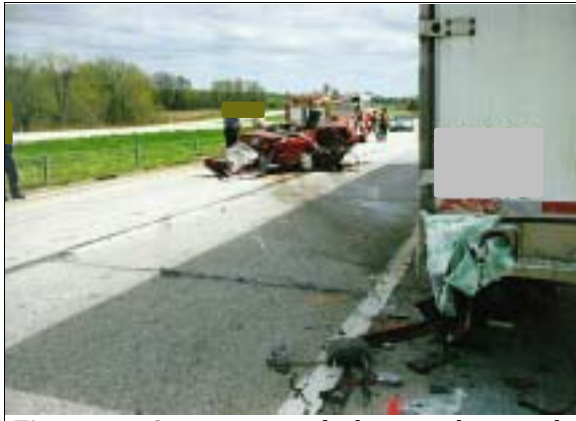
**Figure 5:** On-scene view looking northeastward showing distance from case vehicle's impact with trailer's back to area of final rest (case photo #44)

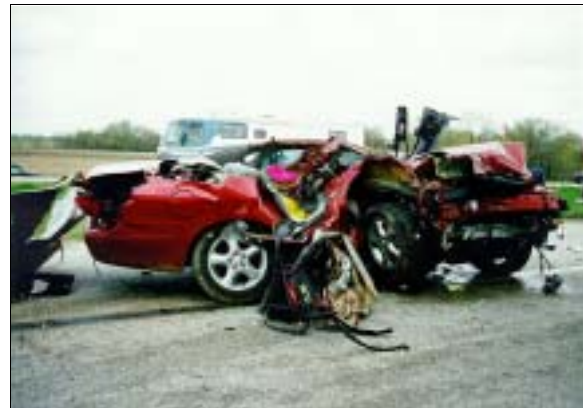
**Figure 6:** On-scene view of case vehicle at final rest, straddling the inside eastbound lane heading southeastward; Note: roof peeled back from severe underride damage (case photo #49)

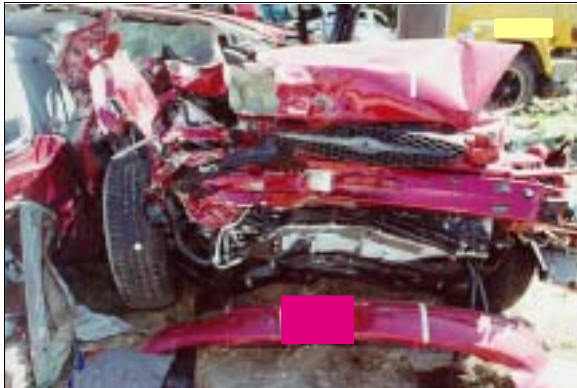
**Figure 7:** Close-up of case vehicle's severe frontal damage; Note: tape indicates direct damage width (case photo #05)

The case vehicle's initial contact with the trailer involved approximately the right two-thirds of its front (**Figures 7 and 8**). Direct damage began 34 centimeters (13.4 inches) left of the vehicle's center line (toward driver's side) and extended, a measured distance of 110 centimeters (43.3 inches), to the front right bumper corner (i.e., passenger's side—**Figure 7**). The case vehicle's off-set impact resulted in the whole front end being displaced to the right approximately 90

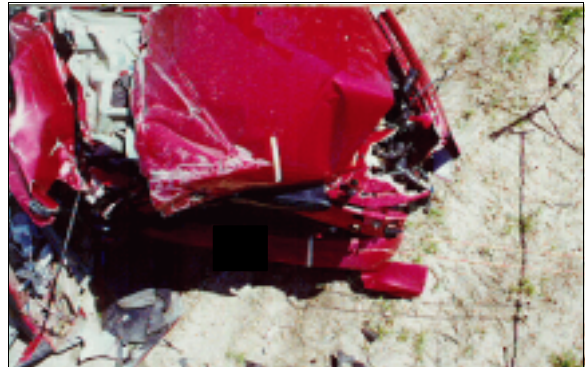
**Figure 8:** Overhead view of case vehicle's severe frontal damage with contour gauge present; Note: front has narrow field "L" that faces primarily downward (case photo #09)

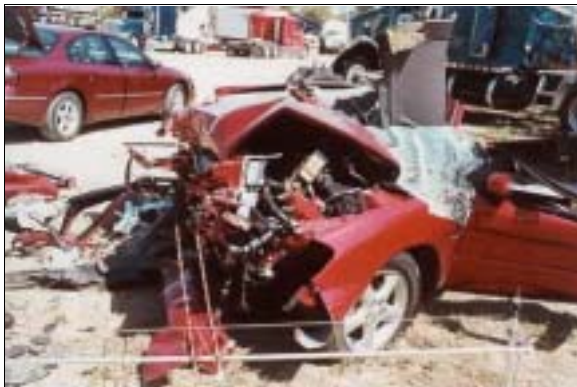
**Figure 9:** Frontal view of damage to case vehicle's front with contour gauge present; Note: narrow field "L" because front end was displaced almost 90 degrees to the right (case photo #08)

degrees (**Figure 9** above). Maximum crush was measured as 214 centimeters (84.3 inches) at C<sub>2</sub>. It should be noted that because of the displacement of the front left bumper, only two C-measurements could be made (**Figures 8** and **9** above). The wheelbase on the case vehicle's right side was shortened 147 centimeters (57.9 inches) while the left side was extended 14 centimeters (5.5 inches). The case vehicle's front bumper, bumper fascia, grille, hood, radiator, right fender, and right headlight and turn signal assemblies and were directly damaged and crushed rearward. The direct damage width above the bumper at the roof line was approximately 74 centimeters (29.1 inches). The case vehicle's underride impact with the trailer was so severe, that the entire roof along with the right "A", "B", and "C"-pillars were peeled back from the front windshield header rearward to the case vehicle's right rear bumper corner (**Figure 10** above). The entire right front door and right rear door skins were also pulled off the case vehicle. The case vehicle's left and right front tires were physically restricted with the right front tire being deflated. The right front tire was pushed backwards into the front right occupant seating area. The left headlight and turn signal assemblies sustained induced damage as well as the left fender. Remote buckling was also found on the driver's door and the roof.

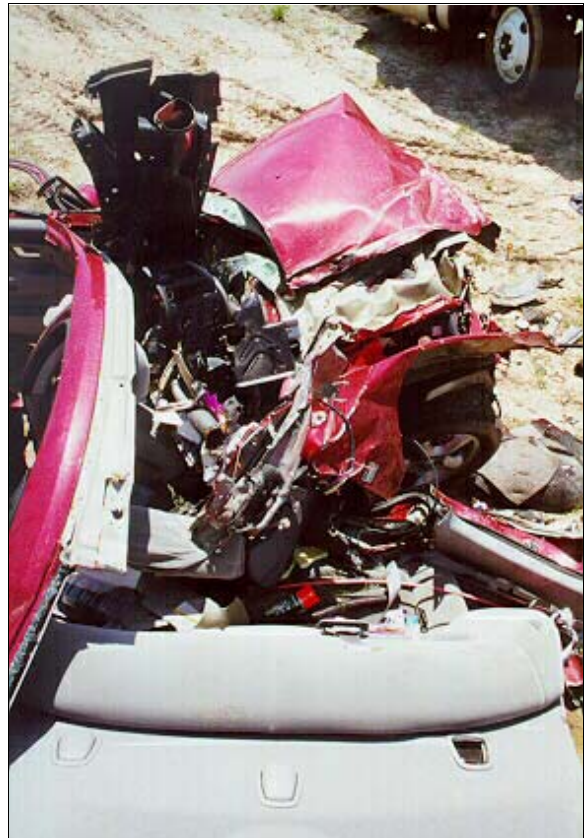
**Figure 10:** Overhead view of case vehicle's severe frontal deformation and intrusion; Note: photo taken while standing on trunk (case photo #40)

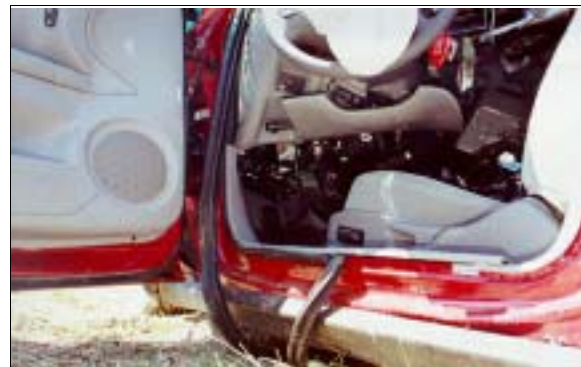
Inspection of the case vehicle's interior revealed two other areas that indicated evidence driver contact. The driver's knee bolster showed scuffs, evidence of contact by the driver's knees (**Figure 11**), and the right instrument panel revealed blood and skin, most likely from contact with the driver's upper body (**Figures 12** and **13** below). Furthermore, there was an area of unknown body fluid splattered on the rear surface of the back seat's back support that was initially suspected to be brain matter; however, the available injury information does not support that possibility. Finally, the intrusion was catastrophic to the majority of the case vehicle's front occupant seating areas (**Figure 14** below), but there was no deformation to the steering wheel rim. The steering wheel's shear capsule and break-away coupling were both completely separated.

**Figure 11:** Intrusion and deformation to case vehicle's lower instrument panel and knee bolster for driver's seating area (case photo #25)

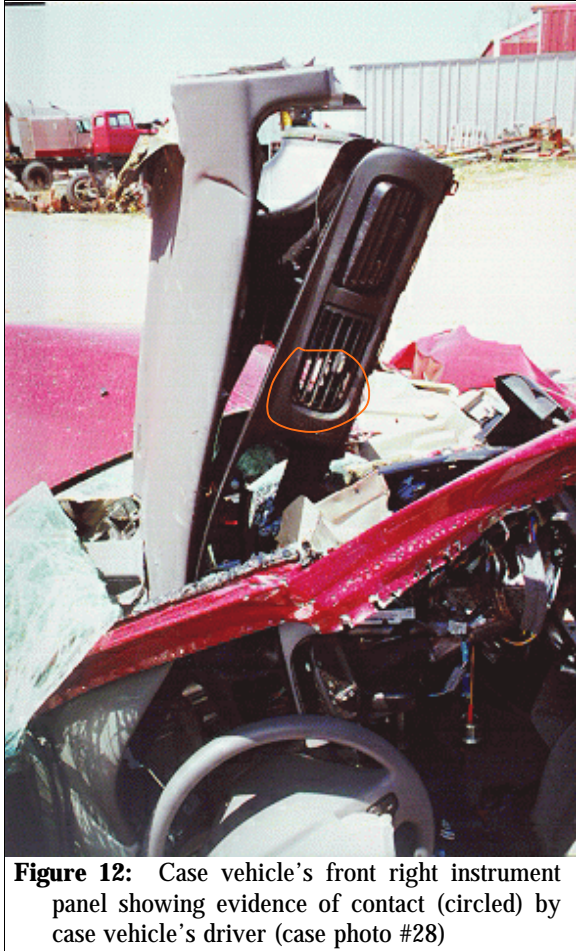
**Figure 12:** Case vehicle's front right instrument panel showing evidence of contact (circled) by case vehicle's driver (case photo #28)

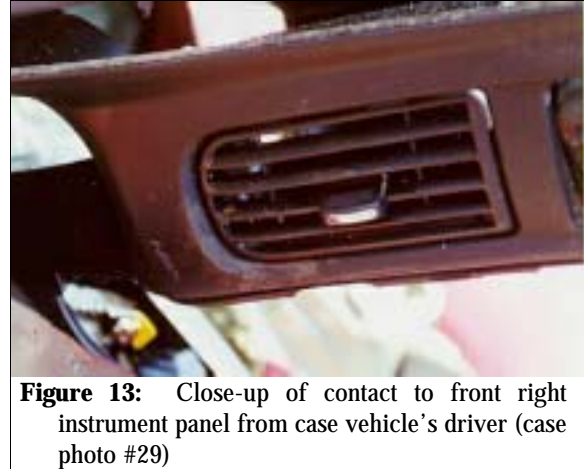
**Figure 13:** Close-up of contact to front right instrument panel from case vehicle's driver (case photo #29)

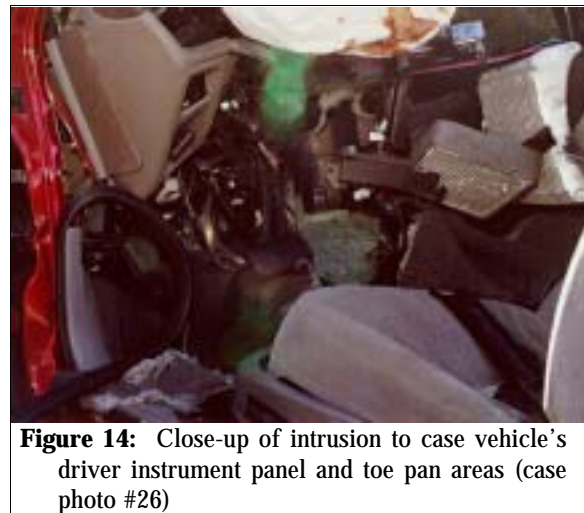
**Figure 14:** Close-up of intrusion to case vehicle's driver instrument panel and toe pan areas (case photo #26)

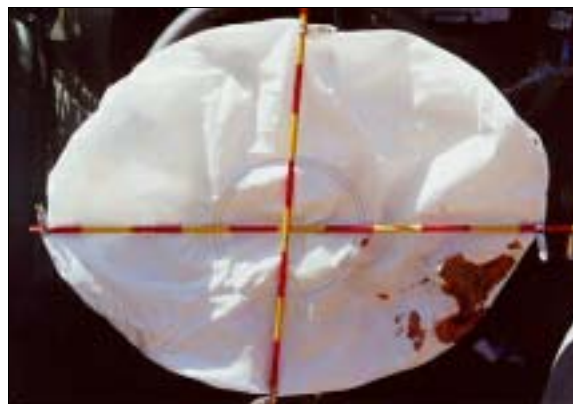
toward the 4 o'clock position. In addition, there were scattered blood spots on the perimeter of the driver's air bag. There were two spots located near the 6 o'clock and a large bloody area between the 4 and 5 o'clock positions (**Figure 15**).

**Figure 15:** Case vehicle's driver air bag showing only a blood transfer on air bag (case photo #32)

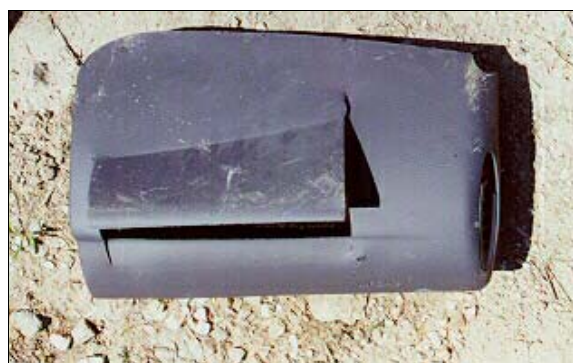
The front right passenger's air bag was located in the top of the instrument panel. There was a single, essentially trapezoidal, modular cover flap. The cover flap was made of a thick vinyl over a thick cardboard type frame. The flap's dimensions were: 27.5 centimeters (10.8 inches) at the forward horizontal seam, 13 centimeters (5.1 inches) along the right vertical seam, and 9 centimeters (3.5 inches) along the left vertical seam. The distance along the angled rear (i.e., toward the windshield) horizontally oriented seam was not recorded. The profile of the case vehicle's instrument panel resulted in a 3 centimeter (1.2 inch) setback of the leading edge of the cover flap relative to the protruding right instrument panel. An inspection of the front right air bag module's cover flap and air bag fabric revealed that the top portion of the right instrument panel, including the entire air bag module, had been torn out of the instrument panel (**Figure 16**) as the vehicle underrode the Wabash semi-trailer. The inspection further revealed that the cover flaps opened at the designated tear points, and there was no evidence of damage during the deployment to the cover flap. However, the air bag's fabric showed discoloration (**Figure 17**), but the origin of the discoloration is unclear (e.g., possibly contact with the under surface of the roof's head liner). Furthermore, the air bag's vent port was torn open (**Figure 18** below) an additional 8 centimeters (3.1 inches).

**Figure 16:** Close-up of case vehicle's right instrument panel which was torn off during underide of trailer; Note: front right air bag module's cover flap (case photo #38)

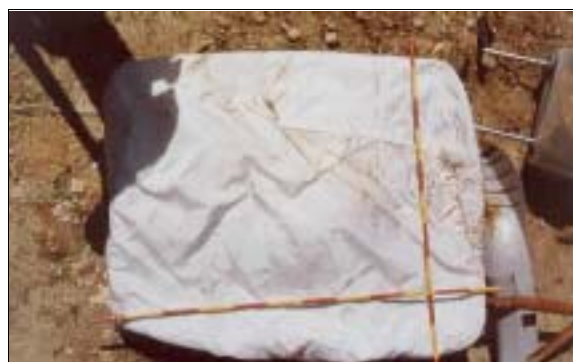
**Figure 17:** Front surface of case vehicle's front right passenger air bag showing discoloration to air bag's fabric as a result of crash (case photo #36)

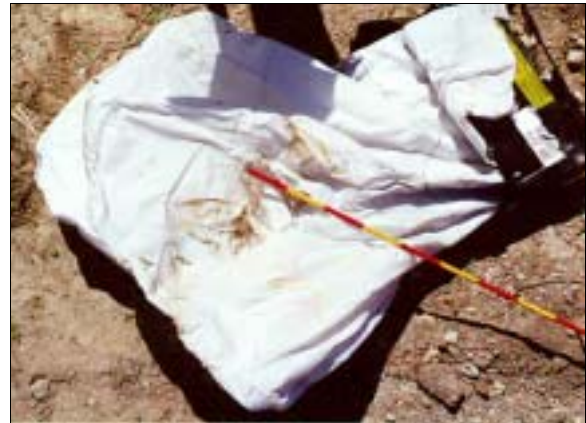
The front right passenger air bag was designed without any tethers. The front right air bag had one vent port, approximately 5 centimeters (2.0 inches) in diameter, located at the 2 o'clock position. The deployed front right air bag was rectangular with a height of approximately 41 centimeters (16.1 inches) and a width of approximately 58 centimeters (22.8 inches). An inspection of the front right passenger's air bag fabric reveal that there was no contact evidence readily apparent on the air bag's fabric.

**Figure 18:** Case vehicle's deployed front right passenger air bag and removed air bag module showing tear to vent port (case photo #35)

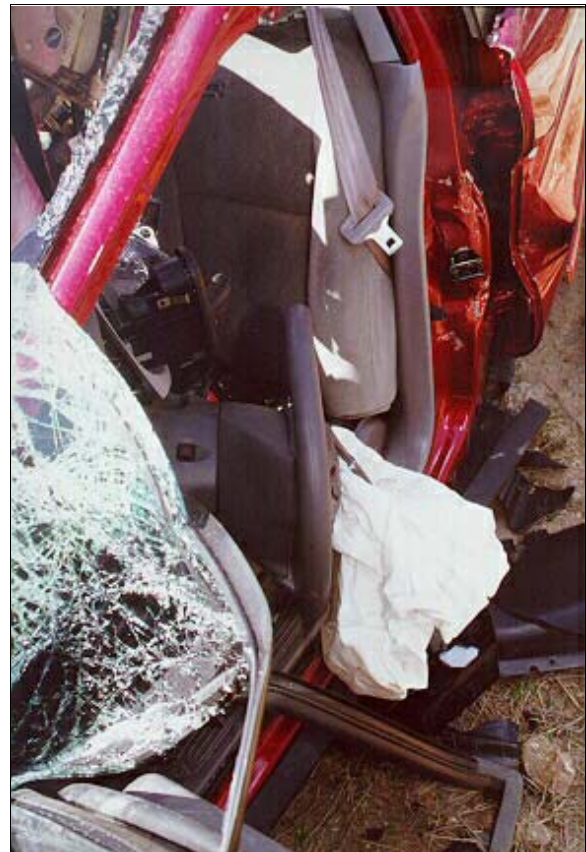
Immediately prior to the crash, the posture of the case vehicle's driver (173 centimeters and 56 kilograms (68 inches, 123 pounds)) is unknown but, presumably, she was seated in an upright posture with her back against the seat back, her left foot on the floor, her right foot on the accelerator, and at least one hand on the steering wheel. Her seat track was located between its middle and forward-most positions, the seat back was upright, and the exact position of the tilt steering wheel could not be determined because of the intrusion and deformation (**Figure 19**).

**Figure 19:** Case vehicle's steering wheel and driver air bag viewed while looking rearward down left side of vehicle (case photo #27)

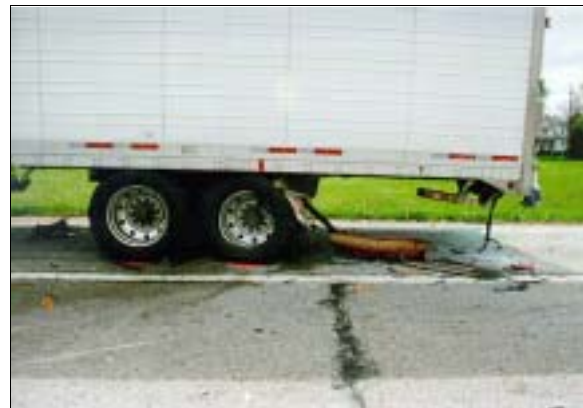
**Figure 20:** On-scene view looking southward at struck trailer showing trailer's underride damage and case vehicle's forward penetration to left rear tandem wheels; Note: rim damage to trailer's left back outside wheel (case photo #48)

Based on the vehicle inspection, the TDC for the semi-trailer was determined to be: **06-BLLE-A (180)**. The Peterbilt truck-tractor was driven from the scene, but the Wabash semi-trailer was towed due to damage. It should be noted that the semi-trailer's underride guard was completely ineffective in preventing the case vehicle's forward penetration.
