INDIANA UNIVERSITY

ON-SITE REDESIGNED AIR BAG INVESTIGATION

CASE NUMBER - IN01-013
LOCATION - MISSOURI
VEHICLE - 1998 CHEVROLET BLAZER
CRASH DATE - April, 2001

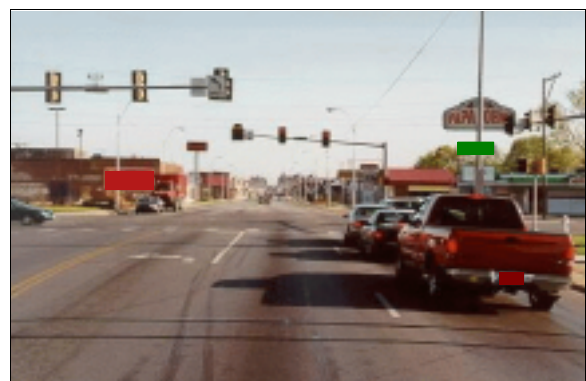
Figure 1: Case vehicle's northward path of travel in inside northbound lane (case photo #01)

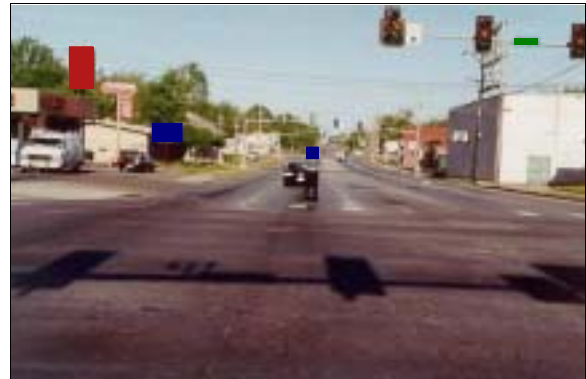
Figure 2: Westward view of Mazda's eastbound path of travel in inside eastbound lane—where police officer is standing (case photo #11)

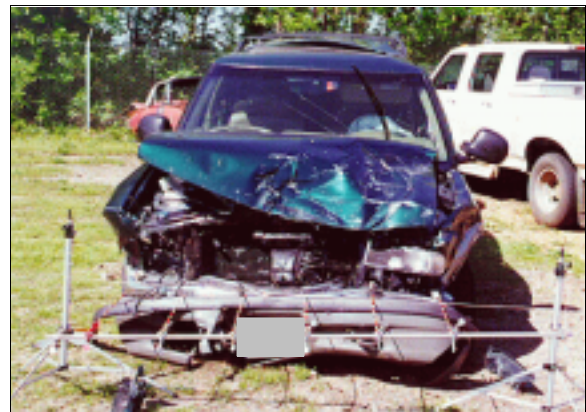
Figure 3: Case vehicle's frontal damaged from impact with Mazda's right side with contour gauge present (case photo #12)

The case vehicle’s initial contact with the Mazda involved the entire front (**Figure 3** above and **Figure 13**). Direct damage extended from bumper corner to bumper corner, a measured distance of 142 centimeters (55.9 inches). Residual maximum crush for frontal (“most severe”) impact was measured as 53 centimeters (20.9 inches) at C₆ (**Figure 7** above). The wheelbase on the case vehicle’s left side was shortened 3 centimeters (1.2 inches) while the right side was shortened 7 centimeters (2.8 inches). The case vehicle’s front bumper, bumper fascia, grille, hood, radiator, right and left headlight and turn signal assemblies, and left fender were directly damaged and crushed rearward (**Figures 3** and **7** above and **Figure 13**). The case vehicle’s left and right front tires were physically restricted from the crash. The windshield was cracked and both the right and left fenders sustained induced damage as well.

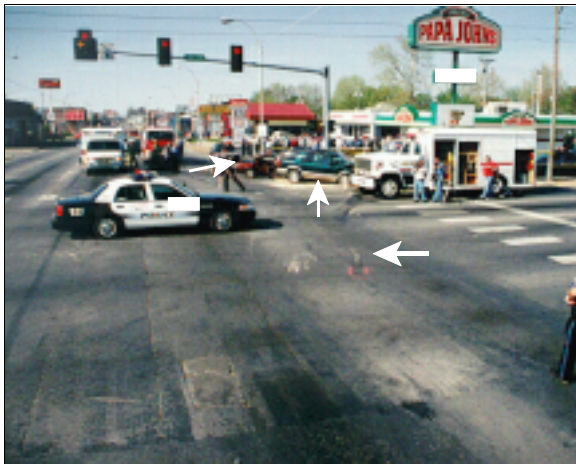
Figure 5: On-scene elevated view of crash scene looking north with vehicles at final rest positions off northeast corner of intersection; Note: impact evidence towards center of intersection (case photo #50)

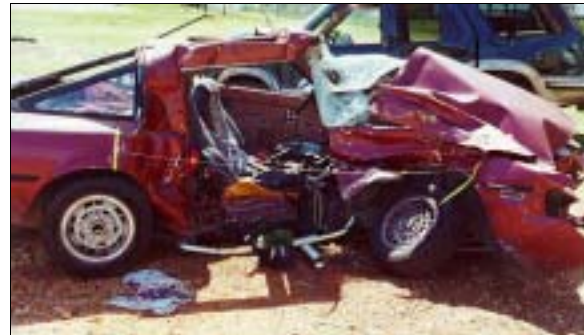
Figure 4: Mazda's struck right side; Note: tape indicates width of direct damage (case photo #44)

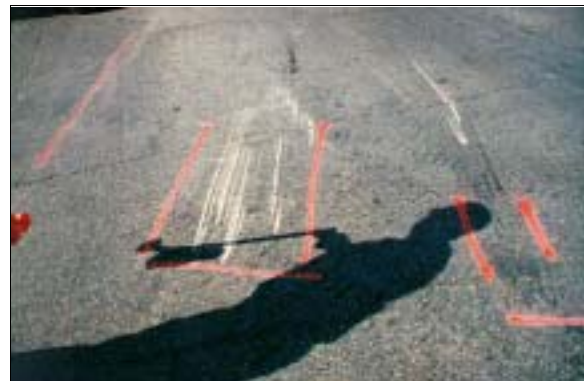
Figure 6: Close-up on-scene view looking north at Mazda's left front tire (right) and undercarriage scraping (center) on asphalt surface at maximum engagement (case photo #50b)

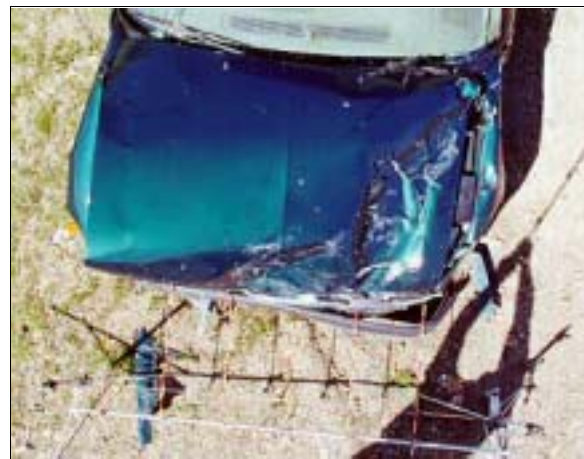
Figure 7: Overhead view of case vehicle's frontal deformation from impact with Mazda's right side; Note: damage atop hood from Mazda's right front door and quarter panel (case photo #13)

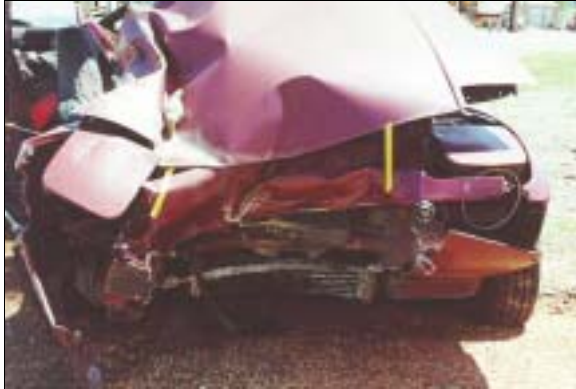
Figure 8: Mazda's frontal deformation from pole impact; Note: tape indicates width of direct damage (case photo #37)

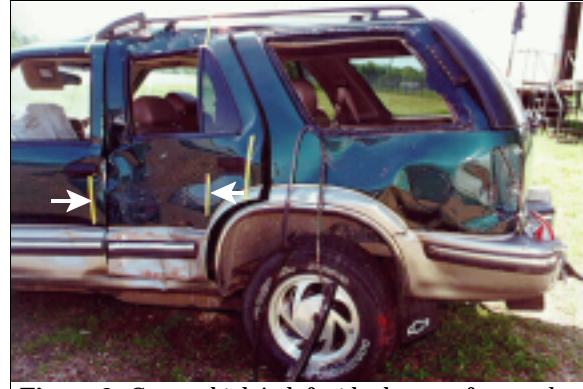
Figure 9 Case vehicle's left side damage from pole (vertical tape and arrows) and side slap impact to left back from Mazda (case photo #20)

doors, left roof, and left quarter panel were directly damaged and crushed inward. Furthermore, the glazing along the entire left side was disintegrated from the two side impacts (**Figure 9** above).

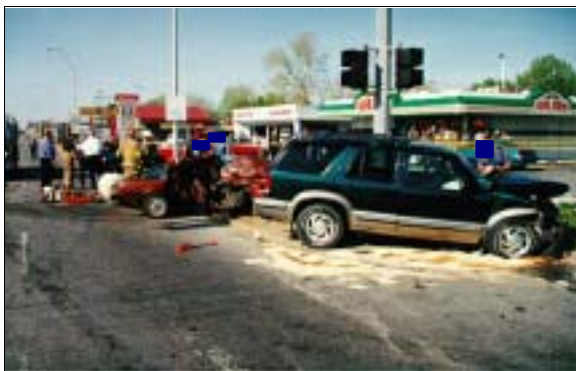
Figure 10: On-scene view looking northeast at case vehicle (foreground) and Mazda (background) at final rest positions (case photo #50c)

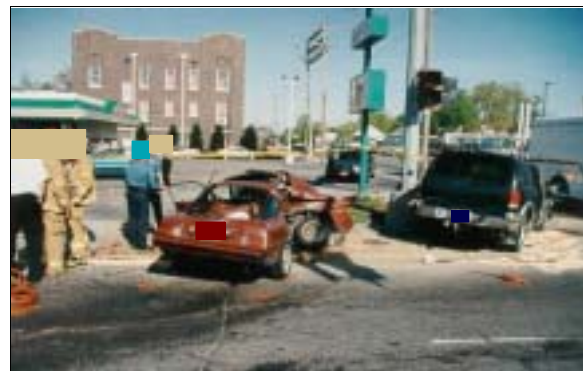
Figure 11: On-scene view looking east-southeast at final rest positions of case vehicle and Mazda (case photo #51)

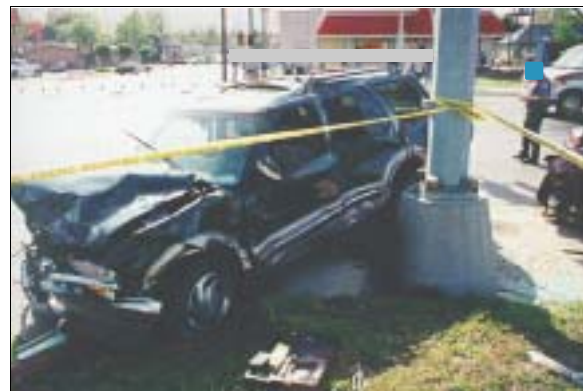
Figure 12: On-scene view looking west showing case vehicle at final rest (case photo #52)

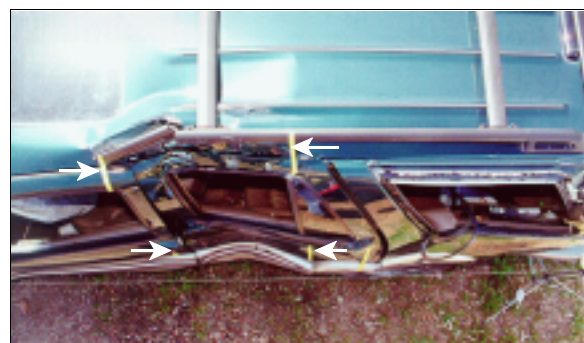
Figure 14: Overhead view of damage from case vehicle’s two left side impacts; Note: tape and arrows indicate width of contact from pole impact (case photo #21)

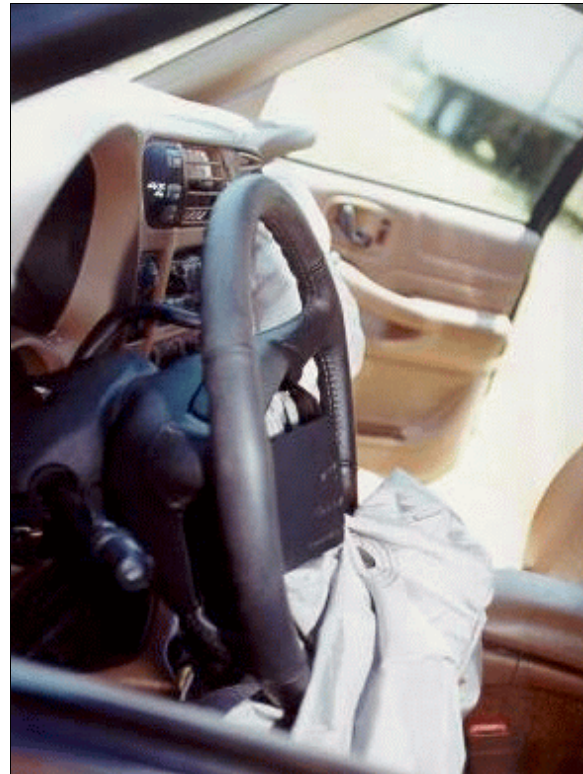
Inspection of the case vehicle's interior revealed that the upper portion of the steering wheel rim was bent toward the left instrument panel, 3 centimeters (1.2 inches), as a result of the driver loading the air bag, momentarily blocking the air bag's forward expansion, and causing the air bag to expand against and bend the steering wheel rim (**Figure 15**). Furthermore, there was scuffing and deformation to the driver's knee bolster, just to the right of the steering column (**Figure 16**), and a crack and scuff to the driver's door armrest which most likely resulted from the minor intrusion that occurred to the case vehicle's left front door, left "B"-pillar, and left rear door panel from the case vehicle's left side impacts. Finally, the energy absorbing steering column showed no evidence of compression.

Figure 15: Case vehicle's steering wheel showing bending to the top portion from occupant loading (case photo #31)

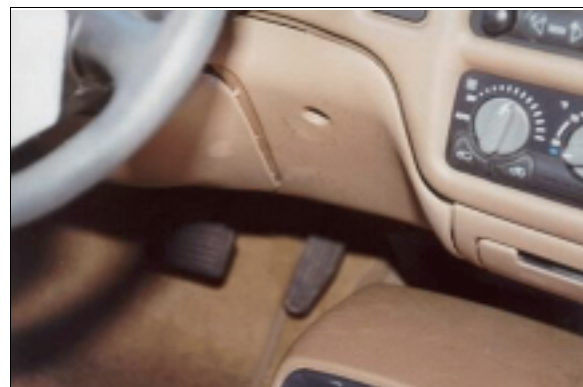
Figure 16: Case vehicle's driver knee bolster on right side of steering column showing scuff and deformation from driver's knee (case photo #33)

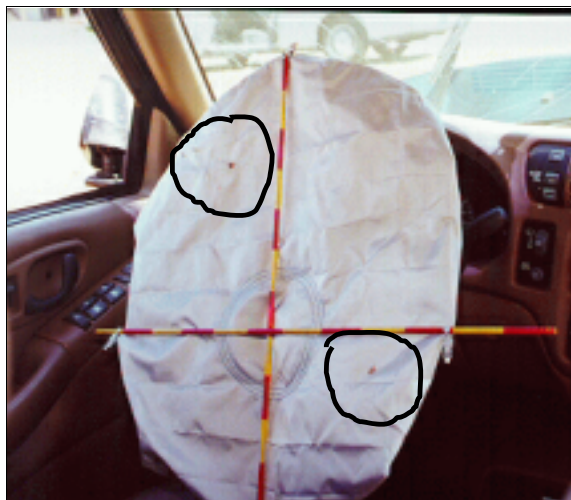
centimeters (3.7 inches) vertically. An inspection of the air bag module's cover flaps and the air bag fabric revealed that the cover flaps opened at the designated tear points, and there was no evidence of damage during the deployment to the air bag or the cover flaps. The driver's air bag was designed with two tethers, each approximately 12 centimeters (4.7 inches) in width. The driver's air bag had two vent ports, approximately 2.5 centimeters (1.0 inches) in diameter, located at the 11 and 1 o'clock positions. The deployed driver's air bag was round with a diameter 62 centimeters (24.4 inches). An inspection of the driver's air bag fabric revealed a skin transfer to the center of the air bag and two small areas with blood and oily transfer. One was located in the upper left quadrant (11 o'clock position) and the other just to the right of center toward the 3:30 o'clock position (**Figure 17**).

Figure 17: Case vehicle's deployed driver air bag highlighting two areas of blood (case photo #27)

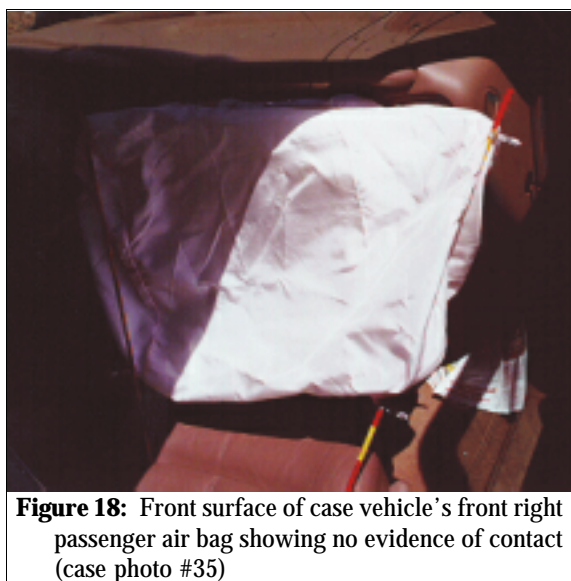
The front right passenger's air bag was located in the middle of the instrument panel. There was a single, essentially rectangular, modular cover flap. The cover flap was made of a thick vinyl over a thick cardboard type frame. The flap's dimensions were 32 centimeters (12.6 inches) at the lower horizontal seam and 13.5 centimeters (5.3 inches) along both vertical seams. The profile of the case vehicle's instrument panel was flush with the leading edge of the cover flap. An inspection of the front right air bag module's cover flap and the air bag's fabric revealed that the cover flap opened at the designated tear points, and there was no evidence of damage during the deployment to the air bag or the cover flap. The front right passenger's air bag was designed without any tethers. The front right air bag had two vent ports, approximately 5 centimeters (2.0 inches) in diameter, located at the 10 and 2 o'clock positions. The deployed front right air bag was rectangular with a height of approximately 41 centimeters (16.1 inches) and a width of approximately 57 centimeters (22.4 inches). An inspection of the front right passenger's air bag fabric revealed that there was no contact evidence readily apparent on the air bag's fabric (**Figure 18**).

Figure 18: Front surface of case vehicle's front right passenger air bag showing no evidence of contact (case photo #35)

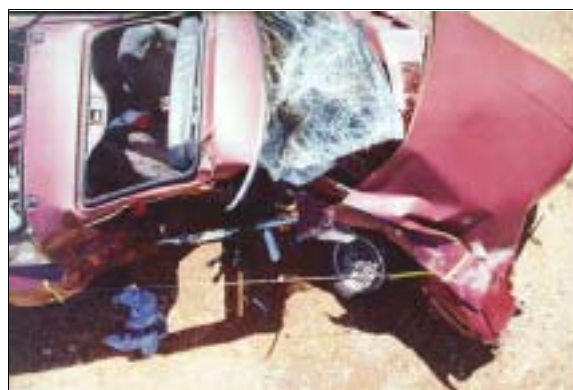
The Mazda’s initial contact with the case vehicle involved its right side. Direct damage began 9 centimeters (3.5 inches) forward of the right rear axle and extended, a measured distance of 190 centimeters (74.8 inches), further forward along the right side and onto the right fender (**Figure 4** above and **Figure 19**). Maximum crush for the Mazda’s most severe impact was measured as 71 centimeters (28.0 inches) at C₄. The wheelbase on the Mazda’s left side was extended approximately 20 centimeters (7.9 inches) while the right side was shortened approximately 72 centimeters (28.3 inches).

Figure 19: Overhead view of Mazda’s extensive right side damage and passenger compartment intrusion; Note: yellow tapes indicates width of direct damage (case photo #45)

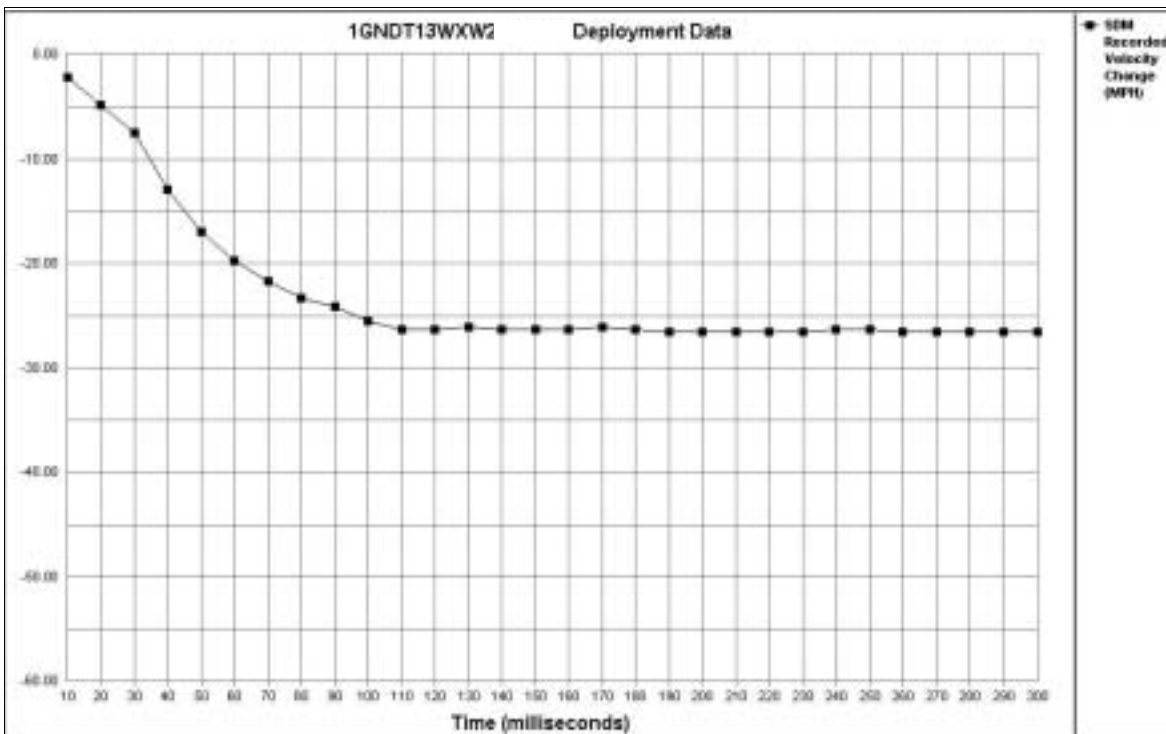
Figure 21: The case vehicle sustained a velocity change of approximately 42 km.p.h. (26 m.p.h.) during the first 110 milliseconds after the crash was detected

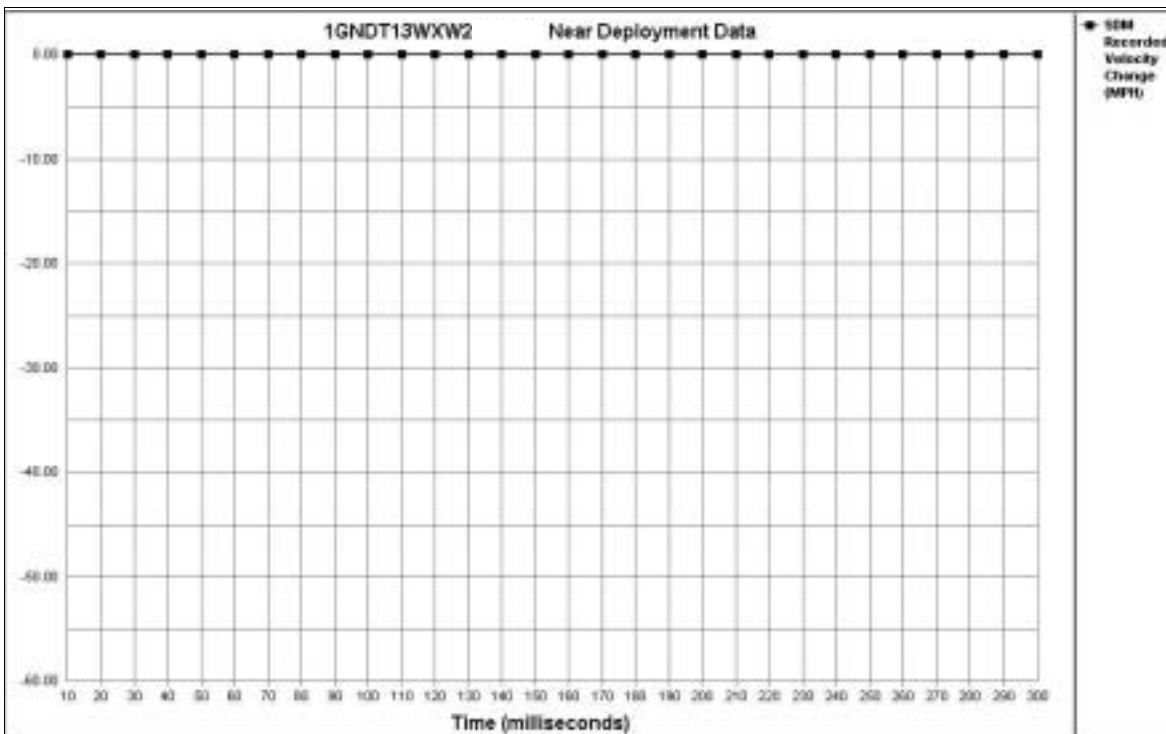
Figure 23: The case vehicle sustained a velocity change of approximately 0 km.p.h. (0 m.p.h.) during the entire 300 milliseconds recorded after the near deployment was detected
