**SIDE IMPACT OCCUPANT PROTECTION INVESTIGATION**

**VERIDIAN CASE NO. CA01-013**

**VEHICLE - 2001 GMC YUKON XL K1500 4X4**

**CRASH DATE - JANUARY, 2001**

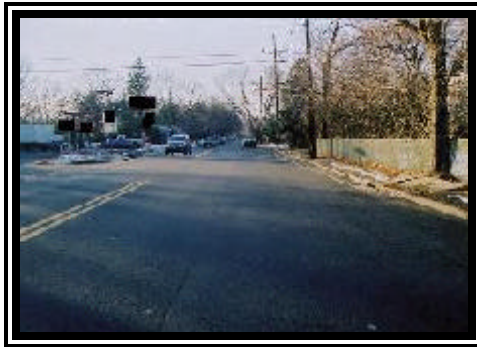
The 37 year old female driver of the 2001 GMC Yukon XL was operating the vehicle westbound (**Figure 1**) at a (vehicle recorded) speed of 71 km/h (44 mph) when she observed the eastbound Pontiac Firebird "fishtail" into her lane of travel. The GMC driver further stated that the left rear section of the Pontiac encroached into the westbound lane during his (*Pontiac driver's*) attempts to regain

**Figure 1. Westbound approach for the 2001 GMC Yukon XL.**

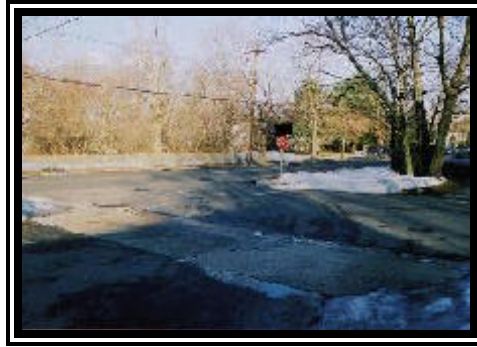
The 26 year old male driver of the 1975 Pontiac Firebird was operating the vehicle in a northeasterly direction when he exited a service station adjacent to the 3-leg intersection and attempted a right turn (east) onto the two lane roadway (**Figure 2**). The Pontiac driver reported to police that he encountered a wet spot in the road which allowed the vehicle to spin out and subsequently enter the westbound lane.

**Figure 2. Northeasterly approach for the 1975 Pontiac Firebird.**

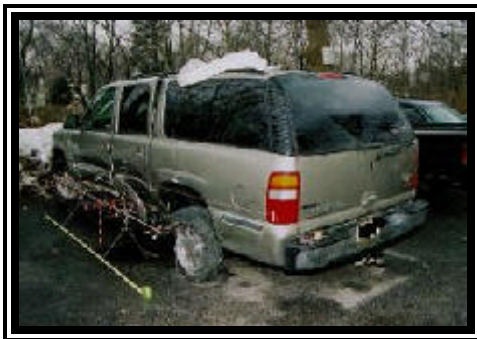
The 2001 GMC Yukon XL sustained moderate left side surface damage as a result of the impact with the Pontiac Firebird (**Figures 3 & 4**). The direct contact damage began 19.0 cm (7.5 in) forward of the left rear axle and extended 220.0 cm (86.6 in) forward. The combined direct and induced damage length (Field L) began 5.0 cm (2.0 in) forward of the left rear axle and extended 285.0 cm (112.2 in) forward. Six crush measurements were documented at the level of the lower door: C1= 0 cm, C2= 17.0 cm (6.7 in), C3= 19.0 cm (7.5 in), C4= 17.0 cm (6.7 in), C5= 12.0 cm (4.7 in), C6= 0 cm. A maximum crush value of 21.0 cm (8.3 in) was identified 19.0 cm (7.5 in) aft of the C3 position. The Collision Deformation Classification (CDC) for this impact to the GMC was 10-LZEW-2 with a principal direction of force of (-)50 degrees. Red paint transfers were noted along the direct contact damage. A rubber transfer was documented along the level of the frame attributed to the left front tire of the opposing Pontiac. Both left side doors were jammed as all tempered glazing (and laminated windshield glazing) remained undamaged. The left rear tire was deflated (not restricted) with contact damage noted to the rim. Induced contact damage produced 6.0 cm (2.4 in) of outward buckling to the left rear door upper window frame.

**Figure 3.** Left side surface damage to the 2001 GMC Yukon XL K1500 4x4.

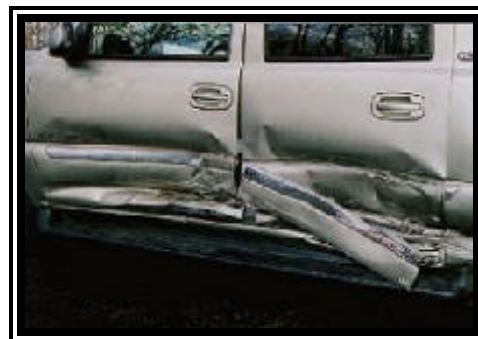
**Figure 4.** Close up view of the direct contact damage.

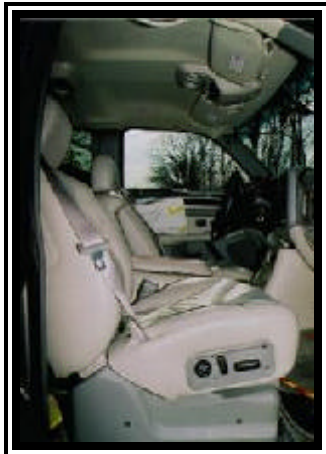
Interior damage to the GMC Yukon identified through the vehicle inspection was minimal and was attributed to occupant contact and component intrusion (**Figures 5 & 6**). Small scuff marks were documented on the left front door panel/armrest from driver contact and upper left door panel area from the side impact air bag deployment. Lateral intrusions into the driver space involved 8.0 cm (3.1 in) of B-pillar, 7.0 cm (2.8 in) of door panel, 3.0 cm (1.2 in) of sill and 3.0 cm (1.2 in) of seat back intrusion. Lateral intrusions into the second row left passenger space involved 8.0 cm (3.1 in) of sill and 7.0 cm (2.8 in) of door panel intrusion.

**Figure 5. Interior view of the 2001 GMC Yukon front seating positions.**

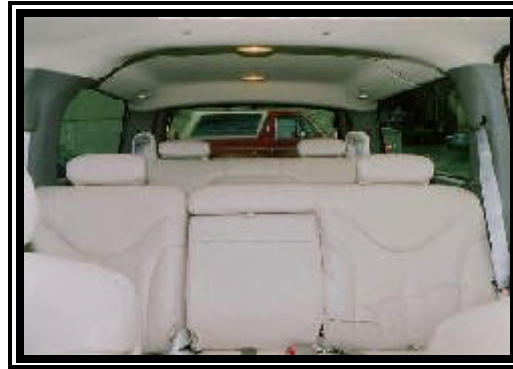
**Figure 6. Interior view of the 2001 GMC Yukon rear seating positions.**

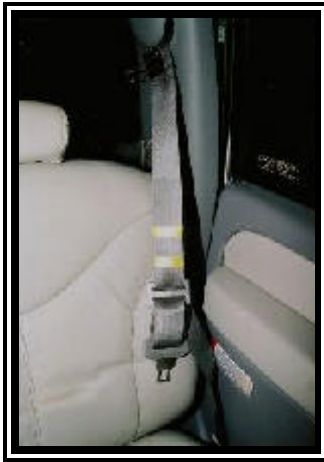
Figure 7. Loading marks to the second row left shoulder belt webbing.

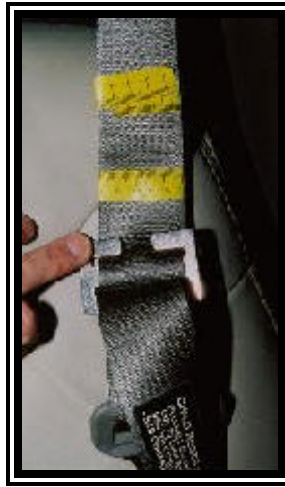
Figure 8. Close-up view of restraint webbing and CSS locking clip.

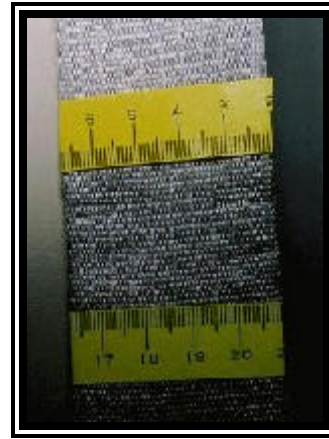
Figure 9. Close-up view of marks produced by CSS locking clip.

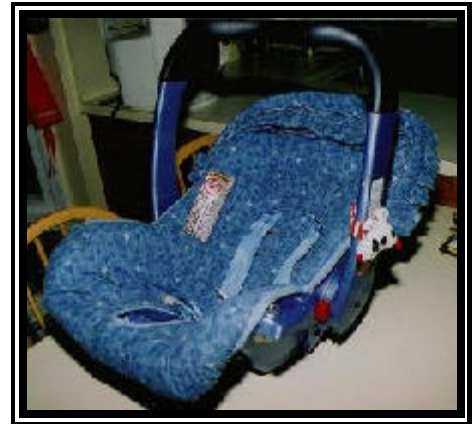
The infant passenger of the 2001 GMC Yukon XL was positioned in a rear-facing child safety seat (RFCSS) in the second row left seat of the vehicle. The child safety seat was manufactured by Century Products on 03/21/2000 and was identified as a Smartfit Plus (**Figure 10**) with a model number of 41321STD. The RFCSS consisted of a molded plastic shell with a folding carrying handle, fabric covered padding, and an integral 3-point harness system. A detachable base was provided with the RFCSS and was in use at the time of the crash. Warning labels were affixed to the shell of the seat with additional warning labels found on the vehicle sunvisors and restraint systems. There was no residual damage to the RFCSS as the shell did not yield evidence of contact (i.e., abrasions, fracture sites).

Figure 10. Century Smartfit Plus RFCSS.

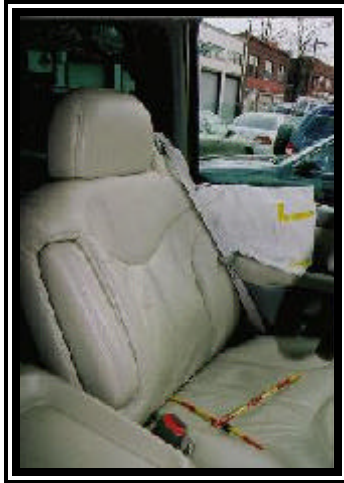
The GMC was also equipped with side impact air bags for the front seated positions. The air bag modules were housed in the outboard side aspect of the front seat backs with a vertically oriented flap tear seam which measured 9.3 cm (3.7 in) in width and 19.8 cm (7.8 in) in height. The left front side impact air bag deployed as a result of the crash (**Figure 11**). The air bag was rectangular in shape and

**Figure 11. 2001 GMC Yukon XL deployed side impact air bag.**

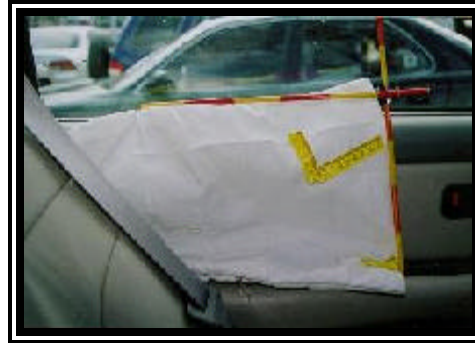
measured 42.3 cm (16.7 in) in width and 27.3 cm (10.7 in) in height in its deflated state (**Figure 12**). No vent ports or internal tether straps were present. A scuff mark was documented at the lower right quadrant of the air bag along with multiple striations at the upper right quadrant from expansion within the module. In addition, bag interaction by the driver produced the noted scuff marks to the upper door panel area. The side impact air bag sensors were located in the front door cavities just below the armrest area.

**Figure 12. Close-up view of the deployed side impact air bag.**

At impact, the driver initiated a lateral and forward trajectory in response to the 10 o'clock impact force and loaded the manual restraint and deployed side impact air bag. Contact to the deployed side impact air bag was evidenced by the scuff marks documented to the lower right quadrant of the air bag face. In addition, driver interaction with the bag produced the noted scuff marks to the upper door panel area. The manual belt system restrained her body as the subsequent counterclockwise vehicle rotation re-directed the kinematic pattern to the right. Following the impact, she exited the vehicle through the right front door (behind the front right passenger) and attended to the infant passenger. The driver was uninjured in the crash. The deployed side impact air bag provided protection against left side components, and potential injury.

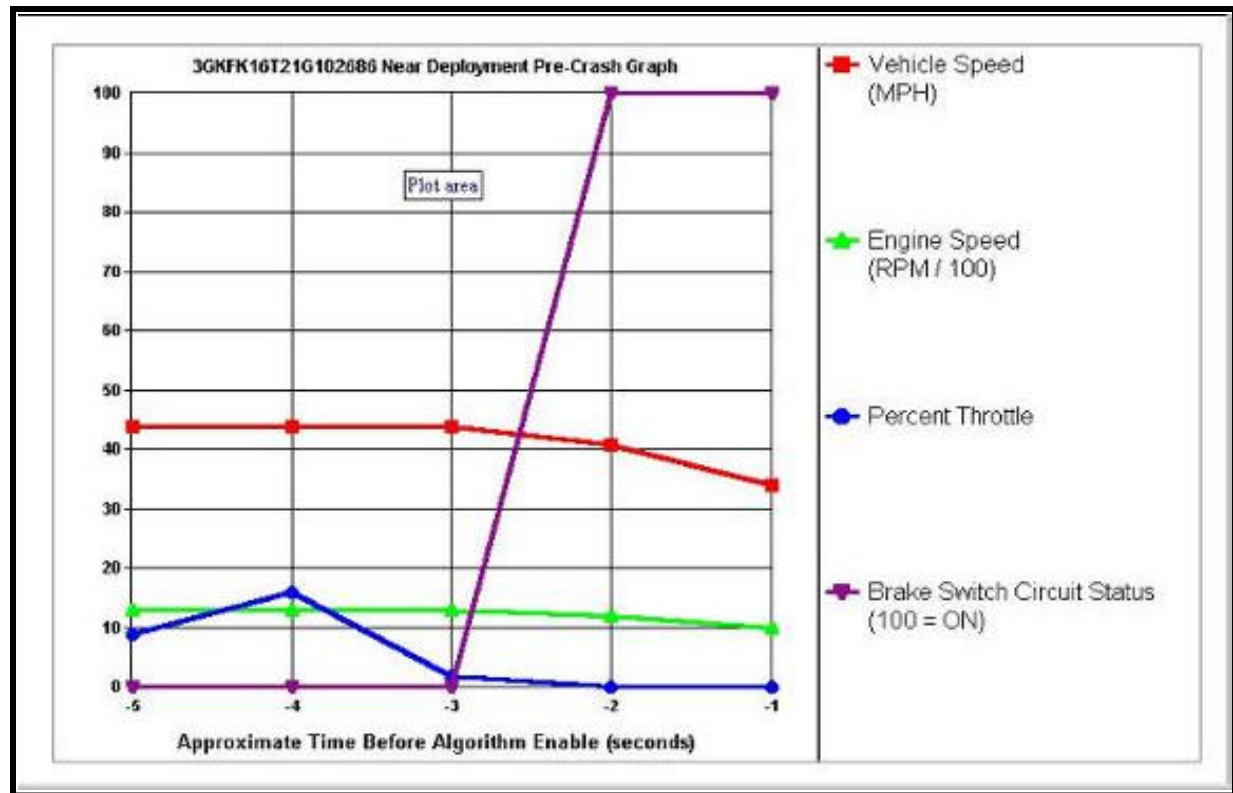
control of the vehicle following the right turn. At this point, multiple steering maneuvers by the Pontiac driver re-directed the vehicle's rotation as the front left area of the Pontiac re-entered the westbound lane into the path of the GMC. Although the GMC driver recalled no avoidance maneuvers in anticipation of the impending crash, the GMC's Event Data Recorder (EDR) logged active braking up to the point of impact (*as a near deployment event; see Figures 13 & 14 - page 9*).

The 2001 GMC Yukon XL SDM was located under the driver's seat as the event data was retrieved via the J1962 connector found to the left of the steering column. The EDR records deployment and near-deployment events for the frontal air bag system. In this crash, the EDR recorded a near deployment event at ignition cycle number 1406. The system status at near deployment reflected the driver's belt switch circuit status as "buckled". As the vehicle and engine speed decreased during the five second pre-crash interval, the brake switch circuit status went from "off" to "on" two seconds prior to algorithm activation.

Figure 14. 2001 GMC Yukon XL EDR report (near deployment event).
