ON-SITE SIDE IMPACT OCCUPANT PROTECTION INVESTIGATION

VERIDIAN CASE NO. CA01-018

VEHICLE: 2000 MERCEDES BENZ E320 STATION WAGON

CRASH DATE: JANUARY 2001

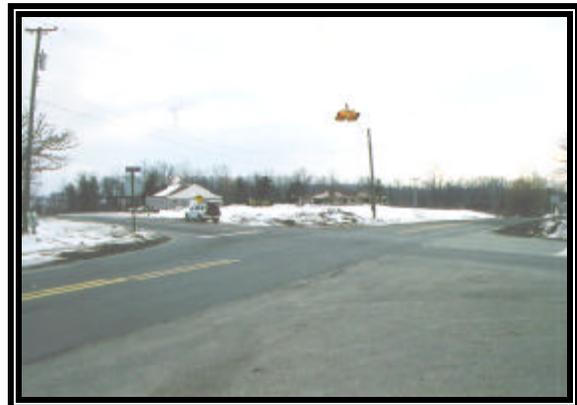
Figure 1: Southwest view into the intersection.

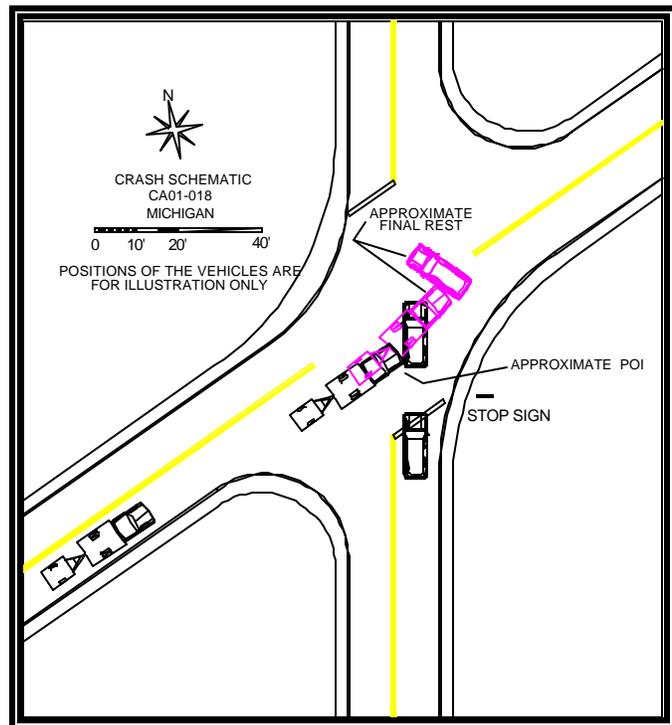
The crash occurred when the right aspect of the Chevrolet's front plane struck the left side plane of the Mercedes immediately aft of the left rear axle. The principle directions of force were 12 o'clock and 9 o'clock for the Chevrolet and Mercedes, respectively. The force of the impact rearward of the Mercedes' center-of-gravity caused it to rotate counterclockwise as it slid to rest. The Mercedes came to rest facing northwest within the intersection. The Chevrolet came to rest in close proximity to the Mercedes in the north-eastbound lane. The respective velocity changes for the Mercedes and Chevrolet calculated by the Damage Only algorithm of the WINSMASH model were 14.2 km/h (8.8 mph) and 9.3 km/h (5.8 mph). These calculations appear to understate the severity of the crash, based on SCI experience.

Figure 2: Crash schematic.

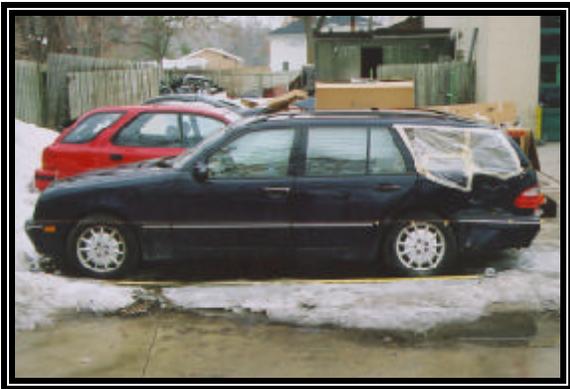
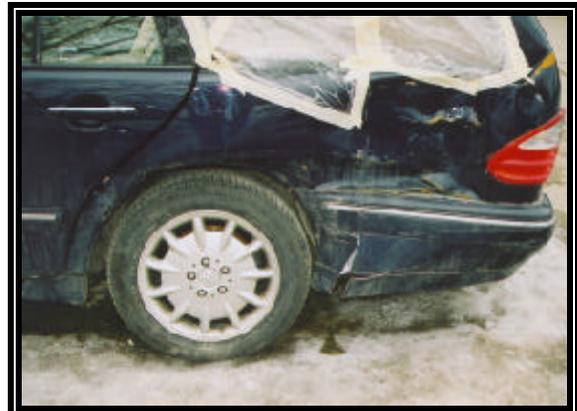
The vehicle's exterior left side damage consisted of 143.5 cm (56.5 in) of induced and direct contact damage, **Figures 3 and 4**. The direct contact damage began 39.9 cm (15.7 in) forward of the left rear axle and extended to the left corner of the rear bumper. The vertical height of the damage measured 97 cm (38 in) consistent with the front profile of the Chevrolet. The residual lateral crush profile measured at the trim elevation was as follows: C1=2.5 cm (1.0 in), C2=12.2 cm (4.8 in), C3=15.2 cm (6.0 in), C4=15.5 cm (6.1 in), C5=5.8 cm (2.3 in), C6=1.5 cm (0.6 in). The maximum crush was 15.5 cm (6.1 in) at C4. A pattern of minor scratches to the painted exterior surface was noted on the aft aspect of the left front door and center aspect of the left rear door. This scratch pattern was linked to probable contact with the front plane of the Chevrolet during the later stages of the impact as the Mercedes rotated counterclockwise to rest. There was no change in the wheelbase dimensions. The Collision Deformation Classification (CDC) was 09-LBEW-2.

Figure 3: Left side of the Mercedes Benz.

Figure 4: Close-up of the left rear quarterpanel damage.

The Damage Only algorithm of the WINSMASH model calculated a total velocity change (ΔV) for the Mercedes of 14.2 km/h (8.8 mph). The longitudinal and lateral components were 3.7 km/h (2.3 mph) and 13.7 km/h (8.5 mph), respectively. In this contractor's opinion, this calculation underestimated the crash severity. A total ΔV in the range of 24 km/h (15 mph) was more representative of the crash severity based on SCI experience. The ΔV was probably underestimated due to the nature of the vehicle's structure and the impact orientation. The left rear tire and wheel were in the region of direct

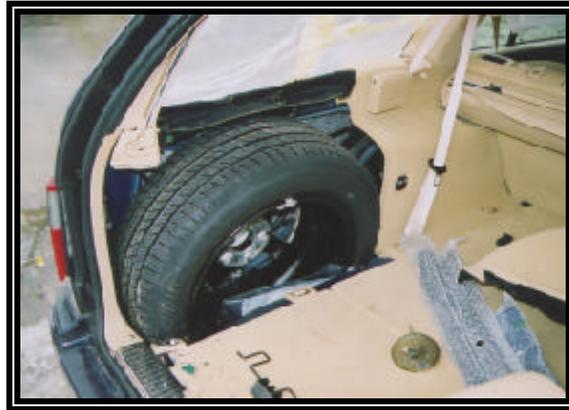
contact and absorbed a portion of the impact energy. In addition, the spare tire was located in a compartment on the interior side of the left rear quarterpanel, directly opposite the impact. The spare tire also absorbed the impact energy and transmitted a portion of that energy in the floor pan of the cargo area, **Figure 5**. The energy absorbed by these components was not accounted for in the WINSMASH analysis, resulting in an underestimated calculation.

Figure 5: Damage to the spare tire compartment.

The interior damage to the vehicle consisted of the minor intrusion [<2.5 cm (<1 in)] of the spare tire into the rear cargo area and the deployment of the vehicle's left side impact air bags and head protection curtain. The intrusion of the spare tire was caused by the exterior force of the impact on the left rear quarterpanel. Refer to **Figure 5** above. There was no interior damage identified that was associated to any occupant interior contacts.

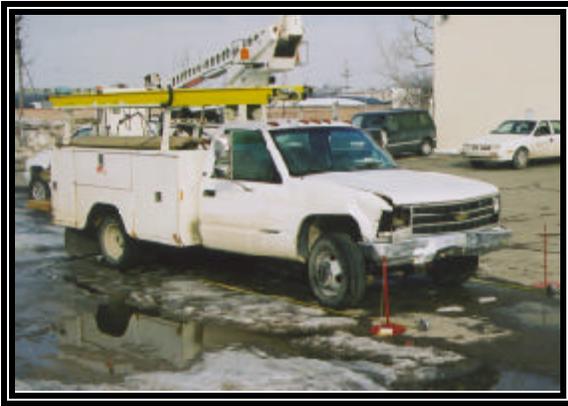
The combined direct and induced damage extended across the full 174 cm (68.5 in) frontal end-width of the Chevrolet. The width of the direct contact damage measured 77 cm (30.3 in) and began 9 cm (3.5 in) right of center extending to the right front bumper corner. The crush profile measured along the front bumper was as follows: C1=1.0 cm (0.4 in), C2=1.0 cm (0.4 in), C3=4.0 cm (1.6 in), C4=7.0 cm (2.8 in), C5=14.0 cm (5.5 in), C6=30.0 cm (11.8 in). The energy of the impact was managed primarily by the frame and bumper structure of the vehicle. The right front fender buckled rearward and the right door was restricted. There was no measurable change in the wheelbase dimensions. The Collision Deformation Classification was 12-FREW-2. The delta V calculated by the Damage Only algorithm of the WINSMASH model was 9.3 km/h (5.8 mph). In this contractor's opinion, this calculation was underestimated as well. A delta V estimate in the range of 16 km/h (10 mph) was more appropriate based on SCI experience.

Figure 6: Right front view of the Chevrolet.

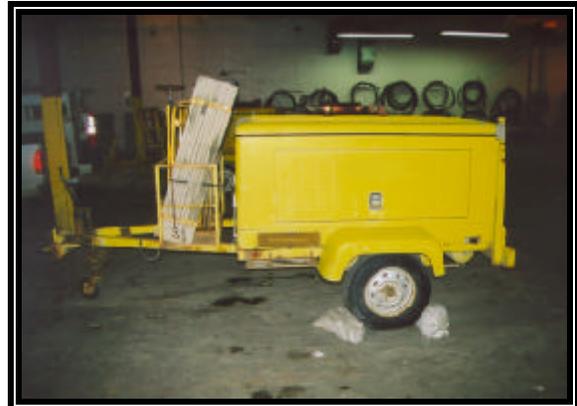
Figure 7: View of the work trailer.

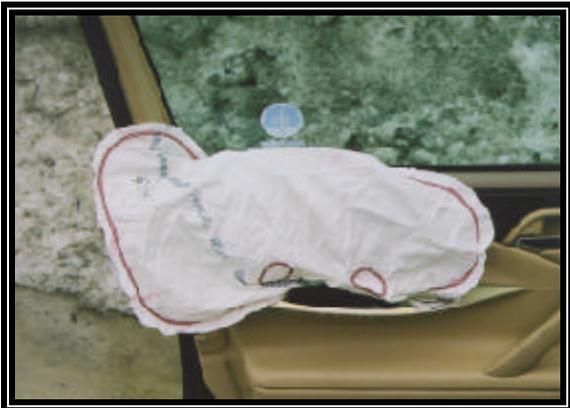
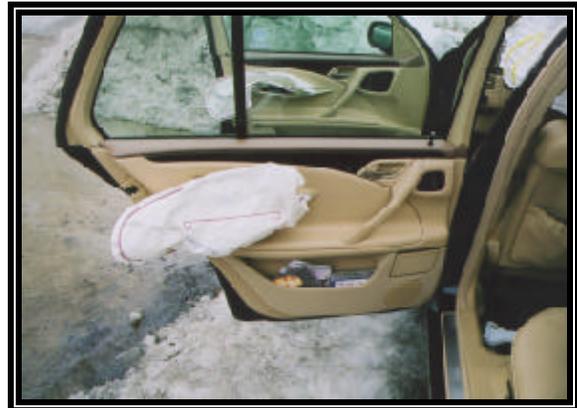
Figure 8 and 9 are views of the side impact air bags that deployed from the front left door and rear left door, respectively. The respective door-mounted air bags were mounted in the upper aft aspect of the door and located in equivalent positions. The left front and left rear air bags were identical. The leather trimmed upholstery split along a 38 cm (15 in) seam allowing for the deployment of the air bag. The air bag was designed to offer thoracic protection and was trapezoidal in shape. The deflated bag measured 46 cm (18 in) in length. The height of the bag measured 20 cm (8 in) at its forward aspect and the height expanded to 28 cm (11 in) over its length. It was not externally vented. The single noted difference between the respective bags was the method of tethering. The front side impact bag was tethered by two straps separated approximately 14.0 cm (5.5 in) apart. The rear left side impact bag was tethered by a single 20 cm (8 in) long strap. Refer to **Figures 8 and 9**. No contact evidence was noted on the face of the respective bags. The following nomenclature was embossed on bag's fabric: PA66 ASCI. A bar code bearing the following numbers identified the device: 8882 99226304. The air bags were manufactured by Automotive Safety Components International, Johnson Controls.

Figure 8: Front left side impact air bag.

Figure 9: Rear left side impact air bag.

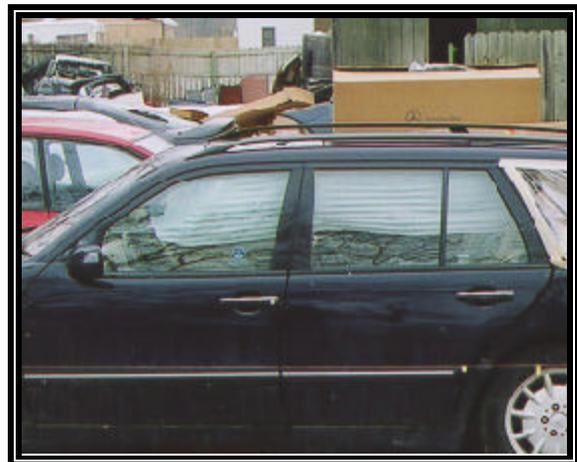
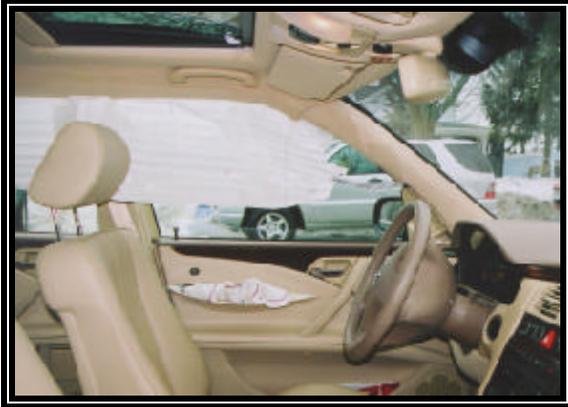
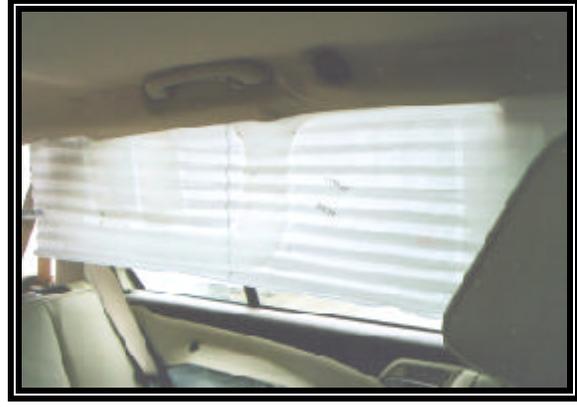
The force of the impact also caused the deployment of the left head protection curtain from the left roof rail. **Figures 10 through 12** are views of the deployed head protection curtain. The headliner separated, along its length, from the upper interior trim allowing the curtain to deploy vertically down. The curtain provided approximately 161.3 cm (65.5 in) of coverage across the vehicle's left side glass. This coverage measured approximately 61 cm (24 in) forward of the B-pillar ending near the forward aft of the left front glazing. The coverage extended approximately 100.3 cm (39.5 in) rearward of the B-pillar, across the left rear glazing and ending immediately rear of the C-pillar. The forward aspect

Figure 10: Left view depicting the coverage of the head protection curtain.

Figure 11: Right interior view of the head protection curtain.

Figure 12: View of the rearward aspect of the head protection curtain.

The curtain was designed with a distinct vertical chambered pattern, refer to Figure 12. This pattern provided the occupant protection when inflated, as well as providing some rigidity to the curtain and helped to maintain its shape. The curtain was not externally vented. A gas cylinder located in the C-pillar provided the means for inflation. The curtain was an estimated 3-5 cm (1-2 in) thick when inflated. The head protection curtain was supplied by Autoliv GMBH and was identified by the following nomenclature:

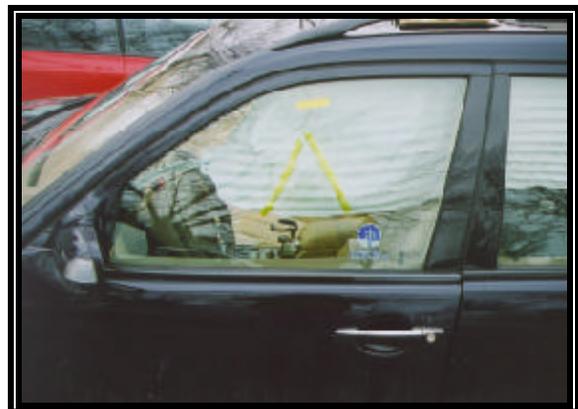
Figure 13 is a view of a contact pattern and scuff identified on the outboard side of the curtain and the interior surface of the glazing, respectively. The contact pattern was triangular in shape and measured 14.0 cm by 15.2 cm (5.5 in by 6 in), length by height. The center of the contact was located 23 cm (9 in) rearward of the tether strap. The contact consisted of a pattern of dirt transferred to the curtain during its contact with the interior surface of the glazing. A 5 cm (2 in) scuff was observed on the glazing immediately above the contact pattern. The scuff was located 38.9 cm (15.3 in) forward of the aft edge of the door and 7.1 cm (2.8 in) below the top edge of the glazing.

Figure 13: View of the contact pattern identified on the exterior surface of the curtain.

These contact patterns resulted from the driver's head responding to the lateral direction of the impact force and contacting the interior surface of the curtain. The driver was not injured in the crash event. It was probable the head protection curtain mitigated any potential injury.
