**VERIDIAN LIMITED ON-SITE SIDE IMPACT  
AIR BAG DEPLOYMENT INVESTIGATION  
VERIDIAN CASE NO. CA01-019  
VEHICLE: 1998 INFINITY I30  
LOCATION: NEW JERSEY  
CRASH DATE: NOVEMBER 2000**

Contract No.  
DTNH22-94-D-07058

14. <i>Sponsoring Agency Code</i>	
15. <i>Supplementary Notes</i> Limited on-site investigation of a side impact air bag deployment crash.			
16. <i>Abstract</i> <p>This limited on-site investigation focused on the performance of a side impact air bag in a 1998 Infinity I30. The Infinity was struck on the left side by a 1988 Ford Econoline E250 van as the 28 year old male driver of the Infinity initiated a left turn across the path of the Ford. The impact resulted in moderate severity damage to the Infinity and deployed the redesigned frontal air bags and the left front seat back mounted side impact air bag. The driver of the Infinity sustained a contusion and abrasion of the left posterior parietal scalp, an abrasion of the left hand, and a contusion of the left lower leg from contact with the interior components of the vehicle. The deployed side impact air bag provided the driver with additional crash protection, thus mitigating potential injury of the abdomen and

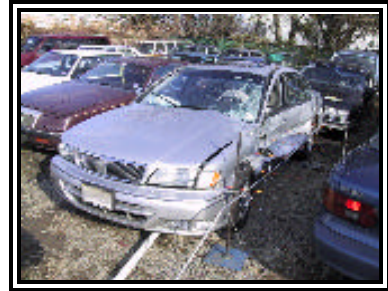
**Figure 1. Left side damage to the Infinity I30.**

The Infinity sustained moderate severity damage to the left side as a result of the intersection-type crash with the Ford Econoline. Maximum crush was 31.0 cm (12.2") located at the mid door level of the vehicle at the left A-pillar area. The direct contact damage began 9.0 cm (3.5") forward of the left front axle position and extended 243.0 cm (95.7") rearward, terminating forward of the left C-pillar (**Figure 2**). The combined induced and direct contact damage began 48.0 cm (18.9") forward of the left front axle and extended 284.0 cm (111.8") rearward to the left C-pillar. A crush profile was documented by the NASS researcher at the level of the mid door. The profile was as follows: C1 = 0 cm, C2 = 21.0 cm (8.3"), C3 = 25.0 cm (9.8"), C4 = 31.0 cm (12.2"), C5 = 6.0 cm (2.4"), C6 = 0 cm. Maximum crush was 31.0 cm (12.2") located at the C4 location. The Collision Deformation Classification (CDC) for this impact was 10-LYAW-3.

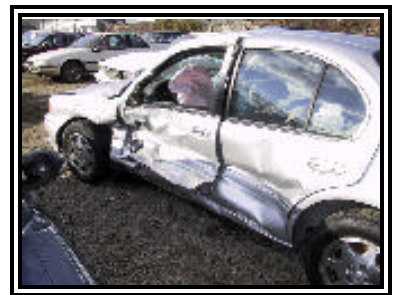
**Figure 2. Exterior damage to the Infinity I30.**

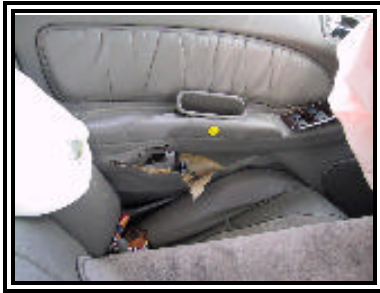
The driver's left hip loaded the intruding left door armrest. The contact deformed the armrest in an outboard direction (**Figure 3**). The leather/vinyl fabric was torn in the area of the contact point, however, it was unknown if this was crash related or resulted from post-crash activity within the vehicle. The driver's left knee contacted the lower aspect of the knee bolster and a support bracket for the steering column. This bracket is depicted in **Figure 4**.

**Figure 3. Driver's left hip loading to the left door armrest.**

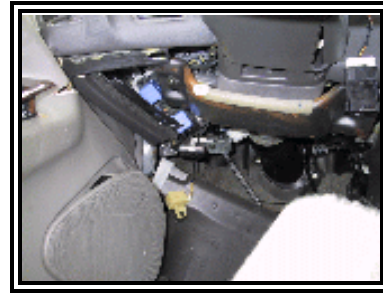
**Figure 4. Driver's left knee contact to the support bracket.**

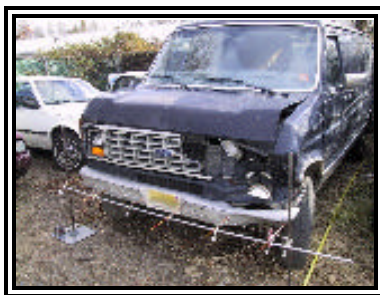
The full frontal area engaged the left side of the Infinity resulting in a direct contact damage length of 188.0 cm (74.0") that extended from bumper corner to bumper corner. Maximum crush was 18.0 cm (7.1") located at the left corner of the bumper. A crush profile was documented at the level of the bumper and was as follows: C1 = 18.0 cm (7.1"), C2 = 5.0 cm (2.0"), C3 = 4.0 cm (1.6"), C4 = 3.0 cm (1.2"), C5 = 2.0 cm (0.8"), C6 = 5.0 cm (2.0"). The CDC for this damage pattern was 01-FDEW-2. The damage profile for the Ford Econoline is documented in Figures 5 and 6.

**Figure 5. Frontal damage to the Ford Econoline.**

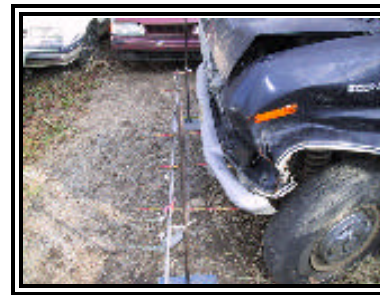
**Figure 6. Profile view documenting the extent of frontal crush.**

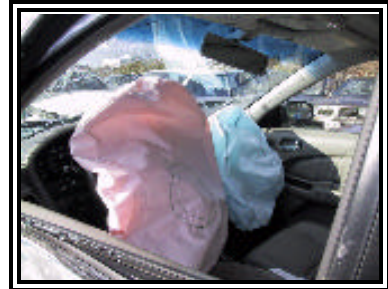
The 1998 Infinity I30 was equipped with redesigned frontal air bags and seat mounted side impact air bags for the driver and right passenger positions. The frontal air bags (**Figure 7**) and the driver's side impact air bag deployed during the left side impact with the Ford Econoline. The frontal air bag system consisted of a driver air bag module that was mounted within the steering wheel rim, a top mount passenger air bag in the right instrument panel, and a single point sensing system and diagnostic module that was located in the rear aspect of the center console.

**Figure 7. Deployed frontal air bags.**

The frontal driver air bag deployed from symmetrical H-configuration module cover flaps. The horizontal tear seam was 15.0 cm (5.9") in width while the upper and lower flaps were 6.0 and 7.0 cm (2.4 and 2.8") in height respectively. The bag was tethered by two internal straps affixed to the face of the membrane. The bag was directly vented into the passenger compartment by two ports located on the back side of the bag at the 10 and 2 o'clock sectors. In its deflated state, the driver air bag measured 68.0 cm (26.7") in diameter. There was no damage or contact evidence to the deployed frontal driver air bag. The horizontal distance between the maximum excursion of the driver air bag and the seat back was documented at 55.0 cm (21.7").

The front right passenger air bag deployed from H-configuration module cover flaps from the right upper instrument panel. The width of the flaps was 24.0 cm (9.4") at the horizontal tear seam and the vertical measurements were 3.0 and 7.0 cm (1.2 and 2.8"), for the upper and lower flaps respectively. The air bag membrane was not tethered. The overall dimensions of the front right air bag was 64.0 cm (25.2") vertically and 36.0 cm (14.2") horizontally. The bag was vented by two lateral ports located at the 3 and 9 o'clock sectors. There was no damage or driver contact to the front right passenger air bag.

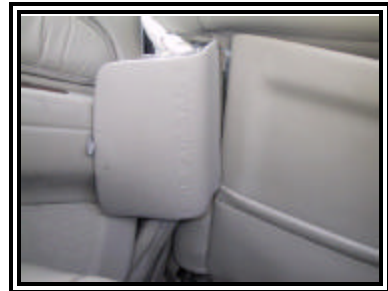
The side impact air bags were mounted in the upper outboard aspects of the front seat back supports and concealed by a single cover flap that opened to the rear of the vehicle (**Figure 8**). Side impact crash sensing was achieved by sensors located in the lower aspect of the B-pillars.

**Figure 8. Side air bag cover flap opening to rear of vehicle**

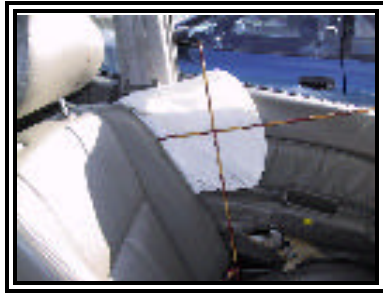
The driver side impact air bag was contained in the outboard aspect of the seat back support and concealed by a single cover flap that was formed in a L-configuration that conformed to the side and rear aspects of the seat back support. The flap was documented by the researcher as 21.0 cm (8.3") in height with the sides measuring 9.0 and 10.0 cm (3.5 and 3.9"), from front to back. The side bag deployed in a forward direction from the seat back support (**Figure 9**). The NASS researcher documented the overall dimensions of the side impact air bag at 42.0 cm (16.5") horizontally and 26.0 cm (10.2") vertically. The

**Figure 9. Deployed driver side impact air bag.**

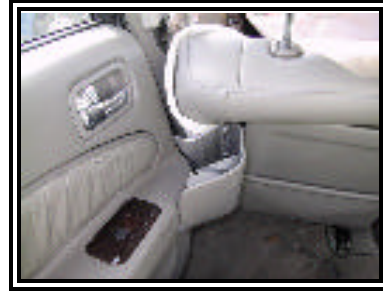
The frontal air bags deployed as designed from the respective module assemblies. The left front seat-back side impact air bag deployed as designed. The left B-pillar intruded into the outboard aspect of the left front seat back support in the area of the air bag module assembly. The side air bag probably deployed prior to intrusion, therefore the performance and deployment path of the side air bag was not impeded or restricted.

bag extended 22.0 cm (8.7") forward of the seat back support and extended 28.0-54.0 cm (11.0-21.3") above the seat cushion. There was no damage to the air bag, however, the cover flap extended rearward of the seat back support due to the lateral intrusion of the left B-pillar (**Figure 10**).

**Figure 10. Intrusion of the left B-pillar against the side air bag module and cover flap.**

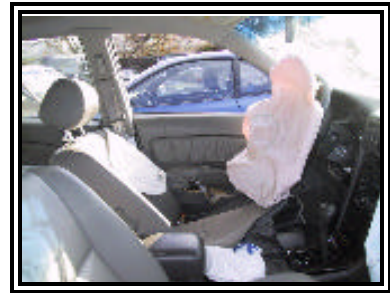
At impact, the frontal air bags and the left side seat mounted side impact air bag deployed. The unrestrained driver initiated a lateral and slightly forward trajectory (**Figure 11**) to his left in response to the 10 o'clock direction of force. His left knee/lower leg contacted the left aspect of the plastic knee bolster panel. The contact cracked the component and resulted in a superficial contusion of the left lower leg. His left hip area contacted the intruding left front door armrest. The padded and plastic component was cracked and deflected in an outward direction. The driver was not injured by the armrest contact.

**Figure 11. Trajectory and driver's contact points.**

His left upper anterior abdominal, chest, and upper arm loaded the deployed side impact air bag. The air bag prevented direct contact against the intruding door panel and mitigated potential injury. The driver's head impacted the intruding left upper B-pillar. Although there was no contact evidence on the pillar covering, the driver sustained a small abrasion of the left posterior/parietal area of the scalp and a left scalp contusion. In addition, the driver sustained abrasions of the left hand that probably resulted from flying glass. There was no contact evidence on the deployed frontal air bag for the driver's position and no related injury from bag involvement. The combination of front and side impact air bags offered adequate protection to the unbelted driver.
