ON-SITE CHILD AIR BAG-RELATED FATALITY INVESTIGATION

CASE NUMBER - IN01-021
LOCATION - TEXAS
VEHICLE - 1996 GEO METRO LSI
CRASH DATE - August, 2001

March 14, 2003

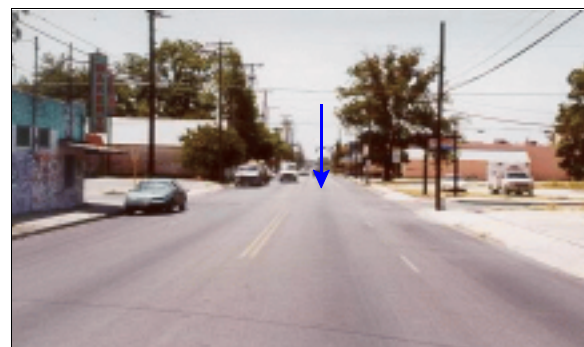
The case vehicle was traveling south in the inside lane of a four-lane, undivided, city street (**Figure 1**) and was approaching a partially controlled four-leg intersection, intending to continue traveling southward (i.e., there were two through lanes in both the north and southbound directions with regulatory **STOP** signs (Manual on Uniform Traffic Control Devices, R1-1) for the east and westbound traffic). The Pontiac had been traveling north in inside lane of the same, two-lane, undivided, city street and was turning left

Figure 1: Case vehicle’s southward travel path in inside southbound lane; Note: arrow shows approximate point of impact with Pontiac which was making a left-hand turn from inside northbound lane (case photo #01)

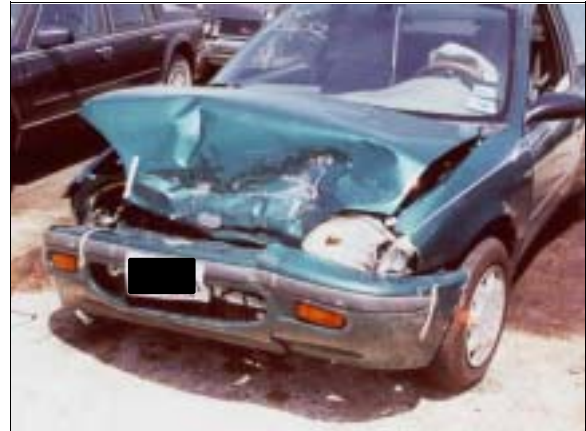
Figure 2: Case vehicle's damaged front viewed from left of front with bumper fascia placed on bumper; Note: tape indicates width of direct damage (case photo #11)

The front (**Figures 2 and 3**) of the case vehicle impacted the front right half of the Pontiac (**Figure 4**), causing the case vehicle's driver and front right passenger supplemental restraints (air bags) to deploy. As a result of the impact, the case vehicle rotated approximately 45 degrees clockwise prior to coming to rest straddling both southbound lanes, heading southwestward. The Pontiac, which had attempted to beat the case vehicle through the intersection by starting its left turn prior to the physical beginning of the intersection, was deflected westward and rotated approximately 30 degrees counterclockwise. The Pontiac came to rest heading primarily westward

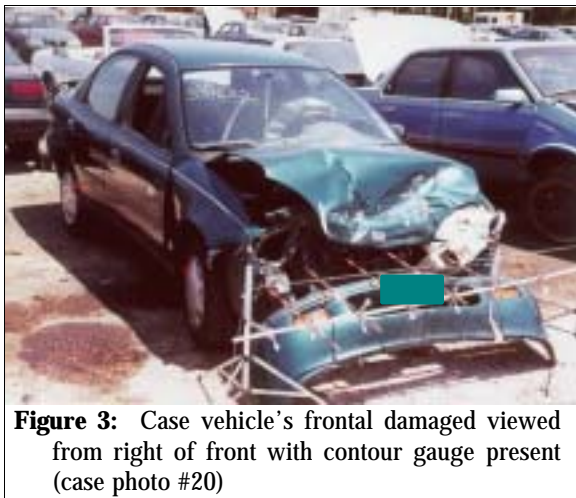
Figure 3: Case vehicle's frontal damaged viewed from right of front with contour gauge present (case photo #20)

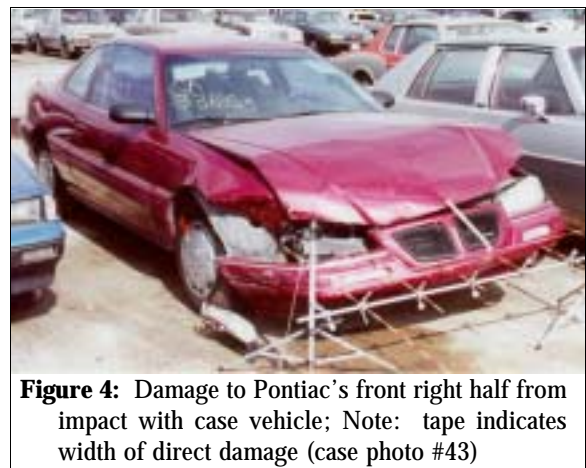
Figure 4: Damage to Pontiac's front right half from impact with case vehicle; Note: tape indicates width of direct damage (case photo #43)

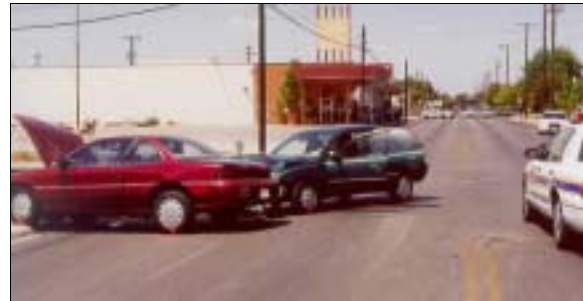
with its left front tire on the west sidewalk and the rear portion of the vehicle in the outside southbound lane (**Figure 5**).

Figure 5: On-scene northerly view of final rest positions of case vehicle (background) and Pontiac (foreground) toward southwest quadrant of inter-section (case photo #45)

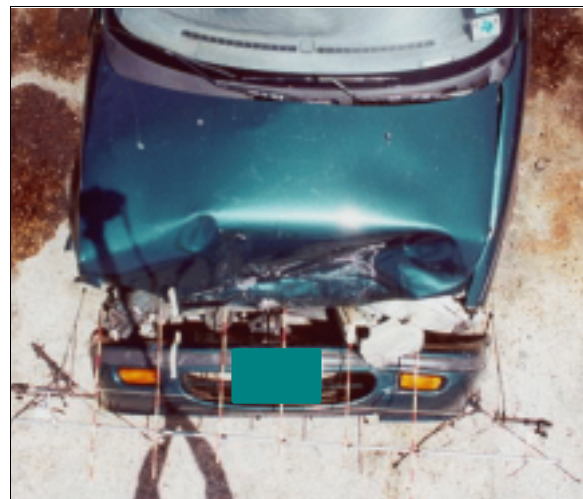
The case vehicle’s contact with the Pontiac involved almost its entire front (**Figure 2** above and **Figure 6**). Direct damage began at the front left bumper corner and extended, a measured distance of 108 centimeters (42.5 inches), along the front bumper towards the right—ending 42 centimeters (16.5 inches) right of center. Residual maximum crush was measured as 36 centimeters (14.2 inches) at C₄. The wheelbase on the case vehicle’s left side was extended approximately 1 centimeter (0.4 inches) while the right side was shortened approximately 1 centimeter (0.4 inches). The case vehicle’s front bumper, bumper fascia, grille, hood, left headlight and turn signal assemblies, and radiator were directly damaged and crushed rearward. None of the case vehicle’s tires were damaged, deflated, or physically restricted. The right headlight and turn signal assemblies sustained induced damage as well as the hood, right outside rearview mirror, and both

Figure 6: Overhead view of case vehicle’s frontal damage with contour gauge present; Note: bumper fascia lying on ground (case photo #12)

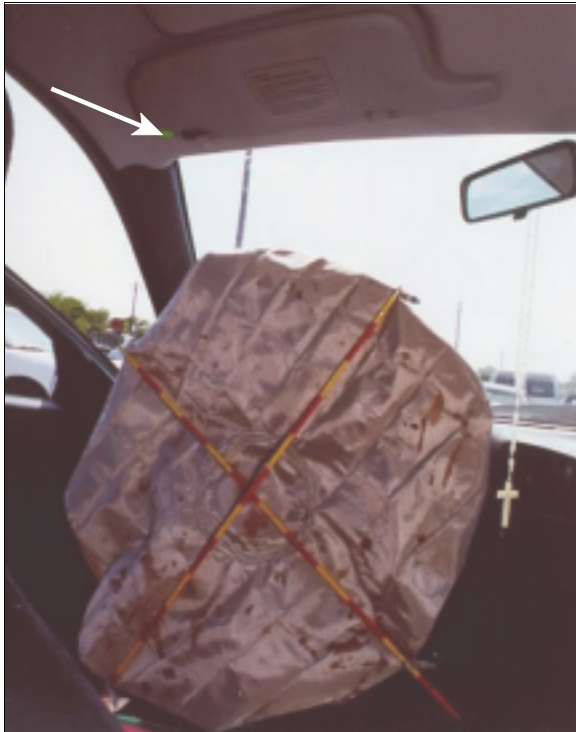
Figure 7: Vertical view of case vehicle's driver air bag and header area showing contact (arrow) to sun visor post (case photo #25)

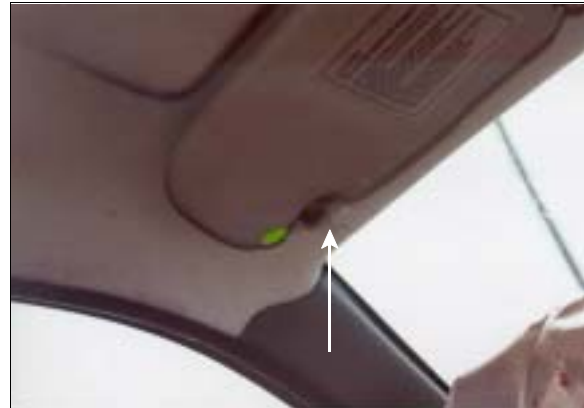
Figure 8: Case vehicle's driver sun visor showing hair clump on sun visor's stem from contact with driver's scalp (case photo #23)

Inspection of the case vehicle's interior revealed that the windshield's glazing was cracked on the driver's side from contact by the driver's left hand and there was a hair deposit on the driver's sun visor stem from the driver's scalp (**Figures 7 and 8**). Furthermore, there was contact to the left instrument panel (i.e., vent cracked) and a scuff on the left side of the driver's knee bolster. There was a small area of blood and possibly skin noted to the right windshield's header just below the sun visor. In addition, the upper right corner of the glove box and/or passenger's knee bolster was scuffed from occupant contact (**Figure 9**) and the front right passenger's seat back was bent forward after being impacted by the back right passenger (**Figure 10 and Figure 11** below). Intrusion to the top of the seat back was visually estimated as 15 to 30 centimeters (between 5.9 and 11.8 inches). There

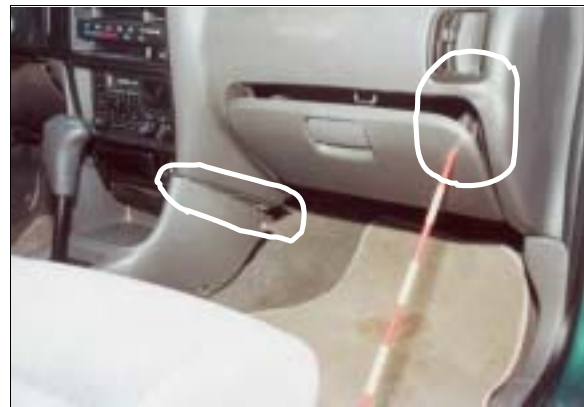
Figure 9: Case vehicle's front right passenger seating area showing right knee contact to glove box and right instrument panel; Note: center floor mounted console also ajar (case photo #32)

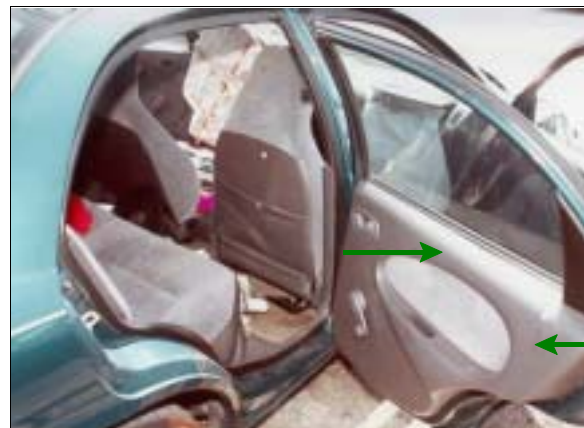
Figure 10: Case vehicle's deformed front right seat back from contact by back right passenger; Note: blood (arrows) on window sill and door panel (case photo #35)

The case vehicle's adult, front right passenger [40-year-old, White (Hispanic) female; 165 centimeters and 109 kilograms (65 inches, 240 pounds)] was seated in an upright posture with her back against the seat back, both feet on the floor, and her right arm around the “on-lap” passenger’s waist. The exact location of her left arm is unknown. Her seat track was located between its middle and rearmost positions, and the seat back was upright. It should be noted that her seat back was deformed forward—approximately 10 degrees forward of 90 degrees (**Figures 10 and 11** above).

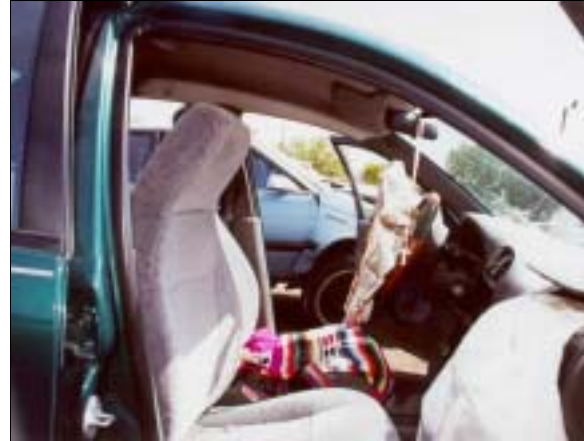
Figure 11 Case vehicle's front seating area showing deformation to front right seat back from contact by back right passenger and deployed frontal air bags (case photo #26)

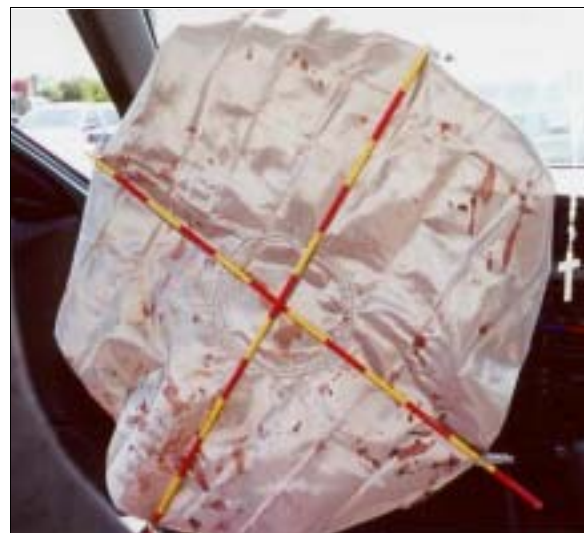
The case vehicle was equipped with a Supplemental Restraint System (SRS) that contained frontal air bags at the driver and front right passenger positions. Both frontal air bags deployed as a result of the frontal impact with the Pontiac. The case vehicle's driver air bag was located in the steering wheel hub. The module cover consisted of asymmetrical "H"-configuration cover flaps made of thick vinyl with overall dimensions of 15.5 centimeters (6.1 inches) at the horizontal seam and 6.5 centimeters (2.6 inches) vertically for the upper flap and 8 centimeters (3.1 inches) vertically for the lower flap. An inspection of the air bag module's cover flaps and the air bag's revealed that the cover flaps opened at the designated tear points, and there was no evidence of damage during the deployment to the air bag or the cover flaps. The driver's air bag was designed with two tethers, each 11.5 centimeters (4.5 inches) in width. The driver's air bag had two vent ports, approximately 4 centimeters (1.6 inches) in diameter, located at the 10:30 and 1:30 o'clock positions. The deployed driver's air bag was round with a diameter of 64 centimeters (25.2 inches). An inspection of the driver's air bag fabric did not revealed any skin evidence readily apparent on the air bag's fabric, but there was a copious amount of blood on the air bag's front surface (**Figure 7** above and **Figure 12**) and a few drops on blood on its back surface near the air bag's vent ports. According to the adult front right passenger, this blood resulted from the driver's scalp laceration.

Figure 12: Case vehicle's driver air bag showing copious blood smears from driver's scalp injuries (case photo #24)

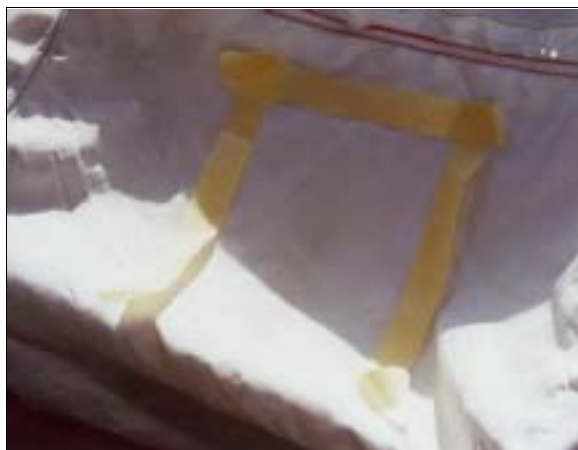
Figure 14: Close-up of skin transfer area on front portion of top surface of case vehicle's front right passenger air bag (case photo #30)

An inspection of the front right air bag's fabric revealed a large area of skin transfer located 15 centimeters (5.9 inches) inward from the air bag's left seam. The area of skin transfer was approximately 7 centimeters (2.8 inches) in width and involved both the front portion of the top surface and the top portion of the front surface. From the seam that separates the top and front surfaces, the transfer area extended a measured distance 12 centimeters (4.7 inches) onto the top surface (Figures 13 and 14) and 24 centimeters

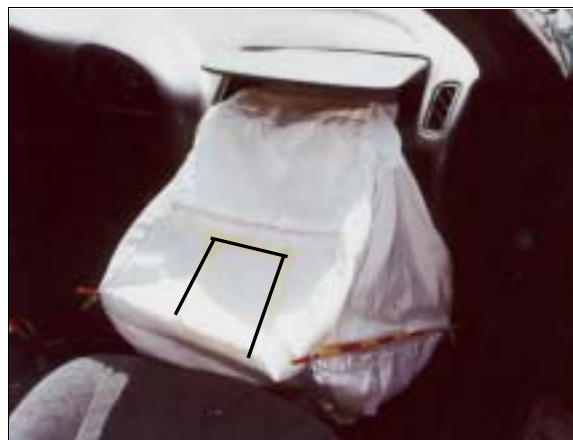
Figure 13: Skin transfer area on front portion of top surface of case vehicle's deployed front right passenger air bag (case photo #29)

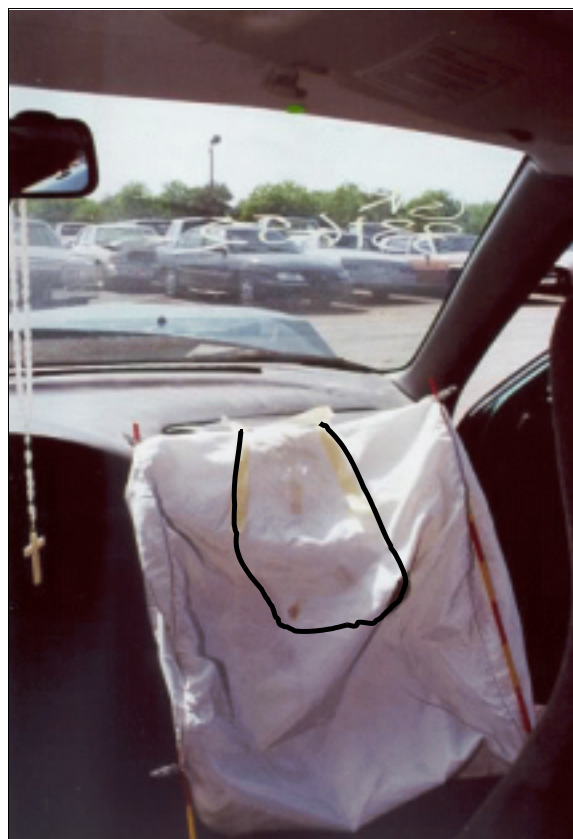
Figure 15: Vertical view showing area of skin transfer on top portion of front surface of case vehicle's front right passenger air bag (case photo #28)

(9.4 inches) downward onto the front surface (**Figure 15** above and **Figure 16**). There was a blood spot on the front surface underneath the area of skin transfer. To the right of this blood spot, there was a 7 centimeter (2.8 inch) hole that had been cut by the applicable police department (i.e., for evidentiary purposes). Furthermore, there were purple/red streaks vertically oriented on the front surface of the air bag that paralleled and outlined the area of skin transfer. In addition, there were two obliquely oriented red streaks located near the front surface's 5 o'clock position. Finally, there was a 3 centimeter (1.2 inch) area of stitching separation along the front surface's right seam that was located 14 centimeters (5.5 inches) down from the aforementioned top horizontal seam.

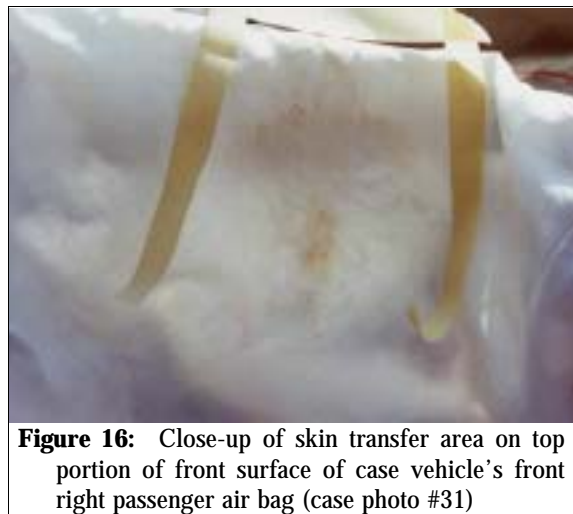
Figure 16: Close-up of skin transfer area on top portion of front surface of case vehicle's front right passenger air bag (case photo #31)

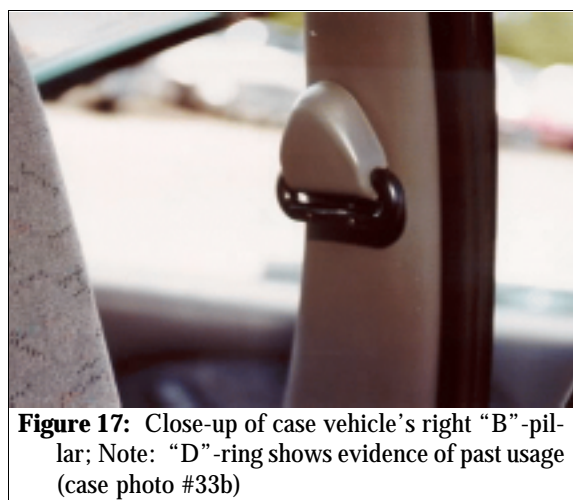
Figure 17: Close-up of case vehicle’s right “B”-pillar; Note: “D”-ring shows evidence of past usage (case photo #33b)

evidence on the shoulder portion of the front right belt webbing; however, little blood was found on any portion of the seat belt's webbing. Finally, according to the Police Crash Report, the investigating officer noted that there was a lot of blood on the front right passenger's "shirt" which was "... coming from the infant's head, nose, and mouth." If the adult front right passenger had been belted, then copious amounts of blood would have been expected on the seat belt's webbing. Based on the vehicle inspection, the case vehicle had previously been in another crash (i.e., the case vehicle has been sold at least two times). The loading evidence on the "D"-ring was deemed most likely to have occurred prior to this crash.

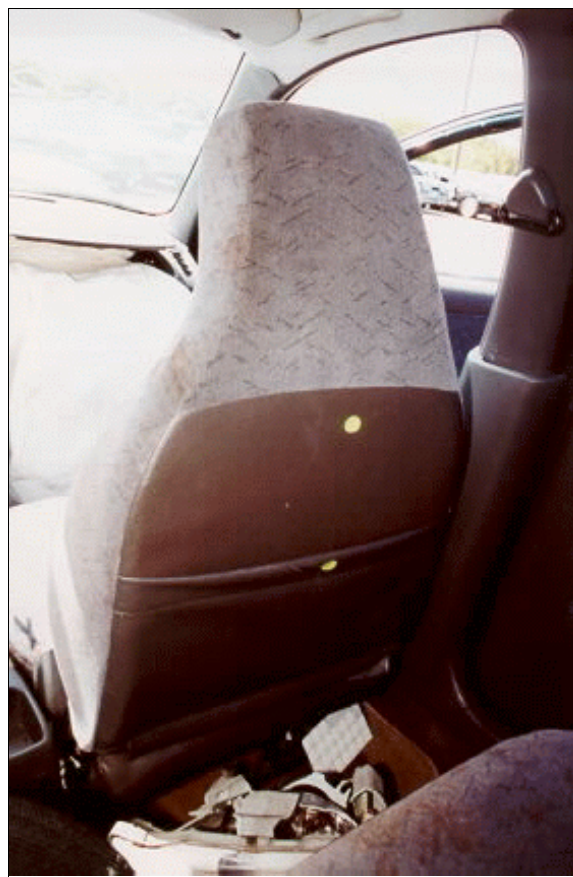
The case vehicle's driver braked, attempting to avoid the crash. As a result of this attempted avoidance maneuver and the nonuse her available safety belts, the back right passenger moved forward and slightly upward just prior to impact. The case vehicle's impact with the Pontiac enabled the case vehicle's back right passenger to continue forward, slightly leftward, and upward toward the case vehicle's 340 degree Direction of Principal Force as the case vehicle decelerated. As a result, she impacted the back surface of the case vehicle's front right seat back (**Figure 18**) with her head, face, and torso, deforming the seat back approximately 10 degrees forward (**Figure 11** above) and depositing contact evidence. The back right passenger's lip was lacerated, most likely from her own teeth. As the case vehicle reached maximum engagement, the case vehicle rotated clockwise. Based on occupant kinematic principals, the back right passenger most likely moved toward the right rear door, the right side

Figure 18: Case vehicle's front right seat back showing contact evidence on back surface from impact by back right passenger (case photo #33a)

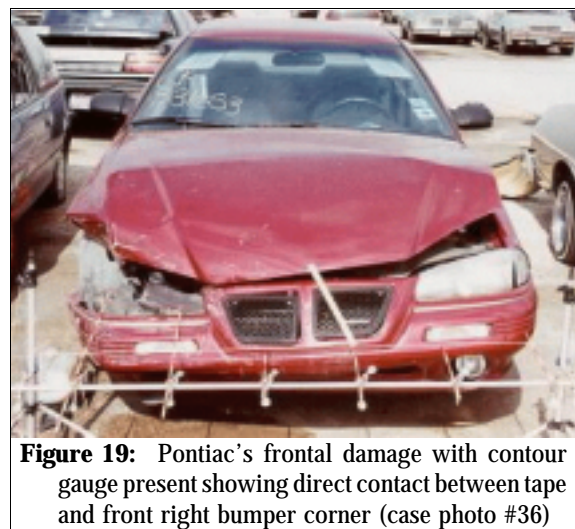
The Pontiac’s contact with the case vehicle involved its front right half (**Figure 19**). Direct damage began 12 centimeters (4.7 inches) to the left of center and extended, a measured distance of 82 centimeters (32.3 inches), along the front bumper to the front right bumper corner. Residual maximum crush was measured as 38 centimeters (15.0 inches) at C₆. The Pontiac’s wheelbase was shortened approximately 1 centimeter (0.4 inches) on both the left and right sides.

Figure 19: Pontiac’s frontal damage with contour gauge present showing direct contact between tape and front right bumper corner (case photo #36)
