**ADVANCED OCCUPANT PROTECTION SYSTEM STUDY
2000 FORD TAURUS INVESTIGATION**

VERIDIAN CASE NO. CA01-022

LOCATION - VIRGINIA

CRASH DATE - JANUARY 2001

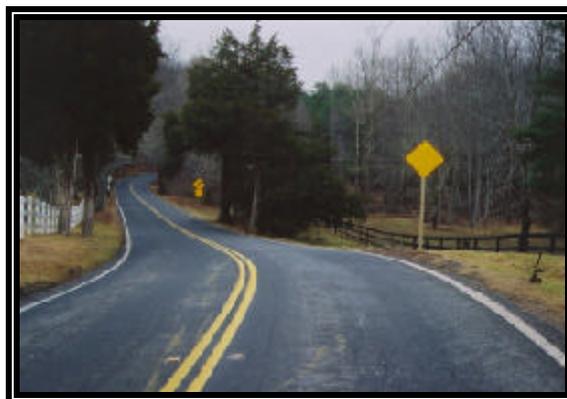
This single vehicle crash occurred during the afternoon hours in January, 2001. At the time of the crash, it was daylight and the weather was not a factor. The road surface was dry. At the crash scene, the road was configured with two lanes, north/south in direction. **Figure 1** is a southbound trajectory of the Ford Taurus. The road was straight with a positive grade on the approach to the crash scene and then changed to a sharp left curve with a negative grade. The radius of the curve measured approximately 99 m (325 ft). The west (right side) road shoulder was grass and sloped away from the traffic lanes. A school bus stop warning sign was located in the curve approximately 2.1 m (6.9 ft) from the road edge. The point of impact was a 51

Figure 1:Pre-crash trajectory view of the Ford.

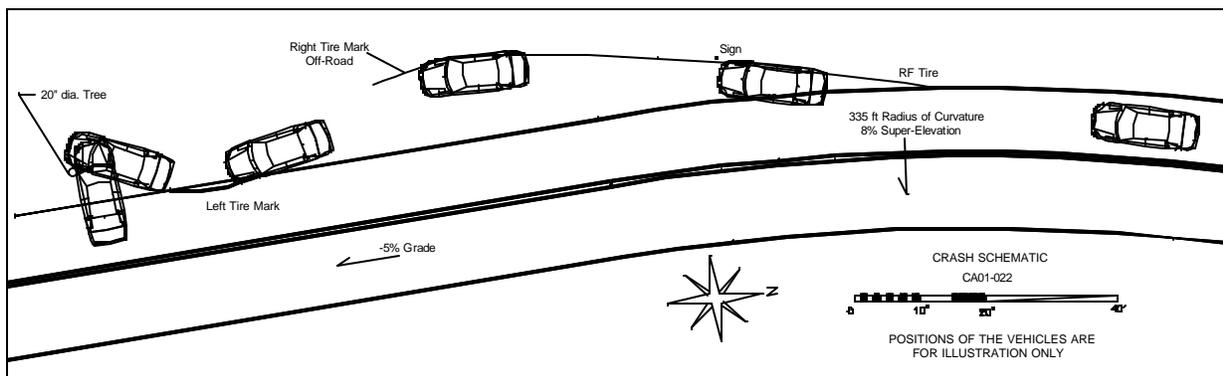
The crash occurred with the forward left side of the Taurus striking a 51 cm (20 in) diameter tree. The left side of the Taurus, in the area of the left front axle, struck the tree in an 11 o'clock impact configuration. The total delta V of the crash calculated by a WINSMASH analysis was 37.0 km/h (23.0 mph). The longitudinal and lateral components were -32.1 km/h (-19.9 mph) and 18.5 km/h (11.5 mph), respectively. The vehicle rotated clockwise approximately 45 degrees and came to rest in contact with the tree, facing westward. The force of the crash caused the driver's buckle pretensioner to fire and deployed the frontal air bags and the left side impact air bag. **Figure 2** is a schematic of the crash.

Figure 2 Crash scene schematic.

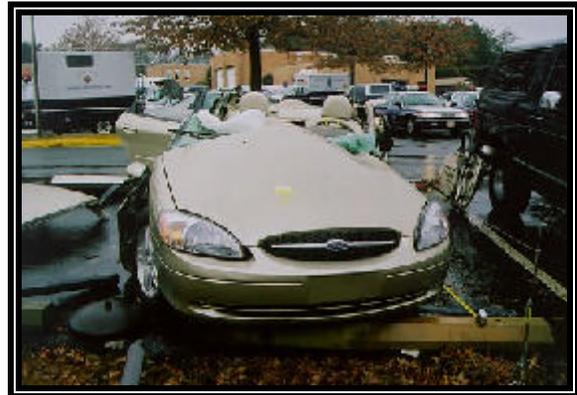
The 2000 Ford Taurus, **Figure 3**, was identified by the Vehicle Identification Number (VIN): 1FAFP56S5YA (production sequence deleted). The vehicle's power train consisted of a 3.0 liter, V-6 engine linked to a 4-speed automatic overdrive transmission. The vehicle had 4-wheel disc anti-lock brakes. The leather trimmed interior was equipped with a power package that included power steering, brakes, windows, door locks, mirrors and a power driver seat. The driver's foot controls were adjustable. The subject vehicle was also equipped with frontal and side impact air bags for the driver and front right passenger. The 4-door sedan was manufactured in March 2000. The odometer read 18,861 km (11,720 miles) at the time of the inspection.

Figure 3: Front view of the Ford Taurus.

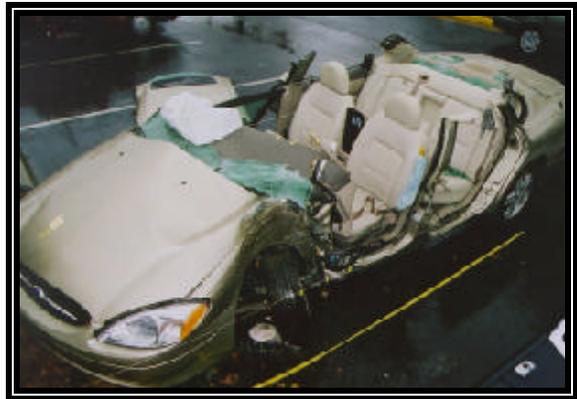
Figure 4 is a left front overhead view of the damaged Ford Taurus. The left side of the vehicle impacted the tree approximately on the left front axle with an 11 o'clock direction of force. The direct contact damage began 22.1 cm (8.7 in) forward of the left front axle and extended longitudinally rearward 51 cm (20 in). The combined length of the direct and induced damage measured 130.3 cm (51.3 in). The measured crush profile of the lateral deformation was as follows: C1=0, C2=27.9 cm (11.0 in), C3=35.6 cm (14.0 in), C4=30.5 cm (12.0 in), C5=20.3 cm (8.0 in), C6=0. The vehicle's lateral end shift measured approximately 25 cm (10 in). The left wheelbase was foreshortened 18 cm (7 in) and the force of the impact separated the wheel from the drive shaft. The left lower sill was buckled to a location that measured 167.9 cm (66.1 in) forward of the left rear axle. The Barrier Algorithm of the WINSMASH model calculated a total damage based delta V of 37.0 km/h (23.0 mph). The

Figure 4: Taurus left front overhead view.

longitudinal and lateral components were -32.1 km/h (-19.9 mph) and 18.5 km/h (11.5 mph), respectively. The delta V calculated by the WINSMASH model appeared reasonable. The Collision Deformation Classification was 91-LYEW-3. (Note, the principle direction of force (PDOF) was incremented by 80 to accommodate the left lateral end shift.)

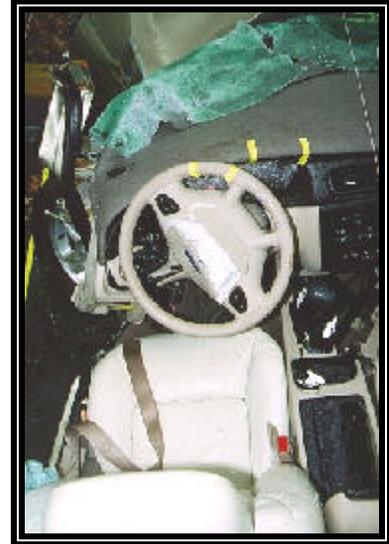
The driver's interior space, **Figure 5**, sustained significant lateral and longitudinal intrusions consistent with the exterior force of the crash. The longitudinal and lateral intrusion of the A-pillar measured 15 cm (6 in) and 10 cm (4 in), respectively. The intrusion of the driver's knee bolster measured 21.6 cm (8.5 in) longitudinally and 10 cm (4 in) laterally. The bolster intrusion was measured at its outboard aspect. The toe pan intrusion documented at the left foot rest location measured 19.1 cm (7.5 in) longitudinally and 27.9 cm (11.0 in) laterally. The 4 o'clock sector of the steering wheel rim contacted the brow of the instrument panel during the impact sequence, as denoted by the contact tape in Figure 5.

Figure 5: Interior intrusion.

The driver's knee bolster exhibited a 1.3 cm (0.5 in) scuff as a result of contact with the driver's right lower extremity. The scuff was located approximately 14.0 cm (5.5 in) right of the steering column center line. The left lower extremity pocketed into and contacted the outboard aspect of the mid instrument panel and forward aspect of the left door. Contact to these surfaces in combination with the intrusion resulted in the bilateral femur fractures and right patella fracture.

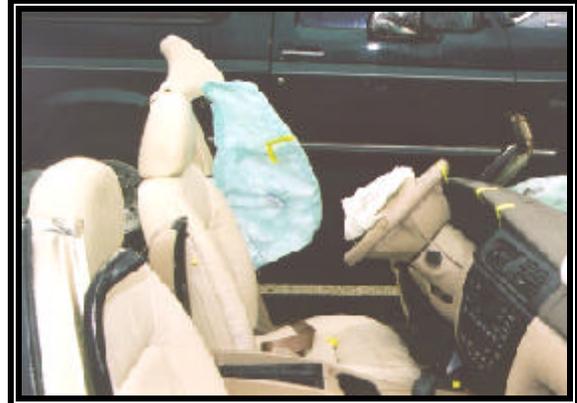
The left side impact air bag, **Figure 6**, had deployed from the driver's seat back as a result of the impact. The side bag was designed to offer head and thorax protection. The bag deployed from a 41 cm (16 in) tear of the outboard seam of the seat back. In its deflated state, the lower edge of the bag extended longitudinally forward approximately 36 cm (14 in) from the seat back. This edge was located approximately 20 cm (8 in) above the seat cushion. The vertical dimension of the bag measured 46 cm (18 in). The top of the bag tapered to a width of approximately 23 cm (9 in). The bag was tethered by a single 8 cm (3 in) wide strap. The length of the tether measured 11.4 cm (4.5 in), approximating the inflated dimension of the bag. A 6.4 cm (2.5 in) diameter scuff to the air bag was identified and attributed to contact from the driver's left shoulder. The scuff was centered 6.4 cm (2.5 in) rear of the forward edge of the bag and 41 cm (16 in) above the lower edge. The location of the contact was consistent with the stature of the driver.

Figure 6: Left side impact air bag.

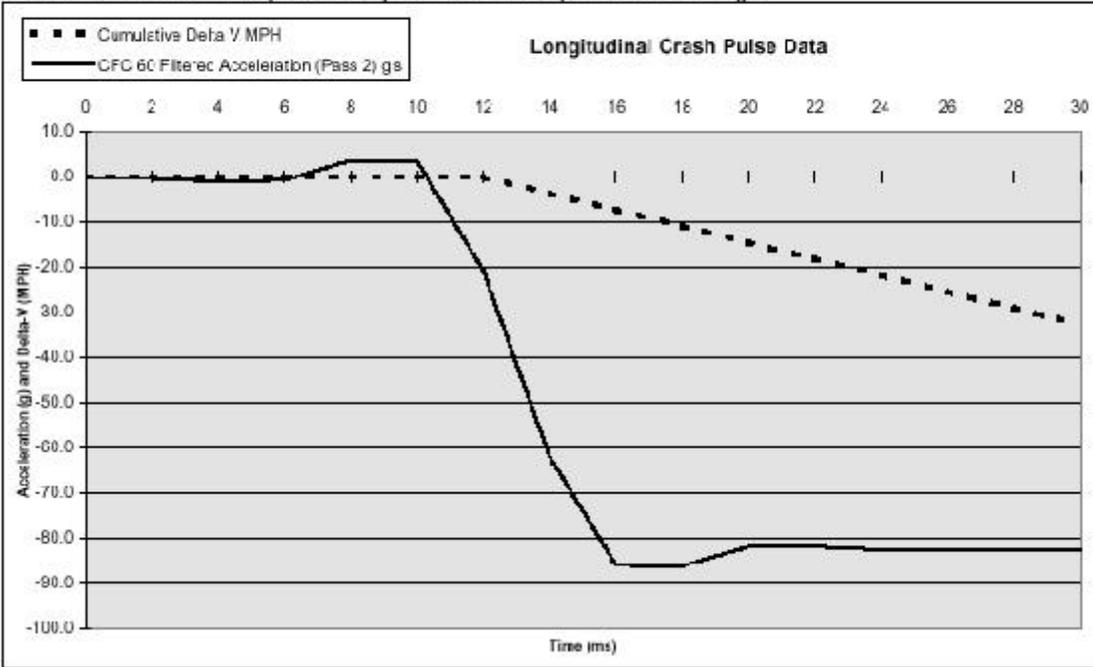
Longitudinal Cumulative Delta-V

The data retrieved from the RCM and subsequently analyzed by Ford was unreliable. The RCM did record the positive status (engaged) of the driver's restraint, however, this condition would have been evoked pre-crash at the vehicle's start-up. The crash event data recorded upon impact was not valid. The RCM did not recognize the deployment of any of the vehicle's safety systems (i.e. pretensioner and/or air bags) and the acceleration data was corrupt. The acceleration data spiked at over 80g's very early in the crash sequence (10-12 milliseconds after initiation) and was not recorded after that time. The RCM was mounted on the center tunnel to the floor pan. The deformation and buckling of the floor pan may have played a role in the loss of the data.

Time (ms)	0	10	20	30	40	50	60	70	78
Delta-V (MPH)	0.0	-0.1	-14.6	-32.7	No Data

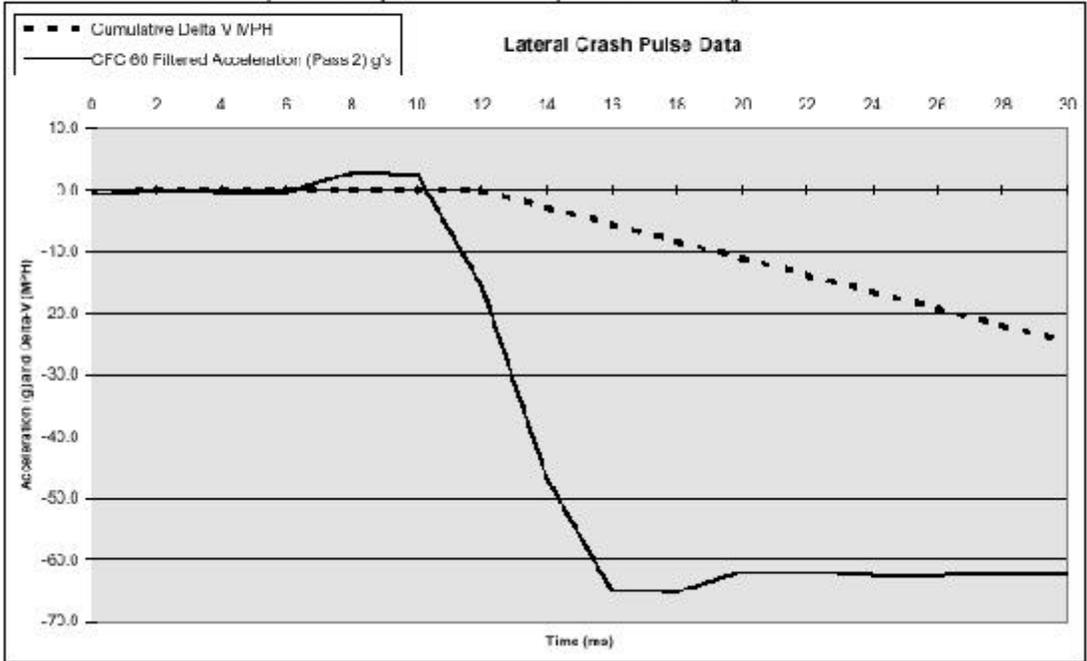
Lateral Cumulative Delta-V

Time (ms)	0	10	20	30	40	50	60	70	78
Delta-V (MPH)	-0.1	0.0	-11.6	-24.7	No Data
