**ON-SITE CHILD SAFETY SEAT CRASH INVESTIGATION
SCI TECHNICAL SUMMARY REPORT**

VERIDIAN CASE NO. CA01-023

VEHICLE - 1997 DODGE CARAVAN

CRASH DATE - FEBRUARY 2001

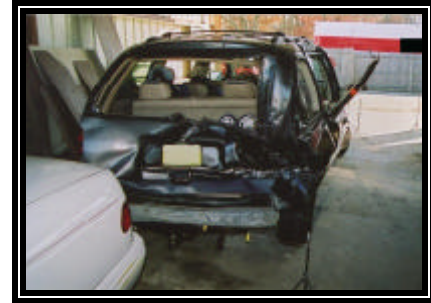
Figure 1. Damaged 1997 Dodge Caravan SE

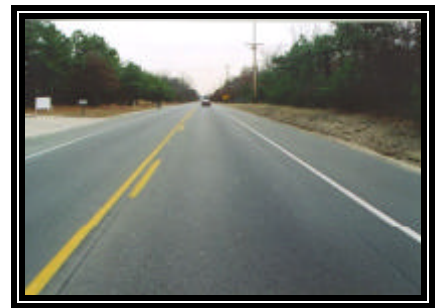
The driver of the 1997 Dodge Caravan had stopped the vehicle in the eastbound lane (**Figure 2**) and was waiting for westbound traffic to clear prior to initiating a left turn onto the church driveway. The driver of the 1985 Chevrolet tow truck was operating the vehicle in an easterly direction behind the Dodge Caravan. The driver of the tow truck stated that he was aware of the van traveling ahead of his vehicle, and that he was distracted by an uninvolved vehicle traveling in the westbound lane. He did not realize the van had stopped in the travel lane. When the driver of the tow truck detected the stopped Caravan, he shifted the manual transmission from third to second gear, applied the brakes in full lockup, and steered right in an attempt to avoid the collision. The combination of braking, steer input, and the wet roadway surface caused the Chevrolet tow truck to initiate a slight clockwise (CW) yaw prior to the impact. The investigating officer documented approximately 13.1 m (43.0') of pre-impact skid marks from the Chevrolet tow truck, however, the marks were not visible at the time of the SCI scene documentation. The driver of the Caravan did not detect the approaching tow truck and did not attempt any avoidance maneuvers. The driver of the 1993 Ford Taurus was operating the vehicle in the westbound travel lane approaching the church driveway and did not anticipate the collision between the Dodge Caravan and the Chevrolet tow truck. The driver of the Taurus did not attempt any avoidance maneuvers until after the initial impact between the Caravan and the tow truck.

Figure 2. Eastbound view for the stopped Dodge Caravan and approach view for the Chevrolet tow truck

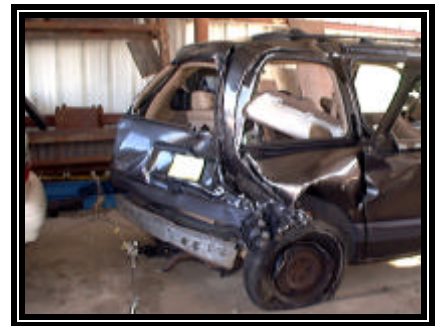
The 1997 Dodge Caravan sustained severe rear damage (**Figure 3**) as a result of the impact with the 1985 Chevrolet tow truck. The direct damage along the rear lift gate started 12.1 cm (4.8") left of center and extended 85.1 cm (33.5") to the right rear corner. The combined direct and induced damage involved the entire rear width of the Caravan and measured 144.2 cm (56.8"). The height of the direct damage extended upward approximately 20 cm (8") above the bottom aspect of the backlight frame, evidenced by red paint transfers and moderate abrasions on the right D-pillar. The maximum crush at the bottom aspect of the rear lift gate measured 54.3 cm (21.4") at the rear right corner. The crush on the right aspect of the lift gate caused the bottom left aspect of the lift gate to pull away from the lift gate frame. The rear bumper fascia was completely separated from the vehicle and the bumper beam was crushed forward on the right side. The maximum crush on the rear bumper beam measured 53.8 cm (21.2") at the rear right corner. The lower aspect of the right D-pillar was crushed forward and the right rear quarter panel was crushed and buckled outward over the right rear wheel. The quarter panel sheet metal was crushed against the right rear tire which caused the right rear wheel to be restricted. The right rear wheel rim was deformed from the impact and subsequent vehicle rotation and the tire was deflated. The leading edge of the right rear quarter panel was also deformed at the right C-pillar. The right rear side window frame was deformed and induced buckling was noted on the roof side rail at

Figure 3. Rear damage to the 1997 Dodge Caravan

the right C-pillar. The right brake light assembly was displaced from the Caravan and was suspended by the wiring harness. The Collision Deformation Classification (CDC) for the rear impact to the Caravan was 06-BZEW-4. Six crush measurements spaced 28.8 cm (11.4") apart were recorded along the rear bumper beam and were as follows: C1 = 1.0 cm (0.4"), C2 = 11.4 cm (4.5"), C3 = 20.6 cm (8.1"), C4 = 32.4 cm (12.8"), C5 = 41.9 cm (16.5"), C6 = 53.8 cm (21.2"). An additional set of crush measurements was taken at the same C locations at the lower aspect of the rear lift gate frame, which were consistent with the measurements recorded on the bumper beam.

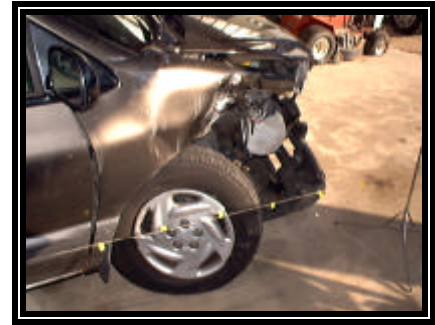
The 1997 Dodge Caravan also sustained moderate damage as a result of the secondary impact with the 1993 Ford Taurus. The damage was concentrated on the right front side area forward of the right A-pillar (**Figure 4**). The direct damage began 151.8 cm (59.8") forward of the rear edge of the right front door at the belt line and extended forward 67.9 cm (26.8") to the right front bumper corner. The combined direct and induced damage began at the right A-pillar and extended 113.7 cm (44.8") to the right front bumper corner along the side trim area. The right front fender was crushed laterally and exhibited white paint transfers and abrasions from direct contact with the Ford Taurus. The rear edge of the fender was pulled forward slightly from the lateral displacement.

Figure 4. View of right front side damage to the Caravan

The hood was displaced vertically from induced damage. The front bumper fascia was fractured and separated at the right front corner. The front right aspects of the bumper beam and radiator support were crushed laterally and rearward from the impact force. The grille assembly was displaced and the front right head lamp assembly was fractured and separated. The front left head lamp assembly was also separated from induced damage. The right front wheel was slightly displaced from direct contact and the wheel cover was partially separated. The right front wheel was restricted but the tire was not deflated. The damaged right front wheel had a significantly greater right steer angle than the left front wheel at the time of inspection. The CDC for the secondary impact with the Ford Taurus was 02-RFEW-3. Six crush measurements were recorded along the right front side trim level and were as follows: C1 = 2.5 cm (1.0"), C2 = 2.5 cm (1.0"), C3 = 15.5 cm (6.1"), C4 = 27.7 cm (10.9"), C5 = 23.2 cm (9.1"), C6 = 0.0 cm.

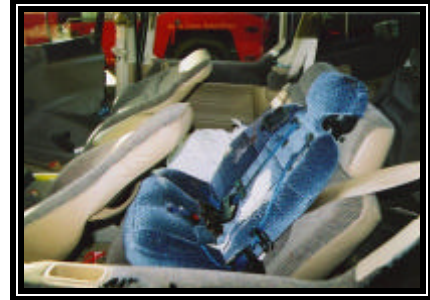
The front seat backs intruded rearward into the second seat area. Both front seat tracks were adjusted to the full-rear positions and the total track travel measured 22.2 cm (8.8") for each seat. Both front seat backs were deflected rearward from occupant loading and rotated slightly inward (**Figure 5**). The residual angle of the front left seat back from a horizontal of zero degrees was 48 degrees at the lumbar region and 45 degrees at the integral head restraint. The residual angle of the front right seat back from a horizontal of zero degrees was 35 degrees at the lumbar region and 46 degrees at the integral head restraint. The dynamic deflection of both front seat backs intruded farther into the second seat occupants' space. The driver's seat back contacted the child seated in the booster seat in the left second seat position. At the time of the vehicle inspection, the space between the front left seat back and the leading edge of the booster seat was 7.0 cm (2.8") and 5.7 cm (2.3") on the left and right sides, respectively. Both outboard front seat back brackets were constructed of a flat stock bracket welded to an extra "U" channel. The reinforced outboard brackets measured 4.1 cm (1.6") fore and aft, and 1.3 cm (0.5") in width (**Figure 6**). The inboard brackets consisted of a flat stock bracket with a radius on the edges and measured 4.1 cm (1.6") fore and aft, and 0.6 cm (0.3") in width (**Figure 7**).

Figure 5. Front seat back deflection

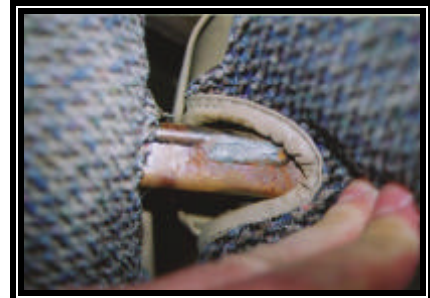
Figure 6. Outboard front seat back bracket

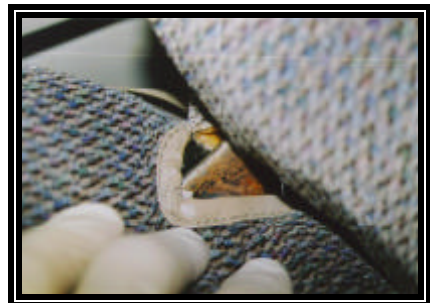
Figure 7. Inboard front seat back bracket

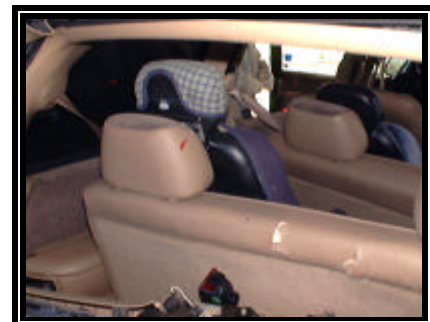
The rear lift gate intruded into the rear cargo area. The maximum lift gate intrusion measured 60.0 cm (23.6"), at 12.7 cm (5.0") right of center. Intrusion into the rear cargo area resulted from penetration of the front aspect of the Chevrolet tow truck. The maximum longitudinal intrusion measured 46 cm (18.1") on the right side of the cargo area. The hood of the Chevrolet tow truck contacted the third seat back which caused the seat back to intrude longitudinally into the third seat area. The maximum intrusion measured 11.4 cm (4.5") on the right side of the seat back and 5.7 cm (2.3") at the center of the seat back. The top aspect of the third seat back exhibited numerous red paint transfers and two moderate fabric lacerations as a result of the direct contact with the tow truck's hood (**Figure 8**).

Figure 8. Paint transfers and fabric lacerations on third seat back

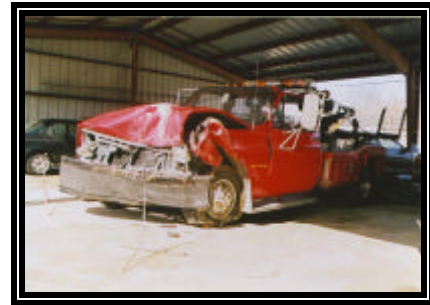
The Chevrolet tow truck sustained moderate frontal damage (**Figure 9**) as a result of the impact with the Dodge Caravan. The direct damage on the hood face began 16.5 cm (6.5") left of the centerline and extended 64.1 cm (25.3") to the left edge. The direct damage on the bumper began 9.8 cm (3.9") right of the centerline and extended 116.2 cm (45.8") to the left corner. The combined direct and induced damage involved the entire frontal plane of the vehicle and measured 193.0 cm (76.0"). The maximum crush measured 47.6 cm (18.8") at the lower radiator support and was located 27.9 cm (11.0") left of center. The left half of the bumper was crushed rearward against the left front wheel. The left front wheel was restricted as a result of the bumper crush and rearward displacement against the rear aspect of the left front fender. The grille and both head lamp assemblies were fractured and displaced. The upper and lower radiator supports were crushed rearward. The hood was buckled and exhibited significant abrasions and missing paint fragments on the left and center aspects. The left front fender was crushed and buckled rearward and outward. A portion of fabric from the third seat of the Dodge Caravan was stuck on the sheet metal of the left front fender. Tinted glazing fragments were scattered along the lower radiator support and surrounding components from the Caravan's backlight. The entire front axle was displaced CCW as a result of the left side impact. The left wheelbase was shortened by 12.1 cm (4.8") and the right wheelbase was extended 12.1 cm (4.8"). The CDC for the frontal impact to the Chevrolet tow truck was 12-FYEW-2. Six crush measurements were taken along the lower radiator support and were as follows: C1 = 36.8 cm (14.5"), C2 = 38.7 cm (15.3"), C3 = 45.1 cm (17.8"), C4 = 27.6 cm (10.9"), C5 = 12.7 cm (5.0"), C6 = 4.1 cm (1.6").

Figure 9. Frontal damage to 1985 Chevrolet tow truck

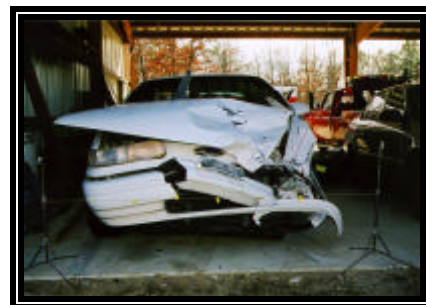
The 1993 Ford Taurus sustained moderate damage (**Figure 10**) as a result of the frontal impact with the Dodge Caravan. The direct damage began 20.3 cm (8.0") left of center on the bumper fascia, and extended to the front left corner. The combined direct and induced damage involved the entire frontal width of the vehicle and measured 116.2 cm (45.8"). The maximum crush was located 6.4 cm (2.5") inboard of the front left bumper corner and measured 31.1 cm (12.3") on the upper radiator support. The

Figure 10. Frontal damage to 1993 Ford Taurus

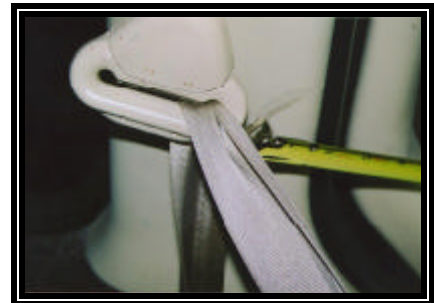
The manual 3-point lap and shoulder belt was used to secure the Century booster seat in the left position on the second seat. The manual restraint was routed through the rear aspect of the child safety seat per the manufacturer's instructions. The webbing exhibited one complete twist between the floor anchor and the D-ring. The webbing was found folded and gathered in the forward aspect of the D-ring from the forward loading of the child safety seat during the rebound after the initial impact and the subsequent lateral loading from the secondary impact (**Figure 11**). Subtle blood spattering was noted on the D-ring. The manual 3-point lap and shoulder belt for the second seat center position exhibited signs of loading on the webbing from the convertible child safety seat.

Figure 11. D-ring for the second seat left position

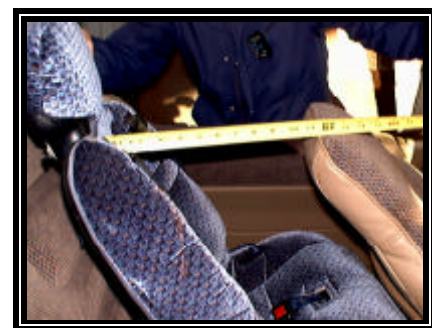
The Century Breverra was found installed in the Caravan. The seat was secured with the manual 3-point lap and shoulder belt and lightweight cinching latch plate. Post-crash observations indicated that the lap portion of the manual 3-point belt was not tightened properly. Post-crash, the child seat freely moved 10.2 cm (4.0") laterally to the right and 12.7 cm (5.0") laterally to the left at the belt path. The child seat also freely moved forward 8.9 cm (3.4") at the top aspect and 10.8 cm (4.3") at the bottom aspect. Due to the rearward deflection of the driver's seat back, the distance between the leading edge of the child seat and the static driver's seat back was 7.0 cm (2.8") on the left side and 5.7 cm (2.3") on the right side. The distance between the top of the child seat and the driver's integral head restraint was 34.3 cm (13.5"), which placed the deflected front left seat back into the forward head excursion range of the child seated in the child seat (**Figure 12**). The NHTSA 213 head excursion limit for forward facing child safety seats is 81.3 cm (32.0") without a tether strap.

Figure 12. View showing distance between the booster seat and the damaged driver's seat back

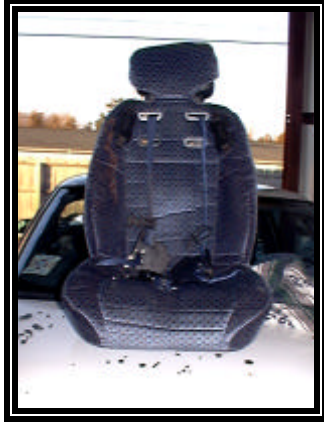
Figure 13. Damaged Century booster seat

At the time of the vehicle inspection, the harness system in the Century Breverra had numerous twists in the webbing (**Figure 13**). The right harness strap had two complete twists between the harness slots and the right shield with tongue. The entire left harness strap had repeated twists in the webbing through upper and lower harness slots, the left retainer clip, and the left shield with tongue (**Figure 14**). The twists significantly reduced the width of the harness straps to a rope-like strap. The harness retainer clip was positioned at the full-down position adjacent to the shields with tongues. The buckle webbing had one complete twist. There were no cracks in the plastic buckle housing and the buckle was operational. A moderate amount of blood was on the inboard right aspect of the fabric cover. Blood was also observed on the right aspect of the fabric below the bottom harness slot, on the mid aspect of both harness straps, on the harness retainer clip, and on the rigid plastic shield with tongues.

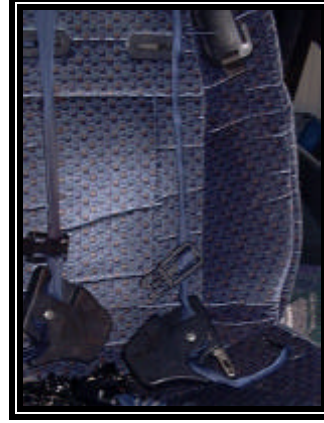
Figure 14. Close up of twisted harnesses and shield with tongues

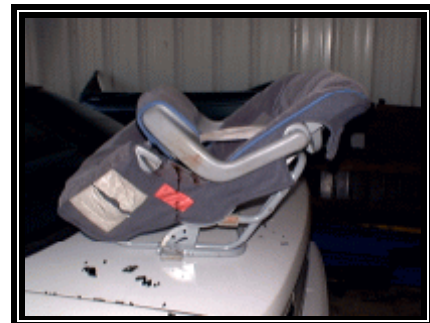
A Fisher-Price convertible child safety seat (**Figure 15**) with a plastic tray shield was installed in the center position on the second seat of the Dodge Caravan. The model number was 9104 and the manufacture date was January 5, 1995. There were no NHTSA recalls associated with this child safety seat. The seat was designed for forward-facing use by children that weighed between 9.1 kg (20.0 lb) and 18.1 kg (40.0 lb). The child safety seat had been removed from the vehicle with the child immediately after the crash

Figure 15. Fisher-Price convertible child safety seat

by a responding police officer. The seat had been installed in the vehicle in a forward-facing orientation. Upon inspection, the seat was found in the rear-facing recline position. The child safety seat was configured with two sets of slots for the harness straps; the bottom slots for rear-facing orientation and the top slots for forward-facing orientation. The harness straps were routed through the top slots of the child seat back, however, both harness straps were folded as they passed through the slots. Between the slots and the tray shield, the left harness strap had one complete twist and the right harness strap had one fold. At the time of inspection, the harness retainer clip was positioned at the lowest aspect of the right harness near the tray shield, and the left harness was not routed through the retainer clip. The buckle assembly beneath the tray shield was operational and was configured with a fixed latch plate with an automatic adjuster inertia lock. Scuff marks were noted on the leading edge of the bottom aspect of the plastic shell and on the bottom aspect of the frame. Blood was noted on the left aspect of the tray shield and fabric cover.

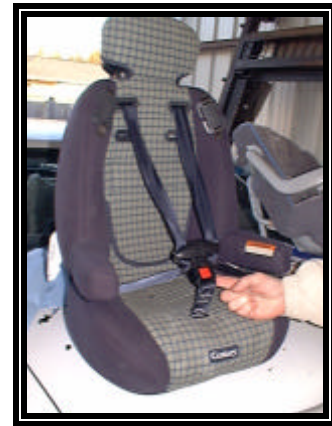
Figure 16. Century belt-positioning booster seat

The Century Breverra Metro seat (**Figure 16**) was used as a belt positioning booster seat and was not secured with the vehicle's manual restraint. Even though the harness system was not used by the child seated in the seat, the harness system was still in place. The harness straps were routed through the top slots on the booster seat back. At the time of the vehicle inspection, the left harness had one complete twist between the upper harness slot and the left latch clip, and a second complete twist between the latch clip and the bottom left harness slot. The right harness strap had one complete twist through the right latch clip. The harness retainer clip was located on the harness straps 34.3 cm (13.5") below the top slots. There were no signs of abrasions or loading to the plastic belt positioner on the left side of the booster seat. Minor abrasions were noted on the bottom aspect of the plastic shell.
