**VERIDIAN ON-SITE AIR BAG RELATED CHILD PASSENGER
FATALITY INVESTIGATION
VERIDIAN CASE NO. CA01-029
VEHICLE: 1997 MITSUBISHI MONTERO
LOCATION: FLORIDA
CRASH DATE: MAY 2001**

1. <i>Report No.</i> CA01-029	2. <i>Government Accession No.</i>	3. <i>Recipient's Catalog No.</i>	
4. <i>Title and Subtitle</i> Veridian On-Site Air Bag Related Child Passenger Fatality Investigation Vehicle: 1997 Mitsubishi Montero Location: Florida		5. <i>Report Date:</i> December 2002

14. <i>Sponsoring Agency Code</i>	
15. <i>Supplementary Notes</i> On-site investigation of a front-to-rear crash that resulted in frontal air bag deployment and the death of a 3 year old male front right child passenger.

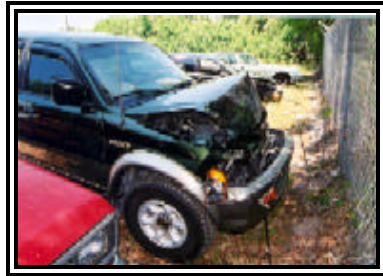
The full frontal area of the Mitsubishi Montero (**Figure 4**) impacted the recycling basket that was mounted on the rear of the straight truck (**Figure 5**). The front bumper of the Montero initially engaged the lower aspect of the basket then underrode the basket as the grille, hood face, and upper radiator support panel of the Montero crushed to maximum engagement. The lower rear aspect of the truck's basket crushed to a maximum residual value of 35.2 cm (13.875") while the left corner of the Montero's radiator support was crushed to a depth of 39.1 cm (15.4") The resultant direction of force were 12 o'clock for the Mitsubishi and 6 o'clock for the struck recycler truck. The crash was outside the scope of the WinSMASH reconstruction program due to the crush of the manufactured basket. A barrier equivalent speed of 21.0 km/h (13.0 mph) was generated for the Montero using the barrier mode of the damage algorithm. The frontal impact deployed the Mitsubishi's frontal air bag system. The air bag system probably deployed late in the crash sequence due to the "soft" crash that involved the underride damage to the Montero and the crush to the basket unit of the recycler truck.

Figure 4. Full frontal damage to the Mitsubishi.

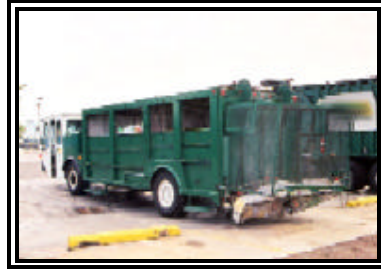
Figure 5. Damage to the rear basket of the recycler truck.

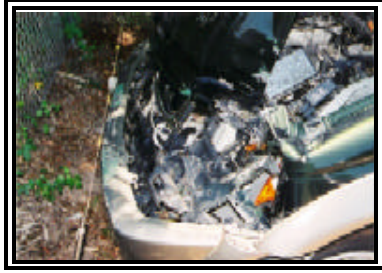
Figure 6. Close-up view of the Montero's bumper fascia support.

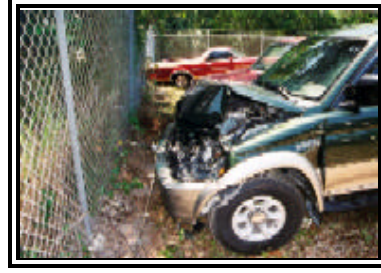
Figure 7. Lateral view of the front left corner of the Montero.

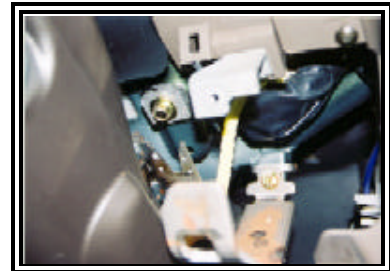
The driver's air bag deployed from the steering wheel mounted module. The driver was contacted by the deploying air bag as evidenced by a tissue transfer to the lower left quadrant of the bag. The unrestrained driver subsequently loaded the air bag and steering assembly as she responded to the 12 o'clock impact force. Her loading force against the steering assembly resulted in compression of the energy absorbing steering column as evidenced by 3.2 cm (1.25") of shear bracket separation (**Figure 8**).

Figure 8. Right shear bracket separation.

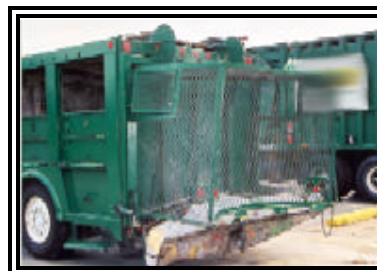
The damage to the rear of the recycler truck was limited to the wire mesh/angle iron basket that was mounted the rear of the vehicle. The impact crushed the lower outboard frame of the basket and deformed the back, bottom, and left side of the mesh walls. The damaged length along the lower edge of the frame was 200.7 cm (79.0") which extended from corner-to-corner of the basket. Maximum crush was measured at 35.2 cm (13.875") located 80.3 cm (31.6") inboard of the left corner. The crush profile measured at the lower edge of the frame work was as follows: C1 = 8.9 cm (3.5"), C2 = 31.75 cm (12.5"), C3 = 35.2 cm (13.875"), C4 = 30.4 cm (12.0"), C5 = 18.7 cm (7.375"), C6 = 0 cm. **Figure 9** is a view of the damage to the recycler truck.

Figure 9. Damage to the rear basket of the recycler truck.

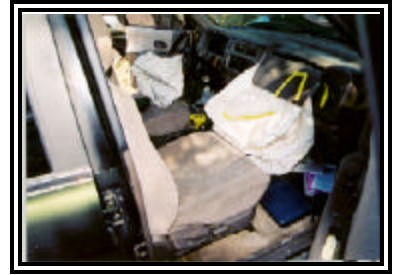
The Montero was equipped with a frontal air bag system for the driver and right passenger positions. The system consisted of two front crash sensors that were mounted to the upper radiator support panel, the steering wheel mounted driver module, the right instrument panel mid mount passenger air bag module, and a center console mounted air bag control module. **Figure 10** is an overall view of the deployed frontal air bag system.

Figure 10. Deployed frontal air bags.

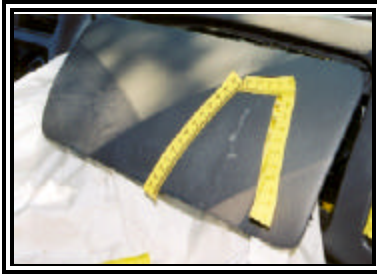
The child passenger was out-of-position forward at the time of deployment. A vertically oriented scuff mark, tissue transfers, and dried body fluid was noted to the face of the flap (**Figure 11**), right of its vertical centerline. The overall location of the scuff mark was located 20.0-25.4 cm (7.875-10.0") right of the left edge of the flap and 0-10.2 cm (0-4.0") above the leading edge. The tissue transfer within the

scuff was located 21.0-22.9 cm (8.25-9.0") right of the left edge and 3.5-6.0 cm (1.375-2.375") above the leading edge of the flap.

Figure 11. Scuff with tissue transfer to the module cover flap.

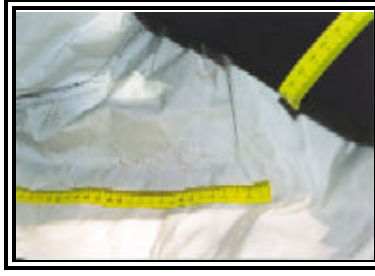
Figure 12. Tissue transfers on the top panel of the front right air bag.

The front right air bag membrane deployed from the mid mount module into the out-of-positioned child passenger. Numerous tissue transfers evidenced the child's involvement with the air bag. Two large diagonally oriented tissue transfers were noted to the top panel of the bag membrane (**Figure 12**). The upper transfer began 8.9 cm (3.5") left of the bag's centerline and extended 13.3 cm (5.25") to the left side panel. The second transfer began 4.4 cm (1.75") right of the referenced centerline and extended 22.2 cm (8.75") left of center. The transfer extended 21.6-35.6 cm (8.5-14.0") rearward of the air bag inflator manifold. This transfer continued on the face and left side of the bag at the perimeter seam. The laterally oriented tissue transfer contained vinyl transfers from bag expansion against the inside surface of the module cover flap. This transfer extended approximately 57.2 cm (22.5") in length.

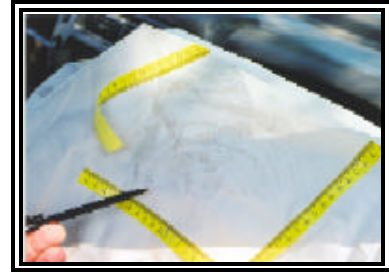
Figure 13. Tissue transfer with blue fabric at the bottom of the bag membrane.

A third transfer of tissue and fabric was noted to the bottom aspect of the bag (**Figure 13**). A 19.1-12.7 cm (7.5x5.0") circular tissue transfer was located on the vertical centerline of the bag. A 2.5x10.7 cm (1.0 x 4.25") band-like (horizontally oriented) blue fabric transfer was located directly under the tissue transfer. There was no structural damage to the air bag membrane from the child passenger contact.

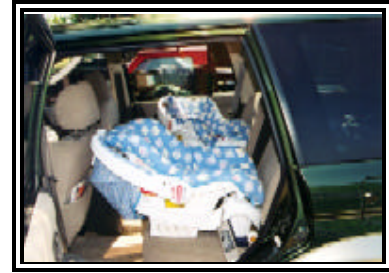
Two rear facing infant child safety seats (CSS) were installed in the second seat of the Mitsubishi Montero (**Figure 14**). These seats were not occupied at the time of the crash. The infant seat in the left rear position was an Evenflo Discovery, Model No. 2121223P1 with a Date of Manufacturer of 20 Dec 00. The CSS was installed in a rear facing position and properly engaged into the detachable base. The base was secured to the Montero by the 3-point lap and shoulder belt system that was properly routed through

the belt path. The retractor was not engaged into the automatic locking mode therefore the CSS was not properly secured by the belt system. The loose routing of the belt system allowed the CSS to rotated freely about the horizontal plane on the seat cushion. The folding handle was positioned in the forward locking position. Although not properly secured to the vehicle, the CSS was resting on the seat cushion at an angle of 45 degrees. The harness straps were twisted and positioned in the lowest of the two sets of slots.

Figure 14. Rear seat mounted child safety seats.

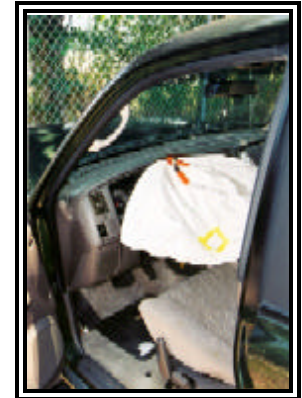
The impact with the angle iron frame and mesh basket that was mounted on the rear of the recycling truck produced an elongated crash pulse and deployment of the frontal air bag system late in the crash sequence (**Figure 15**). At impact, the driver initiated a forward trajectory as the air bag deployed. The driver's face contacted the lower left quadrant of the expanding air bag membrane. A tissue transfer (without make-up) was noted the bag located 7.0-10.2 cm (2.75-4.0") left of center and 14.6-15.9 cm (5.75-6.25") below the horizontal centerline. The driver's continued forward trajectory resulted in her torso loading the air bag and compressing the bag membrane against the steering wheel rim. Her loading force was transmitted into the energy absorbing steering column which compressed the column as evidenced by shear bracket separation. The left shear bracket was separated 2.5 cm (1.0") and remained partially engaged against the block. The right shear bracket was completely separated with a measure forward movement of 3.2 cm (1.25"). The driver was not injured as a result of the crash.

Figure 15.
Trajectory of the driver into the deploying air bag and steering assembly.

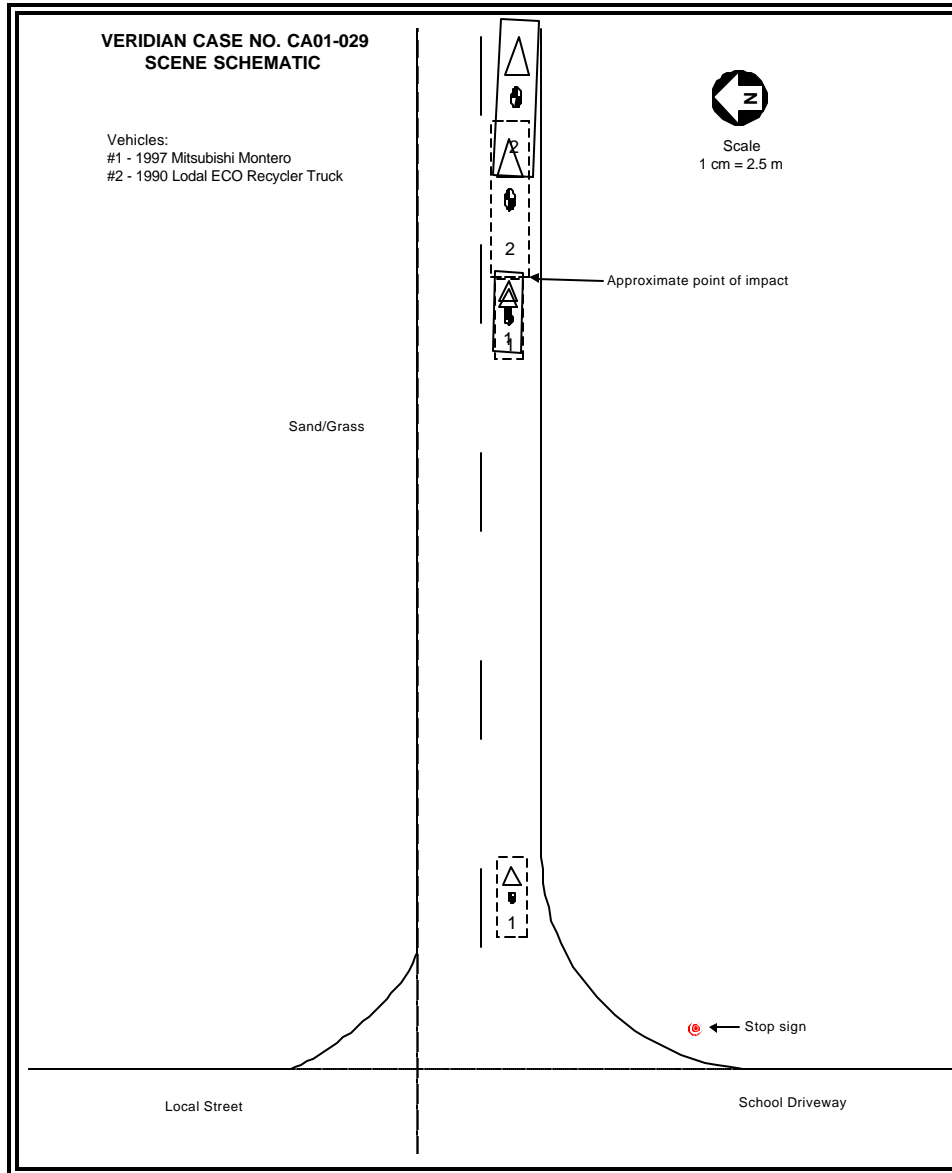
Figure 16. Crash Schematic.

The 31 year old female driver of the 1997 Mitsubishi Montero was traveling in an easterly direction on the county road at an estimated speed of 48 km/h (30 mph). The recycling truck was stopped forward of the Montero. The driver of the Montero was apparently distracted from her driving task and failed to detect the stopped recycling truck in sufficient time to avoid the impending crash. She braked immediately prior to the crash, however, there was no evidence of braking on the asphalt road surface. The Crash Schematic is attached as **Figure 16**, Page 15.
