**ALLEGED SEAT BELT FAILURE INVESTIGATION**

**VERIDIAN CASE NO. CA01-031**

**VEHICLE: 2001 TOYOTA RAV4**

**CRASH DATE: MAY 2001**

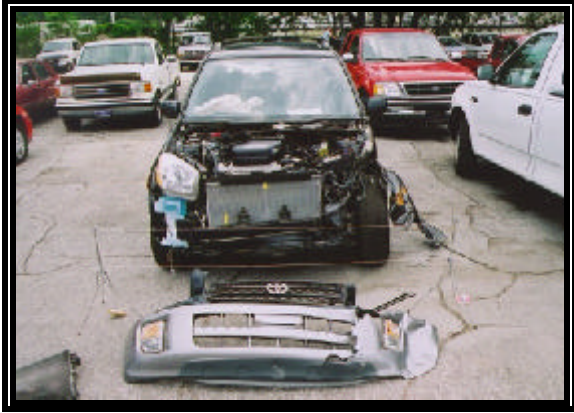
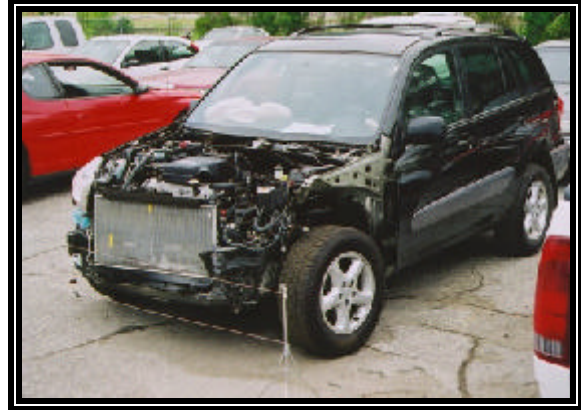
**Figures 2 and 3** are the front and left front views of the Toyota Rav4, respectively. The front exterior damage was localized primarily on the front left corner of the vehicle. The direct contact damage measured 41 cm (16 in). The direct contact began 36 cm (14 in) left of center and extended to the left bumper corner. The crush profile measured at the bumper reinforcement bar was as follows: C1=14.0 cm (5.5 in), C2=14.0 cm (5.5 in), C3=7.0 cm (2.8 in), C4=2.5 cm (1.0 in), C5=0, C6=0. The Principle Direction of Force was within the 12 o'clock sector and was estimated to be 350 degrees (-10 degrees). There was no measurable change in the wheelbase dimensions. However, the left front suspension was damaged in the crash event and was displaced laterally. All the doors remained closed during the crash and were operational. The left side of the windshield was fractured in the impact. There was no side glazing damage. The total delta V calculated by the Barrier Model of the WINSMASH was 17.7 km/h (11.0 mph). The longitudinal and lateral delta V components were -17.5 km/h (-10.9 mph) and 3.1 km/h (1.9 mph), respectively. The Collision Deformation Classification (CDC) was 12-FLEW-1.

Figure 2: Front view of the Toyota Rav4.

Figure 3: Left front view of the Toyota.

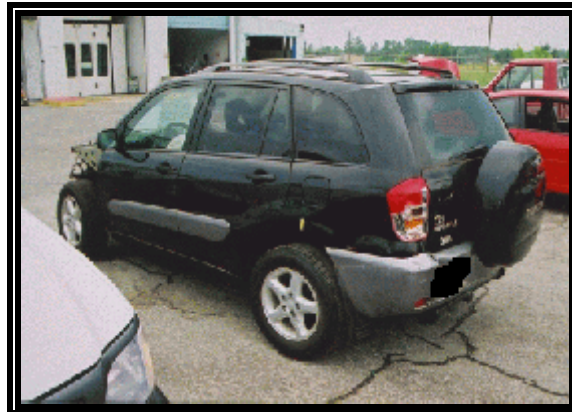
Minor exterior damage consistent with a secondary side slap was identified on the left rear corner of the vehicle, **Figure 4**. The width of the direct contact measured 66 cm (26 in). The damage began 5 cm (2 in) aft of the left rear axle and extended to the left rear corner. The residual crush profile was as follows: C1=3.8 cm (1.5 in), C2=3.8 cm (1.5 in), C3=1.3 cm (0.5 in), C4=0. The CDC of this impact was 09-LBEW-1

Figure 4: Left rear side slap damage.

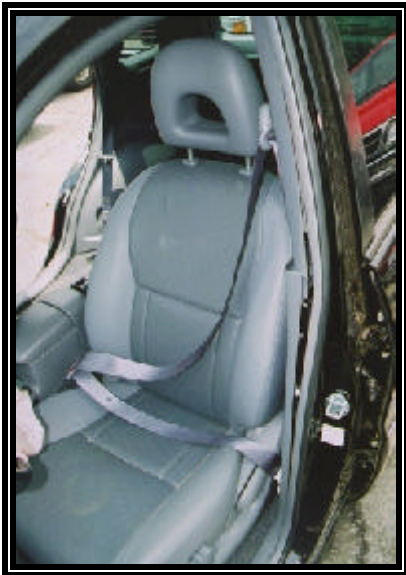
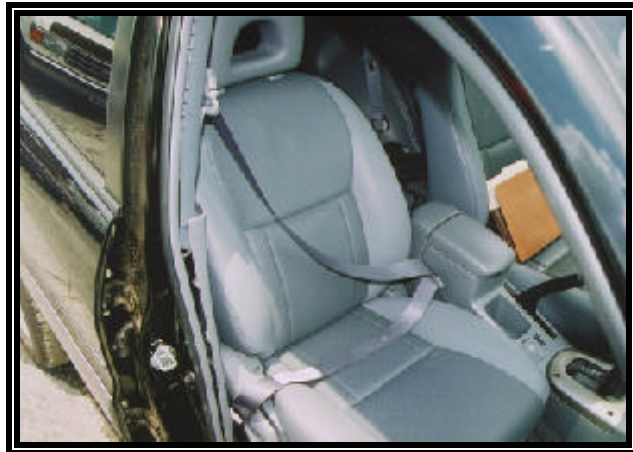
The subject vehicle was equipped with 3-point lap and shoulder belts for the five seat positions. The front restraints were equipped with retractor pretensioners and belt force limiters. **Figures 5 and 6** are views of the front belt systems in the buckled condition. Positive latching occurred between the latch plate and buckle of both restraints. There was no sign of a defective condition. The retractors of both restraints were locked in the at-crash position. The webbing would not spool in either direction indicating the pretensioners had fired and operated as designed. Obvious D-ring transfers to the webbings of each restraint were identified. The D-ring transfers on the left front and right front restraint measured 8.4 cm (3.3 in) and 6.4 cm (2.5 in), respectively. These webbing transfers were located below the D-ring, on the retractor side of the system, prior to removal of the restraints from the vehicle. This location of the transfers indicated there was not excessive pay-out of the webbing during the occupant's ride down. **Figures 7 and 8** are views of the front restraints after removal from the vehicle. The D-ring transfers are denoted by the yellow calibrated tape. The restraints were sent to ODI for further analysis.

All the evidence identified during the course of the SCI inspection indicated the driver and front right passenger were properly restrained at the time of the crash and the restraint system operated as designed. It should be noted that no complaint of restraint failure was ever registered with the police officer during the on-scene investigation.

**Figure 5:** Buckled left front restraint.

**Figure 6:** Buckled right front restraint.

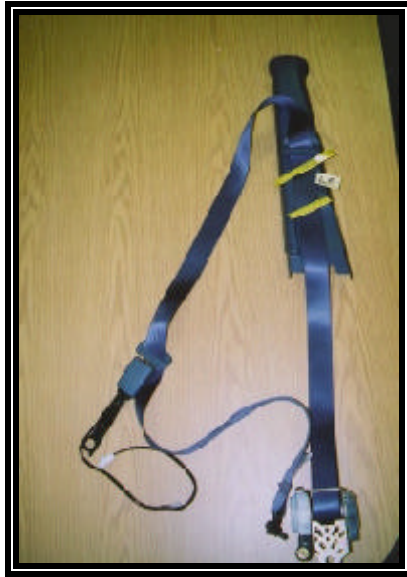
Figure 7: Left front restraint.

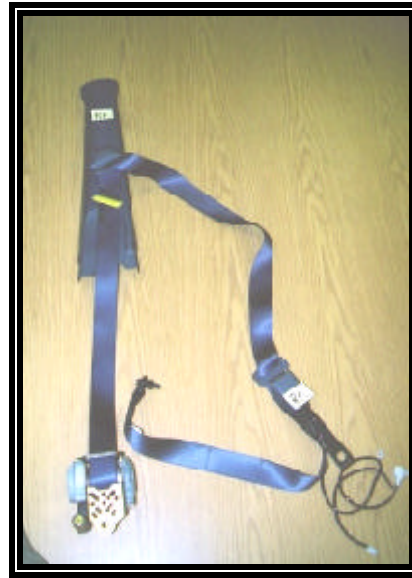
Figure 8: Right front restraint.

The passenger responded to the 12 o'clock direction of the impact force by initiating a forward trajectory and loading the belt system. The forward kinematic pattern was evidenced by a 6.4 cm (2.5 in) webbing transfer from frictional contact with the D-ring. The passenger sustained a right 4<sup>th</sup> rib fracture and abdominal contusion as a result of the seat belt loading. As the passenger's upper torso rode down the crash force, the head flexed forward and down in an arcing pattern. The anatomical structures of the neck reacted to and restrained the head resulting in the reported cervical strain. During this sequence, the passenger loaded the toe pan through her lower extremities resulting in the right toe fracture. The passenger then rebounded back into her seat. The proper use of the manual 3-point belt system effectively restrained the passenger during the crash sequence and helped to minimize her potential injury.

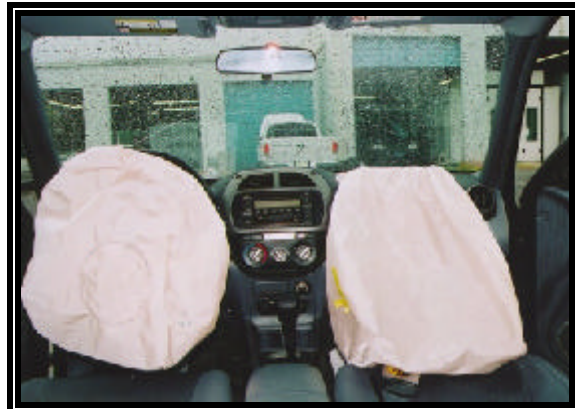
The 2001 Toyota Rav4 was equipped with a Supplemental Restraint System (SRS) that consisted of redesigned driver and front right passenger air bags. The frontal air bags had deployed as a result of the above-threshold crash, **Figure 9**. The driver air bag module was configured in the typical manner in the center hub of the steering wheel. The asymmetrical module cover flaps opened as designed and were free of occupant contact. The driver air bag measured 66 cm (26 in) in its deflated state. The bag was tethered and was vented by two 3.8 cm (1.5 in) diameter ports located in the 11/1 o'clock sectors on the back side of the bag. The bag was identified by a manufacturer's label bearing the number: 011182H0668. A contact scuff measuring 3.8 cm x 10.2 cm (1.5 in x 4.0 in), width by height, was located in the 2 to 3 o'clock sector on the face of the bag. The scuff resulted from probable contact with the driver's upper extremities during the deployment sequence.

Figure 9: Interior view of the deployed air bags.

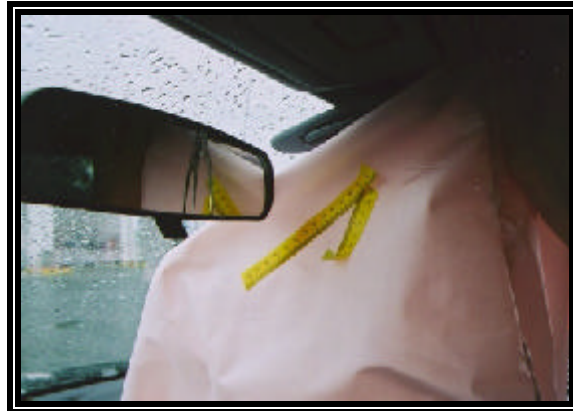
the module as a result of the above-threshold impact. The face of the bag measured 46 cm x 46 cm (18 in x 18 in) and extended 58 cm (23 in) from the module in its deflated state. It was not tethered and was vented by two 6.4 cm (2.5 in) diameter ports on the side panels of the air bag. There was no contact evidence on the face of the air bag. A 2.5 cm (1.0 in) vinyl transfer was identified on the center aspect of the inboard side panel. The transfer was located 15 cm (6 in) forward of the face of the bag and 8 cm (3 in) below the bag's top surface. During the crash sequence, the right passenger deflected the normal deployment path of the front right air bag into contact with the center mirror. The contact fractured the mirror and resulted in the vinyl transfer, **Figure 10**.

**Figure 10:** Contact between the center mirror and passenger air bag.
