**ON-SITE ON-SITE POTENTIAL OVER-SENSITIVE AIR BAG DEPLOYMENT  
INVESTIGATION  
SCI TECHNICAL SUMMARY REPORT**

**VERIDIAN CASE NO. CA01-035**

**VEHICLE - 2001 FORD FOCUS ZX3**

**CRASH DATE - JUNE 2001**

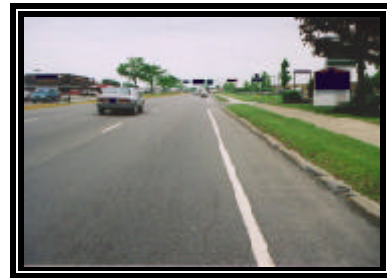
The Ford Focus struck the Honda Odyssey in a front-to-rear configuration (**Figure 4**). Both vehicles were still traveling forward at impact. The directions of force were in the 12 o'clock and 6 o'clock sectors for the Focus and Odyssey, respectively. The driver of the Focus stated that his estimated impact speed was approximately 16 km/h (10 mph). Although the Delta V's appeared to be low for both vehicles, the impact induced deceleration was sufficient to deploy the frontal air bag system in the Ford Focus. The damage algorithm of the WinSMASH program computed velocity changes of 15.0 km/h (9.3 mph) for the Focus and 9.0 km/h (5.6 mph) for the Odyssey based on the respective crush profiles. The Honda Odyssey was displaced forward and came to rest in the travel lane. Although damage was identified on the right rear wheel of the Odyssey that appeared to be from a curb impact, the crash configuration and lack of scene evidence did not support a secondary impact to the Odyssey. The Ford Focus departed the

**Figure 4. Point of impact**

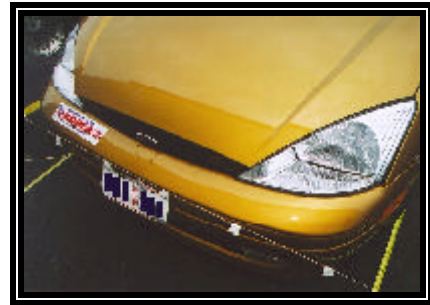
The 2001 Ford Focus sustained minor damage as a result of the impact with the Honda Odyssey. Direct contact began on the bumper fascia 19.8 cm (7.8") to the left of the centerline and extended 48.3 cm (19.0") laterally to the right (**Figure 6**). The front license plate was deformed from direct contact and was displaced downward 2.5 cm (1.0"). An angled abrasion was also noted on the face of the front bumper fascia to the right of the license plate. The combined direct and induced damage involved the entire frontal width of the vehicle. The bumper beam was crushed rearward behind the bumper fascia and Styrofoam filler. The maximum crush at the bumper beam was located 3.8 cm (1.5") to the left of the centerline and measured 5.7 cm (2.3"). The composite bumper beam was also fractured at the location of maximum crush (**Figure 7**). The bumper fascia and Styrofoam filler appeared to have rebounded to the original position after the crash, as there was no significant damage to either component. The Collision Deformation Classification (CDC) for the impact with the Odyssey was 12-FZLW-1. Six crush measurements were taken at the bumper beam and were as follows: C1 = 1.0 cm (0.4"), C2 = 2.0 cm (0.8"), C3 = 4.0 cm (1.6"), C4 = 4.0 cm (1.6"), C5 = 3.0 cm (1.2"), C6 = 1.0 cm (0.4").

**Figure 6. Frontal damage to the Ford Focus**

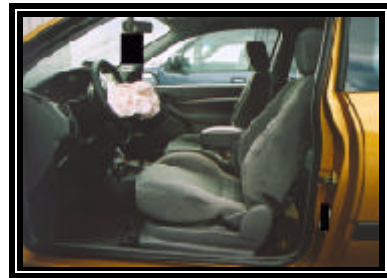
Interior damage to the 2001 Ford Focus was minor (**Figure 8**) and attributed to the activation of the supplemental restraint systems. The windshield was fractured on the right side from the front right redesigned air bag module cover flap. There was no passenger compartment intrusion. A faint scuff mark was identified on the lower left aspect of the rigid plastic knee bolster from possible left knee contact, however, there was no injury to support it.

**Figure 8. Interior view of the Ford Focus**

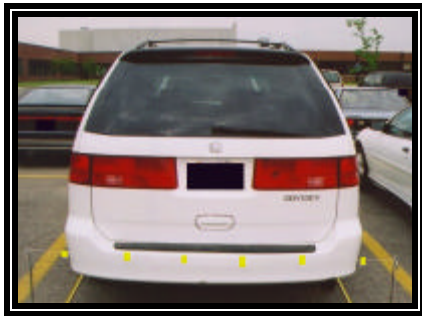
The 2000 Honda Odyssey sustained minor damage as a result of the impact with the Ford Focus. The direct contact damage was located on the rear bumper fascia, and began 2.5 cm (1.0") left of the centerline and extended laterally 55.9 cm (22.0") to the left (**Figure 9**). The direct contact consisted of an abrasion 2.5 cm (1.0") to the left of the centerline and two 1.3 cm (0.5") diameter hexagon shaped impressions 17.8 cm (7.0") to the left of the centerline (**Figure 10**). The hexagon-shaped impressions were from the Focus' top license plate screw heads that were used to anchor the license plate to the bumper fascia. The rubber trim molding on the top aspect of the rear bumper was displaced upward. The maximum vertical displacement was 1.3 cm (0.5") and was located 2.5 cm (1.0") to the left of the centerline. Damage to the outer edge of the right rear wheel cover was identified on the Odyssey that appeared to be from a curb impact. However, the crash configuration and lack of scene evidence did not support a secondary impact to the Odyssey. Therefore, the wheel damage appears to be unrelated to this crash. The CDC for the impact with the Ford Focus was 06-BYLW-1. There was no measurable crush to the Odyssey.

**Figure 9. Damage to the rear bumper of the Odyssey**

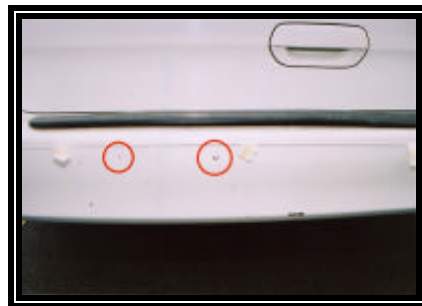
**Figure 10. Marks from the Focus' license plate screws (highlighted in circles)**

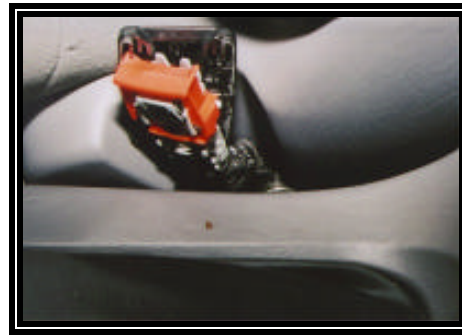
**Figure 12. Front right buckle assembly damage**

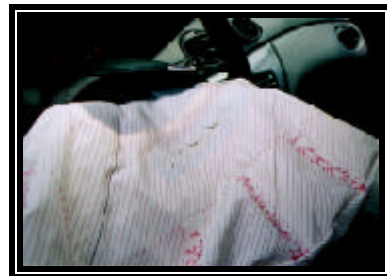
**Figure 13. Driver's redesigned air bag showing vent ports and stitching**

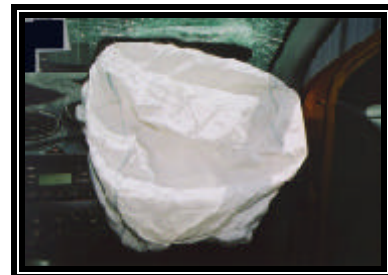
The redesigned front right passenger's air bag deployed from the from a top-mounted module with a single cover flap design hinged at the forward aspect (**Figure 15**). The cover flap measured 12.7 cm (5.0") in height and 41.9 cm (16.5") in width. The air bag measured 58.4 cm (23.0") in height and 45.7 cm (18") in width and was vented by two ports that measured 2.5 cm (1.0") in diameter and were located at the 10 and 2 o'clock aspects. The redesigned front right passenger's air bag was not tethered.

**Figure 15. Redesigned front right passenger's air bag**
