**ON-SITE CHILD SAFETY SEAT CRASH INVESTIGATION
SCI TECHNICAL SUMMARY REPORT**

VERIDIAN CASE NO. CA01-046

SUBJECT VEHICLE - 2000 HONDA ACCORD

CRASH DATE - OCTOBER 2001

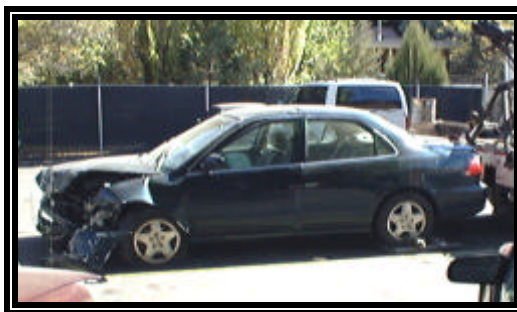
Figure 1. Damaged 2000 Honda Accord

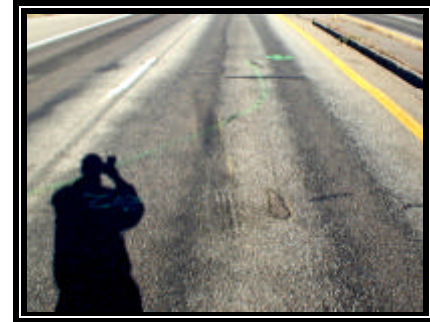
The longitudinal and latitudinal components for the CRX were -34.5 km/h (-21.4 mph) and -6.1 km/h (-3.8 mph), respectively. The impact induced deceleration was sufficient to deploy the frontal air bag system in the Honda Accord. Both vehicles initiated a counterclockwise (CCW) rotation as they disengaged. Tire marks from both vehicles left front wheels were present on the roadway surface in their post-impact trajectories (**Figure 4**). The Accord traveled forward and to the right approximately 10 m (33') as it rotated a total of 220 degrees in a CCW direction from impact to final rest. The Accord came to rest facing northwest in the center of the eastbound travel lanes. The CRX was redirected in a rearward direction and the vehicle rotated CCW. The right rear wheel struck the south edge of the curbed median which arrested the rearward travel and rapidly intensified the CCW rotation. The CRX rotated approximately 190 degrees in a CCW direction over the curbed median. The CRX came to rest on the opposite side of the median facing northeast and straddling the yellow delineation line of the inboard westbound lane.

Figure 4. View looking westbound at point of impact and tire marks

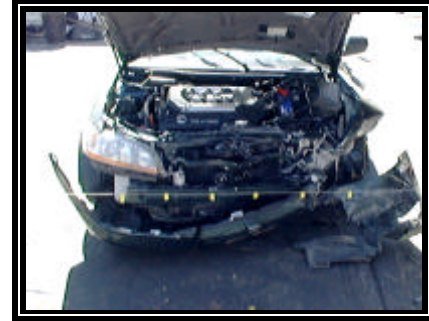
The 2000 Honda Accord sustained moderate damage as a result of the frontal impact with the Honda CRX (**Figure 5**). The direct damage along the leading edge of the hood began 6.4 cm (2.5") left of center and extended 63.5 cm (25.0") to the left corner. The direct damage on the grille area began 14.0 cm (5.5") left of center and extended 66.0 cm (26.0") to the left corner. The combined direct and induced damage involved the entire frontal width of the vehicle and measured 104.1 cm (41.0"). The maximum crush measured 53.7 cm (21.2") and was located at the front left corner of the bumper beam. The front bumper fascia and grille assembly were separated and displaced to the left under the front bumper beam. The left aspect of the bumper fascia was distorted and fractured. The bumper beam was crushed rearward with the most severe crush located at the left corner. The Styrofoam filler was displaced under the bumper beam, however, there was no damage to the filler (**Figure 6**). The upper and lower radiator supports and the radiator core were crushed and displaced rearward on the left side. The hood was buckled and abraded on the leading edge and longitudinal abrasions from the previous crash were noted on the center aspect of the hood. The leading left corner of the hood was crushed from direct contact damage evidenced by white paint transfers and multiple abrasions. The front left head lamp assembly was fractured and separated. The left front fender was buckled outward and crushed rearward which caused the rear edge of the fender to overlap the leading edge of the left front door. The rearward displacement of the fender also contributed to the rearward displacement of the left front door which prevented the door from closing completely. The left rear door was also displaced rearward and the rear edge of the door overlapped the left C-pillar approximately 2.5 cm (1.0"). The front aspect of the right front fender was pulled toward the centerline which resulted in a gap between the leading edge of the right front door and the rear edge of the right front fender. The right frame rail was also displaced laterally toward the centerline. Induced buckling was located on the left A-pillar 53.3 cm (21.0") from the top of the instrument panel at the upper left corner of the windshield. Induced buckling was also located on the left roof side rail forward of the left B-pillar. The left front tire was deflated and the left front wheel was displaced rearward and restricted against the rear aspect of the left front fender (**Figure 7**). The rearward displacement of the left front wheel resulted in a 23.7 cm (9.3") reduction of the left wheelbase. The left side mirror was displaced, however, it was not fractured and was still positioned in the mirror frame. The Collision Deformation Classification for the impact with the CRX

Figure 5. Frontal view of the damaged 2000 Honda Accord

was 12-FYEW-3. Six crush measurements were documented along the front bumper beam and were as follows: C1 = 53.7 cm (21.2"), C2 = 39.4 cm (15.5"), C3 = 26.7 cm (10.5"), C4 = 17.8 cm (7.0"), C5 = 7.0 cm (2.3"), C6 = 0.0 cm.

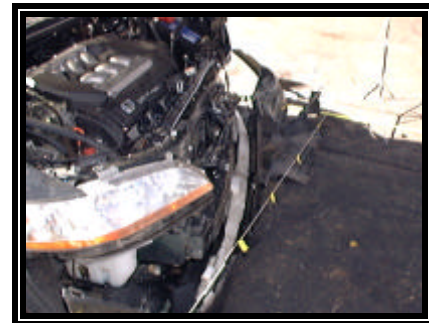
Figure 6. View of the undamaged Styrofoam filler

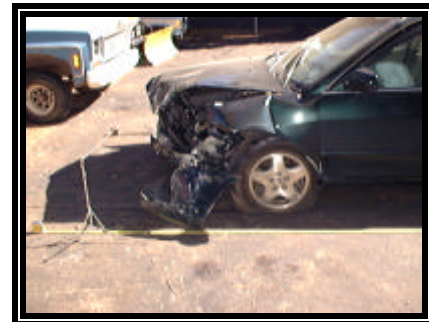
Figure 7. Left side view showing maximum crush and displaced left front wheel

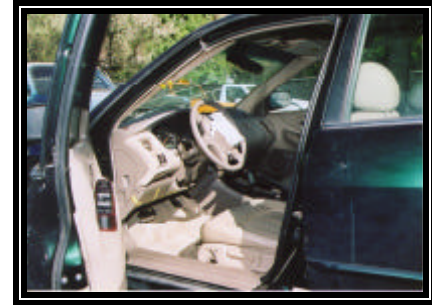
Interior damage to the 2000 Honda Accord (**Figure 8**) was moderate and attributed to compartment intrusion and occupant contact. The windshield laminate sustained fractures as a result of the impact forces and the remaining glazing did not sustain damage. The top aspect of the molding was separated from the left A-pillar. A laterally oriented dark linear scuff was located on the left A-pillar molding 30.5 cm (12.0") above the top of the left instrument panel, possibly a result of the driver's left hand or jewelry. The rear view mirror was displaced forward on the left aspect against the windshield and the roof-mounted sunglass holder was rotated open. Scuffs on the rigid plastic knee bolster were located on the far left aspect and under the steering column as a result of contact from the driver's knees. The lower aspect of the steering column adjacent to the toe pan was collapsed from the toe pan intrusion (**Figure 9**). There was no evidence of steering column compression by the driver. The accelerator pedal was displaced to the right against the lower aspect of the center console from the driver's right foot. The rear seat back was intruded as a result of loading from items in the trunk. Two bottles of radiator coolant and two bottles of motor oil were found in the trunk during the vehicle inspection. The driver stated that a large suitcase weighing approximately 14 kg (30 lb) and a stroller were also in the trunk at the time of the crash. The loading of the items in the trunk caused the rear seat back to intrude into the rear seat area (**Figure 10**). The maximum longitudinal intrusion was located at the rear center position on the lower aspect of the seat back and measured 5.1 cm (2.0"). There was no intrusion of the rear seat cushion. The rear right seat cushion exhibited depressions in the leather from the child safety seat and longitudinal scuff marks from the forward motion of the child safety seat across the cushion at impact. Longitudinal blood spattering was noted on the center aspect of the head liner, on the interior center dome light, and on the right aspect of the head liner adjacent to the right B-pillar. The interior aspects of both C-pillars were abraded in a semi-circular pattern, and appeared to be a result of the child safety seat tray shield contacting the plastic molding of the C-pillars as the shield was raised and lowered.

Figure 8. Left side interior view

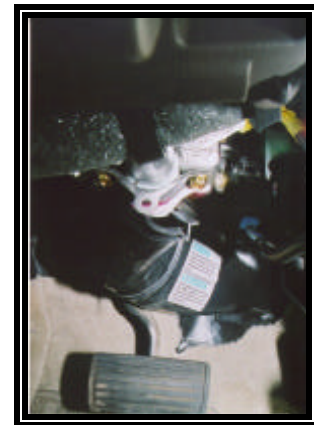
Figure 9. Collapsed lower aspect of steering column

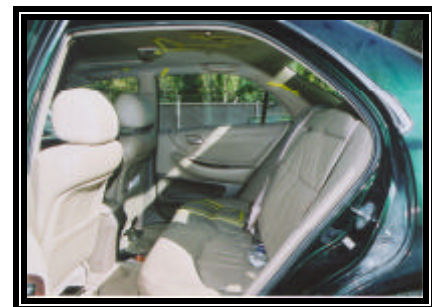
Figure 10. View of rear seat showing intruded seat back

Position	Intruded Component	Intruded Value	Direction
11	Left foot rest	1.3 cm (0.5")	Longitudinal
11	Left toe pan	1.3 cm (0.5")	Longitudinal
21	Rear left seat back	3.2 cm (1.3")	Longitudinal
22	Rear center seat back	5.1 cm (2.0")	Longitudinal
23	Rear right seat back	3.8 cm (1.5")	Longitudinal

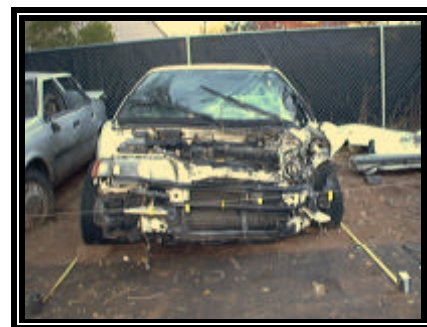
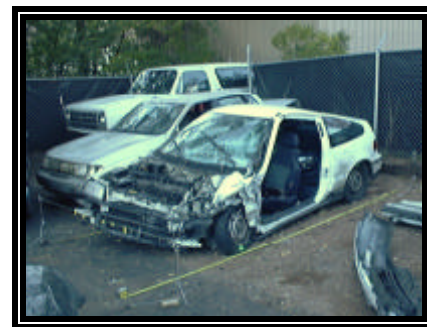
The CRX sustained moderate damage as a result of the frontal impact with the Honda Accord (**Figures 11 and 12**). The direct damage along the leading edge of the hood began at the centerline and extended 50.8 cm (20.0") laterally to the left front corner. The direct damage on the front bumper fascia began 48.3 cm (19.0") to the left of the centerline and extended to the front left corner. The left corner of the front bumper fascia was fractured and separated from the direct contact. The combined direct and induced damage involved the entire frontal width of the CRX and measured 88.9 cm (35.0"). The maximum crush measured 41.9 cm (16.5") and was located at C1 at the front left corner of the lower radiator support. The entire front bumper fascia was separated from the vehicle. The left aspect of the hood was buckled rearward and semi-circular abrasions were present on the left aspect from direct contact with the Honda Accord. The

upper and lower radiator supports were crushed rearward on the left side. The left head lamp assembly was separated from the vehicle, and the left front fender was crushed rearward. The left front wheel was displaced rearward and was deflated and restricted. The outer edge of the left front wheel rim was bent outward in two places. The rearward displacement of the left front wheel resulted in a 31.9 cm (12.6") reduction in the left wheelbase and a 3.0 cm (1.2") elongation of the right wheelbase. The left A-pillar was displaced rearward which resulted in the buckling of the left roof side rail. The displacement of the left A-

Figure 11. Frontal view of damaged 1990 Honda CRX

Figure 12. Left side view of damaged 1990 Honda CRX

pillar also caused the windshield laminate to fracture and separate from the seal along the left A-pillar and lower left corner. Slight buckling was present on the forward aspect of the left sill and the plastic trim piece below the sill was partially separated at the forward aspect. The left side door was separated from the vehicle from rescue efforts. The left rear tire was deflated. The CDC for this impact was 12-FYEW-2. Six crush measurements were taken along the lower radiator support and were as follows: C1 = 41.9 cm (16.5"), C2 = 29.8 cm (11.8"), C3 = 21.0 cm (8.3"), C4 = 10.8 cm (4.3"), C5 = 5.1 cm (2.0"), C6 = 0.0 cm.

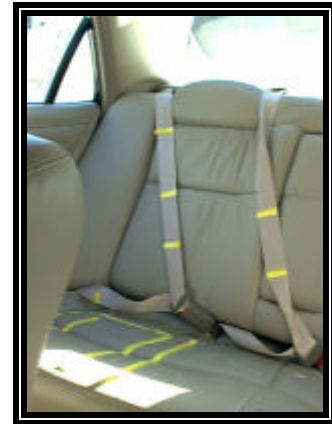
All of the rear seat positions in the Honda Accord were equipped with manual 3-point lap and shoulder belts with sliding latch plates and switchable ELR/ALR, inertial lock/belt sensitive retractors (**Figure 13**). The rear right and rear center manual restraint webbing both exhibited signs of loading, however, the loading to the rear center restraint was not related to this crash.

Figure 13. View of rear left and rear center lap and manual restraints

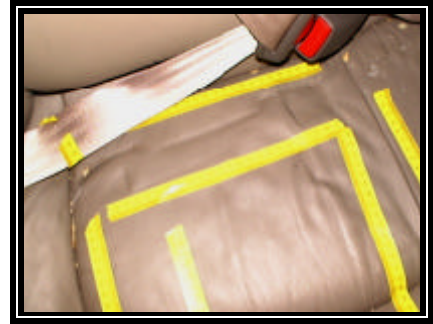
Figure 14. View of the impression in the leather seat from the child safety seat

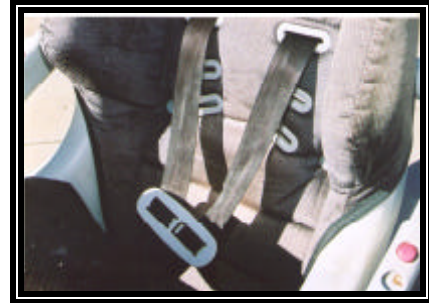
The Evenflo Trooper was configured for forward-facing use. Upon inspection, the harness straps were routed through the top harness slots and were free of any twists or folds (**Figure 16**). The harness retainer clip was affixed to the harness straps per the manufacturer's instructions, but was found on the lower aspects of the harness straps near the tray shield. The three-position adjustable tray shield was located in the full forward position. The kick stand was engaged for forward facing use. The child safety seat latch plate was abraded which suggested frequent usage, and the buckle was operational.

Figure 16. View of the harness straps and retainer clip

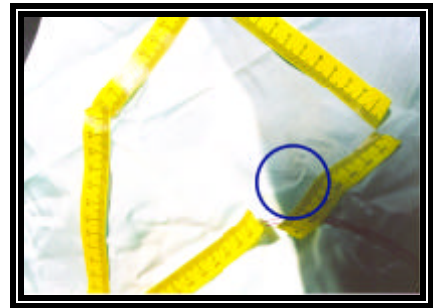
Figure 19. Close-up of driver's air bag, mascara transfer is circled

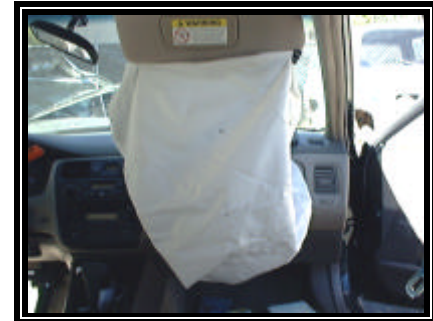
The dual stage front right passenger's air bag (**Figure 20**) deployed from a top-mount module configured with symmetrical H-configuration cover flaps. The module measured 35.6 cm (14.0") in width and 16.5 cm (6.5") in height. The tear seam was vertically located in the center of the module, located 5.1 cm (2.0") inboard of the sides and measured 25.4 cm (10.0") in width. The front right passenger's air bag measured 66.0 cm (26") in width and 66.0 cm (26") in height. The air bag was vented by two circular ports that measured 5.1 cm (2.0") in diameter and were located at the 9 and 3 o'clock positions and 7.6 cm (3.0") forward of the front outboard seams. The front right passenger's air bag was not tethered.

Figure 20. Front right passenger's air bag
