**VERIDIAN REMOTE SIDE IMPACT AIR BAG NON-DEPLOYMENT
INVESTIGATION
SCI TECHNICAL SUMMARY REPORT**

NASS/SCI COMBO CASE NO. 02-02-069A

VEHICLE - 2001 VOLVO S40

CRASH DATE - AUGUST 2002

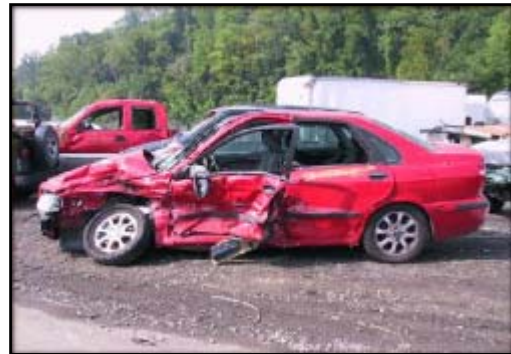
Figure 1. Volvo S40

This remote investigation focused on the non-deployment of the Side Impact Protection System (SIPS) in a 2001 Volvo S40. The safety system included a seat back mounted side impact air bag and roof side rail mounted side impact curtain air bag. The 2001 Volvo S40 was also equipped with dual stage frontal air bags, safety belt retractor pretensioners and a Whiplash Protection System (WHIPS) for the front occupants. The Volvo was occupied by a restrained 57-year-old female driver. The Volvo (**Figure 1**) was involved in a severe intersection crash with a 1998 Ford Econoline van. The

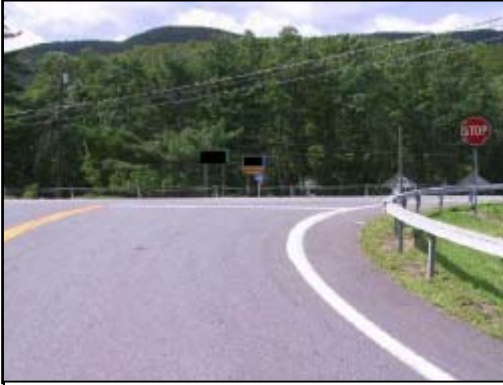
Figure 2. Volvo approach to intersection.

The 57-year-old female driver of the 2001 Volvo S40 was operating the vehicle southbound on approach to the “T” intersection (**Figure 2**). The driver of the 1998 Ford Econoline was operating the vehicle westbound on approach to the “T” intersection (**Figure 3**). It was unknown if the driver of the Volvo came to a complete stop before entering the intersection. No pre-impact evidence was found at the crash site for the Volvo. Based on physical evidence documented at the scene by the NASS researcher, the driver of the Ford Econoline attempted to avoid the Volvo by steering left and braking with sufficient force to lock-up the front wheels of the van. The researcher documented 13.5m (44.3’) of pre-impact skidmarks for the Ford.

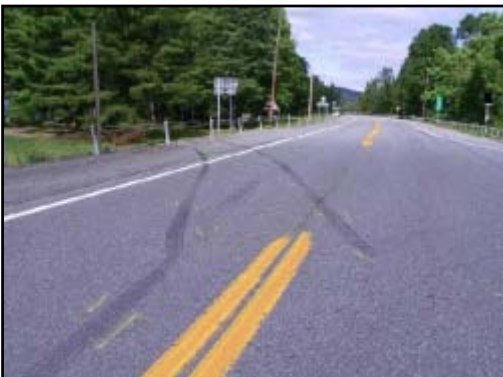
Figure 4. Area of impact.

The frontal area of the Ford van impacted the left front side area of the Volvo. Resultant directions of force were 10 o'clock for the struck Volvo and within the 1 o'clock sector for the Ford van. The Barrier Equivalent Speed computed by the WinSMASH program was 41.0 km/h (25.4 mph) for the Volvo. The lateral crash to the Volvo deployed the front right passenger air bag and fired the driver's safety belt retractor pretensioner. The left side impact air bag system did not deploy.

The impact displaced the Ford laterally left as its momentum allowed the vehicle to continue forward. The vehicles remained engaged as they traversed the mouth of the intersection. The vehicles departed the south road edge west of the intersection. The physical evidence at the crash site yielded 19.5 m (63.9') of post-crash skid marks from the Ford van. A 3.2 m (10.5') lateral right front tire scuff from the Volvo was documented by the NASS researcher.

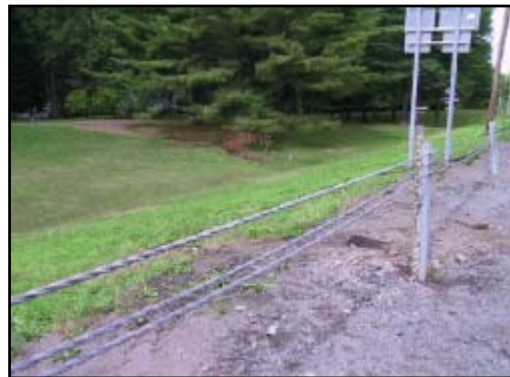
Figure 5. Volvo guardrail rail impact.

As the Volvo was carried off-road, the right side of the Volvo impacted a cable guardrail system. Two guardrail posts were deflected by the impact, which allowed the Volvo to penetrate under the cable system. The cable contacted the roof area of the Volvo as the vehicle came to rest under the guardrail (**Figure 5**).

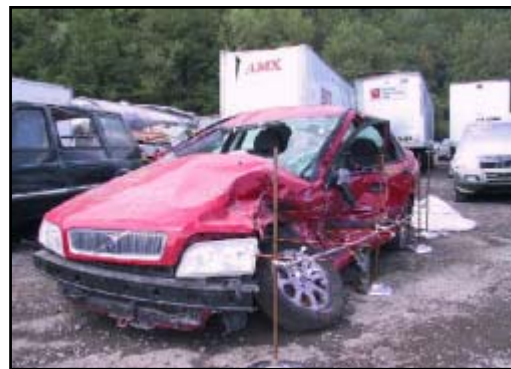
The 2001 Volvo S40 sustained severe left side damage as a result of the impact with the 1998 Ford (**Figure 6**). The left side damage involved a fractured left front axle, left front fender, hood, and both left side doors. The windshield was in place and holed from impact damage. The left front glazing was disintegrated from impact damage; however, it's not known if the left rear glazing was disintegrated by impact or rescue efforts. The left side damage began at the left front bumper corner and extended 282.0 cm (110.0") rearward and terminated 22.0 cm (8.6") forward of the left rear axle. The maximum crush was 37.0 cm (14.6"). The combined direct and induced damage was 306.0cm (120.5") in length. Six crush measurements were documented along the left side at the mid door level and were as follows: C1= 0.0 cm (0.0") C2= 10 cm (3.9") C3= 26 cm (10.2") C4= 26 cm (10.2") C5= 37 cm (14.6") C6= 9.0cm (3.5"). The Collision Deformation Classification for the left side impact to the Volvo was 10-LYAW-3.

Figure 6. Front left oblique.

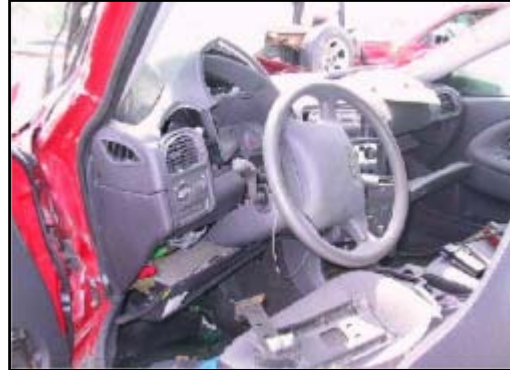
The 2001 Volvo S40 sustained moderate interior damage (**Figure 7**) as a result of the crash. The damage consisted of intrusion associated with exterior deformation and occupant contacts. The intrusions documented by the NASS researcher are identified in the following table:

Figure 7. Interior damage from intrusion.

Intruded Component	Magnitude	Intrusion Direction
Front Right A-Pillar	16.0 cm (6.3")	Vertical
Front Right Roof	3.0 cm to 8.0 cm (1.2" to 3.1")	Vertical
Front Right Roof Side Rail	6.0 cm (2.4")	Vertical
Front Right Windshield Header	10.0 cm (3.9")	Vertical
Front Middle Roof	3.0 cm to 8.0 cm (1.2" to 3.1")	Vertical
Front Middle Windshield Header	8.0 cm (3.1")	Vertical
Front Left A-Pillar	9.0 cm (3.5")	Lateral
Instrument Panel Left	8.0cm (3.1")	Vertical
Front Left Door Panel	12.0cm (4.7")	Lateral
Left B-Pillar	6.0cm (2.4")	Lateral
Left Rear Door Panel	5.0cm (2.0")	Lateral
Front Left Sill	6.0cm (2.4")	Lateral
Front Left Side Panel Forward of A-Pillar	6.0 cm (2.4")	Lateral
Rear Left Roof Side Rail	1.0cm (0.4")	Lateral
Rear Left Roof	1.0cm (0.4")	Vertical

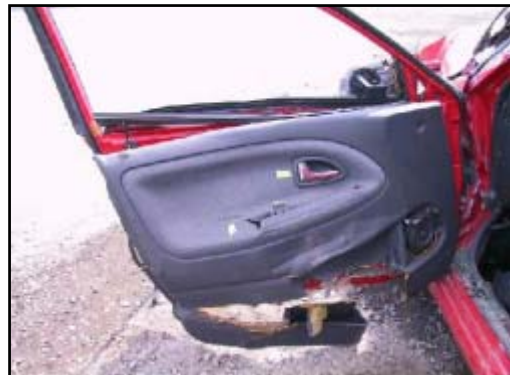
As a result of the driver responding to the 10 o'clock direction of force, her upper and lower torso contacted the interior of the left door resulting in the occupant contact damage to the interior door panel. The damage consisted of denting, cracking and scuffing to the door panel (**Figure 8**). The driver's left knee also contacted and scuffed the left knee bolster.

Figure 8. Interior door panel occupant contacts.

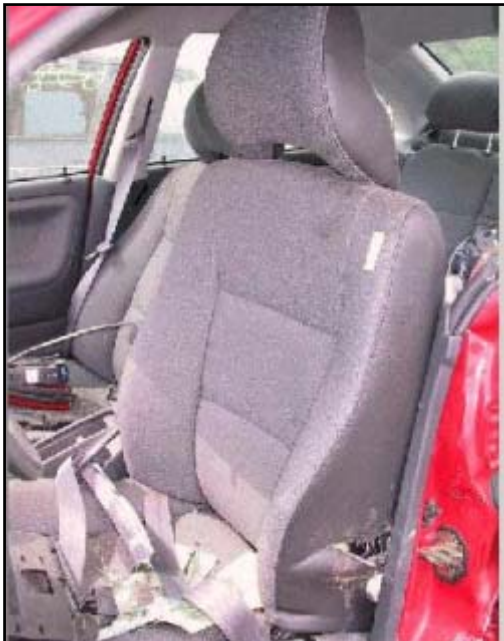
Figure 9. Driver safety belt cut by rescue.

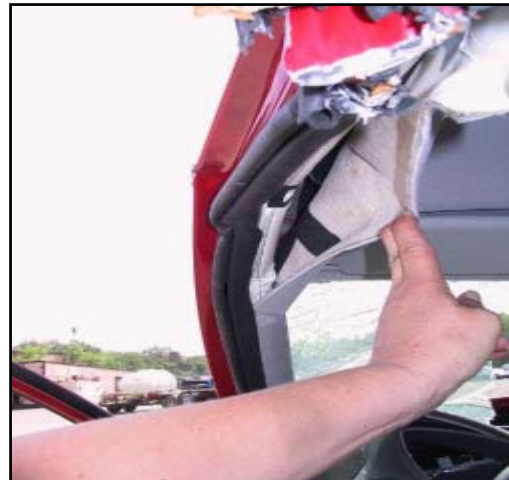
The 2001 Volvo S40 was equipped with a Side Impact Protection System (SIPS) that consisted of front seat back mounted side impact air bags (**Figure 9**) and roof side rail mounted side curtains (**Figure 10**). The SIPS did not deploy in this crash. The SIPS impact sensors were located in the lower B- and C-pillars. The inflatable curtain utilized stored gas cylinders located in the C-pillars to provide inflation. The NASS researcher pulled back the roof side rail trim cover allowing the inflatable curtain to be visible in its original non-deployed state.

Figure 10. Non-deployed curtain in left roof side rail.

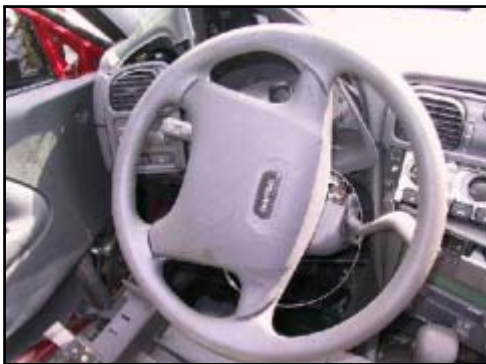
The 2001 Volvo S40 was equipped with dual-stage frontal air bags for the driver and front right passenger positions. The driver's frontal air bag did not deploy as a result of the impact with the Ford (**Figure 11**), however, the front right airbag deployed (**Figure 12**). Due to the lack of Electronic Data Recorder (EDR) data, the deployment stage was unknown. The front right air bag deployed from the top of the right instrument panel. The front right air bag measured 46.0 cm (18.1") in height and 37.0 cm (14.6") in width. The air bag module had two cover flaps. The top flap measured 32.0 cm (12.6") in width and 9.0 cm (3.5") in height. The bottom flap measured 32.0 cm (12.6") in width and 6.0 cm (2.4") in height. The air bag was vented by two ports at the 9 and 3 o'clock positions on the lateral aspects of the air bag. The air bag was not tethered.

Figure 11. Non-deployed driver's frontal air bag.

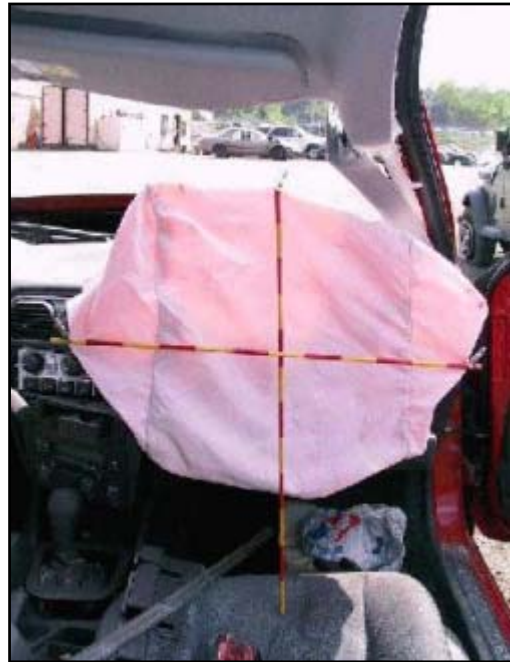
Figure 12. Deployed front right air bag.

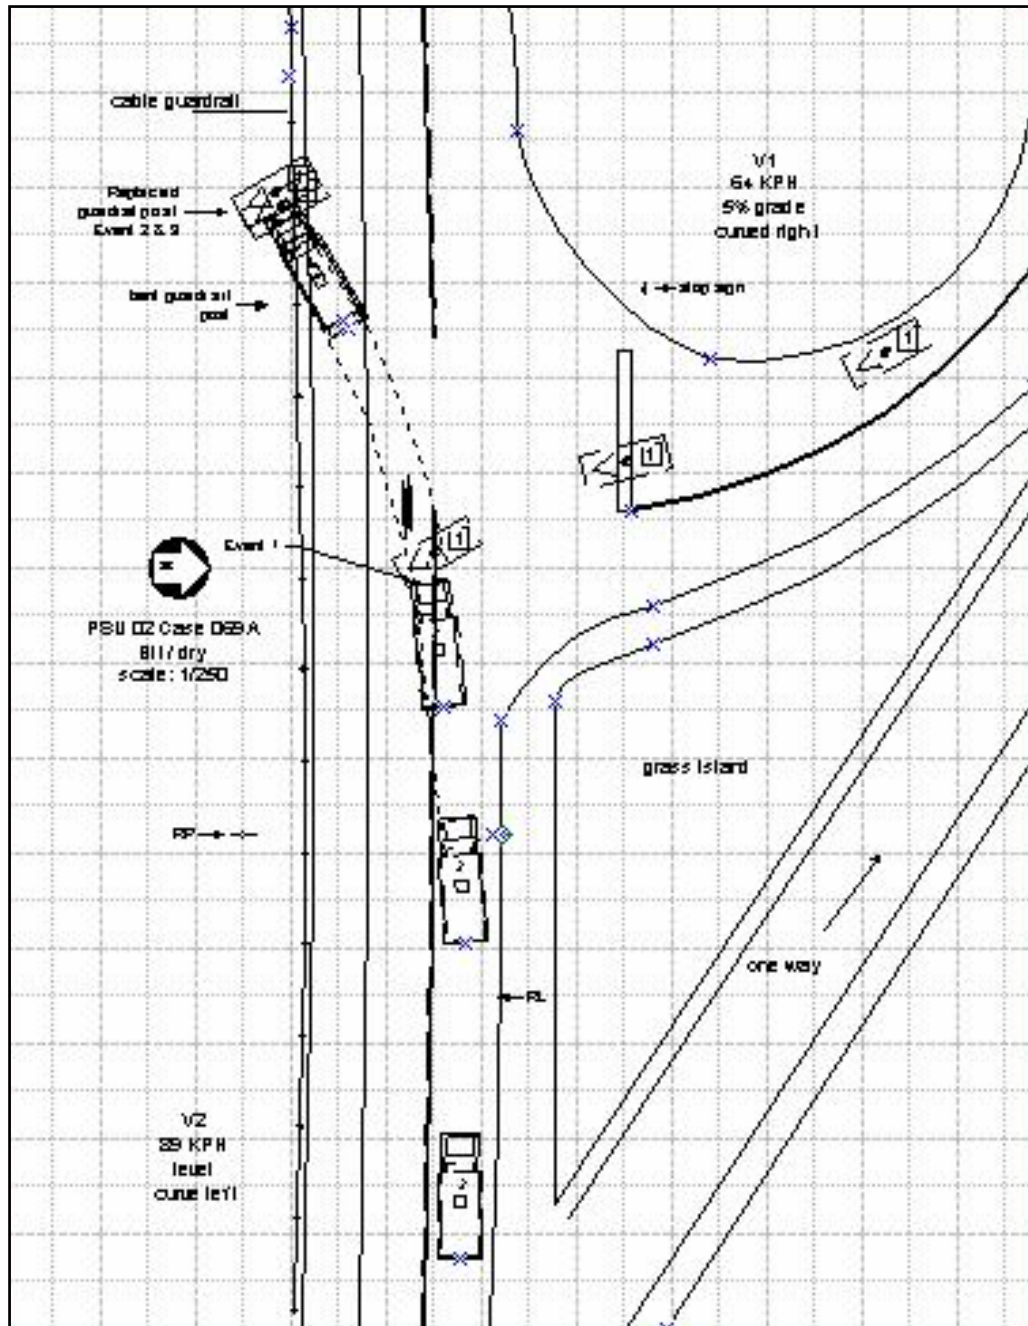
Figure 13. NASS Scene Schematic

This two-vehicle crash occurred during the daylight hours of August 2002 in the state of New York. At the time of the crash, there were no adverse weather conditions and the asphalt road surface was dry. The crash occurred at a “T” intersection of a north/south roadway that intersected an east/west roadway. The north/south roadway was configured with two travel lanes in each direction that were separated by a double-yellow centerline. The roadway curved right for southbound travel with an uphill grade. The north/south roadway was bordered with a cable guardrail system on the west road edge. The southbound lane of the roadway curved right prior to the intersection and had an uphill grade. The east/west roadway was bordered with a white fog line on the north road edge and cable guardrail on the south road edge. The westbound lane had a right turn lane that entered the north/south roadway. The westbound approach to the intersection curved slightly to the left and was level. Traffic flow through the intersection was controlled by a stop sign for southbound travel and no traffic controls were present for east/west travel. The posted speed limit for the north/south roadway was 64 km/h (40 mph) and 89 km/h (55 mph) for the east/west roadway. The NASS scene schematic is included as **Figure 13** of this report.
