**VERIDIAN REMOTE ADVANCED OCCUPANT PROTECTION SYSTEM/SIDE  
IMPACT INFLATABLE OCCUPANT PROTECTION INVESTIGATION  
SCI TECHNICAL SUMMARY REPORT**

**NASS/SCI COMBO CASE NO. 02-04-076E**

**VEHICLE – 2001 BMW 525i**

**CRASH DATE – OCTOBER 2002**

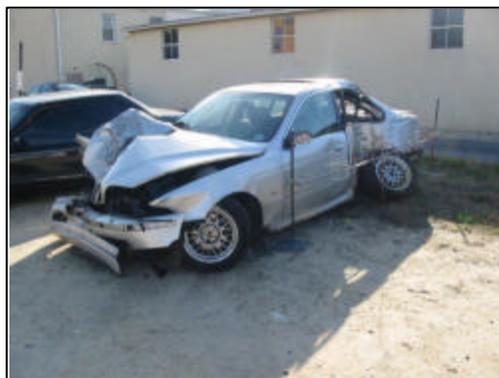
**Figure 1. Damaged 2001 BMW 525i**

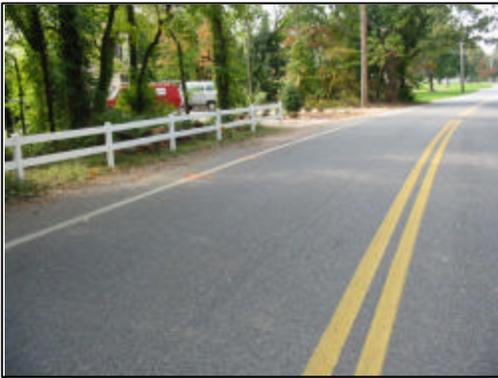
The 17-year-old male driver of the 2001 BMW 525i was operating the vehicle southbound on the two-lane roadway on approach to the right curve (**Figure 2**). Police reported the pre-crash travel speed to be 72 km/h (45 mph). As the BMW entered the curve, the driver lost control of the vehicle due to the wet roadway surface. The vehicle initiated a clockwise (CW) yaw across the centerline and the northbound lane, and departed the opposite roadside near the apex of the curve (**Figure 3**). Scuff marks were present on the roadside from the BMW's tires between the point of roadside departure and the impact with the utility pole. The driver stated that he did not apply the brakes and did not attempt any steering inputs to attempt to regain control of the vehicle. It was not known if the BMW's traction control system engaged.

**Figure 2. Southbound approach for the BMW 525i**

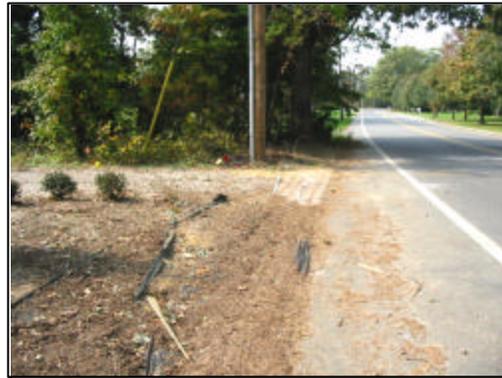
**Figure 3. Close-up of crash site**

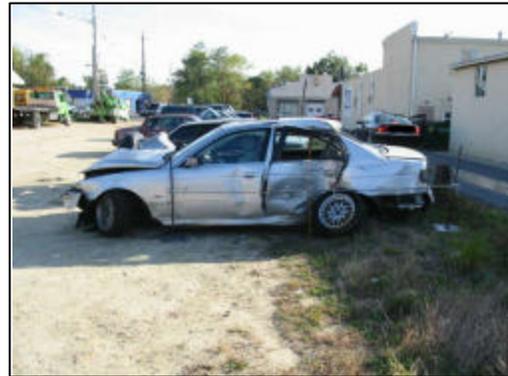
The BMW 525i sustained moderate left side damage as a result of the fence and utility pole impacts (**Figure 4**). The direct damage for the fence impact was located on the left rear quarter panel. The maximum lateral crush was 5 cm (2") for the impact with the fence. The Collision Deformation Classification (CDC) for the fence impact was 10-LBEW-1. The direct damage for the utility pole impact began 45 cm (18") rear of the left B-pillar and extended 45 cm (18") rearward along the left rear door. Pocketing in the sheet metal and wood transfers from the pole were present on the left rear door. The left rear wheel was displaced laterally and the left aspect of the rear bumper fascia was separated. The right rear wheel was displaced as a result of the rapid CCW rotation around the pole. The direct contact involved the entire vertical height of the vehicle. The combined direct and induced damage began at the left B-pillar and measured 90 cm (35") rearward along the left rear door and left rear quarter panel. Due to the overlapping damage from the multiple left side impacts, a single crush profile was documented by the researcher. It should be noted that the crush profile and damage locators were adjusted after Zone Center review and did not coincide with the case photographs of the crush contour gauge. The maximum lateral crush on the left rear door measured 33 cm (13"). The CDC for the utility pole impact was 09-LPAW-3.

**Figure 4. Left side damage to the BMW 525i**

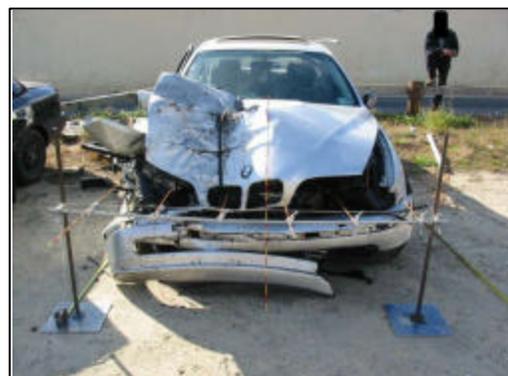
The BMW sustained moderate frontal damage as a result of the impact with the tree (**Figure 5**). The direct damage began 110 cm (43") inboard of the front left bumper corner and extended along the front bumper 50 cm (20") to the front right corner. The bumper fascia sustained abrasions and fractures from contact with the tree. Direct contact abrasions and tree debris were also present on the right aspect of the hood. The hood was buckled rearward and the right front fender was crushed rearward. The combined direct and induced damage measured 160 cm (63") across the entire frontal plane. Six crush measurements were documented by the NASS researcher along the front

**Figure 5. Frontal damage to the BMW 525i**

bumper and were as follows: C1 = 15 cm (6”), C2 = 16 cm (6”), C3 = 22 cm (9”), C4 = 31 cm (12”), C5 = 32 cm (13”), C6 = 24 cm (9”). The CDC for the frontal impact with the tree was 12-FZEW-2.

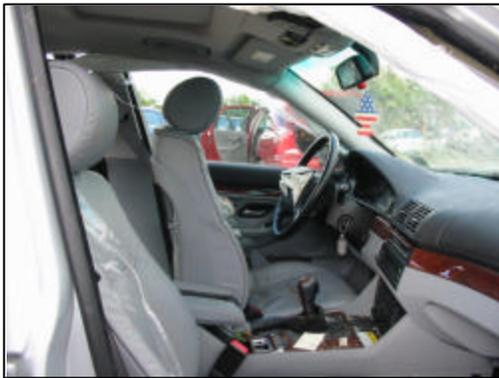
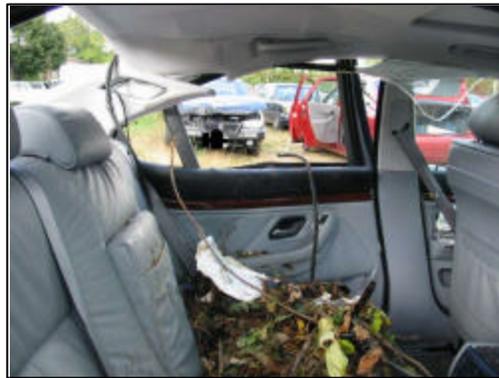
The 2001 BMW 525i sustained moderate interior damage as a result of the multiple impacts (**Figures 6 and 7**). The left rear door was jammed shut at the time of the vehicle inspection. The windshield was fractured from impact forces. The left rear, right front, and backlight glazing was disintegrated from impact forces. The right toe pan intruded longitudinally, and lateral intrusions included the left roof side rail, left door, and left C-pillar. The knee bolster was scuffed on the left aspect from contact with the driver’s left leg. The interior panel of the left front door had been removed at the time of the vehicle inspection. The NASS researcher reported that the rear left head restraint was damaged as a result of the impact with the utility pole. It was separated from the rear seat back at the time of the vehicle inspection. The driver’s safety belt webbing exhibited scuffs on the shoulder portion of the belt.

**Figure 6. View across the front seating positions**

**Figure 7. View across the rear seating positions showing intrusions**

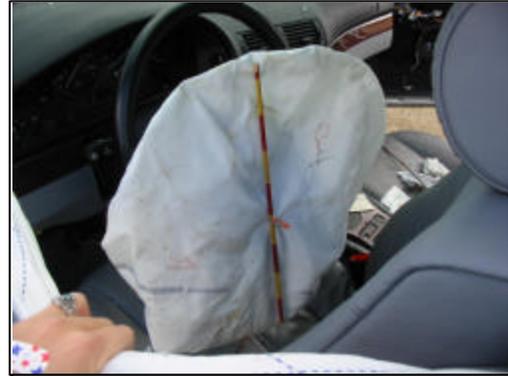
The 2001 BMW 525i was equipped with dual-stage, “smart”, frontal air bags for the driver and front right passenger positions. The driver’s air bag deployed as a result of the frontal impact with the tree. The driver’s air bag deployed from the steering wheel hub that was configured with asymmetrical H-configuration module cover flaps. The upper flap measured 16 cm (6”) in width and 11 cm (4”) in height. The lower flap measured 14 cm (6”) in width and 7 cm (3”) in height. The driver’s air bag (**Figure 8**) measured 58 cm (22”) in diameter and was vented by a single circular port at the 12 o’clock aspect on the rear of the air bag. The air bag was not tethered. The NASS researcher reported no occupant contact evidence on the air bag.

**Figure 8. View of deployed driver's air bag**

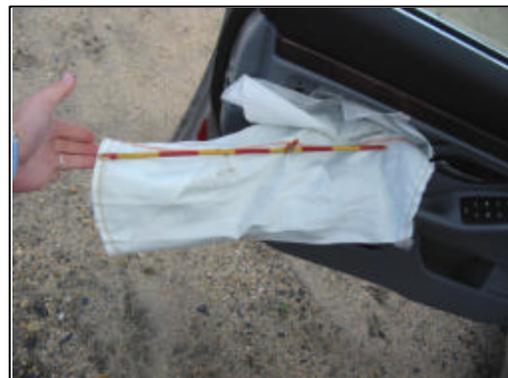
The 2001 BMW 525i was equipped with door-mounted side impact air bags for both front seating positions. Both side impact air bags deployed as a result of the crash. The side impact air bags deployed in a lateral direction from the interior door panels above the arm rests. The cover flaps were in the shape of parallelograms and were hinged at the bottom aspects. The side air bags offered thorax protection and measured 50 cm (20”) in length and 22 cm (9”) in height. Each side air bag was tethered by one internal strap. The deployed driver’s side air bag is shown in **Figure 9**.

**Figure 9. Door-mounted driver's side air bag**

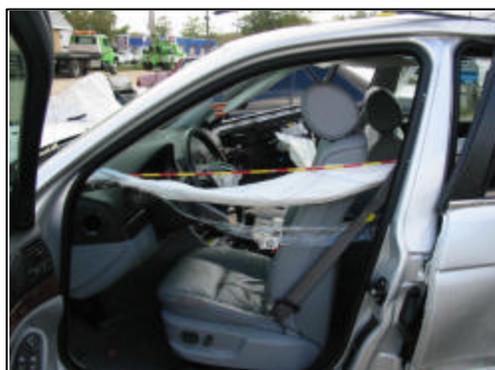
The 2001 BMW 525i was equipped with a HPS that consisted of inflatable tubular structures for both front seated occupants that deployed as a result of the crash. The HPS deployed vertically from the A-pillars and roof side rails and were positioned diagonally across the side windows when fully inflated (**Figure 10**). Both HPS were tethered at the lower aspect of the A-pillars and at the roof side rails between the B- and C-pillars. The HPS cover flaps measured 150 cm (59”) in length and 10 cm (4”) in width. Each HPS air bag measured 120 cm (47”) in length and 16 cm (6”) in diameter. The NASS researcher did not identify any occupant contact to the HPS.

**Figure 10. View of driver's HPS**

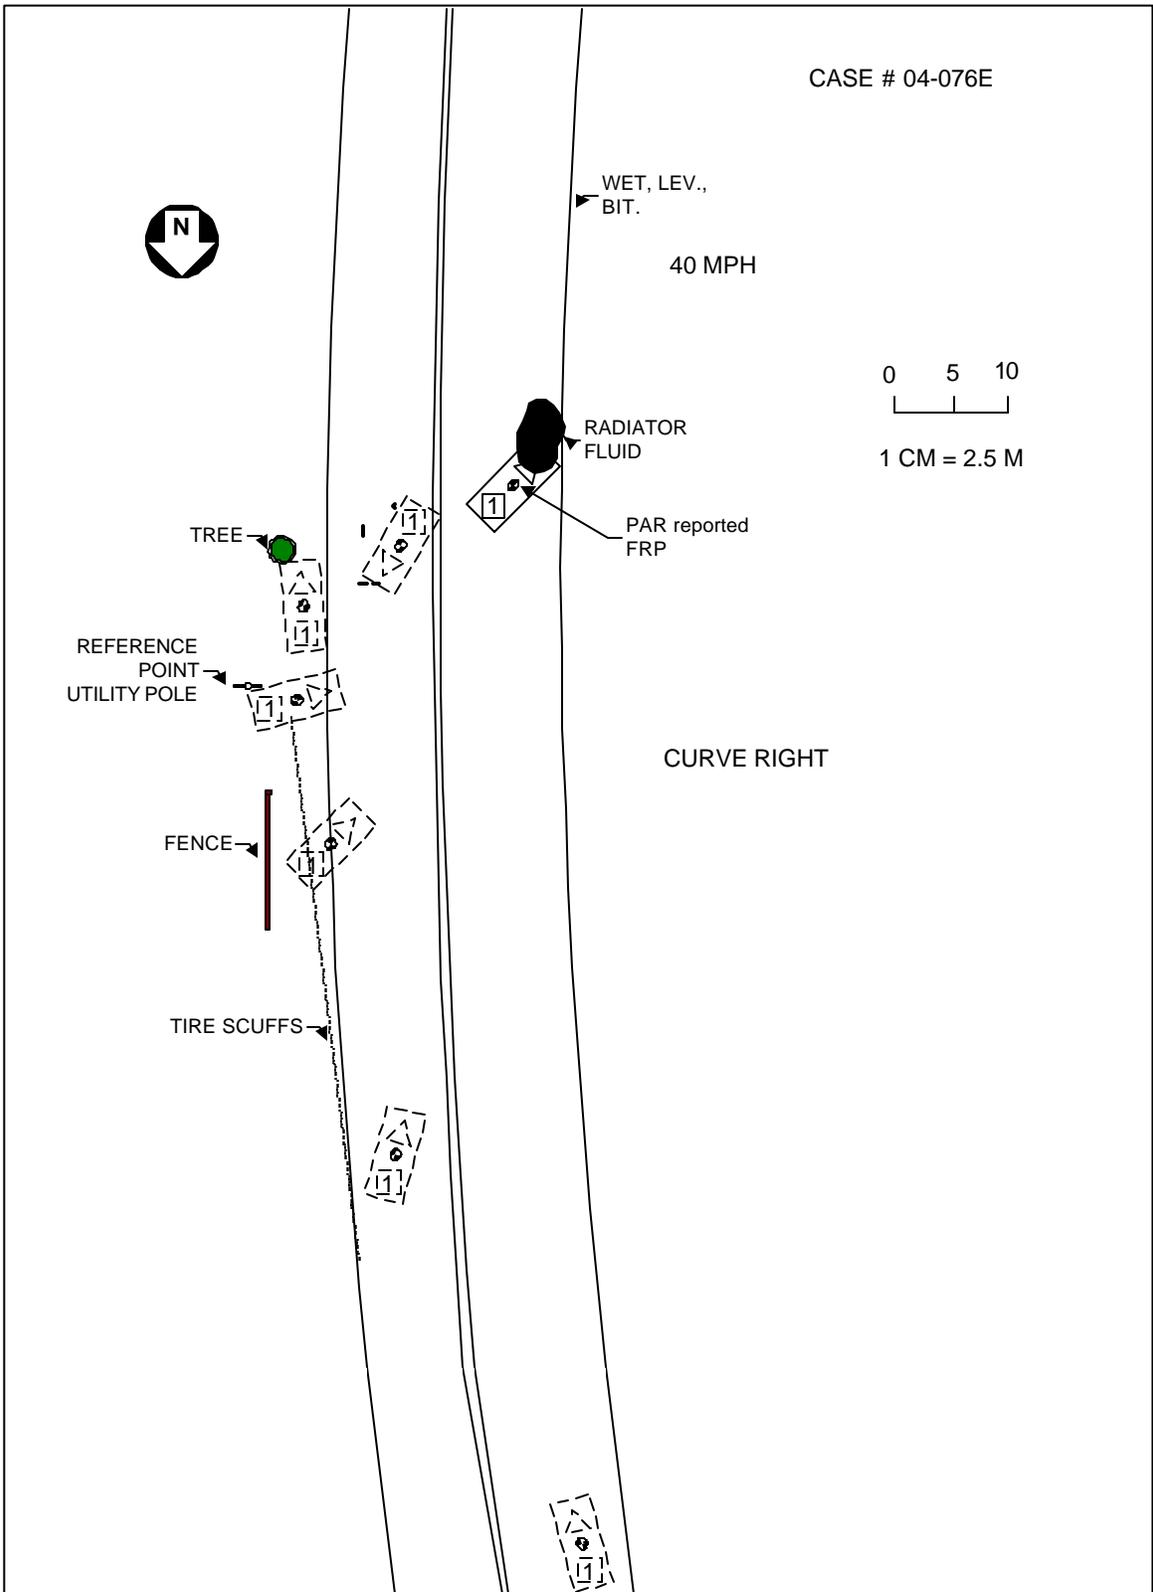
Figure 11. NASS scene schematic

The left side of the BMW struck a wood fence with the left rear aspect. The damage was concentrated on the rear aspect of the left rear quarter panel. Due to the yielding nature of the wood fence, the BMW continued through the fence in the CW yaw. The vehicle struck a wood utility pole with the left rear door area which resulted in moderate left side damage to the BMW and deployed the left and right side impact air bags and the left and right HPS. The pole impact reversed the vehicle's rotation as the BMW's center of gravity was forward of the pole at impact. The BMW rotated approximately 90 degrees in a rapid counterclockwise (CCW) direction around the pole and subsequently struck a tree with the front aspect. The damage algorithm of the WinSMASH program calculated a delta-V of 24 km/h (15 mph) based on the documented frontal crush profile. The tree impact resulted in the moderate frontal damage to the vehicle and was sufficient to deploy the frontal air bag system. The BMW rotated approximately 270 degrees off of the tree in a CCW direction while it traveled back across the roadway. The vehicle came to rest in a lateral orientation straddling the centerline.
