**VERIDIAN REMOTE ADVANCED OCCUPANT PROTECTION SYSTEM
INVESTIGATION
SCI TECHNICAL SUMMARY REPORT**

NASS/SCI COMBO CASE NO. 02-43-212E

VEHICLE – 2002 BMW 325i

CRASH DATE – SEPTEMBER 2002

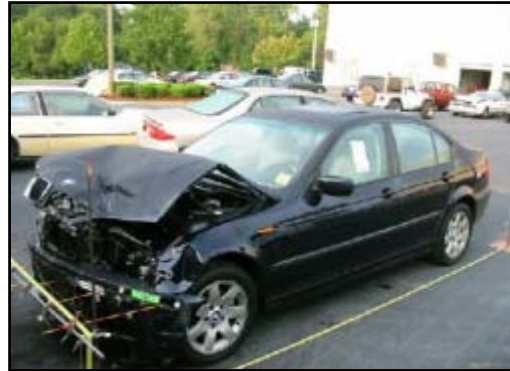
The 2002 BMW 325i sustained moderate severity frontal damage as a result of the intersection type crash with the 1995 Nissan 240SX (**Figure 5**). The direct contact damage width was 153 cm (60.2”) and extended from bumper corner to bumper corner. The damage also consisted of the longitudinal displacement of the hood, left and right front fenders. The front left headlight and left aspect of the center grille were disintegrated. Six crush measurements were documented along the front bumper fascia and were as follows: C1= 25.0 cm (9.8”) C2= 17.0 cm (6.7”) C3= 9.0 cm (3.5”) C4= 7.0 cm (2.8”) C5= 9.0 cm (3.5”) C6= 7.0 cm (2.8”). The Collision Deformation Classification for the frontal impact to the BMW was 01-FDEW-2. The four doors remained closed and operational and all glazing remained intact.

Figure 5. Front damage, BMW.

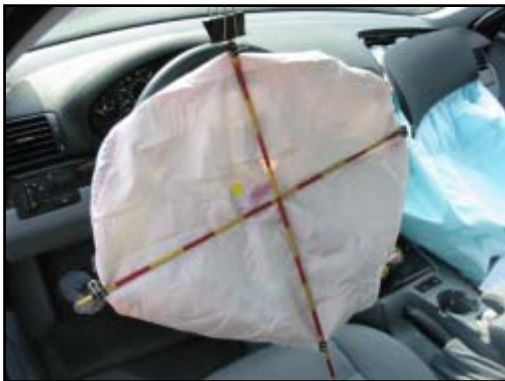
The 2002 BMW 325I sustained minor interior damage as a result of the crash. The damage consisted of occupant contacts to the interior (**Figures 6 and 7**). There was no intrusion into the passenger compartment. The occupant contacts consisted of a make-up transfer to driver’s air bag, an imprint from the driver’s abdomen on the front safety belt, an imprint from the front right occupant’s abdomen on the front safety belt, and the rear of the front right seat back and head restraint was scuffed from contact by the rear right occupant.

Figure 6. Driver's facial contact to air bag.

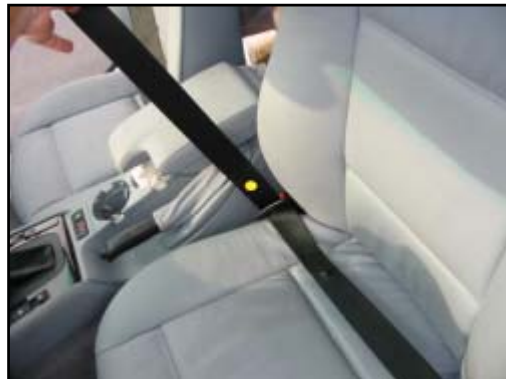
Figure 7. Front left safety belt contact.

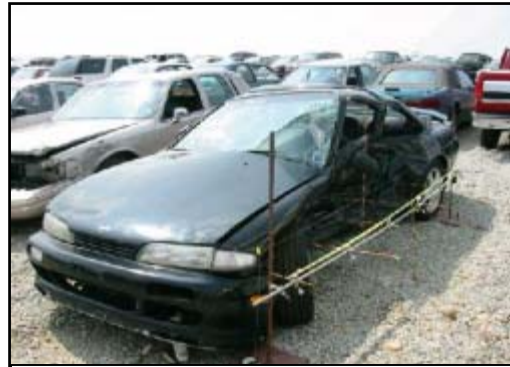
The 1995 Nissan 240SX sustained moderate severity left side damage (**Figure 8**) as result of the impact with the BMW. The damage consisted of lateral displacement of the

left front fender, door, and rear quarter panel. The direct damage began 8 cm (3.2”) aft of the left front axle and extended rearward 164 cm (64.6”). The combined direct and induced damage was 280 cm (110”). Six crush measurements were documented along the left side and were as follows: C1=0.0 cm, C2 =28.0 cm (11.0), C3= 54.0 cm (21.3”), C4= 50.0 cm (19.7”), C5= 13.0 cm (5.1”), C6= 0.0 cm. The Collision Deformation Classification for this impact was 10-LYEW-4. The windshield was in place and cracked. The left front and left rear glazing were disintegrated at impact. The left front door was jammed closed by deformation.

Figure 8. Left side damage of Nissan.

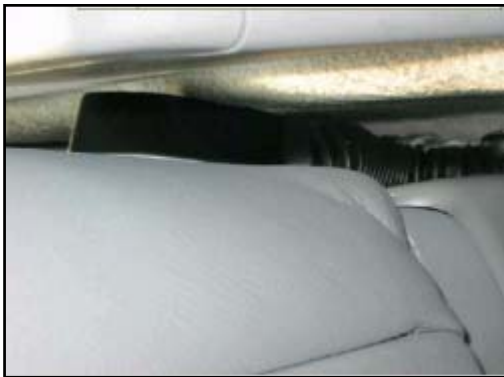
The 2002 BMW 325i was equipped with manual 3-point lap and shoulder belts for each seating position. The front safety belts were equipped with buckle pretensioners, which actuated as a result of the crash (**Figures 9 and 10**). The driver’s safety belt was configured with a sliding latch plate and a belt-sensitive Emergency Locking Retractor (ELR). The front right safety belt was configured with a sliding latch plate and switchable ELR/Automatic Locking Retractor (ALR). The rear outboard safety belts were configured with sliding latch plates and ELR/ALR retractors. The rear center safety belt was configured with a locking latch plate. The driver and front right passenger utilized their safety belts. The rear right occupant did not utilize her safety belt. The rear left safety belt was used with an unknown type child safety seat.

Figure 9. Actuated front left safety belt pretensioner.

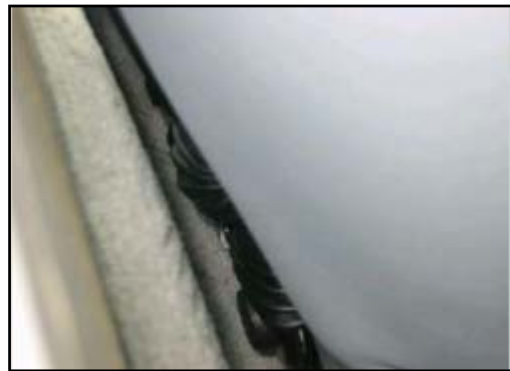
Figure 10. Actuated front right safety belt pretensioner.

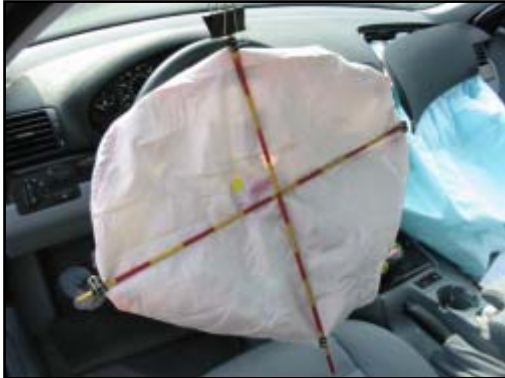
The 2002 BMW 325i was equipped with dual-stage frontal air bags for the driver and front right passenger positions. The driver and front right frontal air bag deployed as a result of the impact with the Nissan (**Figures 11 & 12**). The deployment was recorded by the EDR as a stage two deployment. The front left air bag deployed from the center of the steering wheel hub. The front left air bag module was designed with “H”

configuration asymmetrical cover flaps. The top flap was measured as 15.0 cm (5.9”) in width and 9.0 cm (3.5”) in height. The lower flap was measured as 14.0 cm (5.5”) in width and 8.0 cm (3.1”) in height. The front left air bag was not tethered and was vented by one vent port at the 12 o’clock position.

Figure 11. Front left air bag.

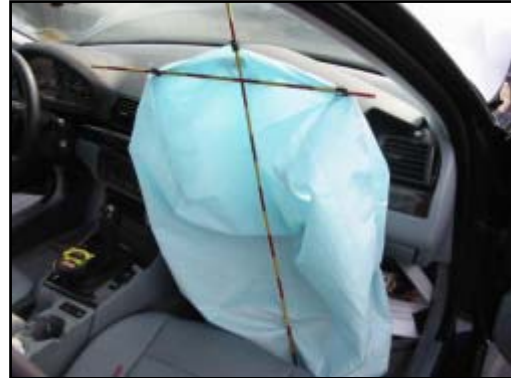
The front right air bag deployed from the top of the instrument panel and was configured with a single cover-flap. The cover flap was measured as 49.0 cm (19.3”) in width and 19.0 cm (7.5”) in height. The front right air bag was not tethered and was vented by two vent ports at the 11 and 1o’clock positions on the air bag side panels.

Figure 12. Front right air bag.

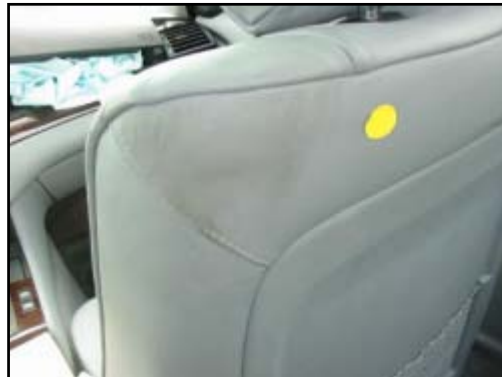
The 23-year-old female passenger was seated in the rear right position in a presumed upright posture and not restrained. At impact, the passenger initiated a forward trajectory and loaded the rear of the front right seatback and head restraint (**Figure 14**) evidenced by scuffing to these components. The passenger was police reported as injured and transported for medical treatment.

Figure 14. Rear right occupant contact to rear of front right seat back.
