REMOTE CHILD SAFETY SEAT CRASH INVESTIGATION SCI TECHNICAL SUMMARY REPORT

NASS/SCI COMBO CASE NO. 02-45-040B

VEHICLE – 1998 JEEP GRAND CHEROKEE

CRASH DATE – MARCH 2002

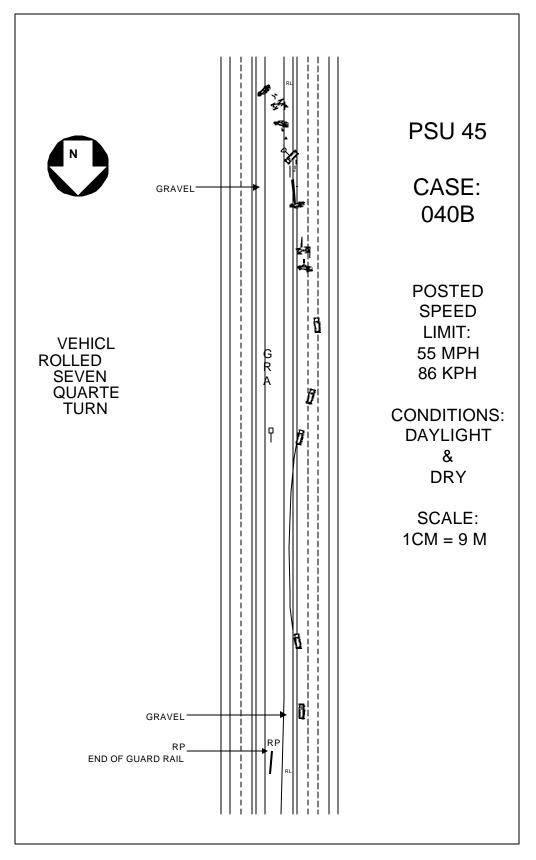
Figure 10. NASS scene schematic

This single vehicle crash occurred on the southbound lanes of a five lane divided highway during the daylight hours of March 2002. At the time of the crash, the weather was clear and the asphalt roadway surface was dry. The roadway was configured with two northbound lanes and three southbound lanes that were separated by a grassy median and bordered by asphalt shoulders. The outboard aspects of the median were gravel, and the median had a negative lateral slope between the southbound lanes and northbound lanes. At the crash site, the roadway was straight and had a positive southbound grade. The roadside environment consisted of grassy areas and commercial properties. There were no traffic controls present at the scene and the posted speed limit for the roadway was 89 km/h (55 mph) The NASS scene schematic is included as **Figure 10** at the end of this report.

The vehicle's yaw caused bead separation and air-outs of the right front and right rear tires. The wheel rim contact with the road surface resulted in gouges, which tripped the Cherokee into a lateral rollover with the right side leading. The rollover began on the center southbound lane and continued in a southeast direction onto the median. Additional gouges were present on the travel lane and on the median within the vehicle's trajectory (**Figure 3**). The Cherokee rolled seven quarter turns over a total distance of 57 m (187'). The rollover resulted in severe damage to the Cherokee. During the rollover, the unrestrained driver was ejected through the left front window. The Jeep Cherokee came to rest on its left side on the east aspect of the median and was facing northeast (**Figure 4**).
