**REMOTE ADVANCED OCCUPANT PROTECTION SYSTEM INVESTIGATION
SCI TECHNICAL SUMMARY REPORT**

NASS/SCI COMBO CASE NO. 02-47-111C

SUBJECT VEHICLE – 2003 FORD CROWN VICTORIA

CRASH DATE – SEPTEMBER 2002

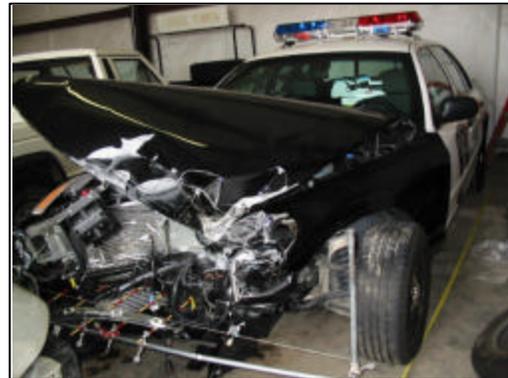
Figure 1. Damaged 2003 Ford Crown Victoria

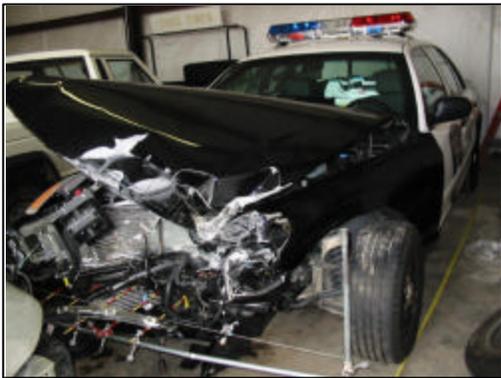
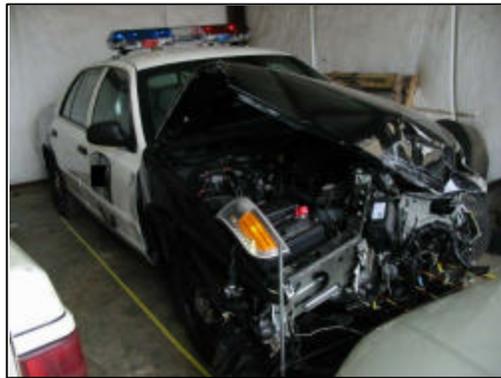
The 2003 Ford Crown Victoria sustained moderate frontal damage as a result of the impact with the Dodge Intrepid. The direct contact damage involved the entire frontal width of the vehicle (**Figures 4 and 5**). The combined direct and induced damage measured 79 cm (31”) across the bumper beam and the maximum crush measured 57 cm (22”) and was located at C2. The left fender and left frame rail were pulled inward as a result of the Intrepid’s momentum across the front of the Crown Victoria. The lateral displacement measured approximately 51 cm (20”) at the forward edge of the left front fender. The hood was displaced to the right and buckled rearward and upward on the right side. Direct contact abrasions were present on the leading edge of the left corner of the hood. The grille, bumper fascia, and head lamps were separated from the vehicle. Six crush measurements were documented along the front bumper beam of the Crown Victoria and were as follows: C1 = 45 cm (18”), C2 = 57 cm (22”), C3 = 56 cm (22”), C4 = 36 cm (14”), C5 = 22 cm (9”), C6 = 8 cm (3”). The Collision Deformation Classification (CDC) for the frontal impact with the Dodge Intrepid was 10-FDEW-2.

Figure 4. Front left view of damaged Crown Victoria

Figure 5. Front right view of damaged Crown Victoria

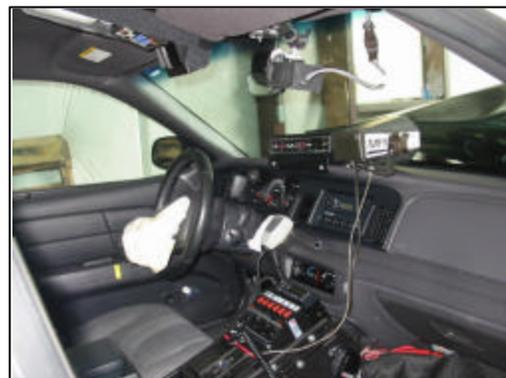
Interior damage to the Ford Crown Victoria was minor (**Figure 6**). There was no integrity loss and no damage to the laminated windshield or vehicle glazing. There was no passenger compartment intrusion. Occupant contact was identified on the left front door armrest from probable interaction with the driver’s left arm.

Figure 6. Interior view of the Crown Victoria

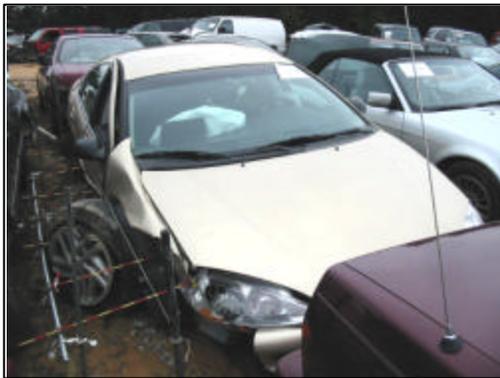
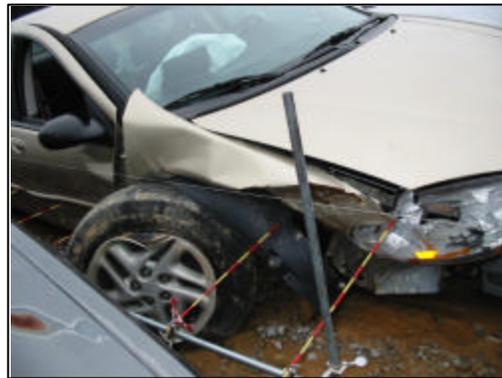
The 2000 Dodge Intrepid sustained moderate damage (**Figures 7 and 8**) as a result of the right side impact with the Crown Victoria and minor damage from the post-crash curb impact and tree impact. The direct damage from the impact with the Crown Victoria began 157 cm (62”) forward of the axle on the right side plane and extended forward 225 cm (89”) to the right front corner. The front bumper fascia was fractured outboard of the right side of the bumper beam. The right front fender was crushed and displaced rearward. The right front wheel was displaced rearward, outward, and was partially separated. The right front tire sustained a tear in the sidewall and partial sidewall separation from the impact. The right front wheel rim was deformed from the impact and the front right tire was flat. At the time of the vehicle inspection, the right front wheel was positioned outboard of the right front fender and the rear aspect of the wheel was adjacent to the right A-pillar. The rearward displacement of the right front wheel against the lower right A-pillar resulted in induced longitudinal crush and deformation to the leading edge of the right front door. Contact abrasions were present on the right front fender and right front door panel from contact with the front aspect of the Crown Victoria. Six crush measurements were taken along the right side plane of the Intrepid at the lower door level and were as follows: C1 = 5 cm (2”), C2 = 14 cm (6”), C3 = 6 cm (2”), C4 = 8 cm (3”), C5 = 4 cm (2”), C6 = 0 cm. The CDC for the impact with the Crown Victoria was 01-RYEW-2.

Figure 7. Front right view of damaged Dodge Intrepid

Figure 8. Close-up of right front damage

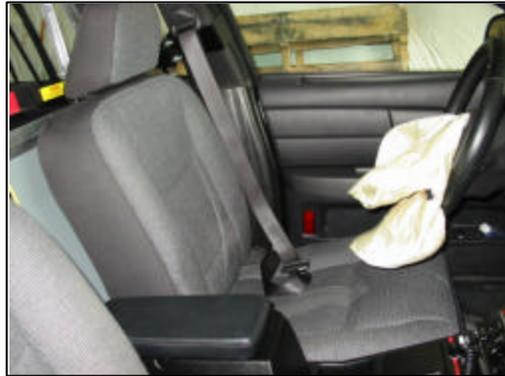
The 2003 Ford Crown Victoria was equipped with manual 3-point, continuous loop, lap and shoulder belts with sliding latch plates. The driver's safety belt (**Figure 9**) was configured with a belt-sensitive, emergency locking retractor (ELR). The remaining safety belts were configured with belt-sensitive, switchable ELR/automatic locking retractors (ALR). The front seat manual restraints utilized adjustable D-rings that were both in the full-down positions. The rear outboard restraints retracted into the inboard aspects of the C-pillars, and the center safety belt retracted into the retractor housing located on the center aspect of the rear deck above the seat back.

Figure 9. View of driver's safety belt in the Crown Victoria

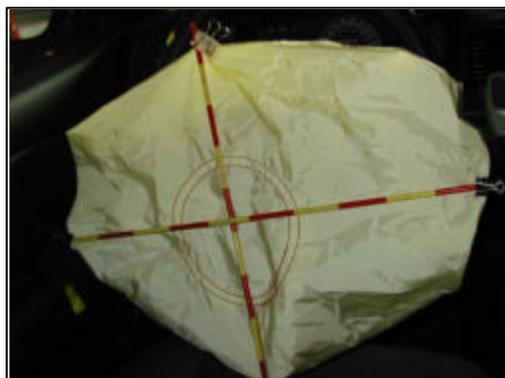
Figure 10. View of the deployed driver's air bag

The driver's air bag (**Figure 10**) was housed in the center of the steering wheel. The module was configured with a single cover flap that measured 10 cm (4”) in width at the top aspect, 18 cm (7”) in width at the bottom aspect, and 12 cm (5”) in height. The driver's air bag measured 56 cm

(22”) in diameter in its deflated state. There was no contact evidence present on the air bag. The air bag was tethered by four internal straps and was vented by two circular ports located at the 11 and 1 o’clock positions on the rear aspect of the air bag.
