## SCI/NASS COMBINATION INVESTIGATION

CASE NUMBER - NASS-2002-50-100E

LOCATION - Texas

VEHICLE - 2002 Honda Accord

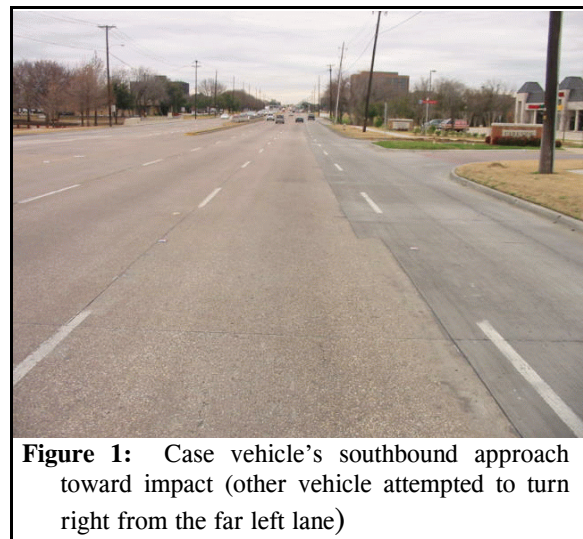
The case vehicle was traveling south in the #2 southbound through lane of a four-lane, one-way roadway that was part of a divided city trafficway, approaching an uncontrolled three-leg intersection and intending to continue south (i.e., there were four lanes in each direction, separated by a curbed median) (**Figure 1**). The intersecting roadway was the entrance to a shopping mall and joined the north-south roadway from the west (i.e., on the right for southbound traffic). It was dark but lighted, the concrete road surface was well-traveled but without defects and dry, and there were no adverse atmospheric conditions. The posted speed limit was 56 km.p.h. [35 m.p.h.]. The Pontiac had been traveling south in the inside (#4) southbound through lane of the same roadway and attempted to make a right turn across three through lanes, intending to travel west on the intersecting roadway. The case vehicle driver braked, attempting to avoid the crash. The crash occurred in the #2 southbound through lane, within the three-leg intersection.

**Figure 1:** Case vehicle's southbound approach toward impact (other vehicle attempted to turn right from the far left lane)

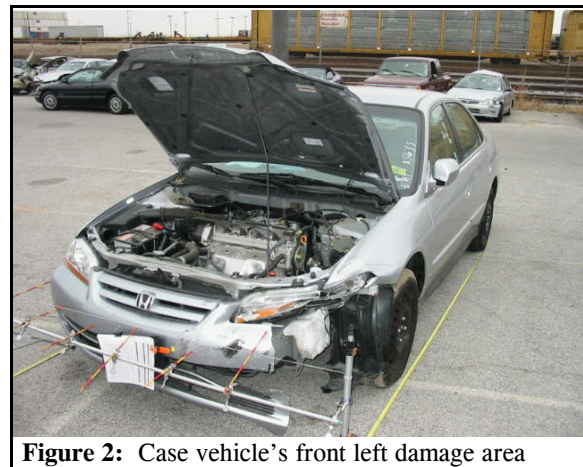
The case vehicle sustained direct contact damage beginning at the front left corner and extending inward for 57 centimeters [22.4 inches], with induced damage extending across the entire front (**Figure 2**). The left-most area of the plastic bumper cover was torn away, with abrading and scuff marks extending nearly to the center, the left headlamp and turn signal assembly was shattered and the leading edge of the left fender was folded under and crushed rearward, causing the front left wheel/tire to be restricted. There was slight bending at the front left corner of the engine hood. Maximum crush was recorded as 17 centimeters [6.7 inches] at the left edge of what remained of the bumper, but this is problematic because the left bumper corner area was broken away (**Figure 3**). The wheelbase was not changed on either side. Except for the crushed left fender pressing against the left front tire, none of the wheels or tires were damaged. The windshield was cracked on the left side and there was no other glazing damage.

The CDC for the case vehicle's single impact was determined to be **12-FLEW-1 (350)**. The WinSMASH reconstruction program, missing vehicle algorithm based on the case vehicle's crush profile, was used. The Total, Longitudinal and Lateral deltaVs for the case vehicle are, respectively: 13.0 km.p.h [8.1 m.p.h.], -12.8 km.p.h. [-7.9 m.p.h.] and +2.3 km.p.h. [+1.4 m.p.h.]. This is a borderline reconstruction but the results appear reasonable. This contractor judges that this was a crash of low severity (14 - 23 km.p.h. [9 - 14 m.p.h.]) for the case vehicle.

**Figure 2:** Case vehicle's front left damage area

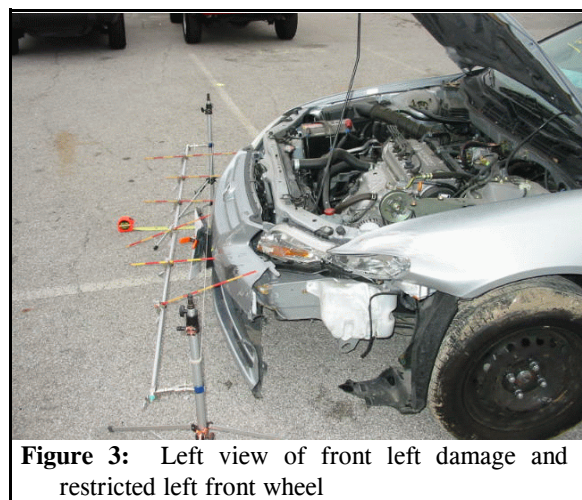
**Figure 3:** Left view of front left damage and restricted left front wheel

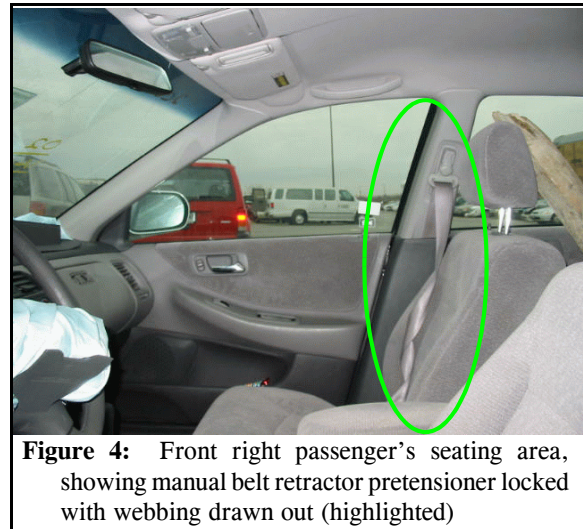
Inspection of the case vehicle's interior revealed no intrusions and no evidence of occupant contact on any of the vehicle's interior components. There was definite evidence of safety belt use by both front seat occupants, consisting of stretching of the safety belt webbing. In addition, both the driver's and front right passenger's safety belt retractors were locked with a substantial amount of webbing played out off the reel, indicating that they were in use when the pretensioners actuated (**Figure 4**).

**Figure 4:** Front right passenger's seating area, showing manual belt retractor pretensioner locked with webbing drawn out (highlighted)

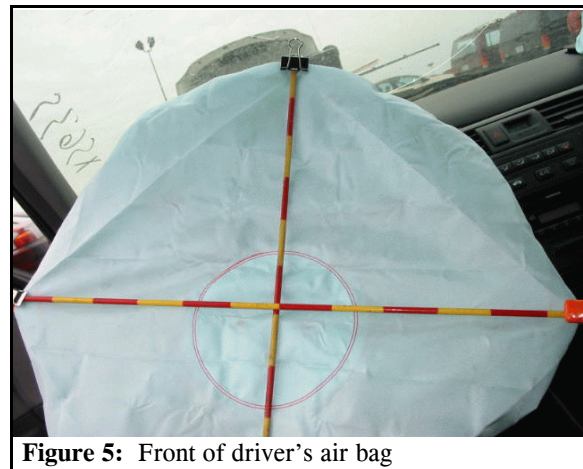
The driver's air bag was located in the steering wheel hub, with the module cover flaps in the H configuration. The module cover flaps were 13 centimeters [5.1 inches] horizontally, with the upper flap measuring 6 centimeters [2.4 inches] and the lower flap 10 centimeters [3.9 inches] vertically. The flaps opened at the tear points and there was no evidence of damage to the flaps or the adjacent structures. The driver's air bag was round with a diameter of 59 centimeters [23.2 inches] and there was no evidence of damage to the air bag. There were routine deployment scuffs on the front of the air bag and no other marks (**Figure 5**).

**Figure 5:** Front of driver's air bag

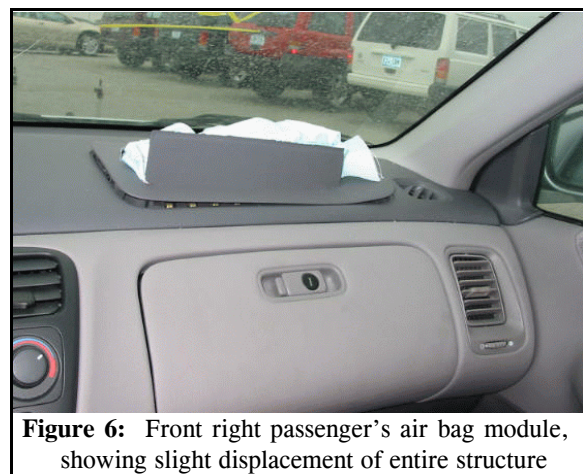
**Figure 6:** Front right passenger's air bag module, showing slight displacement of entire structure

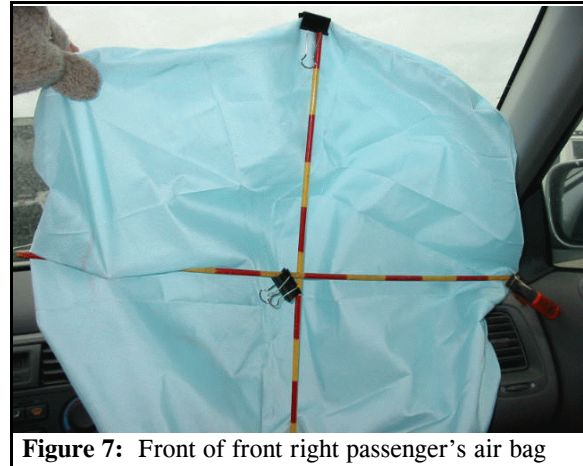
The front right passenger's air bag was located in the top of the instrument panel with two cover flaps in the H configuration. The module cover flaps measured 26 centimeters [10.2 inches] horizontally, with the upper flap measuring 3 centimeters [1.2 inches] and the lower flap 6 centimeters [2.4 inches] vertically. The flaps opened at the tear points and there was no evidence of damage to the flaps, but the entire module was displaced upward with respect to the larger opening into which it was installed (**Figure 6**). The front right passenger's air bag was rectangular, measuring 62 centimeters [24.4 inches] vertically and 65 centimeters [25.6 inches] horizontally. There was no evidence of occupant contact on the air bag (**Figure 7**).

Figure 7: Front of front right passenger's air bag
