Child Safety Seat Combination Investigation / Vehicle to Vehicle  
Dynamic Science, Inc. / Case Number: 2002-76-097A  
2001 Chevrolet Cavalier / 1992 Pontiac Bonneville  
Arizona  
November, 2002

1. Report No. 2002-76-097A	2. Government Accession No.		3. Recipient Catalog No.	
4. Title and Subtitle Child Safety Seat Combination Investigation			5. Report Date November 7, 2003

**Dynamic Science, Inc.**  
**Accident Investigation**  
**Case Number: 2002-76-097A**

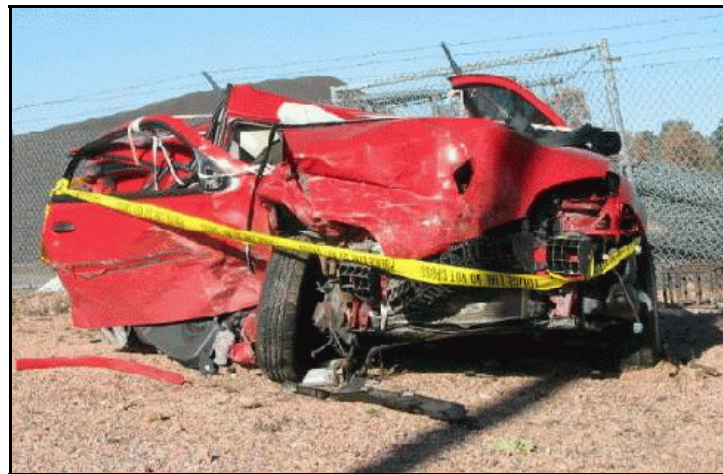
**Figure 3.** Front, Chevrolet Cavalier

The Chevrolet sustained 82 cm (32 in) of direct contact to the front end beginning at the right front bumper corner. The residual crush measured along the bumper was as follows: C1=33 cm (13 in), C2=71 cm (28 in), C3=88 cm (35 in), C4=101 cm (40 in), C5=117 cm (46 in), C6=124 cm (49 in). The maximum crush was located at the right bumper corner. The principle direction of force was within the 1 o'clock sector and was an estimated 20 degrees. The damaged components include the bumper fascia and reinforcement bar, hood, grille, and right side. There was impact force related damage to the windshield and the front right side glass was disintegrated. There was intrusion of the A pillar, instrument panel, and toe pan on the right side. The maximum intrusion was 65 cm (26 in) to the A pillar. There was intrusion of the rear seat back and instrument panel on the left side. The maximum intrusion was 15 cm (6 in) from the seat back.

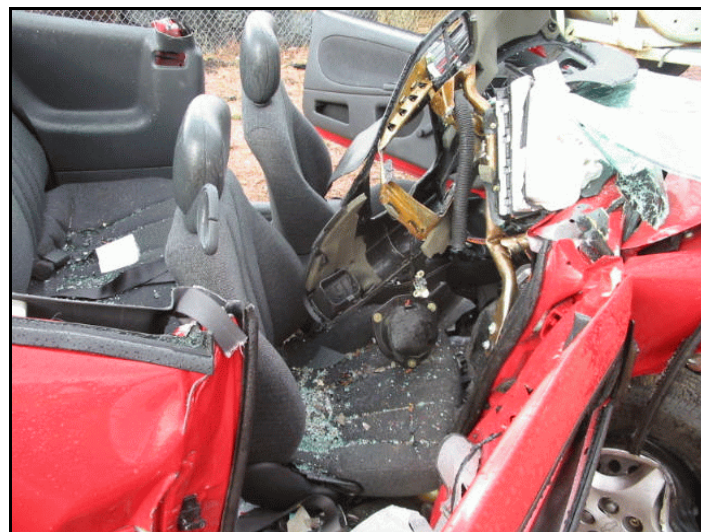
**Figure 4.** Interior view, Chevrolet

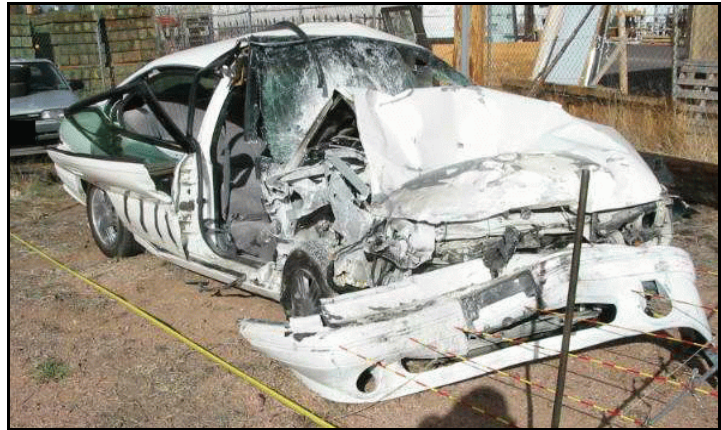
**Figure 5.** Right front, Pontiac

The Pontiac sustained 130 cm (51 in) of direct contact that extended across the entire frontal end width of the vehicle. The residual crush measured along the bumper was as follows: C1=24 cm (9 in), C2=59 cm (23 in), C3=89 cm (35 in), C4=99 cm (39 in), C5=91 cm (36 in), C6=116 cm (47 in). The maximum crush was located at C6. The principle direction of force was within the 12 o'clock sector and was an estimated 350 degrees. The damaged components include the bumper fascia and reinforcement bar, hood, and grille. There was impact force related damage to the windshield and the left front side glass was disintegrated. The right front and right rear doors were jammed shut. There was intrusion of the A pillar, toe pan, windshield header, and B pillar on the right side. The maximum intrusion was to the right instrument panel.

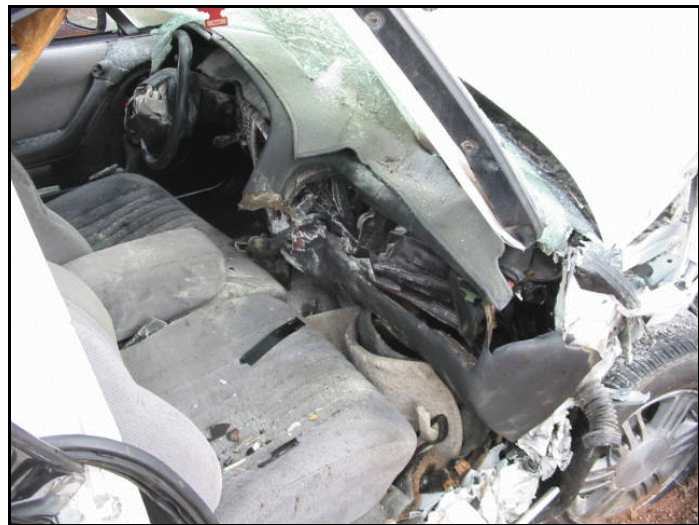
**Figure 6.** Interior view, Pontiac

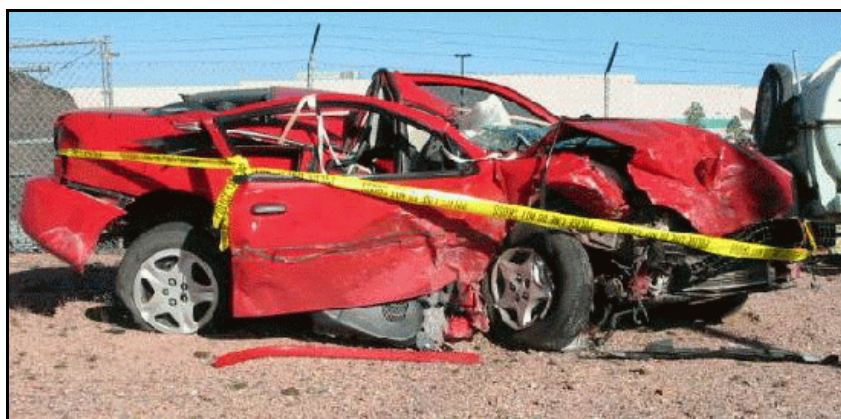
**Figure 8.** Right side, Chevrolet Cavalier

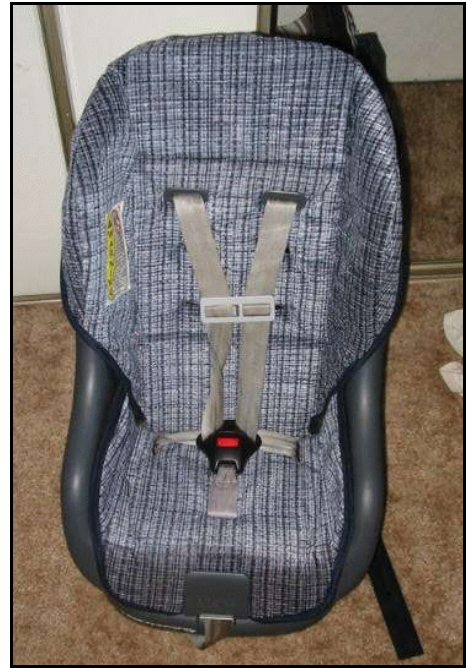
According to the manufacturer, the seat can properly accommodate a child up to 18 kg (40 lbs). The seat was anchored to the vehicle using the available lap and shoulder belt. The harness retainer clip was in use and had been placed at the armpit level. The harness was fitted through the top slots of the seat back. A retrofitted tether was available and was used during the crash. The vehicle's left tether anchorage was loaded and damaged during the crash. A locking clip was available, but was used incorrectly; the clip was installed on the lap and shoulder belt on the outboard side of the seat—opposite the seat belt latch plate.

**Figure 12.** Cosco Touriva CSS, left rear, Chevrolet

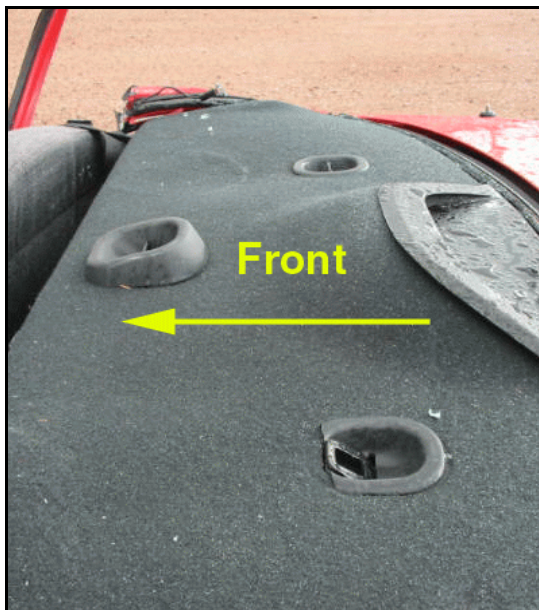
**Figure 13.** Left and right tether anchorages. Left anchorage damaged by loading.

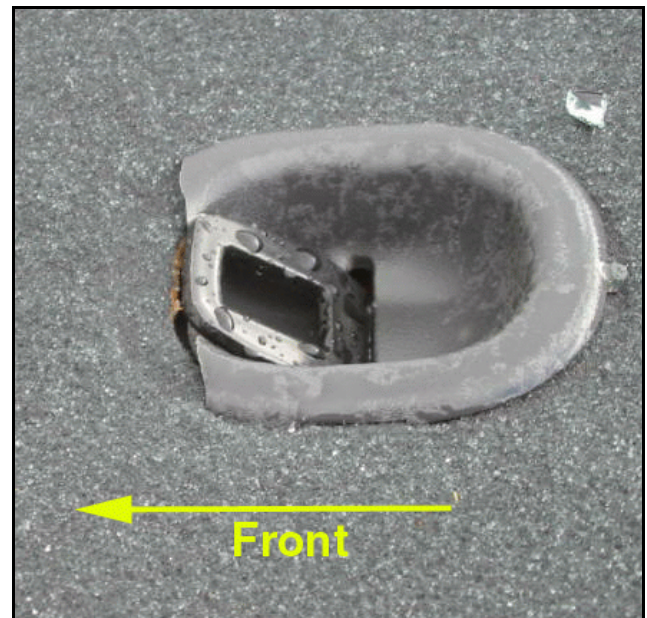
**Figure 14.** Close up of left tether anchorage

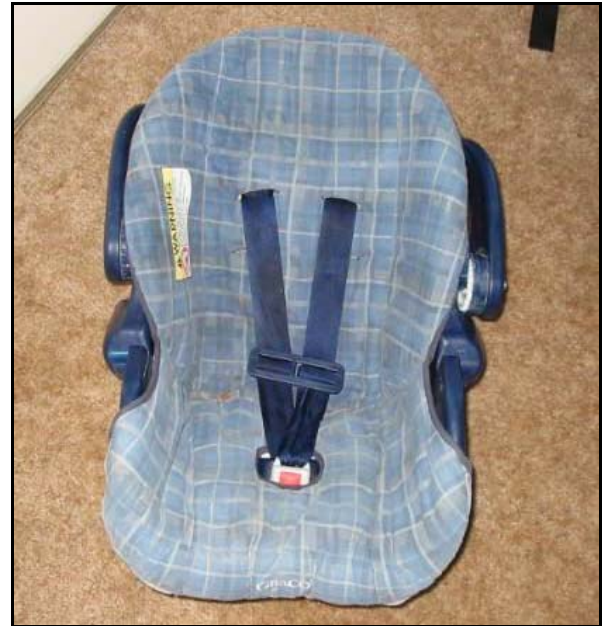
The rear right seat was occupied by an 11-month old male (66 cm/26 in, 11 kg/25 lbs) seated in a Graco Snugride (Model 8457 MV) ISS that was being used in a rear facing fashion. The seat was anchored to the vehicle using the available lap and shoulder belt. A locking clip was used with the lap and shoulder belt, but was used incorrectly (located on the webbing on the outboard side of the child seat opposite of the latch plate). The CSS was equipped with a 3-point harness. The harness straps were in the top slots, which would be appropriate for a child at the upper weight/height limit. The NASS investigator indicated that the seat harness had...”failed due to age and the harness free end not double back through the locking D ring on the back of the seat.” This does not appear to be the case. Figure 16 shows the harness properly inserted into the harness tightener. The harness clip, however, was placed in a position that would have been well below the child’s armpit level. The carrying handle was in the reclined position. It was not designed with a top tether or LATCH. The seat was manufactured on August 10, 2000. According to the manufacturer, the maximum weight capacity for this seat was 9 kg (20 lbs). The child was 1.8 kg (5 lbs) heavier than the recommended weight. The left carrier handle broke off during the crash due to contact with the front right seat back.

**Figure 15.** Graco Snugride ISS, right rear, Chevrolet

Remedy: Graco will provide a replacement seat or base free of charge. The manufacturer has reported that owner notification began March 19, 2002. Owners who do not receive the free replacement seat or base within a reasonable time should contact Graco Century at 1-800-345-4109. [NHTSA Recall No. 02E014]

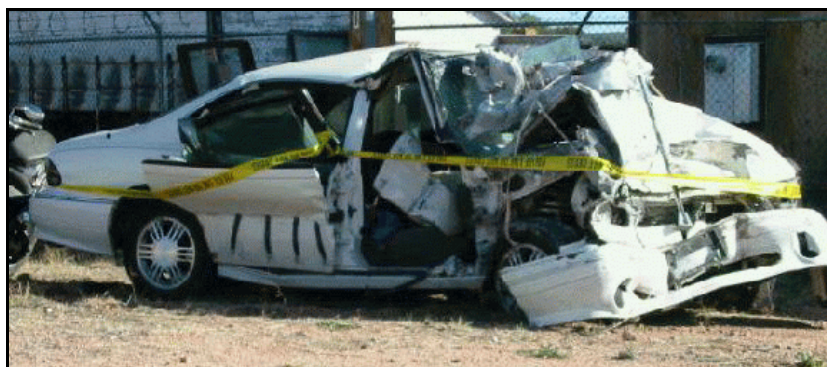
**Figure 17.** Right side, Pontiac Bonneville

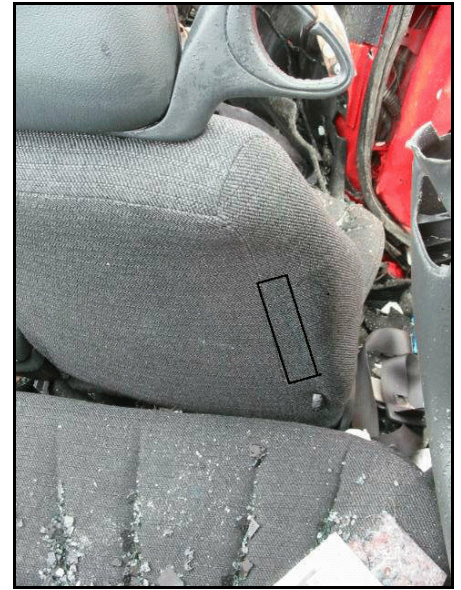
The 11-month old male (66 cm/26 in, 11 kg/24 lbs) rear right seat occupant was seated in a Graco Snugride seat (Model 8457 MV) ISS that was being used in a rear facing position. The infant seat was anchored to the fabric covered bench seat using the available lap and shoulder belt. A locking clip was used with the lap and shoulder belt, but was used incorrectly (located on the webbing on the outboard side of the child seat opposite of the latch plate). The front right seat had been adjusted to the rear most track position and the seat back slightly reclined—placing the seat back as close to the child seat as physically possible. The infant seat was, by design, reclined in approximately a 45 degree angle towards the front of the vehicle. The seat was equipped with a 3-point harness. The harness straps were in the top slots, which would be appropriate for a child at the upper weight/height limit. The investigator indicated that the seat harness had...”failed due to age and the harness free end not double back through the locking D ring on the back of the seat.” This does not appear to be the case. The harness clip, however, was placed in a position that would have been well below the child’s armpit level. At impact, the child seat pitched forward and the child seat back rotated downward—engaging the rear of the right front seat. The rear seat back intruded forward 15 cm (6 in) further reducing the available distance between the front and rear seat backs. The child’s head pitched toward the front and to the right of the vehicle and engaged the left side of the infant seat back (when facing rearward)—causing the skull fracture and brain injuries. The initial impact was functionally between the infant seat back and the back of the right front seat.

**Figure 23.** Back of front right seat—shows infant seat contact
