Office of Defects Seat Belt Investigation / Single Vehicle Rollover
Dynamic Science, Inc. / Case Number: DS02-001
2000 Honda CR-V LX 5-door
Louisiana
November, 2001

**Dynamic Science, Inc.
Accident Investigation
Case Number: DS02-001**

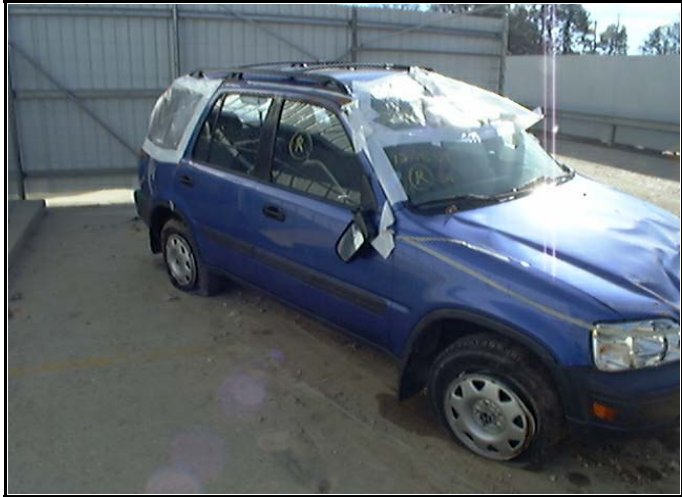
Figure 2. Exterior damage to case vehicle-right side.

The case vehicle sustained rollover (00TDDO2) type damage about the entire vehicle. There was scratching on the top of the vehicle that extended from the hood to the rear of the vehicle. There was scratching to the left and right top rails and along both sides. The rear right, left rear side windows and backlight disintegrated. Both front right and rear right tires had deflated and there was scratching to the rims. The windshield and the roof header intruded into the driver's compartment area. The vehicle was towed from the scene and declared a total loss by the insurance company. The rollover collision was beyond the scope of the WinSmash reconstruction algorithm to produce delta V results.

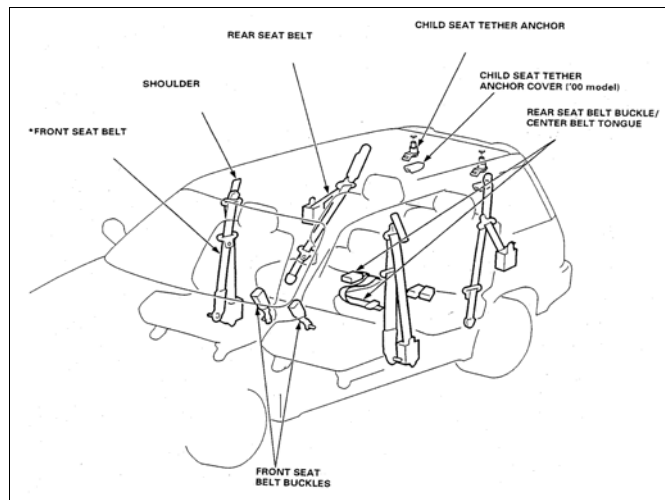
Figure 3. Seat belt and buckle locations.

Both outboard front seating positions of the case vehicle were equipped with 3-point continuous loop manual seat belts with Automatic Tensioning System (tensioners) within the retractors mounted on the lower B pillars. The vehicle was also equipped with redesigned driver's and front right passenger's airbags. The airbags were located in the steering hub and the top aspect of the front right

instrument panel, respectively. According to Honda, the Automatic Tensioning System (tensioners) within the front seat belts are integrated with the deployment of the front airbags. The Automatic Tensioning System (tensioners) will deploy only when the front airbags deploy. The airbags in this crash did not deploy. The Automatic Tensioning System (tensioner) did not deploy in either front seat position.

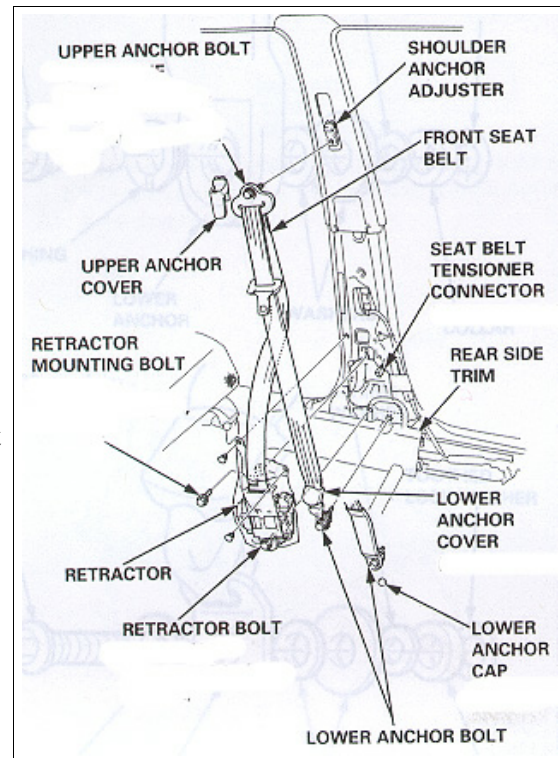
It is not known what caused both of the front buckles to unlock and release the metal seat belt latch. Visually, there did not appear to be anything abnormal about the seat belt latches or buckles, and there was no indications of failure.

Figure 4. Front seat belt components.

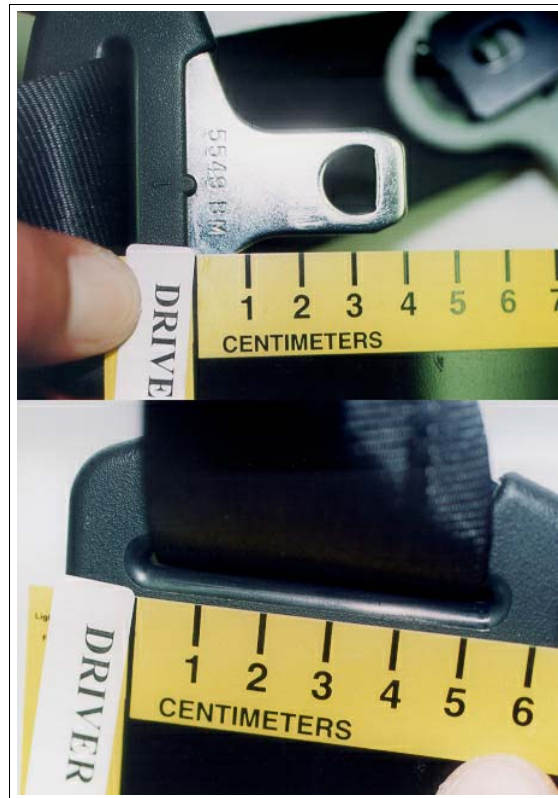
The metal tongue portion of the sliding latch belt assembly for both the driver and front right occupant had scratching from normal use. There was evidence of historical use on both the driver and front right seat belt latches, but there was no evidence of loading. The seat belts pass through slots on the latches and both the driver and front right occupant latches were slightly abraded from normal use. The front right occupant's latch had a "nick" on the top right corner. Evidence of seat belt loading as a result of rollover type forces in this crash was not expected, nor found. The driver's retractor was an Emergency Locking Retractor (ELR) and the front right occupant's was a switchable type retractor from ELR to ALR mode. The driver and front right occupant buckle assembly was mounted on the inboard sides of both front seats. There were no visual indications of failure to either seat belt buckle. The metal tongues were latched and locked into both of the seat buckles. Both belts were pulled forcefully and both remained latched and locked.

Figure 5. Driver's seat belt latch.

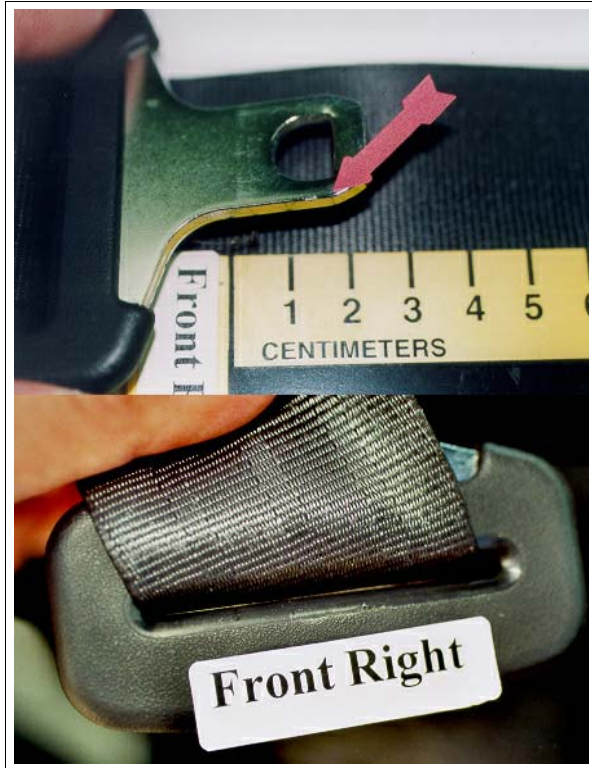
Figure 6. Front right seat belt latch.

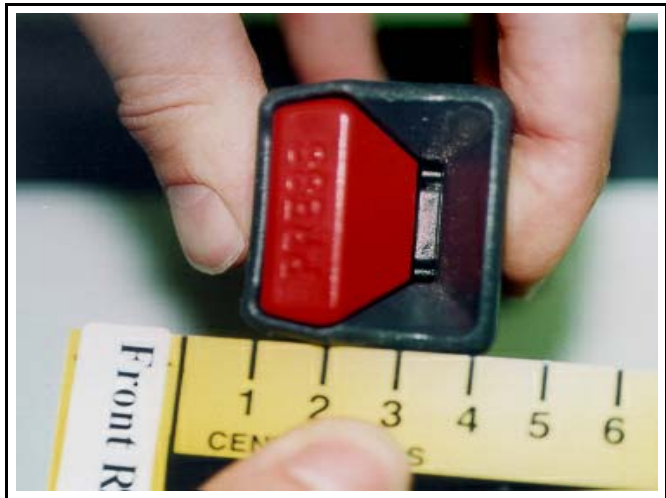
Figure 7. Front right occupant's seat belt latch.

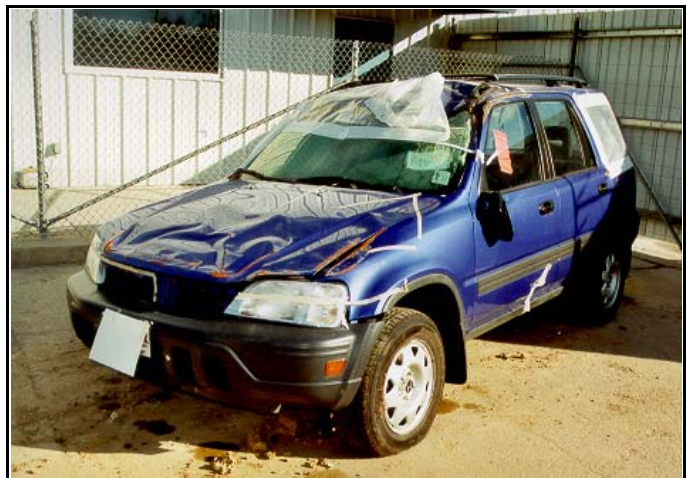
Damage Description: Moderate sheet metal damage extended from the hood rearward to the back of the vehicle. Both rear side windows and backlight disintegrated. The roof and left windshield header corner intruded into the driver's compartment area. Rollover scratching was present on both top side rails and both sides. Vehicle towed due to damage. Declared a total loss by insurance company.

Figure 9. Exterior damage to case vehicle-left side.

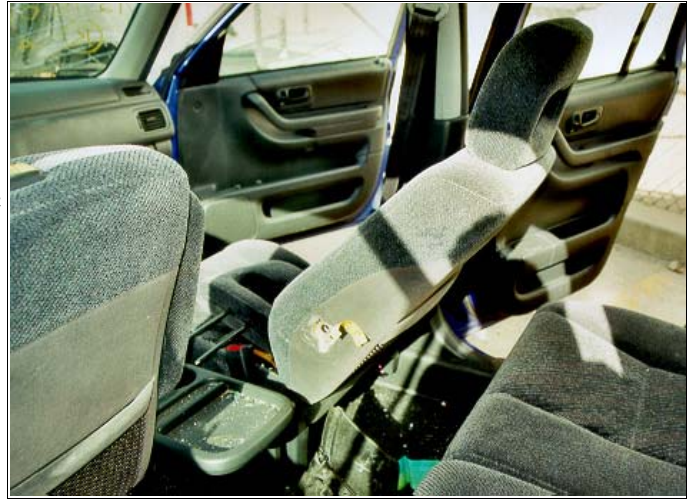
Figure 10. Front right seat, note front right seat arm rest.

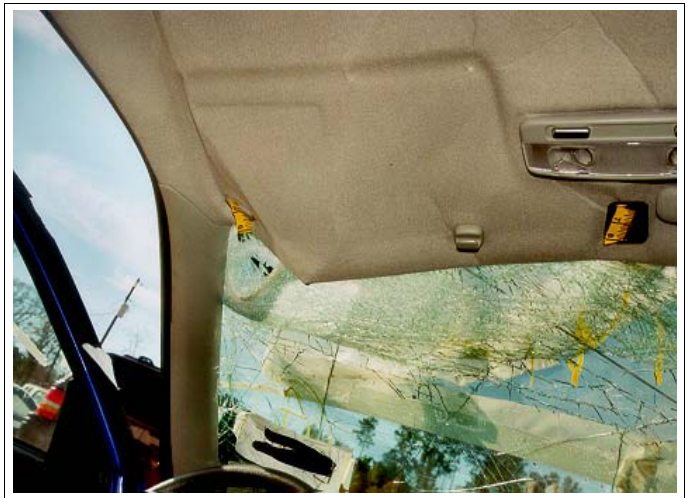
Figure 11. Driver's sunvisor and the rear view mirror knocked off.

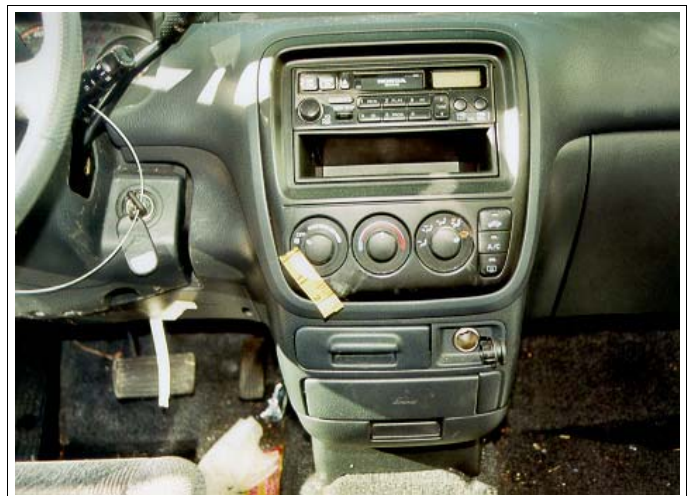
Figure 12. Damaged left and center instrument panel.
