# INDIANA UNIVERSITY

### ON-SITE CHILD AIR BAG-RELATED SERIOUS INJURY INVESTIGATION

CASE NUMBER - IN-02-003  
LOCATION - OHIO  
VEHICLE - 1993 DODGE INTREPID ES  
CRASH DATE - July 2002

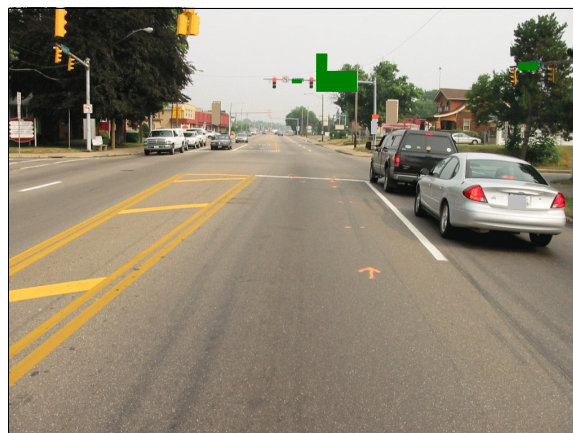
**Crash Environment:** The trafficway on which both vehicles were traveling (**Figure 1**) was a four-lane, divided, city street, traversing in a north-northwesterly and south-southeasterly direction, and the case vehicle was approaching a four-leg intersection (i.e., the city trafficway was divided but only at the mouth of the intersection—**Figure 2**). On the southern leg of the intersection, both the northerly and southerly roadways had two through lanes.

**Figure 1:** Case vehicle's northerly travel path in inside northbound lane of northbound roadway just prior to impact; Note: trafficway was divided near mouth of intersection only (case photo #02)

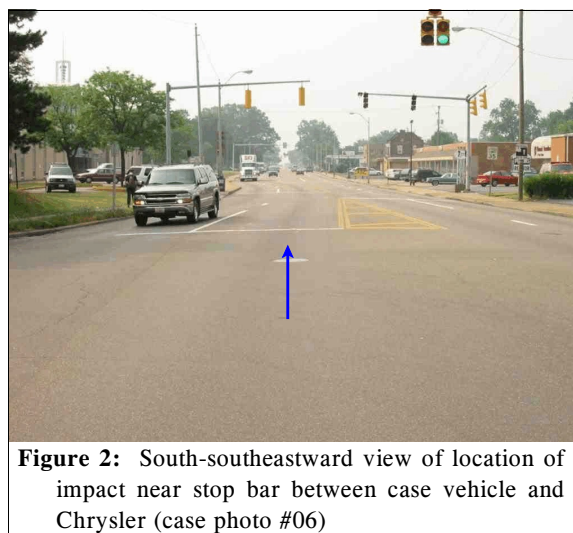
**Figure 2:** South-southeastward view of location of impact near stop bar between case vehicle and Chrysler (case photo #06)

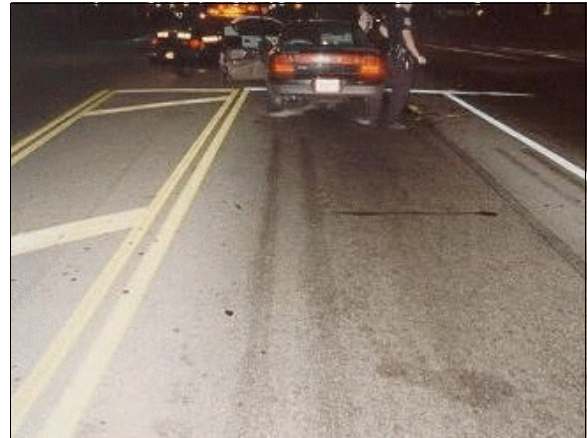
damage to the Chrysler, just prior to the crash the case vehicle's driver braked sharply, attempting to avoid the collision (**Figure 3**). The Police Crash Report estimates the case vehicle's pre-crash speed at 56 km.p.h. (35 m.p.h.). The crash occurred in the same travel lane, just south-southeast of the intersection.

**Figure 3:** On-scene view of case vehicle's final rest position near stop bar and likely pre-crash skid marks; Note: trafficway divided at mouth of intersection (case photo #70)

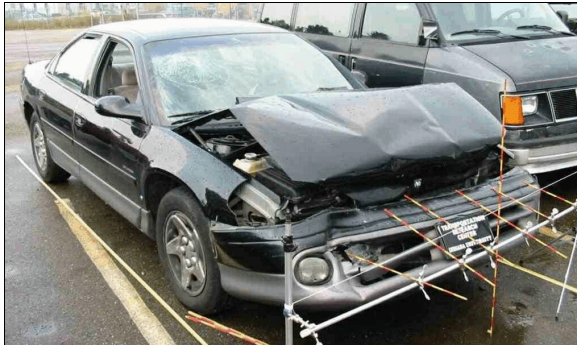
**Crash:** The front (**Figure 4**) of the case vehicle collided with and underrode the back (**Figure 5**) of the Chrysler, just southward of the traffic signal light, causing the case vehicle's driver and front right passenger supplemental restraints (air bags) to deploy (**Figure 6**).

**Figure 4:** Case vehicle's bumper and above bumper frontal damaged viewed from right of front with contour gauge positioned along top of bumper (case photo #28)

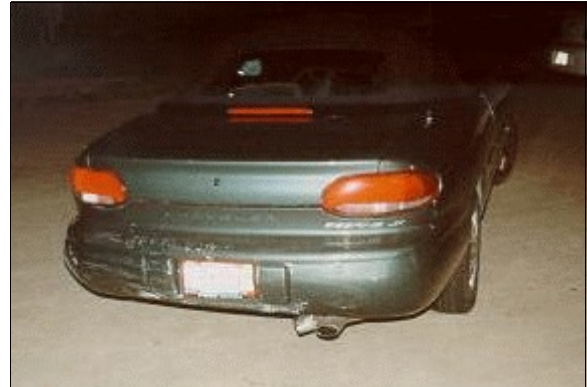
**Figure 5:** On-scene view of Chrysler's damage back (case photo #79)

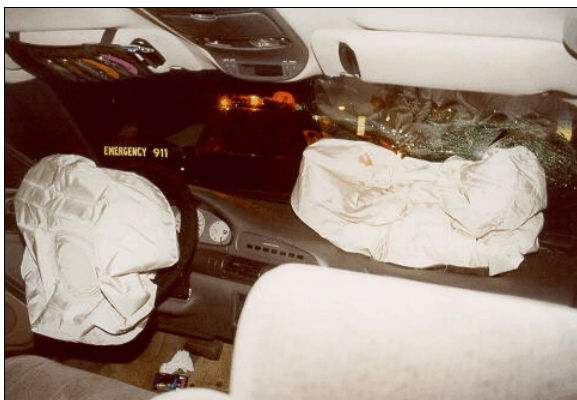
**Figure 6:** On-scene view of case vehicle's deployed driver and front right passenger air bags; Note: cracked right windshield glazing above front right air bag's fabric (case photo #76)

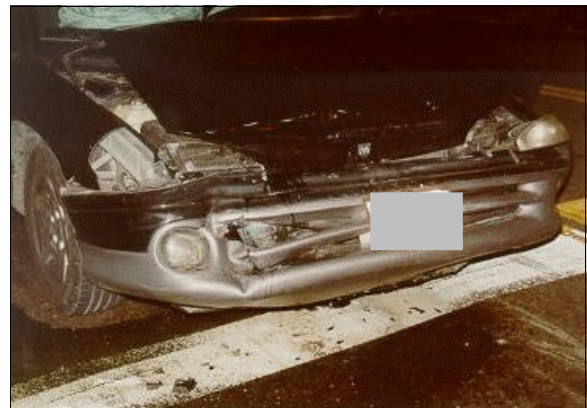
**Figure 7:** On-scene view of case vehicle's frontal damage at final rest near intersection's stop bar; Note: upward rotation of bumper fascia as a result of underide impact (case photo #72)

(Figure 7 above). The Chrysler's final rest location is unknown, but based on the available information it was pushed a short distance into the intersection and subsequently driven into a parking lot off the northeast corner of the intersection.

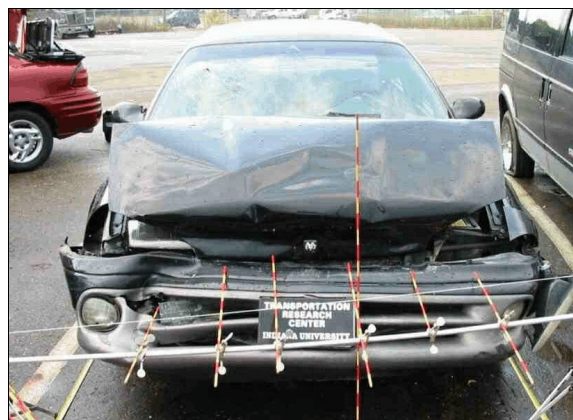
**Figure 8:** Case vehicle's front bumper and above bumper damage with contour gauge positioned at top of bumper's fascia (case photo #07)

**Exterior Damage:** The case vehicle's contact with the Dodge involved the entire front bumper (Figures 8 and 9). Direct damage extended from bumper corner to bumper corner and measured 110 centimeters (43.3 inches). Crush measurements were taken on the actual metal bumper because of a gap between the bumper and plastic bumper fascia and above the bumper as well. Residual maximum crush at the bumper was measured as 25 centimeters (9.8 inches) at C<sub>4</sub>. Above the bumper the residual maximum crush was measured as 7 centimeters (2.8 inches) at C<sub>5</sub>.

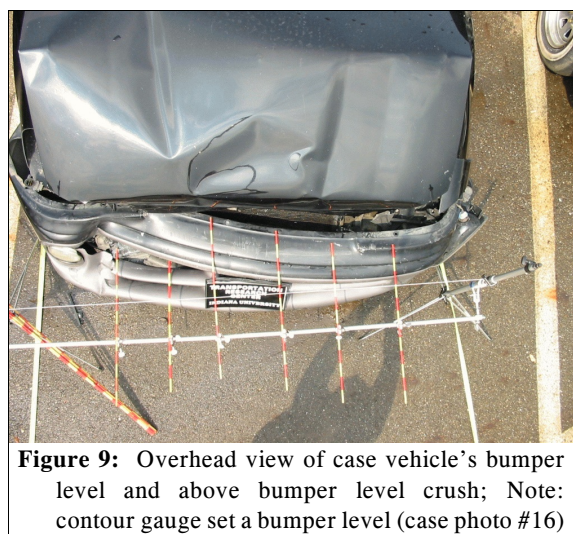
**Figure 9:** Overhead view of case vehicle's bumper level and above bumper level crush; Note: contour gauge set a bumper level (case photo #16)

and C<sub>6</sub>–6 centimeters (2.4 inches) at C<sub>4</sub>. Because the crush averaging requirements were not met, only the bumper level crush was used.

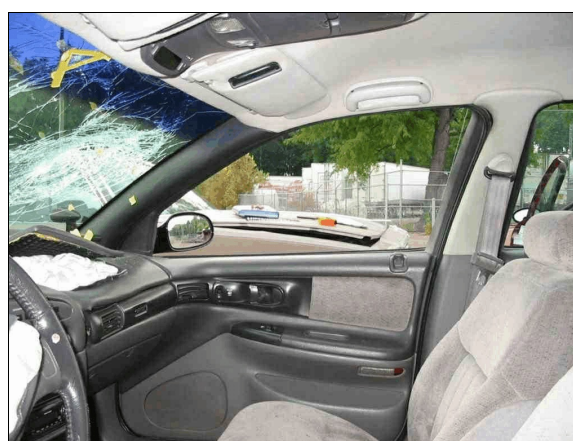
**Figure 10:** Case vehicle’s front right passenger seating area viewed from left showing deployed air bags and spider-web type contact evidence on right windshield’s glazing; Note: yellow tape that appears to be on right “A”-pillar is actually affixed to a hair hanging from windshield’s glazing (case photo #34)

**Interior Damage:** Inspection of the case vehicle's interior revealed that there was a significant spider web-type contact to the windshield (**Figure 10** above and **Figure 11**), including a small hole in the windshield's glazing (**Figure 12**), most likely from contact by the front right passenger's head. Furthermore, there was hair hanging in the broken glazing (**Figures 13** and **14**). The

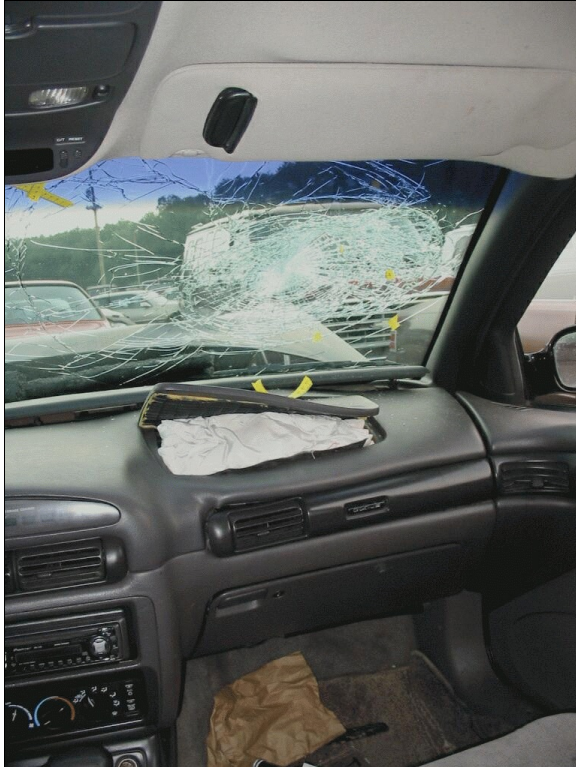
**Figure 11:** Vertical view of case vehicle's front right seating area showing uneven opening pattern to front right air bag module's cover flap, spider web-type contact to right windshield's glazing, and lack of contact evidence on right sun visor, "A"-pillar, or knee bolster (case photo #38)

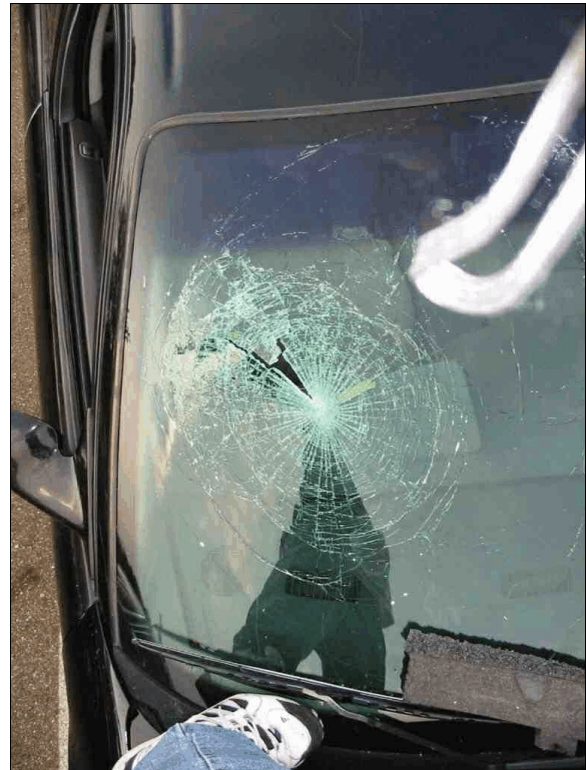
**Figure 12:** Overhead view of hole in case vehicle's front right windshield glazing in contact by front right passenger's scalp(case photo #42)

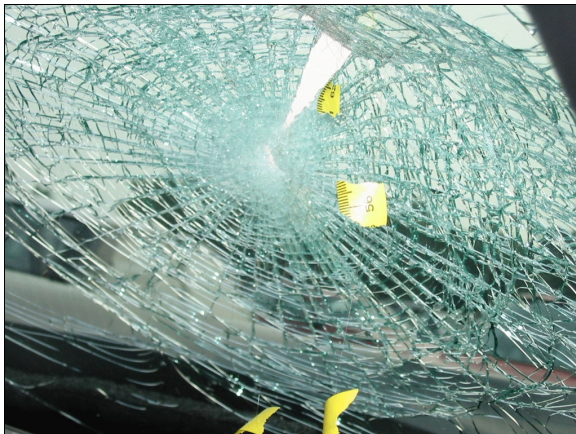
**Figure 13:** Close-up of contact evidence on case vehicle's right windshield glazing; Note: yellow tape marks strands of hair in glazing (case photo #41)

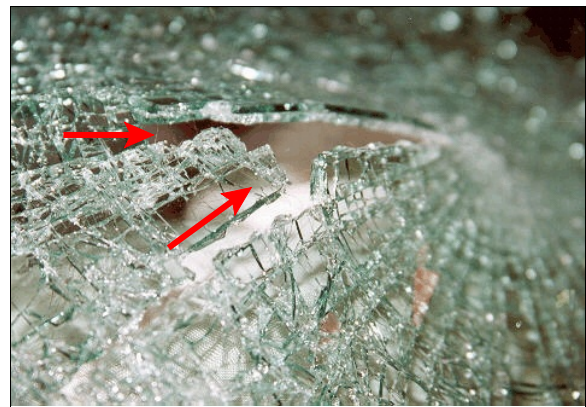
**Figure 14:** On-scene close-up view of case vehicle's holed right windshield glazing showing strands of hair in glazing from scalp of front right passenger (case photo #77)

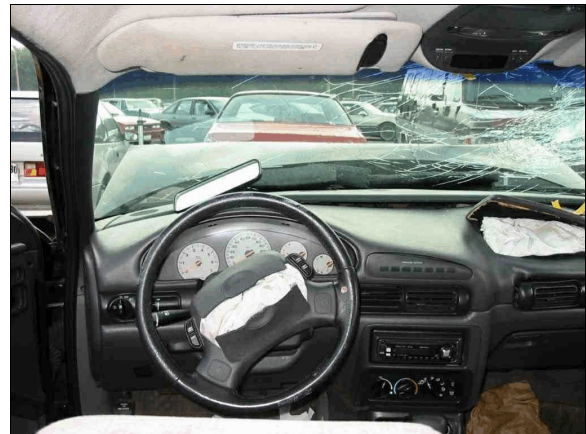
windshield mounted rearview mirror had been displaced from the windshield (**Figure 15**). Finally, there was no evidence of intrusion to the case vehicle's interior, no evidence of compression to the energy absorbing shear capsules in the steering column, and no deformation to the steering wheel rim.

**Figure 15:** Case vehicle's driver seating area showing deployed air bags, displaced rear view mirror, and no obvious evidence of occupant contact in driver's area (case photo #36)

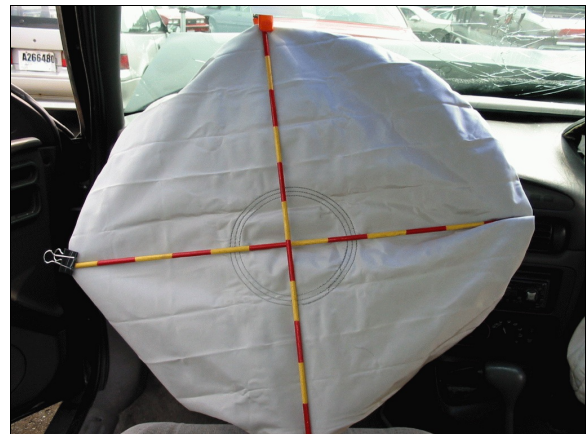
The case vehicle was equipped with a Supplemental Restraint System (SRS) that contained frontal air bags at the driver and front right passenger positions. Both frontal air bags deployed as a result of the frontal impact with the Chrysler. The case vehicle's driver air bag was located in the steering wheel hub. The module cover consisted of symmetrical "H"-configuration cover flaps made of thick vinyl with overall dimensions of 16.5 centimeters (6.5 inches) at the horizontal seam and 7 centimeters (2.8 inches) vertically for both the upper flap and lower flaps. An inspection of the air bag module's cover flaps and the air bag's fabric revealed that the cover flaps opened at the designated tear points and there was no evidence of damage during the deployment to the air bag or the cover flaps. The driver's air bag was designed with two tethers, each estimated at approximately 6 centimeters (2.4 inches) in width. The driver's air bag had no vent ports. The deployed driver's air bag was round with a diameter of 62 centimeters (24.4 inches). An inspection of the driver's air bag fabric revealed no contact evidence readily apparent on the air bag's fabric (**Figure 16**).

**Figure 16:** Case vehicle's deployed driver air bag showing no obvious evidence of occupant contact (case photo #47)

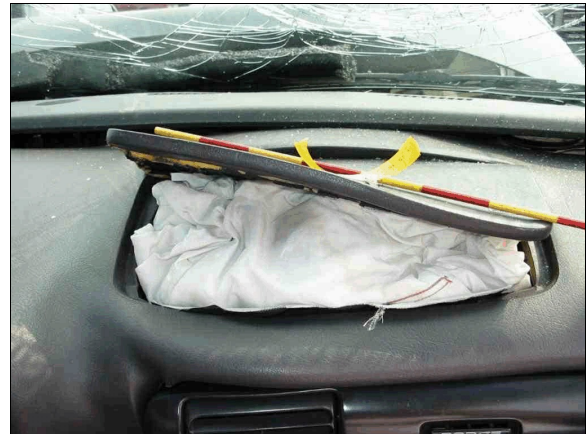
cover flap relative to the protruding right instrument panel. An inspection of the front right air bag module's cover flap and the air bag's fabric revealed that the cover flap opened at the designated tear points, and there was no evidence of damage during the deployment to the air bag's fabric. However, there was an uneven opening of the module's cover flap, with the left portion more open than the right (**Figure 11** above and **Figure 17**). Furthermore, there was a cut on the leading edge of the flap near the center (**Figure 18**), most likely from impacting the windshield's glazing. The front right passenger's air bag was designed with two very wide tethers. The upper tether measured approximately 44 centimeters (17.3 inches) and lower tether measured 47 centimeters (18.5 inches) in width. The front right air bag had no vent ports. The deployed front right air bag was rectangular with a height of approximately 71 centimeters (28.0 inches) and a width of approximately 55 centimeters (21.7 inches). An inspection of the front right passenger's air bag fabric revealed blood stains on the front left portion of the bag, above and below the air bag's middle (**Figure 19** below). Furthermore, there were more significant blood stains on the left side of the air bag (facing the driver) near the vertical center.

**Figure 17:** Close-up of case vehicle's front right passenger air bag module showing distortion to module's cover flap caused by uneven opening (case photo #68)

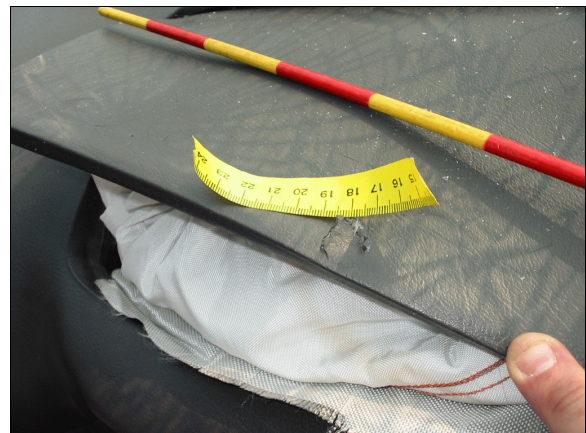
**Figure 18:** Close-up of case vehicle front right passenger air bag module's cover flap showing cut near front edge of flap (case photo #67)

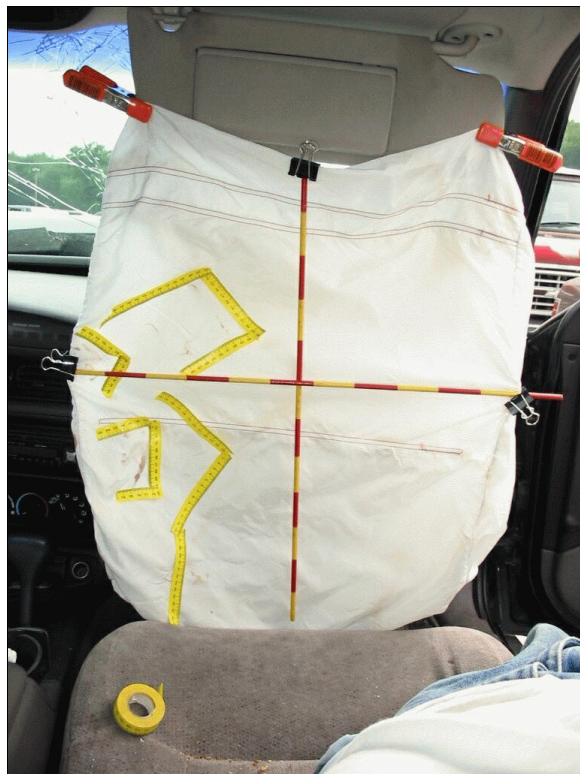
**Figure 19:** Front surface of case vehicle’s deployed front right passenger air bag showing contact evidence situated along left side of bag’s fabric (case photo #52)

Based on the available evidence (i.e., blood evidence on air bag), the child contacted the deploying air bag primarily along its left side. This is consistent with the uneven pattern shown by the air bag module’s cover flap where it appears that the more of the air bag’s fabric was able to get out through the side of the cover flap closest to the middle of the vehicle. Furthermore,

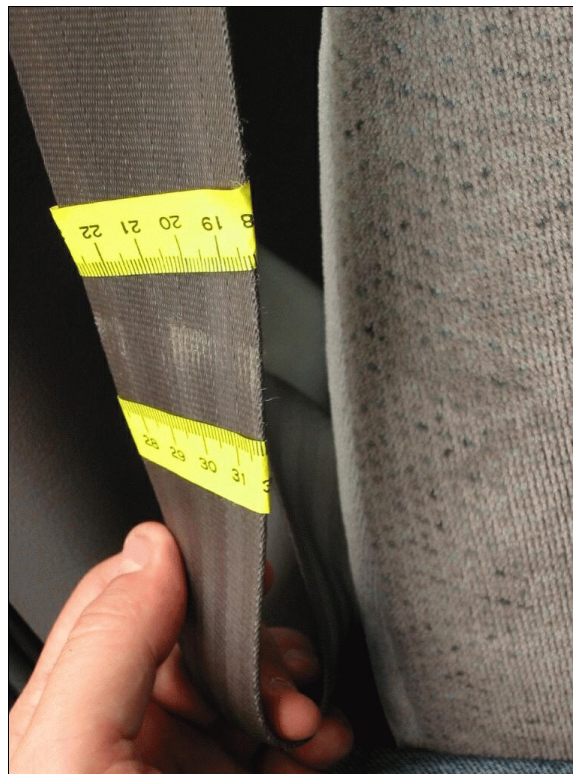
ring, and latch plate showed evidence of loading near the “D”-ring (**Figure 20**). In this contractor’s opinion, this loading evidence was not related to this crash.

**Figure 20:** Close-up of case vehicle’s front right passenger safety belt showing evidence of loading, previous or otherwise, on inside of belt’s webbing near “D”-ring (case photo #32)

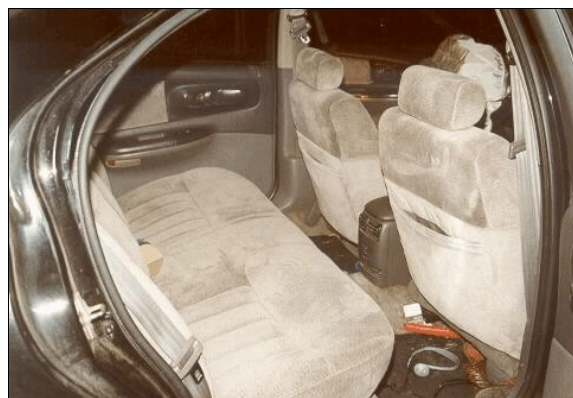
**Figure 21:** On-scene view of case vehicle's back seating area showing no evidence of occupant contact to back surface of front right passenger's seat back (case photo #78)

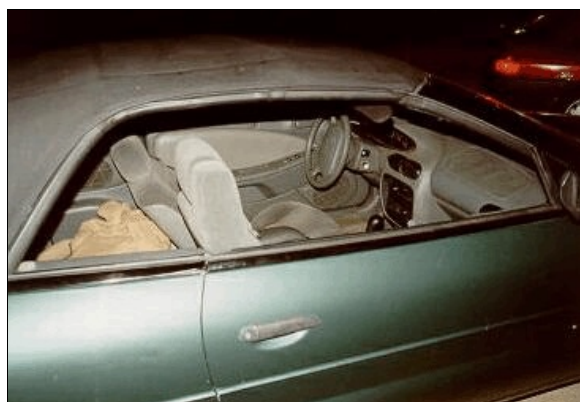
Furthermore, the Chrysler was equipped with driver and front right passenger air bags which did not deploy as a result this vehicle's impact (**Figure 22**). In addition, the Chrysler had manual, three-point, lap-and-shoulder, safety belt systems for at least the front outboard seating positions. The interior was equipped with bucket seats for the driver and front right passenger, and the back bench seat was non-adjustable.

**Figure 22:** On-scene view of Chrysler's interior showing non-deployed driver and front right air bags (case photo #81)

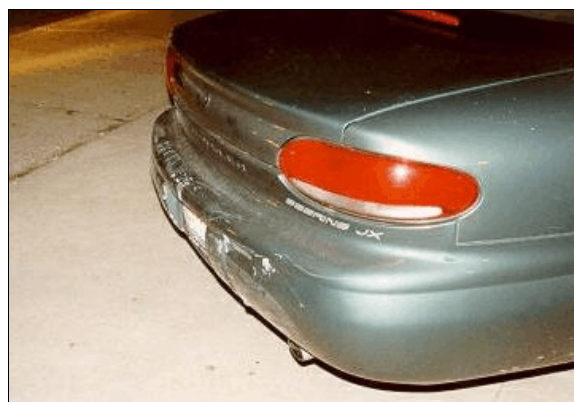
**Figure 23:** On-scene view of Chrysler's rear bumper viewed from right back showing contact evidence across bumper's fascia from impact with case vehicle (case photo #80)

**Exterior Damage:** Based on the available police photographs (**Figure 5** above and **Figure 23**), the CDC for this vehicle is estimated as: **06-BDEW-01 (180 degrees)**. The WinSMASH reconstruction program, missing vehicle algorithm, was used on the Chrysler's highest severity impact. The Total, Longitudinal, and Lateral Delta Vs are, respectively: 26.0 km.p.h. (16.2 m.p.h.), +26.0 km.p.h. (+16.2 m.p.h.), and 0.0 km.p.h. (0.0 m.p.h.). The Chrysler was driven from the scene.
