On-scene Investigation / Vehicle to Vehicle  
Dynamic Science, Inc. / Case Number: DS02004  
2002 Jaguar X type 3.0  
California  
February, 2002

1. Report No. <b>DS02004</b>	2. Government Accession No.	3. Recipient Catalog No.	
4. Title and Subtitle <b>In-Depth Accident Investigation</b>		5. Report Date

**Dynamic Science, Inc.**  
**Accident Investigation**  
**Case Number: DS02004**

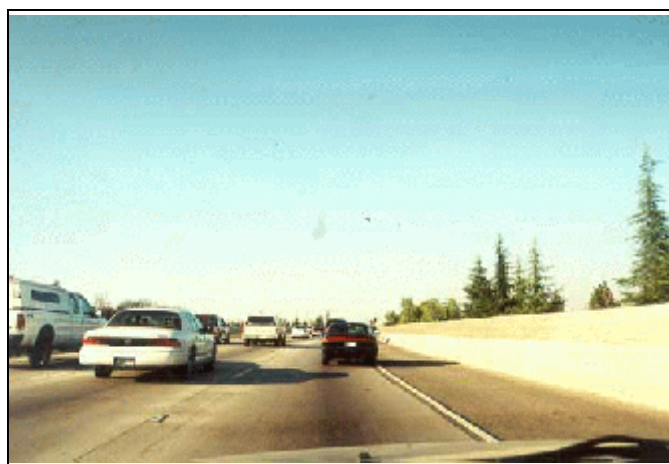
**Figure 1.** Area of impact (north)

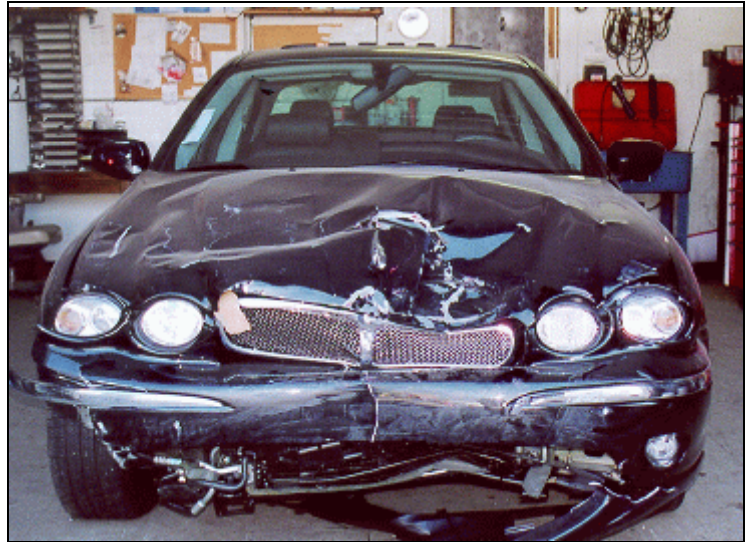
**Figure 2.** Front, case vehicle

The driver of the other vehicle slowed/braked for some unknown reason. The front of the case vehicle (12FDEW1) struck the rear of the other vehicle (06BDEW6).

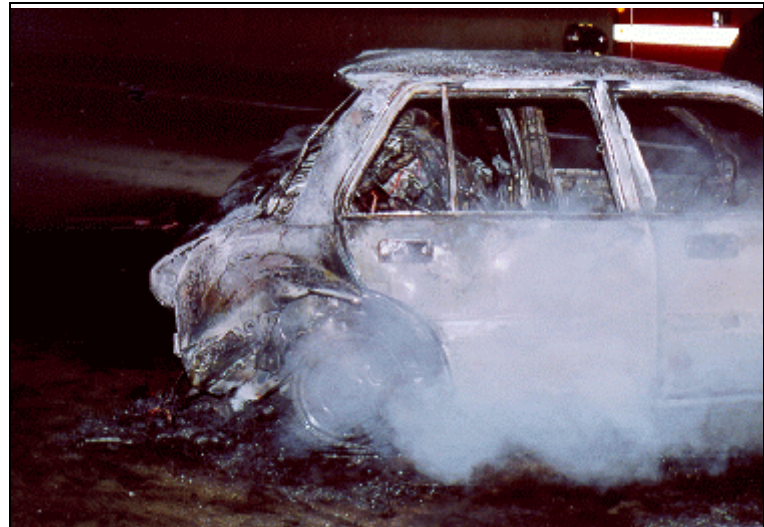
**Figure 3.** Honda at final rest

The Honda was pushed into a clockwise rotation. The front of this vehicle struck a concrete wall on the right side of the roadway<sup>2</sup>. The vehicle continued rotating until it came to rest in the middle travel lane facing east.

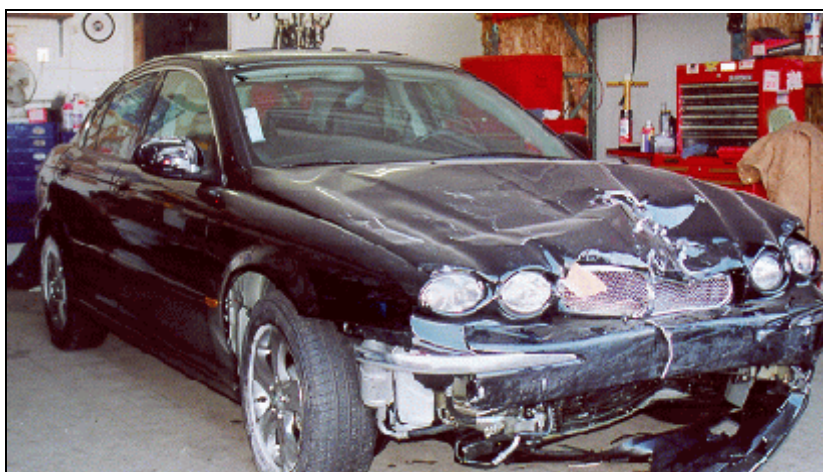
**Figure 5.** Front right, case vehicle

The case vehicle sustained 141 cm (56 in) of direct contact that extended across the entire front end width of the vehicle. The residual crush measured along the bumper was as follows: C1=0 cm (0 in), C2=0 cm (0 in), C3=3 cm (1 in), C4=6 cm (2 in), C5=7 cm (3 in), C6=4 cm (2 in). The maximum crush was located at C5. The principle direction of force was within the 12 o'clock sector and was an estimated 0 degrees. The impact energy was managed by the forward structures of the vehicle. The damaged components include the bumper fascia and reinforcement bar, hood, and grille. There was no measured change in the wheelbase dimensions. There were no glazing fractures and all the doors remained operational.

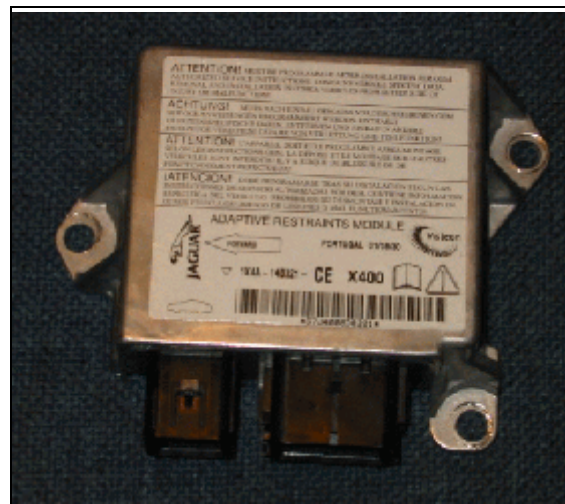
The air bag control module was removed by this investigator and released by the police to this investigator. The module was manufactured by the Visteon Corporation for Jaguar. DSI contacted Ford Motor Company to locate the proper Visteon contacts in order to download any available data from the module. After some NHTSA intervention, DSI was provided with the party's name and number. DSI first contacted the police agency to determine the legality of shipping the module to Visteon. The police agency agreed and on March 11, 2002, DSI shipped the module via Federal Express to the Visteon Technical Center in Detroit, Michigan. On March 13, 2002, DSI was contacted by Visteon and Ford. The purpose of the call was to explain some possible data loss issues that might come about as the module is downloaded and to indicate that it is still necessary to obtain the driver's permission to read the module. Visteon returned the module to DSI the following week. Since that time the investigating police agency requested that the module be returned to their official custody; this was done. At the time of this writing the module remains unread.

Figure 7. Control module

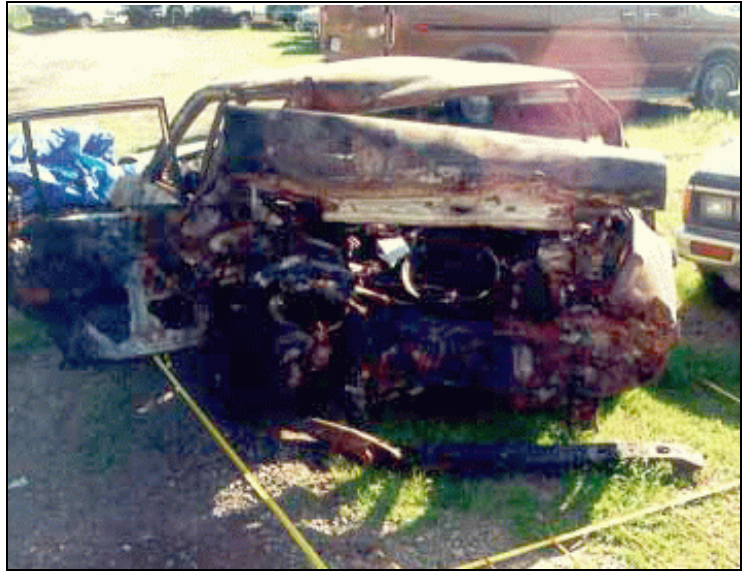
As a result of the vehicle to vehicle impact, the Honda sustained 138 cm (54 in) of direct contact damage that extended across the entire rear end width of the vehicle. The residual crush measured along the rear surface behind the reinforcement bar was as follows: C1=123 cm (48 in), C2=120 cm (47 in), C3=116 cm (46 in), C4=95 cm (37 in), C5=77 cm (30 in), C6=55 cm (22 in). The maximum crush was located at C1. The principle direction of force was within the 6 o'clock sector and was an estimated 180 degrees. The rear structure failed. The damaged components included the bumper fascia and reinforcement bar, trunk lid, rear axle, fuel tank, left rear door, and rear passenger compartment. The left wheelbase was reduced by 16 cm (6 in). The right rear door was jammed shut. The backlight and left rear side glass were likely disintegrated by the impact. Shortly after the crash, this vehicle caught on fire due to a ruptured fuel tank. The vehicle was completely engulfed by the fire.

**Figure 8.** Rear left, Honda

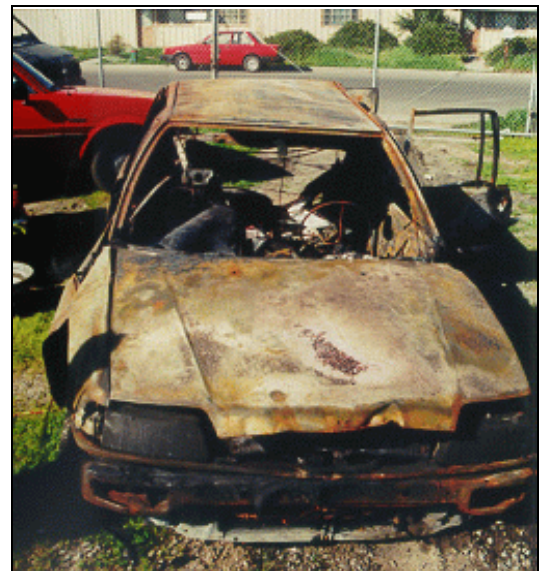
<sup>2</sup>There was no mention of a second impact in the police report; however, vehicle dynamics and frontal damage to the vehicle suggest otherwise.

**Figure 9.** Frontal damage to Honda from barrier impact

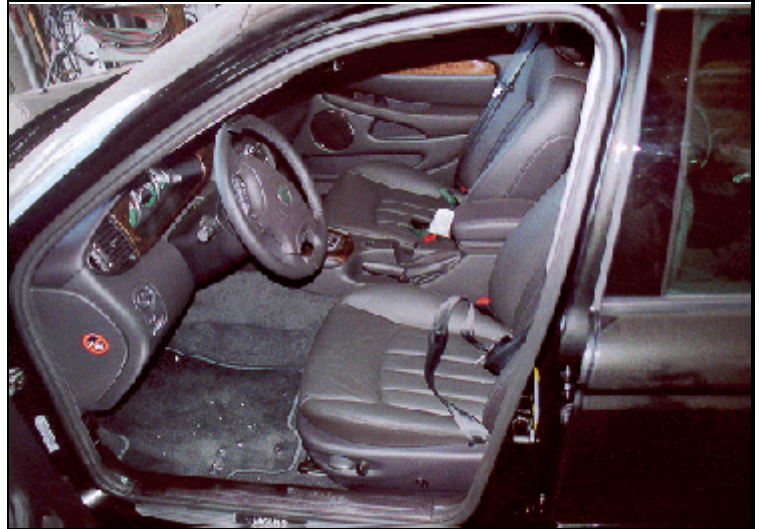
The 55-year-old male driver (206 cm/81 in, 118 kg/260 lbs) of the case vehicle was using the available lap and shoulder belt. He was seated in a forward facing position. The leather covered seat had been adjusted to the rear-most track position. The seat belt anchorage was in the full up position. Upon impact, the driver's pretensioner fired. The driver responded to the 12 o'clock direction of force by exhibiting a forward trajectory and loading the pretensioned and locked manual restraint system. The belt became entrapped in the sliding latch plate as it began to load. The soft tissue injuries to his left shoulder and left chest were caused by the seat belt, as was the sternal fracture.

Figure 10. Driver's seated position

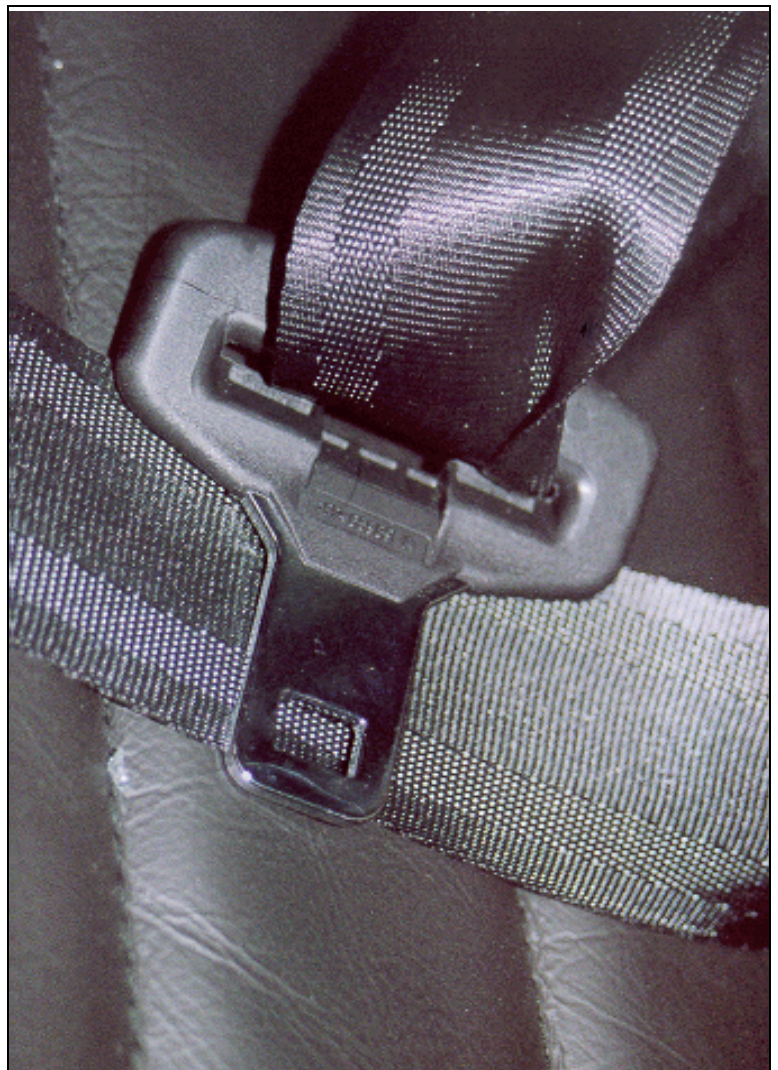
Figure 11. Driver's seat belt latch
