Air Bag Related Child Passenger Investigation / Vehicle versus Animal
Dynamic Science, Inc. / Case Number: DS02-006
2000 Suzuki Esteem
Oklahoma
March, 2002

Dynamic Science, Inc.
Crash Investigation
Case Number: DS02-006

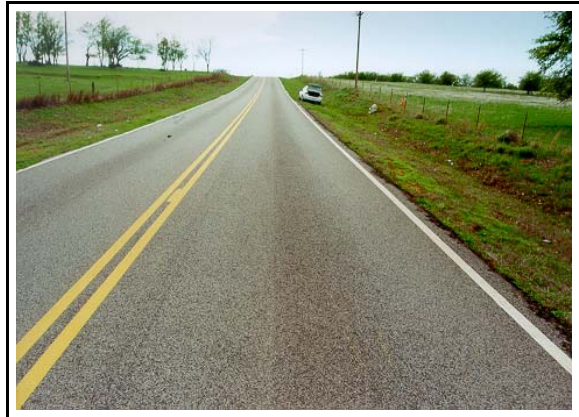
Figure 1. Direction of travel towards impact area (west)

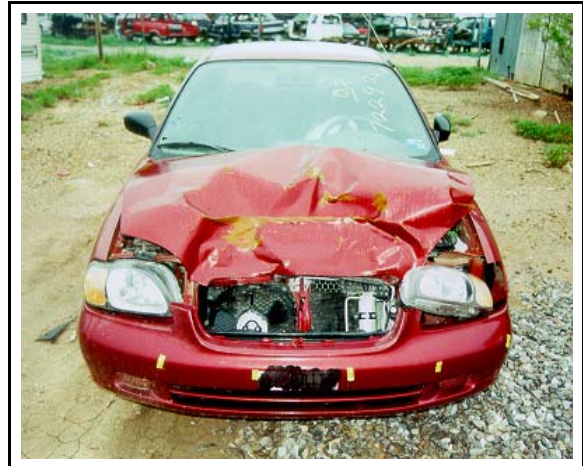
Figure 2. Exterior damage to case vehicle

Damage Description:	Moderate above bumper damage to the front grille, hood, upper radiator support. Cracked windshield.	
CDC:	12FDEW1	
Delta V:	Total	15.0 km/h (9.3 mph)
	Longitudinal	-15.0 km/h (9.3 mph)
	Latitudinal	0.0
	Energy	6,269 joules (8,499 ft-lbs)

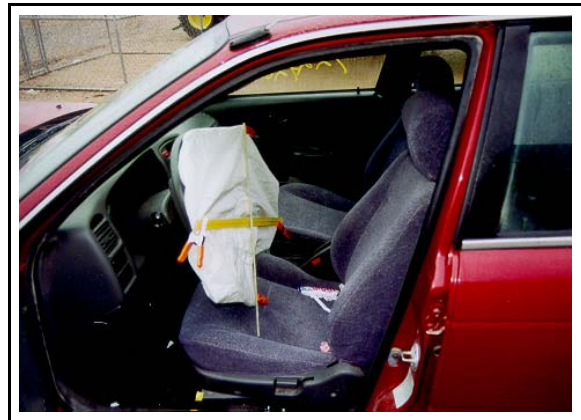
Figure 3. Driver's seat

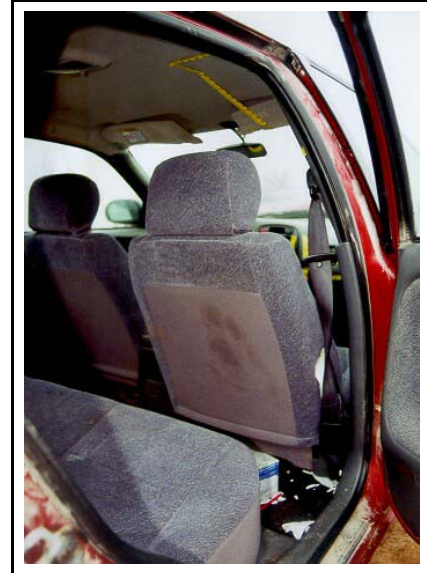
This vehicle had four separate inspections prior to this contractor's inspection. The coroner's inspector photographed the front right and rear right seat position. The front right seat back reclined rearward into the child seat positioned in the rear right seat position. The insurance company inspection noted that the front right seat back was fully reclined and locked into this

position. On a secondary inspection, the insurance inspection found that the front right seat back was upright and functioning properly.

This contractor's inspection of the front right seat found the seat back operational and not damaged. The back of the seat back was soiled but there was no evidence of loading or damage.

Figure 4. Front right seat back

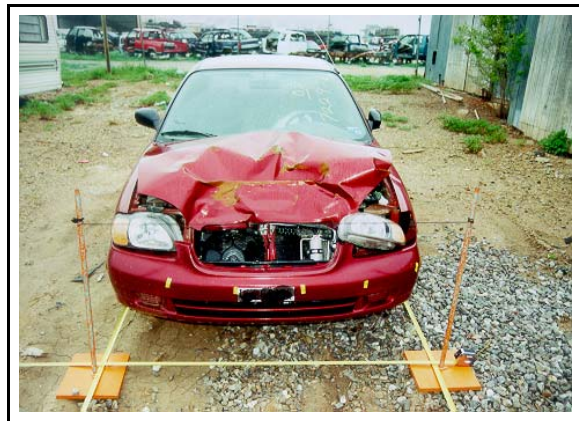
The case vehicle sustained moderate above bumper damage that began 33 cm (13 in) to the left of the front right bumper corner and measured 103 cm (41 in). The residual averaged crush measured along the front bumper and above the bumper were as follows: C1=0 cm (0 in), C2=10.0 cm (3.9 in), C3=0 cm (0 in), C4=1.0 cm (0.4 in), C5=0 cm (0 in), C6=0 cm (0 in). The maximum crush was measured at C2. The principle direction of force was within the 12 o'clock sector and was an estimated 0 degrees. The damaged components were mainly above the front bumper and included the hood, grille, and the upper radiator support and radiator. The right side of the windshield glazing was cracked from the front right passenger's air bag.

Figure 5. Exterior damage

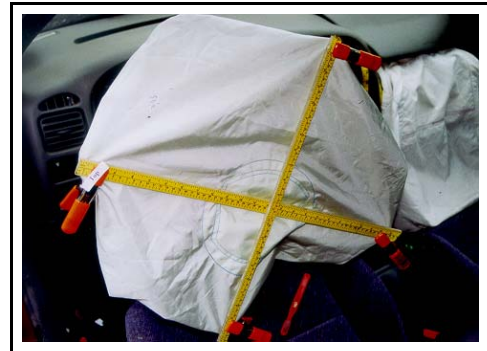
The case vehicle was equipped with redesigned² driver and front right passenger's air bags. Both air bags deployed. The driver's air bag was mounted in the steering wheel. The deflated air bag was circular in shape with a diameter of 58.0 cm (22.8 in). There were six vertical folds, two tethers, and two vent ports at the 01 and 11 o'clock positions. The air bag had a maximum excursion of 33.0 cm (13.0 in). The module cover had an "I" tear type configuration. Both right and left module covers were symmetrical and measured 8.5 cm (3.3 in) wide by 12.5 cm (4.9 in) high. Lipstick and makeup transfers were found on the upper right quadrant of the air bag. An unknown faint brownish transfer was found on the back upper left quadrant of the driver's air bag.

Figure 6. Driver's air bag

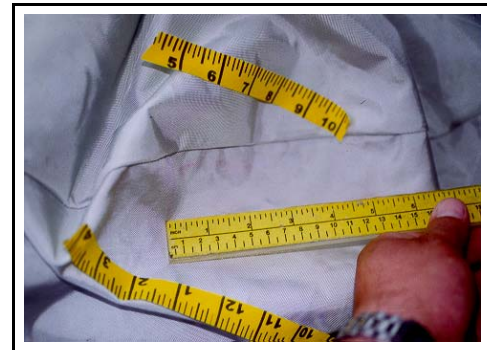
Figure 7. Driver's air bag-lipstick transfer

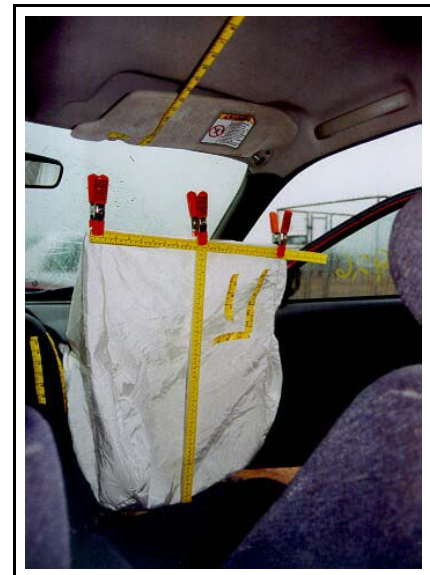
The front right passenger's air bag was a mid-mount design located in the right third of the instrument panel. The deflated air bag measured 50.0 cm (19.7 in) wide by 54.0 cm (21.3 in) high. There were five horizontal folds, no tethers, and no vent ports. The air bag had a maximum excursion of 46.0 cm (18.1 in). The module consisted of single module cover flap and measured 41.0 cm (16.1 in) wide by 27 cm (10.6 in) high. There were two occupant contacts that appeared to be skin transfers located on the top aspect of the air bag just left of center, and to the face of the air bag located at the right edge near the stitching. The skin transfers were from the 3-year-old child. There was also module cover scuffing on the top and right edge of the air bag.

Figure 8. Front right air bag with skin transfer

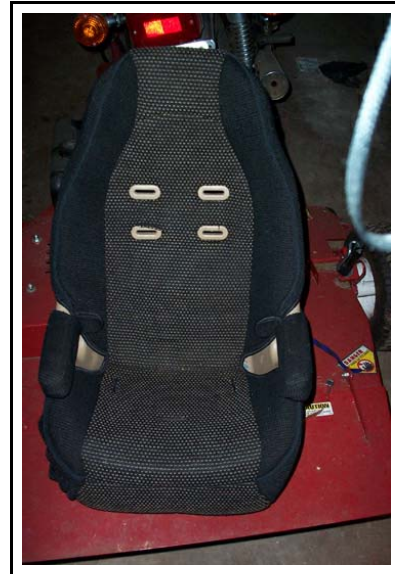
The driver indicated that the 3-year-old child was seated in a forward facing child seat that was being used as belt position booster seat. The child seat was not inspected by this contractor. Photographs were obtained from the insurance adjuster and the child seat was identified as a Cosco Vision High Back Booster child safety seat, Model #02-409-PEP that was manufactured on 12/20/2000. The child seat was in a forward facing position with the child seat harness removed. The manufacturer recommends usage of the child safety seat as a belt-positioning booster for children weighing between 13.6-36.3 kg (30-80 lbs) and a height of 129.5 cm (51.0 in). The 3-year-old child was at the recommended weight but far below the recommended height. The front right seat was equipped with a 3-point lap and shoulder safety seat belt with a sliding latch plate and a switchable retractor. The vehicle's safety belt had indications of historical usage, but there was no evidence of loading as a result of this crash. According to the driver, the 3-year-old child had the ability and history of unbuckling the safety belt.

Figure 9. On scene view of child seat

It is the opinion of this contractor that the unrestrained 3-year-old child was seated in the front right seat and was not using the child safety seat.

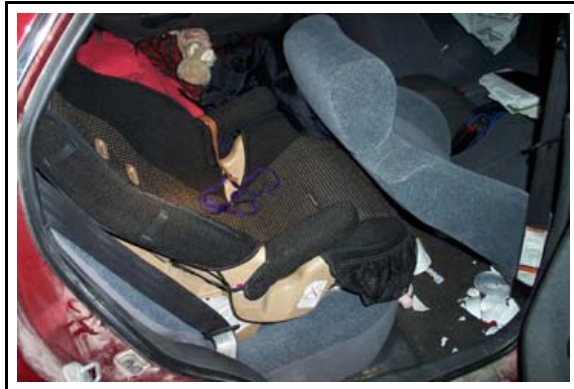
Figure 10. On scene view of rear right seat and child seat

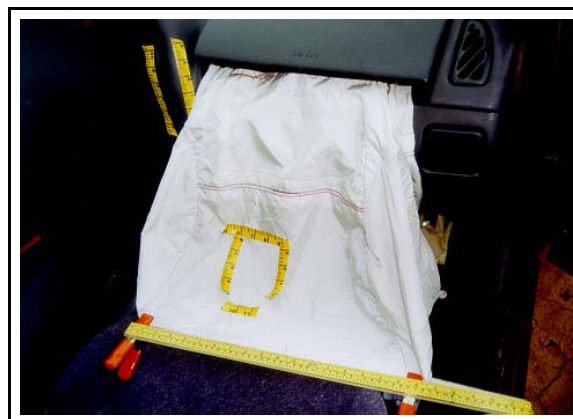
Figure 11. Front right air bag top skin transfer

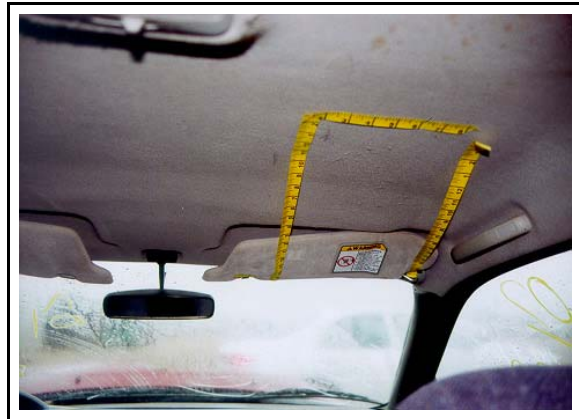
The front right area of the windshield glazing was cracked by the deployed front right passenger's air bag. The front right sun visor bracket was cracked by contact with an unknown body part of the front right occupant. There was an indentation/depression of the roof header that began at the front right sun visor and extended rearward. The front right shoulder belt upper anchorage adjustment knob was knocked off and cracked by contact with the 3-year-old child's head. There was white transfer/smudging to the right aspect of the instrument panel that did not fit anything related to this crash. Initially this contractor thought that the child safety seat had slid forward and struck the instrument panel on impact with the deer. This was later discounted based on the coroner's investigator photographs of the post crash position of the child seat (right rear seat).

The 3-year-old child sustained an abrasion, air bag burn, on both sides of his face, neck and left shoulder. The air bag lifted him up to some extent and his body contacted the right sun visor and roof header above the sun visor. The sun visor was damaged and there was a visible depression to the roof header. The 3-year-old child

Figure 12. Front right header occupant contact

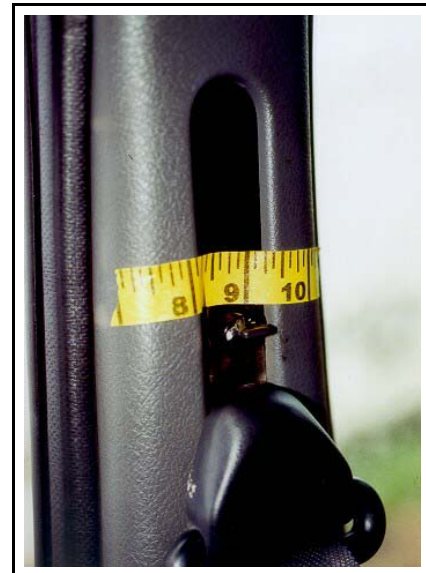
engaged the front right passenger's air bag and was thrown rearwards into the front right "B" pillar where the right side of his forehead struck the seat belt upper anchorage adjustment knob/steel shaft which was in the full down position. The knob was broken off, cracked and smeared with blood and other unknown matter. The 3-year-old child sustained an exposed depressed skull fracture (round puncture wound) with intracranial contents noted, and a laceration (7.0 cm/2.8 in by 7.0 cm/2.8 in) on his right forehead above his right eye from contacting the anchorage adjustment knob. There was an abrasion to right shoulder/upper arm 8.0 cm by 3.0 cm (3.1 in by 1.2 in). The emergency room medical records noted an apparent bony drop-off between the C5-C6 posterior neck, and the medical examiner's report indicated a possible cervical neck fracture. No x-rays were performed at the hospital and the medical examiner only conducted an external examination of the body. The driver indicated that the 3-year-old child came to rest on the rear left floor area behind the driver. The driver removed him from the vehicle and they were both transported to a local hospital by a passing vehicle. The driver indicated that the 3-year-old child was not breathing and unconscious. He was seen in the emergency room at 2008 hours with no pulse and not breathing. He was pronounced dead in the emergency room at 2035 hours of the same day.

Figure 13. Front right seat belt anchorage adjustment

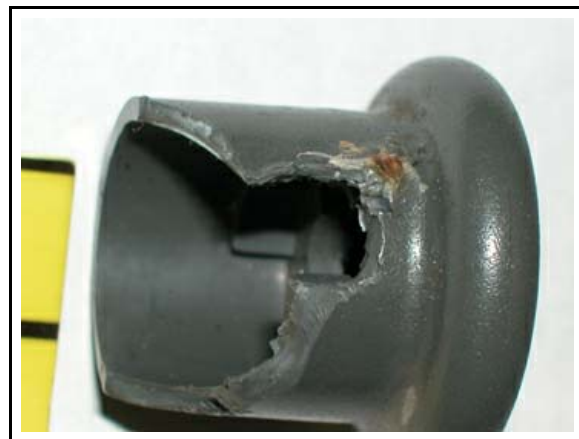
Figure 14. Front right seat belt anchorage adjustment knob
