ON-SITE ADVANCED OCCUPANT PROTECTION SYSTEM INVESTIGATION

CASE NUMBER - IN-02-008
LOCATION - TEXAS
VEHICLE - 2003 TOYOTA COROLLA CE
CRASH DATE - September 2002

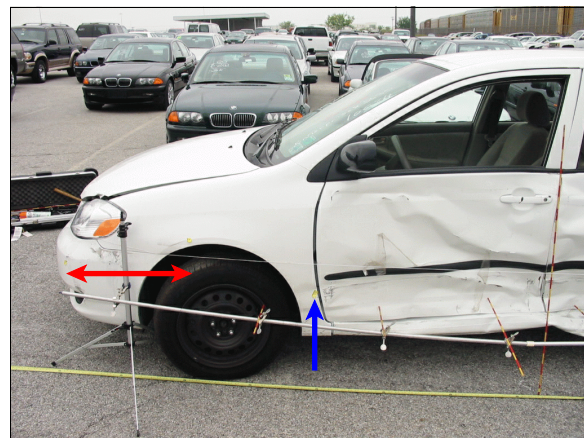
Figure 4: Forward portion of case vehicle's left side impact with contour gauge present; Note: single arrow indicates forward-most location of direct damage and double arrow shows side slap impact to front portion of left fender (case photo #17)

fender (**Figure 4** above) side slapped the Chevrolet, most likely in its left front fender. The force from the initial impact caused the case vehicle to move in an east-northeasterly direction into a raised, paved median while continuing to rotate counterclockwise (**Figure 6**). The case vehicle came to rest on the median heading southeastward, straddling the east and westbound roadways (**Figure 7**).

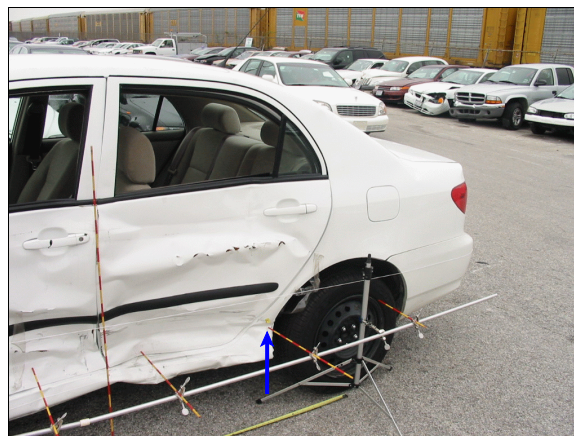
Figure 5: Rearward portion of case vehicle's left side impact with contour gauge present; Note: arrow indicates rear-most portion of direct damage (case photo #18)

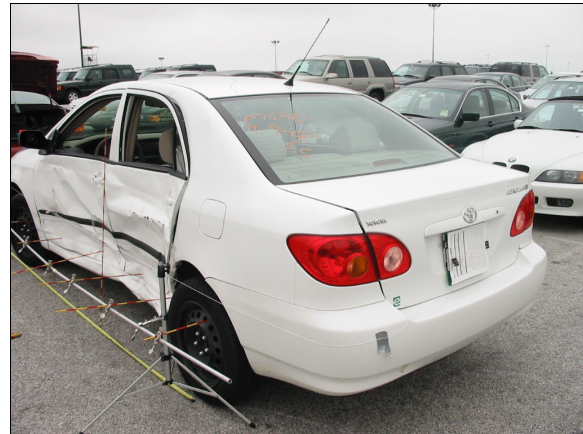
Exterior Damage: The case vehicle’s initial contact with the Chevrolet involved the left front and rear doors (**Figure 8**). Direct damage began 41 centimeters (16.1 inches) forward of the left rear axle (**Figure 9** and **Figure 5** above) and extended toward the front a measured distance of 175 centimeters (68.9 inches) along the door panels (**Figure 10** and **Figure 4** above). The Field L began 16 centimeters (6.3 inches) rearward of the left rear axle and extended toward the front a measured distance of 251 centimeters (98.8 inches). Maximum crush was measured as 23 centimeters (9.1 inches) at C₃. The case vehicle’s side slap impact with the Chevrolet involved the front portion of the left fender. Direct and induced damage began 10 centimeters (3.9 inches) forward of the left front axle (**Figure 4** above) and extended toward the front left headlight assembly a measured distance of 60 centimeters (23.6 inches). Crush along the entire area was only superficial and unmeasurable. The wheelbase on the case vehicle’s left side was unaltered while the right side was extended at most 1 centimeter (0.4 inches). The case vehicle’s left side doors and “B”-pillar were directly damaged and crushed inward toward the center of

Figure 8: Case vehicle’s left side impact viewed from left of back with contour gauge present (case photo #22a)

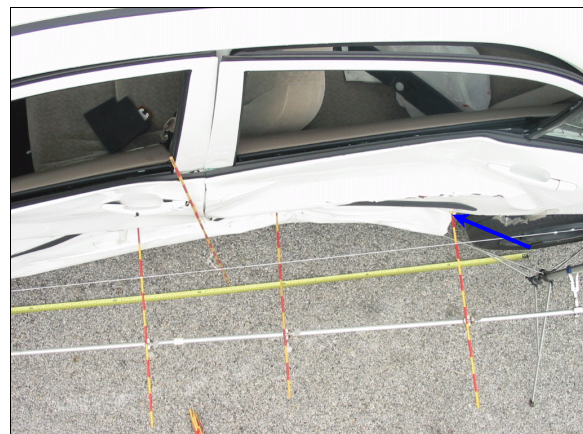
Figure 9: Overhead view of rearmost damage to case vehicle’s left sill area from impact by Chevrolet pickup; Note: arrow indicates rearmost location of direct damage (case photo #21)

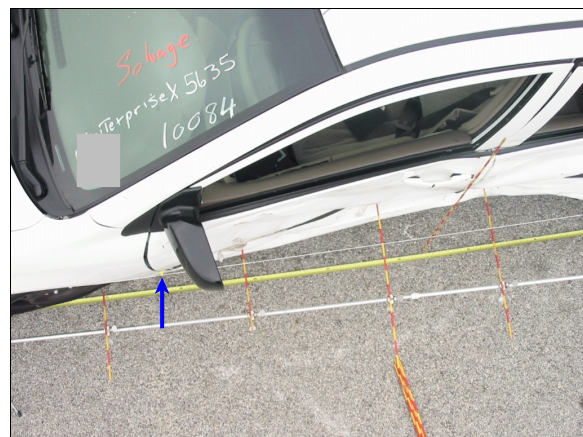
Figure 10: Overhead view of forward-most damage to case vehicle’s left sill area from impact by Chevrolet pickup; Note: arrow indicates forward-most location of direct damage (case photo #20)

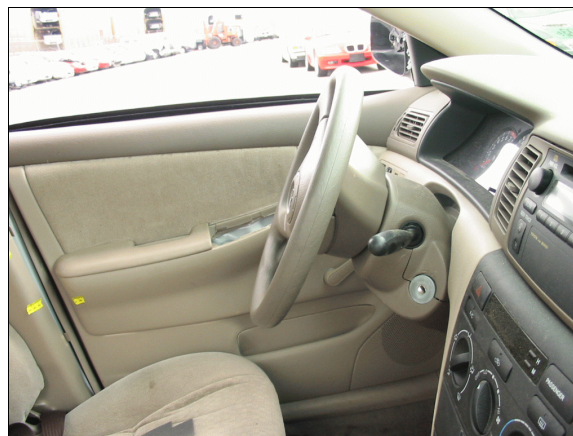
Interior Damage: Inspection of the case vehicle's interior revealed a minor scuff on the left front door's arm rest and left "B"-pillar of the case vehicle (Figures 11 and 12). There was no apparent evidence of occupant contact to the case vehicle's steering wheel, instrument panel, or greenhouse areas. Lateral intrusion was present along the case vehicle's left side, involving both doors, both door sills, the left "B"-pillar, the driver's seat back, and the back left seat cushion. The largest intrusion occurred to the left rear door and was measured as 14 centimeters (5.5 inches). The greatest intrusion near the case vehicle's occupant occurred to the left "B"-pillar and measured 8 centimeters (3.1 inches). Finally, there was no evidence of compression of the energy absorbing shear capsules in the base of the steering column and no deformation to the steering wheel rim (Figure 11).

Figure 11: Occupant contact evidence on interior surface of case vehicle's driver door and left "B"-pillar; Note: no movement to steering wheel rim or deployment of driver's air bag (case photo #35)

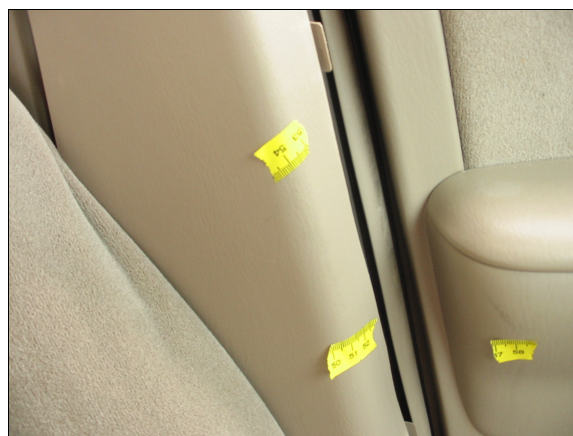
Figure 12: Close-up of occupant contact evidence on interior surface of case vehicle's driver door and left "B"-pillar (case photo #37)

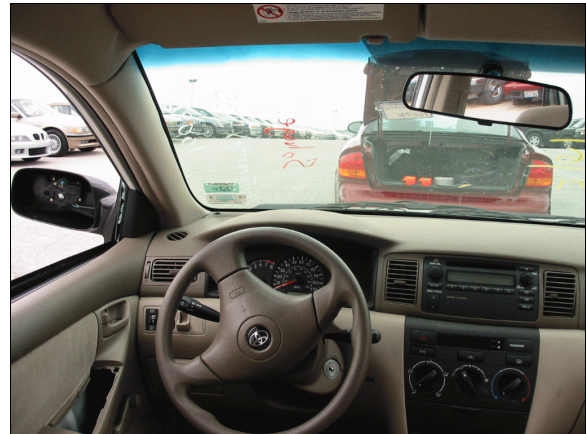
Report noted that at least the driver's air bag deployed, but our inspection revealed that this was not the case (Figure 13). The front right passenger air bag was located in the top of the instrument panel (Figure 14).

Figure 13: Case vehicle's driver seating area showing non-deployment of driver's air bag and no apparent occupant contact evidence on steering wheel, instrument panel, or greenhouse areas (case photo #39)

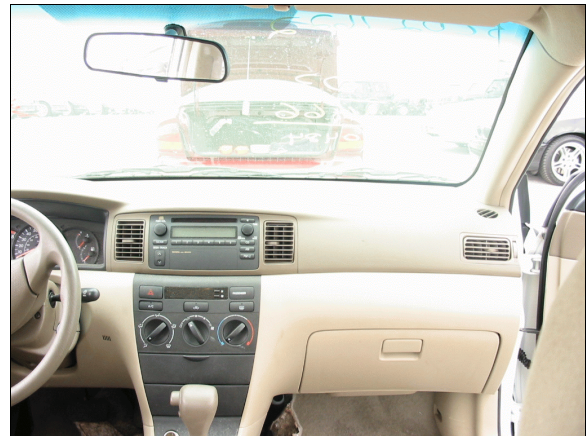
Figure 14: Case vehicle's non-deployed front right passenger air bag and no apparent occupant contact evidence on center and right instrument panel or front right greenhouse areas (case photo #41)
