On Site Child Safety Seat Investigation / Vehicle to Vehicle  
Dynamic Science, Inc. / Case Number: DS02008  
2002 Volvo V70 AWD Cross Country station wagon  
Washington  
May, 2002

1. Report No. <b>DS02008</b>		2. Government Accession No.		3. Recipient Catalog No.	
4. Title and Subtitle <b>On Site Child Safety Seat Investigation</b>				5. Report Date <b>September 3, 2003</b>

**Dynamic Science, Inc.**  
**Accident Investigation**  
**Case Number: DS02008**

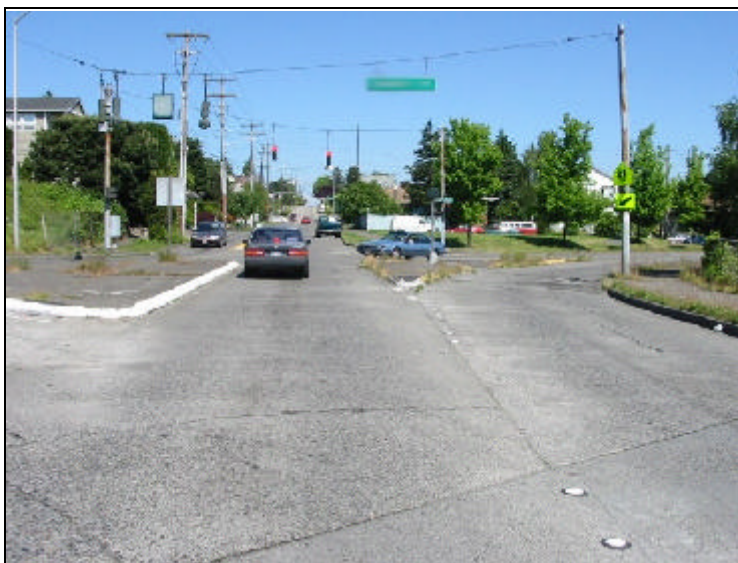
**Figure 1.** Approach to area of impact – east (case vehicle)

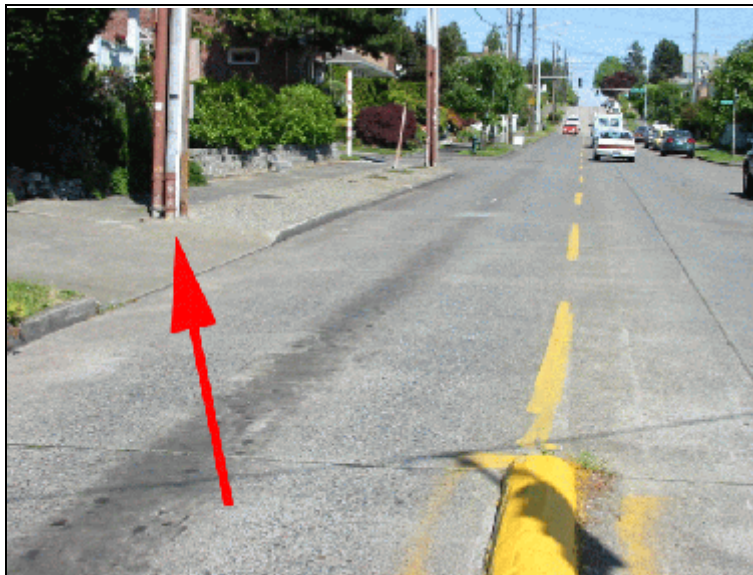
**Figure 2.** Case vehicle approach to overturn and impact with power pole—east

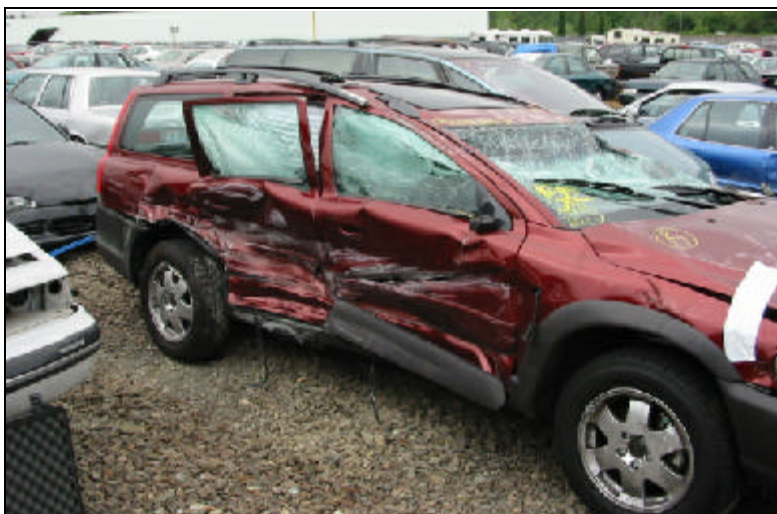
**Figure 3.** Right side, case vehicle

The front of the other vehicle struck the right side of the case vehicle (01RZEW2). The total velocity change calculated by the missing vehicle algorithm of WinSmash was 14.0 km/h (8.7 mph). The longitudinal and lateral components were -10.7 km/h (-6.7 mph) and -9.0 km/h (-5.6 mph)<sup>1</sup>, respectively. The case vehicle began a clockwise rotation. The front left tire engaged a yellow colored raised curb in the eastern leg of the intersection. This tripped the vehicle and it began a roll onto its left side. The vehicle continued rolling over and went onto its roof (00TDDO2). While overturning, the vehicle was also rotating in a clockwise direction. The vehicle continued northeast until the left side (while upside down) contacted a wooden power pole (00LFEE3). This impact redirected the vehicle into a counterclockwise rotation and came to rest on its roof facing south. The other vehicle rotated clockwise after impact and came to rest in the intersection.

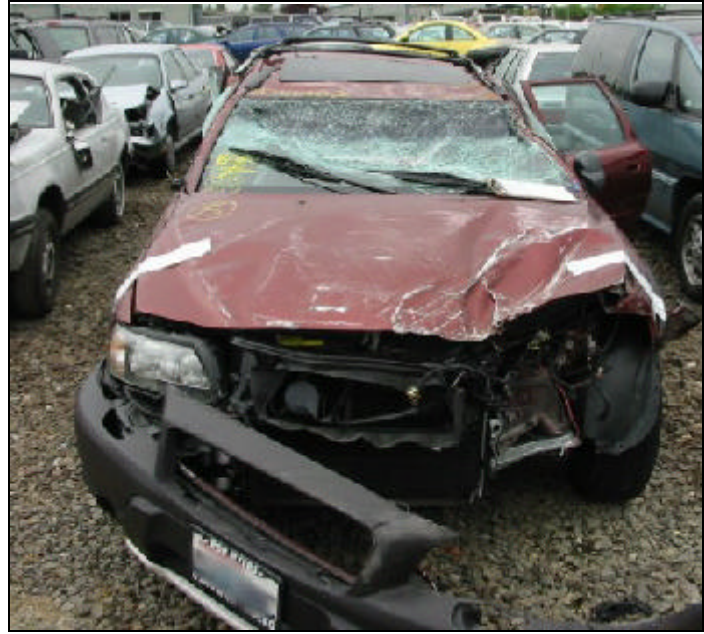
**Figure 4.** Front of case vehicle

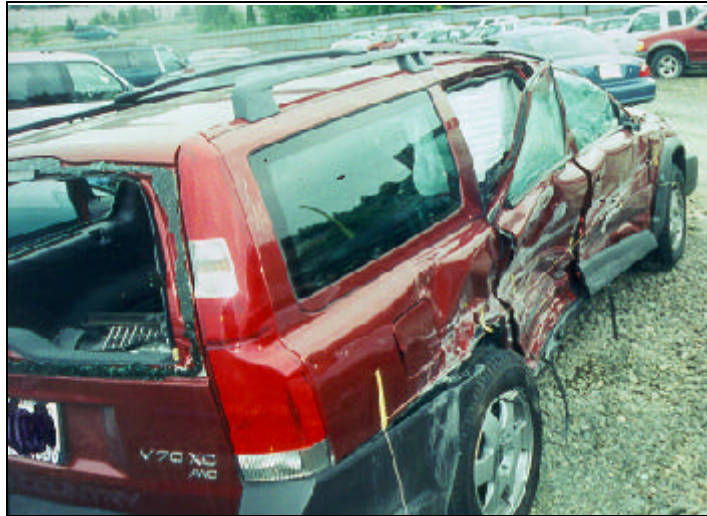
During the first impact, the case vehicle sustained 288 cm (113.4 in) of direct to the right side. The maximum crush was located at C3 and measured 16 cm (6.3 in). The principle direction of force was within the 1 o'clock sector and was an estimated 40 degrees. The impact caused both right side doors to be jammed. The right rear side glass was fractured but remained in place<sup>2</sup>. The window frame was bent outward, but this was at least partially as a result of extrication efforts. There was a 2 cm (0.8 in) shortening of the wheelbase on the right side.

**Figure 6.** Right side, case vehicle

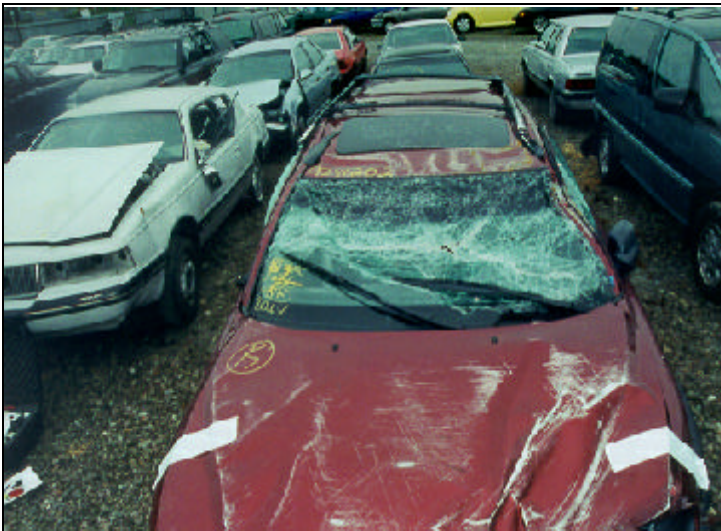
During the subsequent rollover, the case vehicle sustained direct contact damage to the roof, windshield, and hood. The fixed left rear side glass and the backlight disintegrated during the rollover.

**Figure 7.** Top, case vehicle

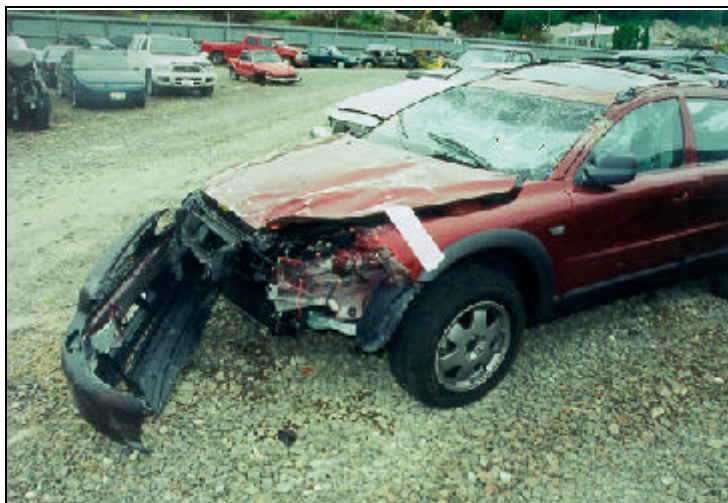
After the rollover, the case vehicle began rotating clockwise. The roof and hood remained in contact with the ground. The rotation brought the front left fender into contact with a wooden power pole.

**Figure 8.** Left side, case vehicle

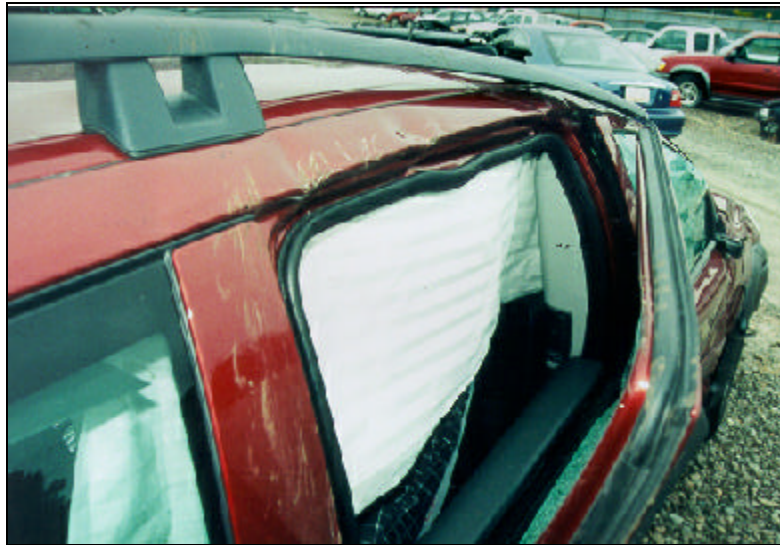
**Figure 9.** Outside view of side curtain

Both the front right passenger side air bag and right side curtain deployed during the initial impact with the other vehicle in this case. The curtain likely remained inflated throughout the rollover event. There were no visible occupant contacts to the curtain. The pretensioner for the front right side fired and locked the unlatched lap and shoulder into place. The pretensioner on the driver's side did not fire.

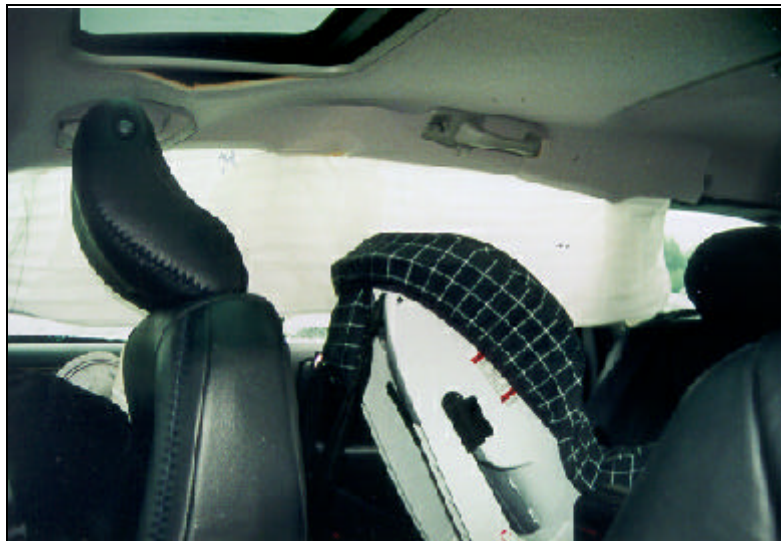
**Figure 10.** Inside view of side curtain

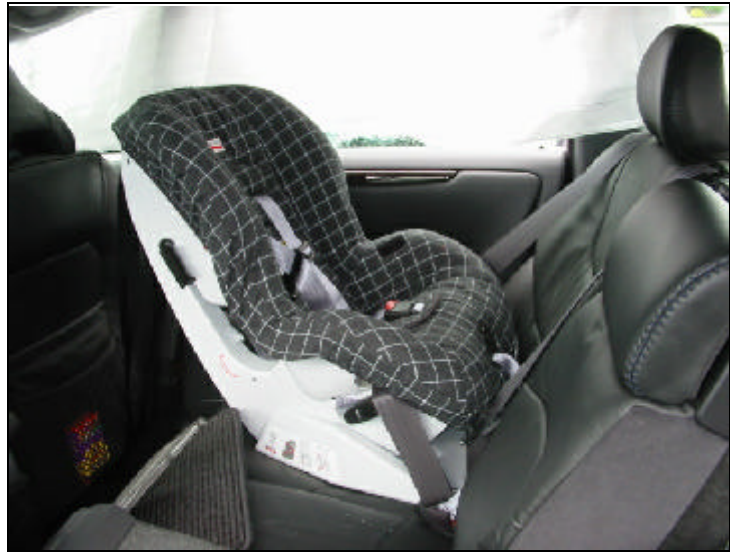
At the time of the vehicle inspection, the child seat was found to be securely fastened to the vehicle. There was less than one inch of movement to either the front/rear or, side-to-side.

**Figure 11.** Britax Roundabout convertible child safety seat

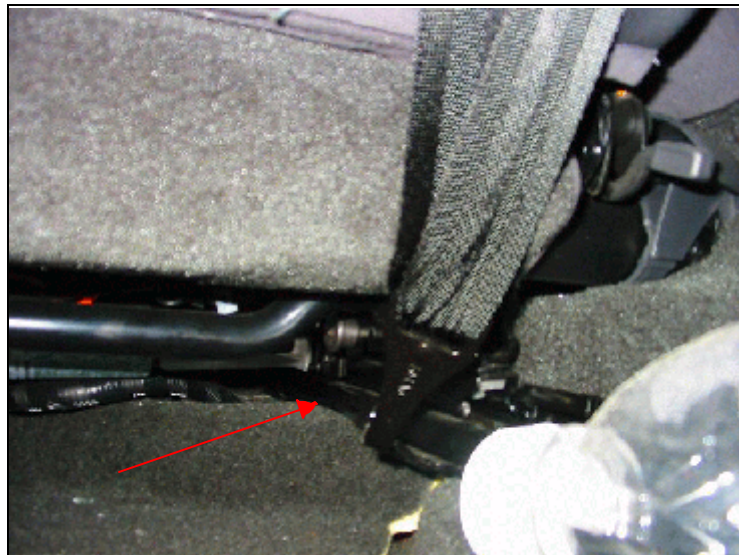
The second occupant in the case vehicle was seated in the right rear seat in a Britax Roundabout convertible child safety seat. The seat had been placed in the rear-facing position. The seat is designed to be rear-facing for infants up to 13.6 kg (30 lbs). The seat had been anchored to the vehicle using the available lap and shoulder belt<sup>4</sup>. The seat had been secured to the seat belt using the CSS built-in lock-off clamps. The seat had also been secured to the vehicle using the Britax Versa-Tether as recommended by the manufacturer for rear facing seats. The tether extended from the top of the child seat back forward to the tether attachment anchorage present beneath the right front seat. The tether attachment is original equipment for this vehicle.

**Figure 12.** Tether attachment anchorage

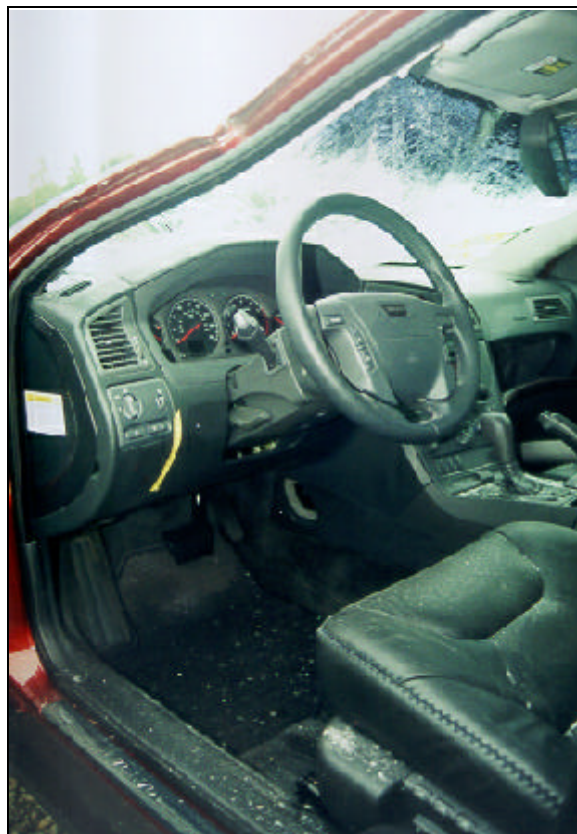
The 33-year-old driver (193 cm/76 in, 122 kg/270 lbs) of the case vehicle was initially seated in a normal, upright fashion. He was wearing prescription glasses. He was using the available lap and shoulder belt. He was seated in a leather covered bucket seat that had been adjusted to the rear-most track position. His left hand was on the steering wheel, his right hand was reaching to the right rear seat position trying to calm the child in that seat position. His left foot was on the floor, his right on the accelerator. At impact, he pitched to the right and forward. As the vehicle rotated clockwise he continued that right side movement until being constrained by the seat belts. As the vehicle tripped and went over onto its left side, the driver engaged the door/B pillar with his left shoulder—causing an abrasion. As the vehicle continued to roll, both of the driver’s knees engaged the lower instrument—causing bilateral abrasions. As the vehicle struck the wooden pole with its left side, the driver would have moved to his left. This occurred while the vehicle was upside down.

**Figure 13.** Driver's seated position

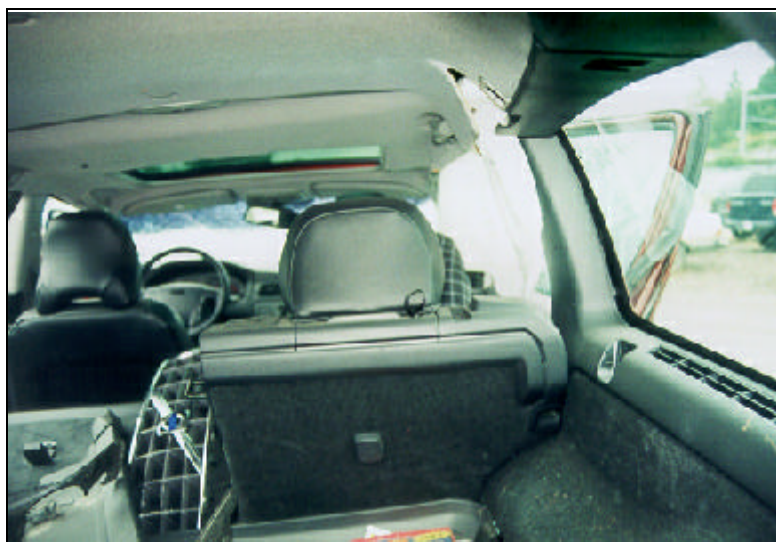
**Figure 14.** Rear right passenger seated position

occupant moved to his left then back again as the roll continued. As the vehicle struck the wooden pole with its left side, this occupant would have moved to his left. It appears that the child was securely fastened and these movements would have had minimal effect on this occupant's torso, but would have resulted in violent movements of his head. He did not, however, impact any objects with sufficient force to cause any injuries.
