**VERIDIAN ON-SITE AMBULANCE CRASH INVESTIGATION
SCI TECHNICAL SUMMARY REPORT**

VERIDIAN CASE NO. CA02-009

VEHICLE - 2000 FORD E-350 TYPE III AMBULANCE

CRASH DATE - MARCH 2002

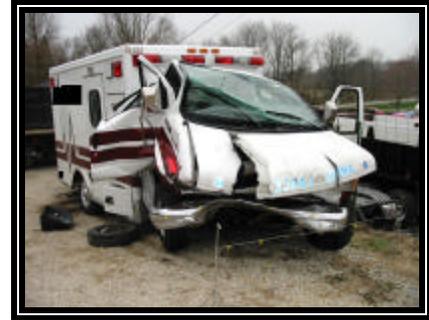
This on-site investigation focused on the crashworthiness issues and occupant protection systems of a chassis cab/box body Type III ambulance unit (**Figure 1**). The vehicle was a 2000 Ford E-350 that was equipped with an ambulance body. The ambulance was being operated by a crew of two and was transferring a patient in a non-emergency mode to a regional hospital. The driver was an unrestrained 22-year-old male state-certified Emergency Medical Technician (EMT), and the patient care provider (PCP) was a 37-year-old male state-certified Paramedic. The PCP was unrestrained on the center position of the side bench seat in the patient compartment. The 34-year-old male patient was restrained in a supine position on the ambulance cot with his head slightly elevated, and the patient's 41-year-old brother, was restrained on the rear-facing attendant's seat. The ambulance was involved in an offset head-on collision with a 1995 Mitsubishi Eclipse driven by a 17-year-old male. The severe impact resulted in the deployment of the frontal air bags in both vehicles. The Eclipse was redirected rearward and came to rest 31.8 m (104.3') rear of the point of impact on the roadside. The ambulance overturned onto its left side, slid in a forward direction, and came to rest on the roadway. The ambulance driver sustained a forehead contusion and a right leg contusion. He exited the ambulance through the right front door window opening. The PCP loaded the front right interior shelves and sustained a loss of consciousness, a right parietal/occipital scalp laceration, a right maxillary sinus fracture, a right occipital scalp contusion, a nasal fracture, a laceration of the right cheek/nose, and a right thigh contusion. He also sustained a left occipital intraparenchymal hemorrhage, a left occipital brain contusion a result of the shelf contact. He rebounded into the opposite side interior cabinetry which resulted in a left forearm abrasion and a left hand laceration. The patient's brother sustained minor internal injuries from the lap belt and assisted the patient out of the rear of the ambulance. The patient and his brother left the scene with family members who were following the ambulance in a non-contact vehicle. They were transported to a regional hospital. The driver of the ambulance and PCP were transported by ambulance to a regional hospital. The driver was treated and released and the PCP was admitted two days for treatment. The 17-year-old male driver of the Mitsubishi sustained critical injuries and expired 10 hours following the crash.

Figure 1. Damaged Type III ambulance

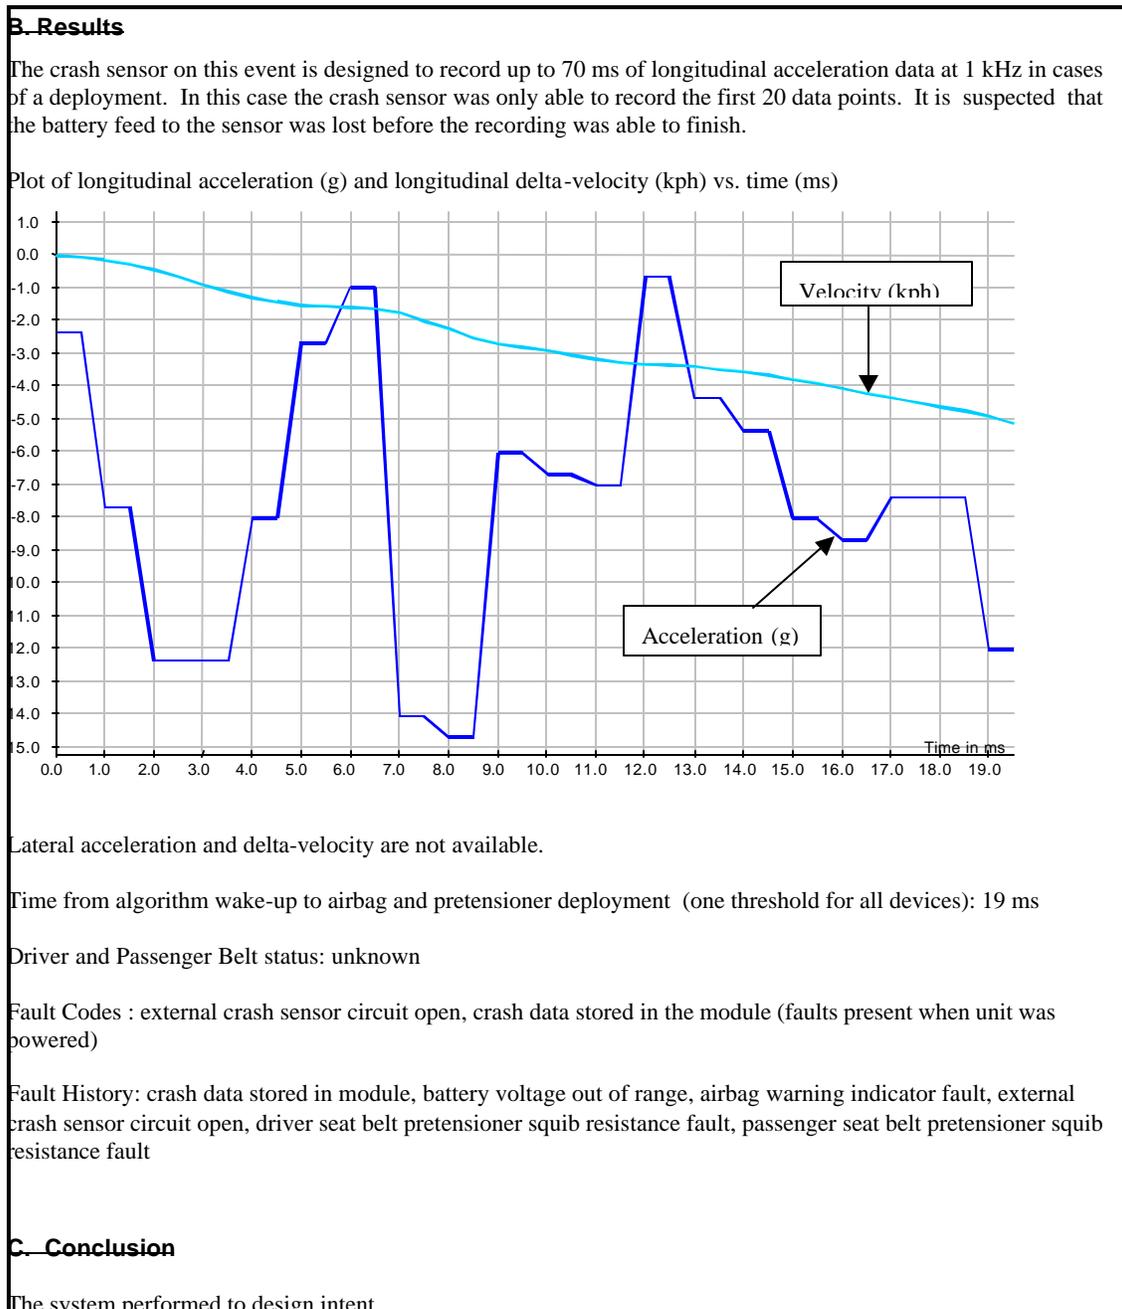
mph) and 108.3 km/h (67.3 mph), respectively. The Ford E-350 ambulance was equipped with an Event Data Recorder. The EDR module was removed from the vehicle during the vehicle inspection and forwarded through NHTSA to Ford/Siemens to be downloaded. The Field Event Analysis Report received from Ford/Siemens stated that in this crash, the EDR was only able to record the first 20 milliseconds. It was suspected that the battery feed to the EDR was lost before the recording was complete. Therefore, lateral acceleration and delta-V were not available. The Field Event Analysis Report results are summarized as follows in **Figure 4** :

Figure 4. Results of the EDR download for the Ford E-350 ambulance

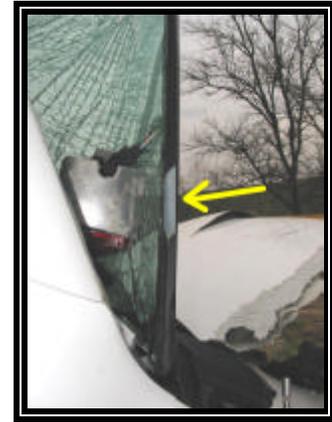
Figure 5. Close-up view of silicone caulk bead on the right aspect of the windshield

The windshield was configured with a rubber gasket that surrounded 100 percent of the laminate which was bonded to the opening. During the vehicle inspection, it was noted that minimal bonding agent existed on the gasket or the vehicle. Beads of silicone caulk that measured approximately 5 - 8 cm (2 - 3") in length were found on the rubber gasket and windshield frame on the lower right A-pillar (**Figure 5**), both upper A-pillars, and at the juncture of the right windshield header and left A-pillar. It appeared that the OEM windshield had been replaced prior to the receipt of the ambulance from the supplier. There was concern that the methods used to install the windshield may have contributed to significant bond separation that violated the integrity of the windshield.

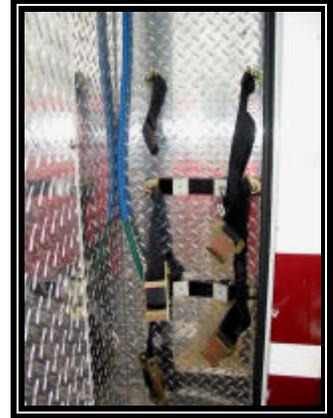
The forward exterior compartment on the left aspect (**Figure 6**) housed an H-size oxygen cylinder that measured 110.5 cm (43.5") in height and 17.8 cm (7.0") in diameter. The H-cylinder was secured on top of a 3.8 cm (1.5") hat channel that was welded to the bottom of the compartment. Two sets of heavy-duty straps that measured 5.1 cm (2") in width with ratchet adjustments were attached to 27.9 cm (11.0") wide brackets to secure the tank upright in the cabinet. The brackets were located 27.9 cm (11.0") and 52.1 cm (20.5") above the bottom of the cabinet, respectively. A third set of straps was located 73.7 cm (29.0") above the bottom of the cabinet and was configured with a locking latch plate and spring-release buckle. Creases were present on the heavy-duty straps from the ratchet-style clasp, but there was no evidence of loading on the straps.

Figure 6. Forward compartment for oxygen cylinder

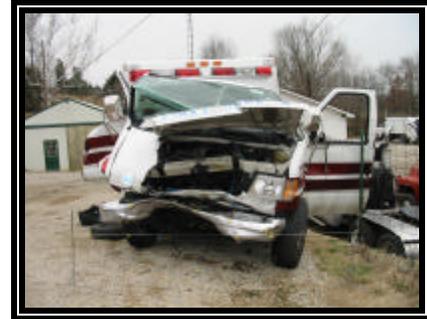
The 2000 Ford E-350 ambulance sustained severe frontal damage as a result of the impact with the Mitsubishi Eclipse (**Figure 11**). The direct damage on the bumper began 8.9 cm (3.5") inboard of the front left corner and extended laterally 160.0 cm (63.0") to the front right corner. The combined direct and induced damage measured 148.6 cm (58.5") from bumper corner to bumper corner. The right side of the bumper separated from the right frame rail which resulted in understatement of the bumper crush. The front right bumper corner was located 18.0 cm (7.1") forward of the leading edge of the frame. The maximum crush on the bumper was located at C6 at the front right corner and measured 85.7 cm (33.8"). Crush measurements were also documented along the lower radiator support. The maximum crush along the lower radiator support was located at C5 and measured 78.1 cm (30.8"). Six crush measurements were taken along the front bumper and were as follows: C1 = 0.0 cm, C2 = 23.2 cm (9.1"), C3 = 53.3 cm (21.0"), C4 = 75.9 cm (29.9"), C5 = 83.2 cm (32.8"), C6 = 85.7 cm (33.8"). The right wheelbase was shortened by 78.1 cm (30.8"). The right front tire was deflated and restricted due to its rearward displacement. The right front wheel exhibited a dent to the outer bead that measured 17.8 x 3.8 cm (7.0 x 1.5").

Figure 11. View of frontal damage to the ambulance

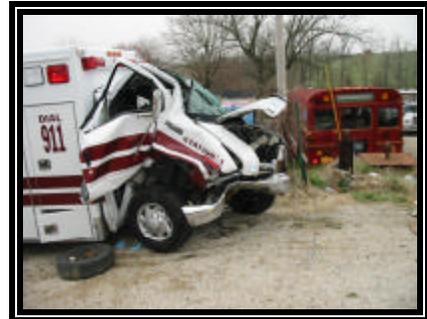
Figure 12. Lateral view of frontal damage

The fiberglass hood sustained a complete longitudinal fracture to the right of the centerline and a second longitudinal fracture to the left of the centerline. The right front fender and right front door were crushed and displaced rearward (**Figure 12**). The right front door was also severely deformed and bowed 61.0 cm (24") outward due to rearward displacement. The right sill was deformed rearward and upward. The frame rails and cab of the Ford E-350 was shifted to the right. The forward aspect of the left frame rail was displaced 29.8 cm (11.8") laterally to the right. The forward aspect of the right frame rail was displaced 70.5 cm (27.8") to the right. The lateral shift of the cab resulted in stress overload on the bolts that secured the left rear outboard aspect of the cab to the patient compartment. The stress resulted in a 7.6 cm (3.0") separation of the left rear aspect of the cab from the patient compartment. The Collision Deformation Classification for the impact with the Mitsubishi Eclipse was 12-FDEW-6. The incremented CDC adjusted for the end shift to the right was 72-FDEW-6.

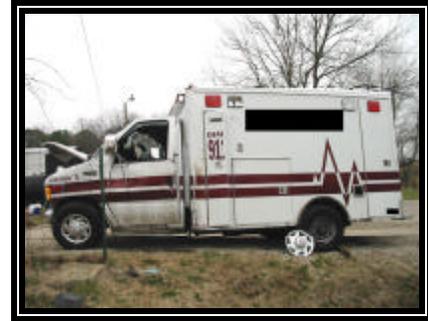
The Ford E-350 ambulance also sustained moderate damage as a result of the rollover onto the left side after the initial impact. The left side rollover damage began 139.7 cm (55.0") rearward of the left rear axle and extended 342.9 cm (135.0") on the body of the ambulance (**Figure 13**). The vertical height of the rollover damage was 214.6 cm (84.5"). The left outside mirror was folded into the door window frame and sustained abrasions on the outboard aspect. The rear edge of the left front door was abraded adjacent to the latch and at the beltline. There was no abrasion damage to the left B-pillar and no damage forward of the left A-pillar. Heavy longitudinal abrasions were noted on the left front corner of the patient compartment and were more pronounced at the top corner and bottom aspect. Vertical corner separation that measured 2.5 cm (1.0") wide between the front and left side panels of the patient compartment occurred 88.9 cm (35.0") below the top aspect. The forward aspect also overlapped the left side aspect at the corner which began at the bottom aspect and extended 90.8 cm (35.8") vertically. Both top front corners of the patient compartment sustained fractures. The top left side rails of the patient compartment were heavily abraded. The left rear wheel sustained a 22.9 cm (9.0") long minor bending of the bead area that measured 1.3 cm (0.5") in maximum depth. The wheel cover was separated and sustained abrasions on the center aspect. The left rear tire was also abraded from the rollover. The CDC for the rollover event was 00-LDAO-1

Figure 13. View of left side rollover damage

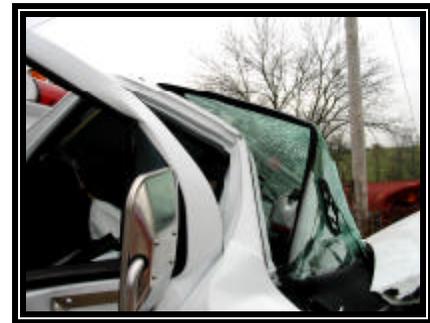
The 2000 Ford E-350 ambulance cab sustained severe interior damage as a result of the frontal impact with the Mitsubishi Eclipse. Interior damage to the cab area of the ambulance was attributed to occupant contact and compartment intrusion. The minimal bonding agent (silicone caulk) on the windshield gasket combined with the induced damage as a result of the frontal impact resulted in significant bond separation of the windshield (**Figure 14**). The windshield separation was 100 percent at the right A-pillar, approximately 33 percent on the right side of the windshield header, 100 percent at the left A-pillar, and approximately 30 cm (12") at the bottom left aspect, inboard of the left A-pillar. The significant bond separation provided an avenue for possible occupant ejection. The maximum separation between the windshield frame and the windshield laminate measured approximately 15 cm (6") at the center aspect of the right A-pillar. The entire windshield laminate was stress-cracked. Both the left front and right front glazing were closed prior to impact and disintegrated from impact forces.

Figure 14. Right side view of windshield bond separation

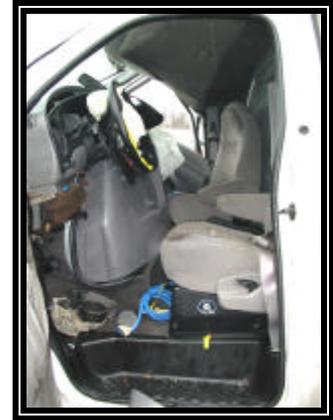
Figure 15. View of cab interior

Multiple intrusions in the cab of the Ford E-350 ambulance were noted as a result of the frontal impact (**Figure 15**). The engine shroud/cover was displaced rearward and laterally to the left into the front left position and the front left floor pan was crushed laterally. In the front right occupant space, the entire top and right side aspect of the engine cover/shroud was separated from the body due to deformation. Intrusions are summarized as follows:

Position	Component	Intrusion	Direction
11	Engine shroud/cover	8.9 cm (3.5")	Lateral
11	Left floor pan	3.8 cm (1.5")	Lateral
13	Roof	24.1 cm (9.5")	Vertical
13	Right A-pillar	19.1 cm (7.5")	Longitudinal
13	Right mid-instrument panel (center aspect)	15.9 cm (6.3")	Longitudinal
13	Right mid-instrument panel (right aspect)	18.4 cm (7.5")	Longitudinal
13	Right lower instrument panel	21.6 cm (8.5")	Longitudinal
13	Engine shroud/cover	3.8 cm (1.5")	Longitudinal
13	Right toe pan	38.1 cm (15.0")	Longitudinal

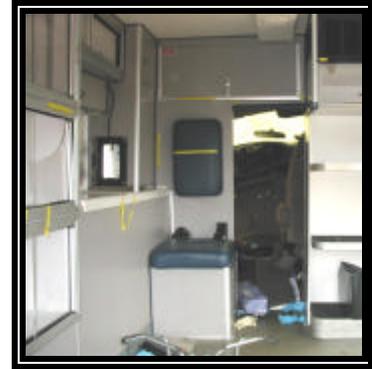
Interior damage to the patient compartment was moderate and attributed to occupant contact. The pass-through door between the patient compartment and cab was fully opened and positioned behind the driver's seat. The inboard roller was off of the door track. The wall panel forward of the rear-facing attendant's seat was constructed of 1.9 cm (0.8") thick Luan plywood with two layers of laminate. The panel was fractured on the inboard side of the attendant's seat 73.7 cm (29.0") above the floor due to occupant loading. The vinyl seat back cushion of the attendant's seat was deformed from the forward loading of the seated occupant (**Figure 16**). The middle aspect of the panel behind the seat back was displaced forward 1.7 cm (0.7") on the outboard side of the attendant's seat from occupant loading. The top left corner of the front pass-through door frame sustained a fracture that measured approximately 3.0 cm (1.2") in length. A second fracture was located 7.0 cm (2.8") above the top right corner of the pass-through door opening.

Figure 16. View of interior damage to the front left area of the patient compartment

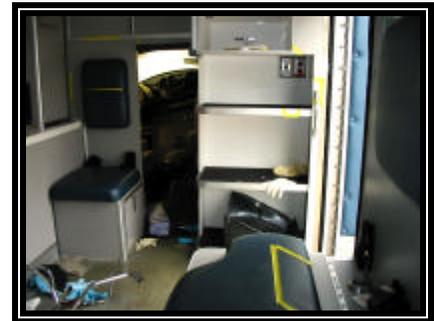
The right side forward panel adjacent to the forward edge of the right side door was fractured as a result of a head strike by the PCP (**Figure 17**). Hair and tissue were embedded in the fractured laminate from the occupant. The fracture was located 99.7 cm (39.3") above the floor, inboard and slightly above the front right assist handle and measured 5.1 cm (2.0") vertically. Additional contact from the head strike was located on the 3.8 cm (1.5") wide aluminum face of the top open shelf below and inboard of the panel fracture. A tissue transfer measured 4.4 cm (1.8") in width and 0.6 cm (0.3") in height and was located 7.6 cm (3.0") inboard of the right side wall. A heavy front-to-rear abrasion/scuff and a slight fracture were noted on the inboard edge of the action area on the left wall rear of the attendant's seat from probable contact with the occupant's arm. The abrasion measured 5.1 cm (2.0") in height on the plastic and a total height of 12.7 cm (5.0"). It was located 79.4 cm (31.3") forward of the forward patient compartment panel, and extended 14.6 cm (5.8") longitudinally.

Figure 17. Front right area of the patient compartment showing contacts and damage

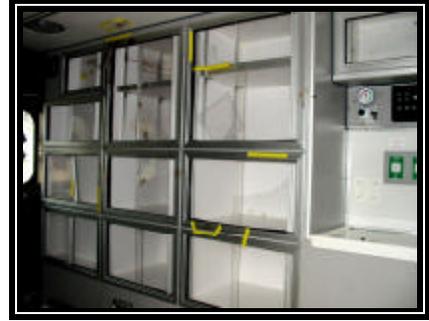
Front-to-rear body fluid spatter was present on the left side cabinetry. Many of the plexiglass sliding cabinet doors were fractured from the occupants walking on them to exit the overturned ambulance (**Figure 18**). A large amount of body fluid (blood) and some hair was present on the outer aspect of the top middle cabinet where the PCP came to rest. The fracture in the plexiglass door allowed the body fluid to collect inside the cabinet. The lower rear cabinet was closed during the vehicle inspection, however, a large amount of hair was present inside the cabinet. A dent was present on the aluminum trim cover on the left rear corner of the patient compartment. It was located 105.4 cm (41.5") above the floor and measured 2.5 cm (1.0") in height.

Figure 18. Damaged left side cabinetry

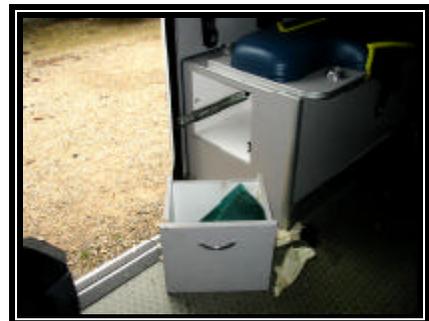
The sliding drawer under the forward aspect of the bench seat was displaced forward as a result of the crash forces (**Figure 19**). The drawer was configured with metal arms on the outboard aspects that slid inside metal rails on the interior of the drawer opening. There was no locking mechanism on the drawer. A 3.1 liter (3.3 quart) sharps container and a 3.8 liter (1 gallon) trash container used for bio-hazardous waste were contained in the drawer. The PCP stated that there was no hazardous waste in the drawer at the time of the crash, however, he could not recall the post-crash status of the sharps container.

Figure 19. View of displaced sliding drawer that housed the sharps container

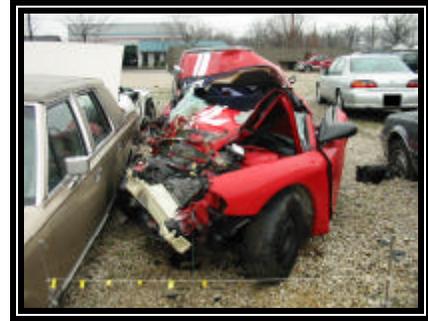
The 1995 Mitsubishi Eclipse sustained severe damage as a result of the frontal impact with the Ford E-350 ambulance (**Figure 20**). The front bumper fascia was completely separated at the time of the vehicle inspection. The direct damage on the front bumper fascia started 30.5 cm (12.0") right of center and extended laterally 45.7 cm (18.0") to the front right corner. Direct contact evidence included heavy abrasions and fractures on the fascia. The direct damage along the upper radiator support began at the front left corner and extended 129.5 cm (51.0") laterally to the front right corner. The combined direct and induced damage involved the entire frontal width of the vehicle and measured 66.7 cm (26.3") across the upper radiator support. The maximum crush was located at C6 at the front right corner and measured 171 cm (67") at the upper radiator support. The left frame rail was shifted laterally to the right. The left wheelbase was shortened 9.7 cm (3.8") and the right wheelbase was shortened 90.9 cm (35.8"). The hood was crushed and buckled rearward. The left front fender was pulled inward and the right front fender was crushed rearward (**Figure 21**). The right A-pillar sustained induced rearward displacement, and the roof was buckled. The windshield was fractured from impact forces and the windshield and roof were removed by rescue personnel to facilitate the removal of the driver. The CDC for the impact with the Ford E-350 ambulance was 12-FDEW-8. Due to the crush variance between the bumper beam and the upper radiator support, six crush measurements were averaged between the front bumper beam and the upper radiator support and were as follows: C1 = 53.3 cm (21.0"), C2 = 105.7 cm (41.6"), C3 = 118.5 cm (46.7"), C4 = 127.7 cm (50.3"), C5 = 145.9 cm (57.4"), C6 = 151.5 cm (59.6").

Figure 20. Frontal damage to the Mitsubishi Eclipse

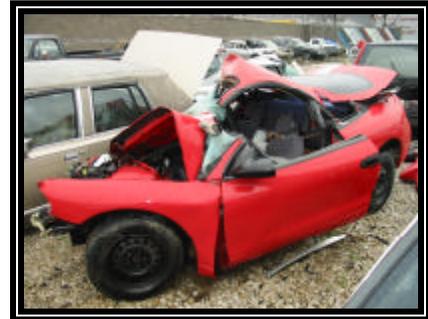
Figure 21. Left side view of the damaged Mitsubishi Eclipse

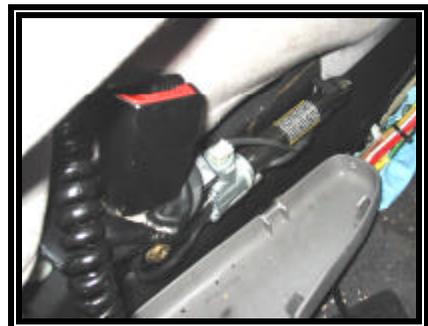
The front seat positions in the Ford E-350 ambulance were configured with manual 3-point lap and shoulder belts with sliding latch plates. Both manual restraints were configured with adjustable D-rings that were in the full-down positions and had 8.9 cm (3.5") of vertical travel. There was no loading evidence on the driver's latch plate plastic, D-ring, or restraint webbing indicative of usage. Both frontal manual restraints were also equipped with buckle pretensioners located on the inboard aspects of the seats (**Figure 22**). Both pretensioners fired as a result of the crash and had uniform piston travel. The cable and crimp nut protruded out of the forward aspects of both barrels 1.6 cm (0.6"). Based on the uniform piston travel and protrusion of the cable out of the barrel,

Figure 22. Driver's buckle pretensioner

there did not appear to be any resistance in the driver's manual restraint which also suggests lack of belt usage by the driver. The release button in the left buckle housing was flush with the top aspect of the housing. The release button in the right buckle housing was pulled into the buckle housing 1.0 cm (0.4").

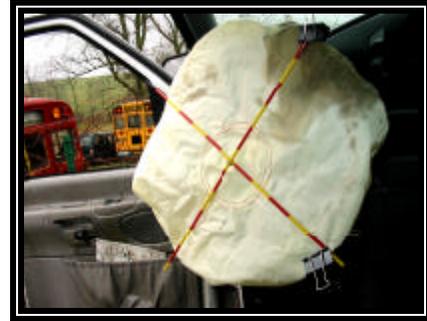
The Ford E-350 ambulance was equipped with redesigned frontal air bags for the driver and front right passenger positions that deployed as a result of the impact with the Mitsubishi Eclipse. The driver's air bag (**Figure 25**) was housed in the center of the steering wheel with a single cover flap design hinged at the top aspect. The cover flap measured 12.7 cm (5.0") in width at the top aspect and 19.1 cm (7.5") in width at the bottom aspect. The top aspect of the cover flap was contoured to the steering wheel hub and had a longitudinal depth of 5.7 cm (2.5"). The height of the cover flap measured 10.2 cm (4.0"). The driver's air bag measured 61.0 cm (24.0") in diameter in its deflated state. The air bag was tethered by two internal straps that measured 12.7 cm (5.0") wide and were located at the 3 and 6 o'clock aspects. The air bag was vented by two circular ports that measured 2.5 cm (1.0") in diameter and were located at the 11 and 1 o'clock positions and located 7.6 cm (3.0") fore of the peripheral seam. There was no evidence of occupant contact on the air bag membrane and heavy oil transfers were present at the 3 and 6 o'clock positions of the air bag membrane.

Figure 25. Redesigned driver's air bag

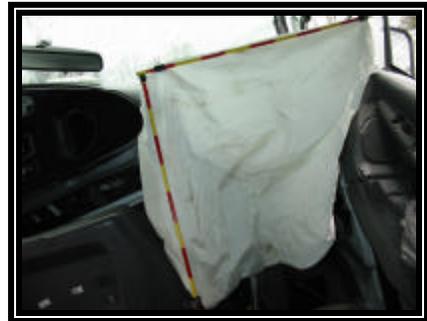
The redesigned front right passenger's air bag deployed from a mid-mount module configured with a single cover flap hinged at the top aspect (**Figure 26**). The cover flap followed the contour of the upper instrument panel and measured 37.8 cm (14.9") in width and 29.8 cm (11.8") in height. "AIRBAG" was molded into the lower right corner of the cover flap. The redesigned front right passenger's air bag measured 45.7 cm (18.0") in width and 43.2 cm (17") in height. The maximum excursion measured approximately 56 cm (22"). The air bag was vented by two 6.4 cm (2.5") diameter ports located at the 3 and 9 o'clock positions on the side panels of the air bag and centered 14.0 cm (5.5") rear of the mid panel flap position. The redesigned front right passenger's air bag was not tethered.

Figure 26. Redesigned front right passenger's air bag

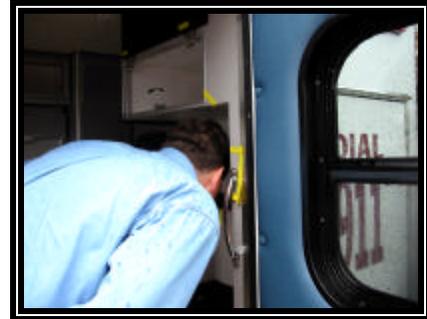
He continued forward and struck the assist handle and the edge of the Formica wall with the right aspect of his head which resulted in a fracture of the Formica and hair/tissue deposits in the fracture (**Figure 28**). He sustained a positive loss of consciousness for unknown period of time, a 20 cm (8") laceration on the right parietal/occipital scalp, and a right occipital scalp contusion as a result of the contact with the wall. He also sustained a left occipital intraparenchymal hemorrhage and a left occipital contusion (brain contusion). Based on the contact evidence and injury pattern, it appeared that they were a contre coup injury. His right facial area struck the aluminum face of the open top shelf evidenced by a tissue transfer. He sustained an anterior wall fracture of the right maxillary sinus, a nasal fracture with deviation of nasal septum, and a laceration of the right cheek/nose as a result of the contact with the shelves. His knees struck the aluminum face of the lower open shelf which resulted in bilateral knee abrasions. He rebounded to the left as the ambulance rolled onto its left side and slid to final rest. The PCP contacted the center aspect of the padded headliner evidenced by a body fluid (blood) contact with a hair pattern. He continued the lateral trajectory and impacted the left side cabinetry with his left shoulder which resulted in a left forearm abrasion and a left hand laceration. He came to rest with his head positioned at the top aspect of the left side cabinets approximately 76 cm (30") forward of the rear bulkhead (**Figure 29**).

Figure 28. Photograph depicting head/facial contacts from the PCP

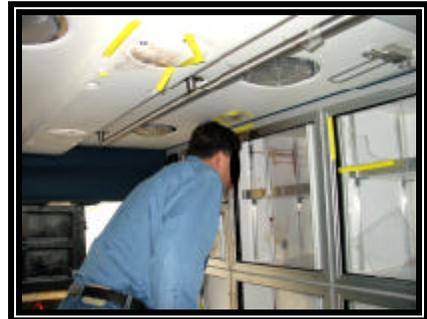
Figure 29. Photograph depicting the final rest position of the PCP's head/face

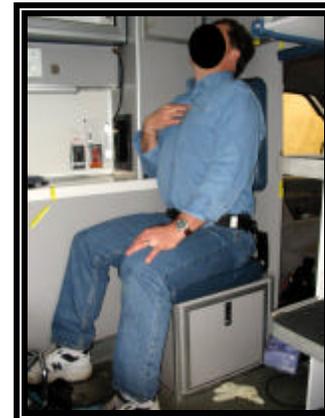
The patient’s brother was seated in the rear-facing attendant’s seat and was restrained by the 2-point lap belt with an ALR. The PCP stated that he advised the occupant to use the lap belt when the transport began. At impact, the rear-facing occupant initiated a rearward trajectory toward the front of the patient compartment and loaded the seat back and front left wall (**Figure 30**). Although there was no identifiable contact, the rear aspect of his head contacted the upper aspect of the forward wall. He sustained an abrasion and contusion on the occipital scalp from the wall contact. The loading to the wall resulted in a fracture of the wall on the left inboard aspect of the pass-through door frame and a fracture in the upper left corner of the door frame. The loading also resulted in 1.7 cm (0.7) of forward displacement at the vertical midpoint of the panel behind the vinyl seat back.

Figure 30. Photograph depicting rearward trajectory of the patient’s brother

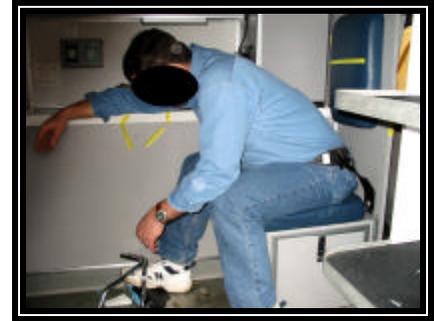
He rebounded forward and loaded the manual lap belt and sustained a kidney contusion. A heavy front-to-rear abrasion/scuff and a slight fracture were noted on the inboard edge of the action area on the left wall rear of the attendant’s seat from probable contact with the occupant’s arm as the ambulance rolled onto the left side to final rest (**Figure 31**).

Figure 31. Photograph depicting rebound trajectory of the patient’s brother
