REMOTE CHILD SAFETY SEAT REPORT

CASE NUMBER - IN-02-011

LOCATION - Louisiana

VEHICLE - 1994 Mercury Villager

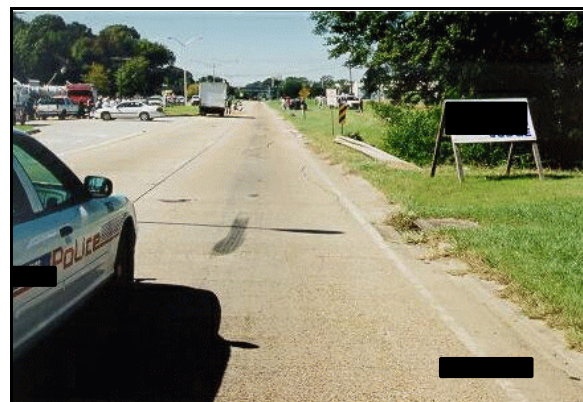
The Isuzu straight truck attempted to change lanes to the right and the right rear corner area of the Isuzu impacted the left front corner area of the Freightliner tractor (event #1) (**Figure 1**). The Freightliner's driver braked and steered right in an attempt to avoid further contact with the Isuzu and the right side of the Freightliner tractor impacted a W-beam guardrail (event #2), causing the Freightliner's driver to lose control. The Freightliner was redirected to the left and the driver braked. The tractor-trailer combination began to jackknife and yaw with the right side leading, skidded across the inside westbound lane

Figure 1: Freightliner's and Isuzu's westbound approach toward crash area, black scuff shows the approximate area of the first harmful event (case photo #01)

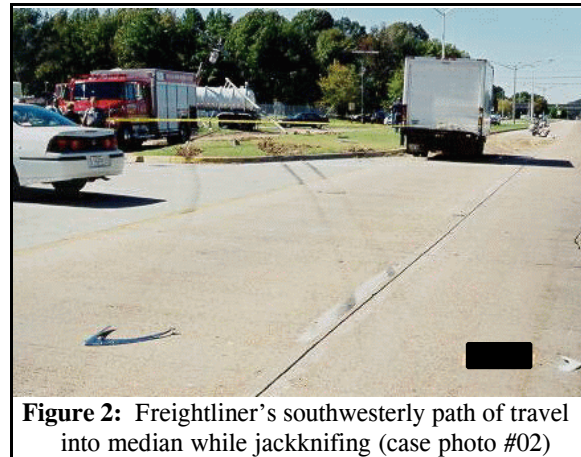
and entered the grass median (**Figure 2**). The tractor's right front wheel/tire impacted the median curb, breaking the wheel rim and the axle (event #3). The right side of the tractor impacted and folded down a U-channel sign support (event #4), and then impacted and sheared off a breakaway luminaire support (event #5). The tractor-trailer combination continued sliding across the median in a southwesterly direction, with its wheels and the tractor's undercarriage digging deep furrows in the soil, and entered the eastbound lanes (**Figure 3**). The right side of the tractor's engine compartment impacted the left front corner area of the case vehicle (event #6) in the inside westbound lane. The tractor-trailer pushed the case vehicle across the outside lane and off the south edge of the road. The tractor was rotating counterclockwise and the case vehicle separated from the tractor, coming to rest heading east (**Figure 4**). The tractor-trailer continued sliding in a southwesterly direction and the tractor sustained intraunit damage as a result of the jackknife (event #7). The right side of the semi-trailer impacted and sheared off a timber utility pole (event #8), causing the electric power lines to fall to the ground. The tractor-trailer continued a short distance further southeast where it impacted a chain link fence (event #9), penetrating the fence and coming to rest (**Figure 12**). The Camry's driver observed the events ahead and pulled onto the south shoulder in an attempt to avoid the crash. The falling electric power lines fell onto the Camry (event #10), causing minor damage. The case vehicle and the tractor-trailer rig were towed due to disabling damage. The Isuzu and the Camry were driven from the scene.

Figure 2: Freightliner's southwesterly path of travel into median while jackknifing (case photo #02)

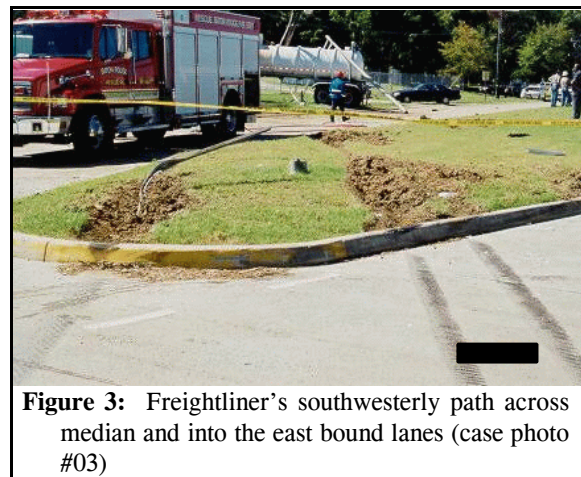
Figure 3: Freightliner's southwesterly path across median and into the east bound lanes (case photo #03)

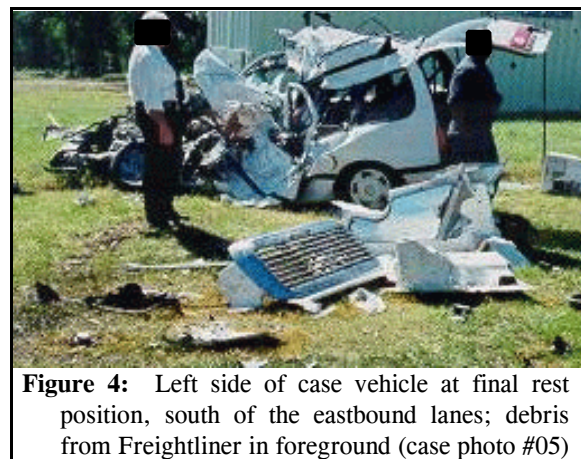
Figure 4: Left side of case vehicle at final rest position, south of the eastbound lanes; debris from Freightliner in foreground (case photo #05)

The front and left side of the case vehicle were massively crushed and catastrophically destroyed (**Figures 4 and 5**). The engine compartment penetrated under the Freightliner tractor's right side. The case vehicle's engine hood was folded and pushed through the windshield opening, both A-pillars were sheared, the windshield header was crushed rearward and the roof was buckled. The driver's door, left B-pillar and left side panels were crushed rearward and inward. All of the glazing except the backlight was shattered. The right side sustained major deformation due to induced damage (**Figure 6**). The CDC for the case vehicle, estimated from photographs, is **11-LYAW-8 (320)**. This catastrophic collision is out of scope for the WinSMASH reconstruction program.

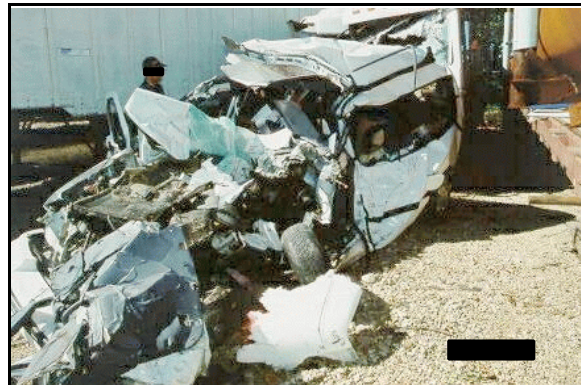
Figure 5: Front-left view of case vehicle at tow yard (case photo #12)

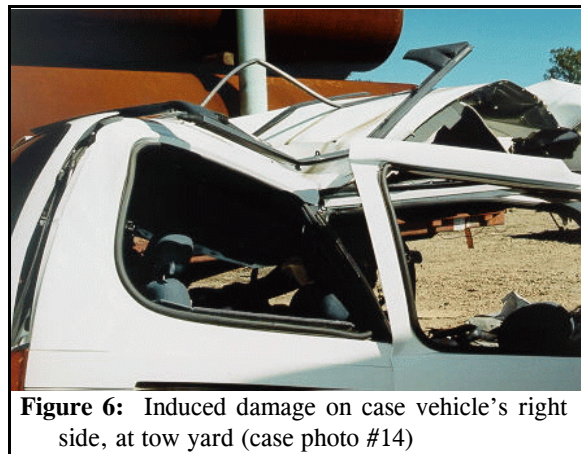
Figure 6: Induced damage on case vehicle's right side, at tow yard (case photo #14)

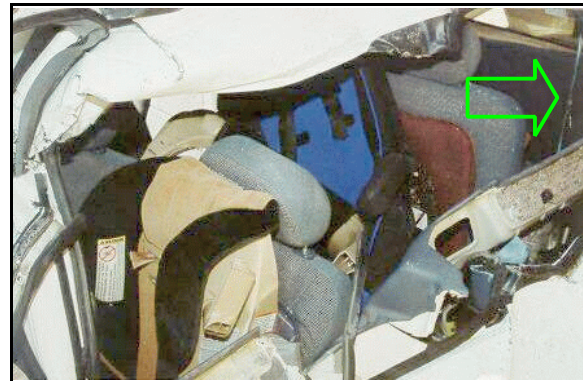
The second row left position contained a Century Products, Inc., unknown model, convertible child safety seat (CSS) with a tray shield (**Figures 7 and 8**). It was installed in the forward facing configuration and appears to have been secured with the vehicle's safety belt threaded through the CSS frame (**Figure 8**). It is not known if a tether was used with this CSS. The CSS had two sets of slots for the shoulder harness, with the harness straps threaded into the

The third row left position contained a Century Products, Inc., "Next Step" model, high-back, forward facing only, belt positioning booster seat (BSS) (Figures 7 and 8). It should be noted that the vehicle's third row left safety belt webbing and latch plate can be seen in the stowed configuration, apparently undamaged (i.e., unused) (Figure 7). It is possible that this BSS might have been located in the third row center position. The police crash report shows the third row left position as the location for this BSS and its occupant. The BSS had two sets of slots for the shoulder harness, with the harness straps threaded into the upper slots. The child occupant was reported as restrained and the harness straps were cut. The BSS did not sustain any obvious damage. The child in this seat sustained fatal injuries.

Figure 7: Looking into the case vehicle from the left, second row left CSS and third row left BSS; note, third row left safety belt hanging loose (arrow) (case photo #16)

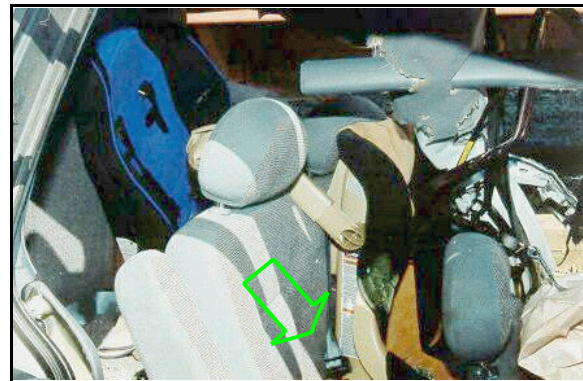
Figure 8: Looking into the case vehicle from the right, second row left CSS and third row left BSS; note, second row left safety belt threaded through CSS frame and buckled (arrow) (case photo #17)

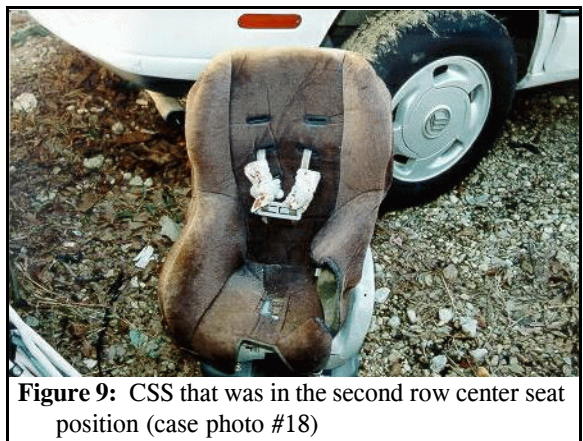
The second row center position contained a Century Products, Inc., "Smartmove" model, convertible child safety seat (CSS) with a three-point harness (Figure 9). It was positioned in the forward-facing configuration, but there is no knowledge concerning the installation. The CSS had three sets of slots for the shoulder harness, with the harness straps threaded into the center slots and a retainer clip in use. The child occupant was reported as restrained and the harness straps were cut. There are stress marks and a fracture on the forward edge of the left side panel, probably a result of this CSS being impacted by the CSS in the second row left position as the left CSS was pushed rightward. The child in this seat sustained serious injuries and was hospitalized.

Figure 9: CSS that was in the second row center seat position (case photo #18)

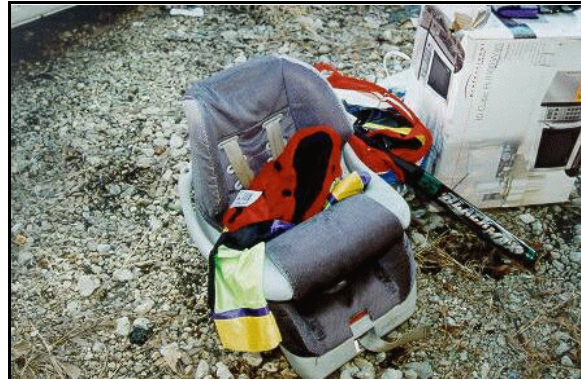
The third row right position contained what appears to be an Evenflow Co., Inc. “Champion” model, convertible child safety seat (CSS) with a three-point harness and a tray shield (**Figure 10**). It was positioned in the forward-facing configuration, but there is no knowledge concerning the installation. The CSS had three sets of slots for the shoulder harness, with the harness straps threaded into the upper slots. The child occupant was reported as restrained, and he sustained minor abrasion injuries consistent with harness use. The upper portion of the CSS seat back appears to be slightly distorted, probably as a result of the CSS impacting the case vehicle’s right side interior surface as the vehicle was redirected by the collision events. This CSS was in the least-damaged portion of the case vehicle (**Figure 6**). The child in this seat sustained minor soft tissue injuries and was treated and released at a hospital emergency department.

Figure 10: Child seat that was in the third row right seat position (case photo #19)

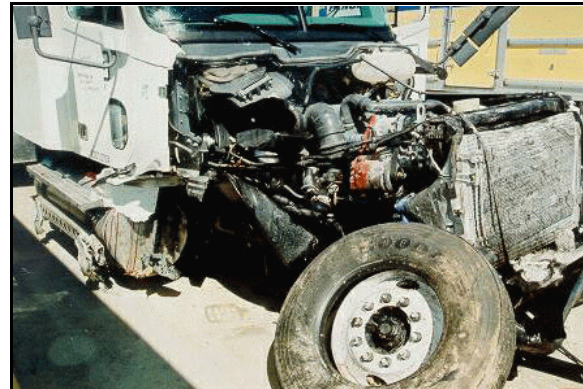
The first other vehicle was a 2002 Freightliner CL-120 conventional 6 x 4 truck tractor (VIN: 1FUJA6CG62L-----) pulling a single, two-axle tank semi-trailer (VIN: unknown) (**Figures 11 and 12**). The tank trailer had hazardous materials placarding indicating Class 8 (corrosive), ID Number 1789 (hydrochloric acid solution/hydrogen chloride solution/muriatic acid) liquid cargo. The police crash report indicated there was no cargo spillage. The tractor-trailer rig was towed due to heavy damage on the tractor. The tank semi-trailer did not sustain any apparent structural damage, except on the right side where the semi-trailer impacted the timber utility pole, which caused an area of narrow crush just aft of the center. Because of the many impacts and multiple areas of very heavy damage, the TDCs for the tractor-trailer's nine impacts were not estimated. The Freightliner's engine compartment and front axle area were destroyed, with the front right wheel completely separated and the fenders and hood torn away. There was substantial damage along the lower right side of the cab area, including direct damage to the right side of the saddle fuel tank but apparently without fuel leakage. There was also intra-unit damage on the left side of the area behind the cab as a result of the jackknife rotation by the tractor into the trailer.

Figure 11: Right side of Freightliner tractor at tow yard (case photo #20A)

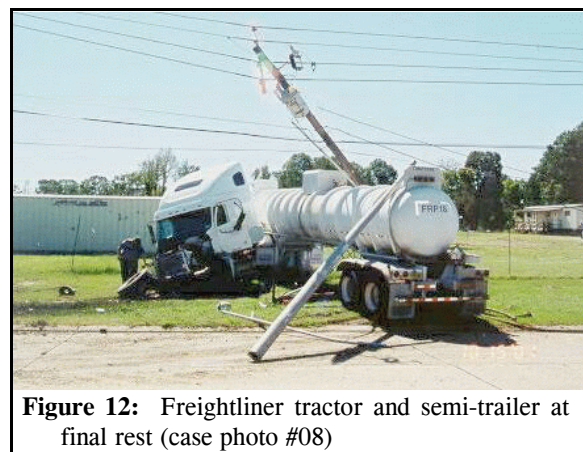
Figure 12: Freightliner tractor and semi-trailer at final rest (case photo #08)

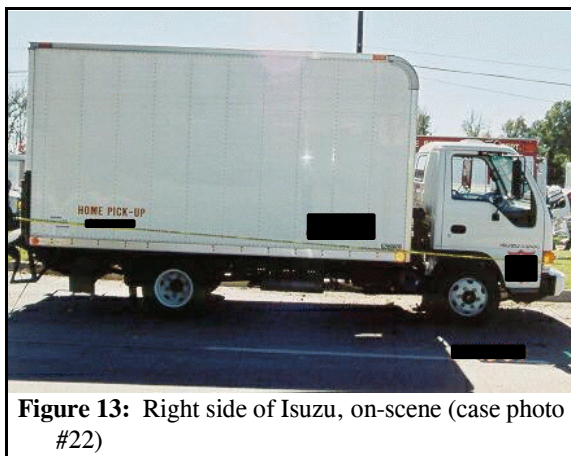
Figure 13: Right side of Isuzu, on-scene (case photo #22)

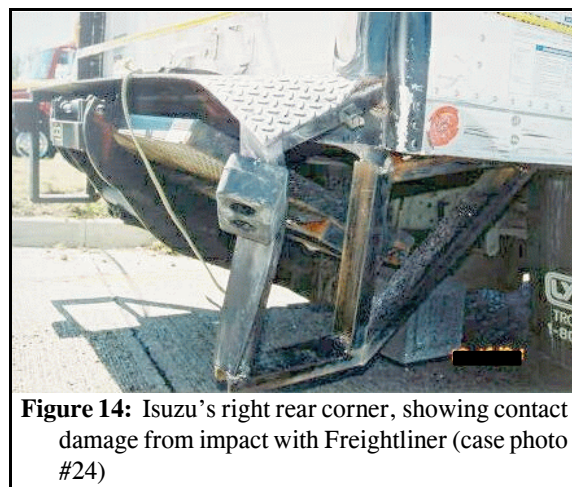
The second other vehicle was a rear wheel drive 2001 Isuzu NPR/W-series tilt cab, two-axle, six-wheel, medium-duty straight truck (VIN: JALB4B14617-----), equipped with a 4-cylinder 4.75 liter turbocharged diesel engine. The VIN indicates that this was an incomplete vehicle. The photos indicate that it was finished as a box van. Its wheelbase is not known, but the specifications indicate between 277 - 447 centimeters [109.0 - 176.0 inches], with a GVWR of 5,443 - 6,577 kilograms [12,000 - 14,500 pounds]. The Isuzu was driven away from the scene (**Figures 13 and 14**). The Isuzu sustained minor deformation at the right rear corner area, mainly to an aftermarket retractable steel elevator platform that protruded beyond the back of the cargo deck and the folding components in their stowed position under the deck, but also including light damage to the box structure above the cargo deck. The photo estimated TDC for the Isuzu's single impact (event #1) is estimated as **04-RBLN-A (120)**.

Figure 14: Isuzu's right rear corner, showing contact damage from impact with Freightliner (case photo #24)
