Office of Defect Investigations Potential Fail-to-Deploy Investigation / Vehicle to Object
Dynamic Science, Inc. / Case Number: DS02011
2001 GMC Yukon XL 2WD Four Door Sport Utility Vehicle
California
June, 2002

Dynamic Science, Inc.
Crash Investigation
Case Number: DS02-011

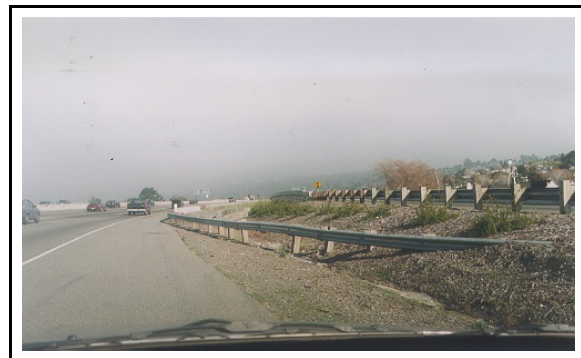
Figure 1. Area of impact 1 (eastbound)

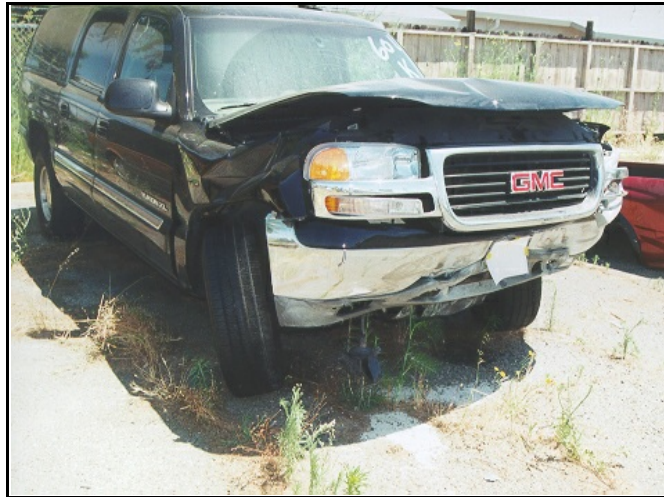
Figure 2. Impact 1, frontal damage vs guardrail.

Damage Description (Impact 1 - Guardrail): Moderate to severe damage to front bumper, hood, grille area, both front fenders, cracked windshield and possible front axle damage.

The case vehicle sustained moderate to severe damage to the front bumper as a result of striking the metal/wood guardrail (Impact 1). Direct and induced damage began at the front right bumper corner and extended laterally to the front left bumper corner. The damage was assigned a Collision Deformation Classification (CDC) of 11FDEW1, and a Principle Direction of Force (PDOF) of 340 degrees. The combined direct and induced damage width was 173.3 cm (68.2 in) [SMASH L = 176 cm (69.3 in)]. Six crush measurements were documented at the level of the bumper: C1= 12.0 cm (4.7 in), C2= 17.0 cm (6.7 in), C3= 18.0 cm (7.1 in), C4= 14.0 cm (5.5 in), C5= 7.0 cm (2.8 in), C6= 12.0 (4.7 in). The maximum crush depth was 18.0 cm (7.1 in.) and was located at C3.

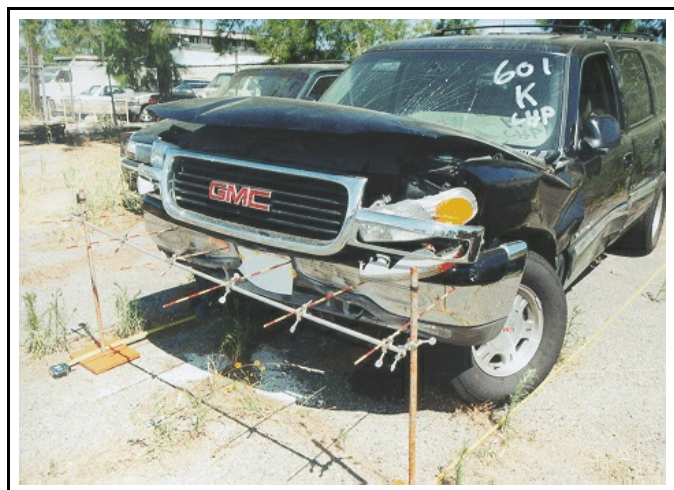
Figure 3. Impact 1, with crush stands.

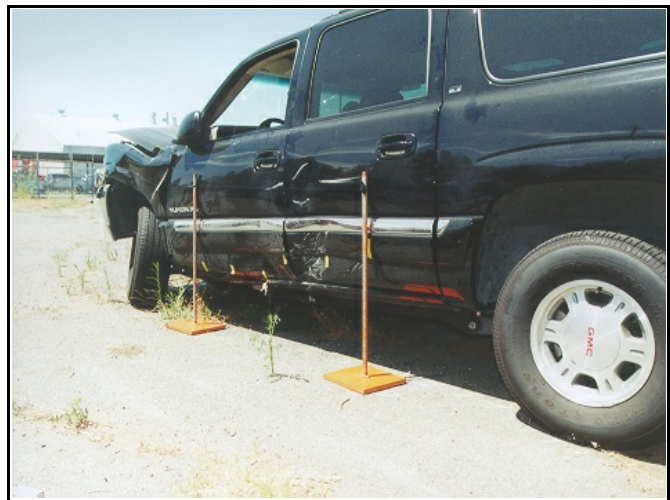
Damage Description (Impact 2 - 2002 Acura 3.2 TL): Moderate damage to the left side.

The case vehicle sustained moderate damage to the left side as a result of the front of the Acura striking the left side of the case vehicle (Impact 2). Direct and induced damage began 98 cm (38.5 in) forward of the rear left axle, and extended forward. The damage was assigned a CDC of 08LPEW1, and a PDOF of 240 degrees. The combined direct and induced damage width was 138.0 cm (54.3 in) [SMASH L = 138.0 cm (54.3 in)]. Six crush measurements were documented at the sill and above levels: C1= 0.0 cm (0.0 in), C2= 4.0 cm (1.6 in), C3= 13.0 cm (5.1 in), C4= 6.0 cm (2.4 in), C5= 9.0 cm (3.5 in), C6= 0.0 (0.0 in). The maximum crush depth was 13.0 cm (5.1 in.) and was located at C3.

Figure 4. Impact 2, left side damage vs other vehicle.

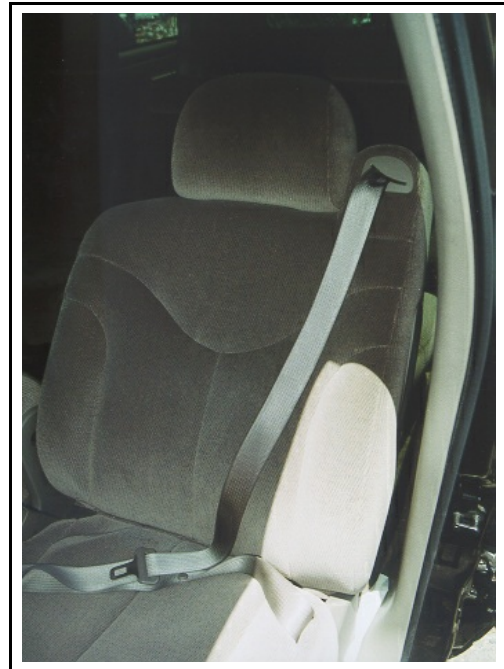
The driver's 3-point manual lap and shoulder safety belt system was integrated into the seat back and consisted of a continuous loop belt webbing with a sliding latchplate and a dual mode retractor (inertial lock/belt sensitive). The middle seat's (fold away jump seat) manual lap safety belt system consisted of a locking latchplate and no retractor. The front right 3-point manual lap and shoulder safety belt system was also integrated into the seat back and consisted of a continuous loop belt webbing with a sliding latchplate and a retractor equipped with an inertial and switchable lock mechanism. The driver's lap and shoulder belt was completely spooled out and the retractor was locked indicating that the lap and shoulder safety belt was in use at the time of the crash. The data downloaded from the SDM also indicated that the driver's seat belt was "BUCKLED". The middle lap belt had no evidence of historical usage and was found buckled. The front right latchplate was scratched indicating historical usage. No pretensioners were identified.

Figure 5. Driver's safety seat belt.

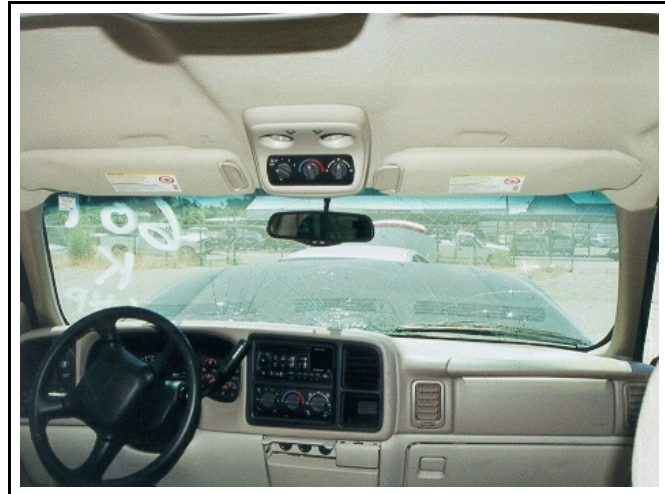
The case vehicle was equipped with redesigned frontal air bags for the driver and front right passenger positions that did not deploy as a result of the crash. The driver air bag was housed in the center of the steering wheel hub. The front right passenger air bag was housed in the mid-instrument panel area. The SDM was located on the floor under the driver' seat.

Figure 6. Non-deployed frontal air bags.

This crash involved a relatively long duration impact with a guardrail (impact 1). This enabled the algorithm and generated a non-deployment event. It appears that the system worked properly and the non-deployment decisions was correct.

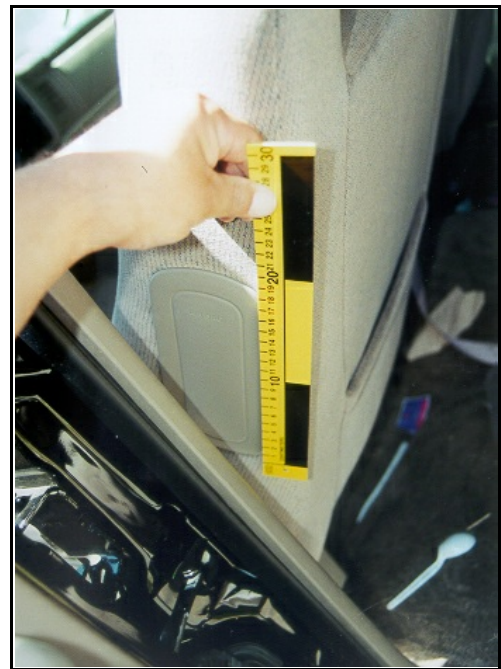
The case vehicle was also equipped with side air bags for the outboard seat positions which did not deploy. The air bag modules were housed in the outboard side aspect of the front seat backs.

Figure 7. Non-deployed driver's side air bag.
