**ON-SITE AIR BAG RELATED ADULT DRIVER FATALITY INVESTIGATION  
SCI TECHNICAL SUMMARY REPORT**

**VERIDIAN CASE NO. CA02-016**

**VEHICLE - 1996 FORD F-150 PICKUP TRUCK**

**CRASH DATE - JUNE 2001**

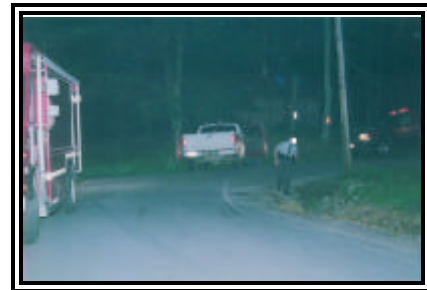
**Figure 3. On-scene photograph showing pre-impact skid marks**

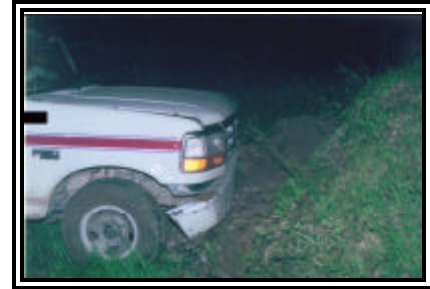
The 1996 Ford F-150 pickup truck impacted the dirt embankment with the front bumper area (**Figure 4**). Impact resulted in moderate damage to the pickup truck. The principal direction of force was in the 12 o'clock sector, and the impact was sufficient to deploy the frontal air bag system in the vehicle. The damage algorithm of the WinSMASH program computed a barrier equivalent speed of 18.7 km/h (11.6 mph) based on crush measurements along the front bumper. The longitudinal delta-V component was -18.7 km/h (-11.6 mph) and the lateral delta-V component was 3.3 km/h (2.1 mph). Based on the direct contact damage to the bumper, it appeared that the bottom aspect of the bumper struck a moderately-sized rock with the center aspect as it impacted the embankment. The pickup truck appeared to have partially ramped up the front aspect of the embankment and may have slid rearward slightly to final rest. The front wheels came to rest in the shallow drainage ditch which measured 15.2 cm (6.0") in depth.

**Figure 4. View showing final rest of the pickup truck relative to the dirt embankment**

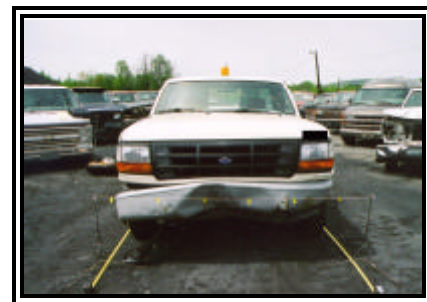
The Ford F-150 sustained moderate frontal damage as a result of the impact with the dirt embankment (**Figure 5**). Numerous longitudinal abrasions were present on the lower aspect of the front bumper. The direct damage was concentrated on the lower aspect of the front bumper and involved the entire width of the bumper. The entire bumper was displaced vertically and rearward, and the bottom right corner was rotated slightly outward. The left frame rail was protruding forward from the bumper 3.8 cm (1.5"). Moderate deformation was present slightly right of the center aspect of the bumper from probable contact with a rock. The direct damage

**Figure 5. View of frontal damage to the Ford F-150 pickup truck**

from the rock contact began 41.3 cm (16.3") left of center and extended 77.5 cm (30.5") across the bumper. The maximum crush was located 7.6 cm (3.0") right of the centerline on the bumper and measured 24.1 cm (9.5"). The combined direct and induced damage measured 179.7 cm (70.8") and involved the entire width of the bumper and extended vertically to the grille area. The vertical and rearward displacement of the front bumper resulted in slight induced buckling on the left front fender and left front corner. The Collision Deformation Classification (CDC) for the impact with the dirt embankment was 12-FDLW-1. Six crush measurements were taken along the bumper and were as follows: C1 = 7.0 cm (2.8"), C2 = 7.0 cm (2.8"), C3 = 12.1 cm (4.8"), C4 = 18.4 cm (7.3"), C5 = 2.5 cm (1.0"), C6 = 2.5 cm (1.0").

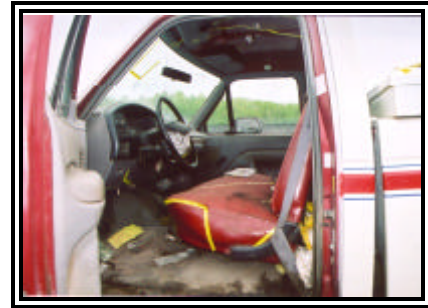
The 1996 Ford F-150 pickup truck sustained moderate interior damage as a result of occupant contact (**Figure 6**). There was no damage to the windshield laminate, side glazing, or backlight glazing. There was no passenger compartment intrusion. The knee bolster was scuffed from the driver's left knee. The scuff was located 5.1 cm (2.0") to the left of the center of the steering column and extended 11.4 cm (4.5") to the left at an upward angle. Although there was no deformation to the steering wheel rim, the steering column was compressed as a result of occupant loading (**Figure 7**). The left shear capsule displacement measured 6.5 cm (2.5") and the right shear capsule displacement measured 7.0 cm (2.8"). Two pronounced body fluid (blood) spatters were present on the interior roof. The first was located 27.9 cm (11.0") left of center and 20.3 cm (8.0") rear of the windshield header. It extended 30.5 cm (12.0") rearward and measured 7.6 cm (3.0") wide at the rear aspect. The second was located 24.1 cm (9.5") left of center and 43.2 cm (17.0") rear of the windshield header. It measured 12.7 cm (5.0") in width at the rear aspect. Clear body fluid spatter was noted on the driver's sun visor, the left aspect of the windshield header, and on the top aspect of the windshield to the right of the steering column. A large amount of body fluid (blood) was present on the left and center aspects of the bench seat where the driver came to rest. Lateral abrasions were present on the forward aspect of the driver's head restraint, but did not appear to be related to this crash.

**Figure 6. Left side interior view of the Ford F-150 pickup truck**

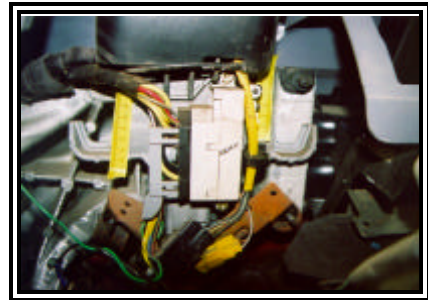
**Figure 7. View of shear capsule displacement**

The driver's loading force against the steering wheel assembly and the air bag module, in combination with the deploying air bag against his chest, produced compression of the energy-absorbing steering column. The compression of the steering column resulted in complete separation of the shear capsules. The left side separation measured 6.4 cm (2.5") and the right side separation measured 7.0 cm (2.8").

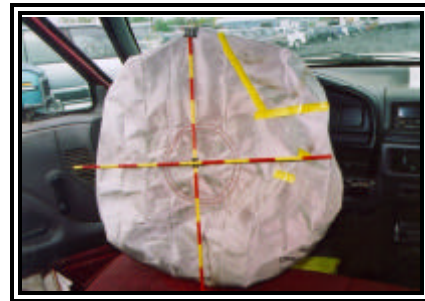
The 1996 Ford F-150 was equipped with a frontal air bag for the driver's position (**Figure 8**). The air bag was housed in the center of the steering wheel with asymmetrical H-configuration module cover flaps. The top flap measured 12.7 cm (5.0") in height and 20.3 cm (8.0") in width. The bottom flap measured 3.8 cm (1.5") in height and 20.3 cm (8.0") in width. The post-crash longitudinal distance between the steering wheel hub and the seat back measured 56.0 cm (22.0").

**Figure 8. Driver's air bag**

Due to the yielding nature of the soft soil, the air bag deployed late in the crash sequence as the front bumper engaged the embankment. The driver's air bag was circular in shape and measured 67.3 cm (26.5") in diameter. The air bag was vented by two circular ports at the 12 o'clock sector that measured 3.8 cm (1.5") in diameter. The air bag was tethered by two internal straps that measured 11.4 cm (4.5") in width and were located at the 12 and 6 o'clock aspects. The air bag excursion measured 27.9 cm (11.0"). Body fluid (blood) transfers were present on the upper right quadrant on the face of the air bag. Green fabric transfers from the driver's shirt were present on the bottom rear aspect of the air bag. The fabric transfer was offset slightly to the left and measured 11.4 cm (4.5") in height and 6.4 cm (2.5") in width. A large tissue transfer from the driver's neck was also present on the bottom rear aspect of the air bag (**Figure 9**). The transfer was located in the center aspect and measured 24.1 cm (9.5") in height and 10.2 cm (4.0") in width.

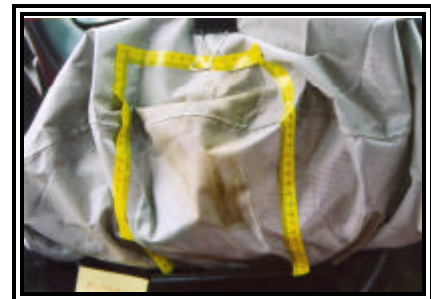
**Figure 9. Rear bottom view of the driver's air bag showing the tissue and fabric transfers**

The fold pattern of the air bag was such that the bottom rear aspect deployed first. A large tissue transfer which measured 24.1 cm (9.5") in height and 10.2 cm (4.0") in width was present in the center of the bottom rear aspect of the air bag from expansion against the driver's neck. The air bag also expanded against the driver's shirt which resulted in a faint green transfer on the bottom rear aspect of the air bag to the left of the tissue transfer which measured 11.4 cm (4.5") in height and 6.4 cm (2.5") in width. The expansion of the driver's air bag produced a 36.8 x 22.9 cm (14.5 x 9.0") diffuse superficial abrasion of the lower neck and bilateral chest wall, two parallel abrasions 7.6 cm (3.0") in length on the left upper chest with 1.6 cm (0.6") separation contiguous with parallel abrasions of the left mid chest measuring 5.1 cm (2.0") in length with 2.5 cm (1.0") separation, fractures of the right lateral ribs 2-5, fractures of the left lateral ribs 2-5, fracture of the right 2nd posterior rib, a contusion and crushing of the adipose tissue of the upper anterior chest, a 3.0 cm (1.2") laceration of left posterior pericardial sac at the area of the left pulmonary vein, a partial transection of the proximal descending aorta with hemorrhage into the posterior mediastinum, multiple intimal lacerations of the thoracic aorta, and an endocardial laceration of inferior vena cava and right atrium. The vertical expansion of the air bag hyper-extended the driver's neck which produced a transverse basilar skull fracture which extended through the bilateral petrous ridges and sella turcica, contiguous with fractures of the bilateral posterior cranial fossa. The fracture and associated lacerations extended to the posterior pharynx. The vertical expansion of the air bag also caused the driver to sustain crush trauma and transection of the pons from the cerebrum, crush trauma and near total
