On-scene Investigation / Vehicle to Vehicle
Dynamic Science, Inc. / Case Number: DS02019
2002 Toyota Prius four-door
California
August, 2002

1. Report No. DS02019		2. Government Accession No.		3. Recipient Catalog No.	
4. Title and Subtitle In-Depth Accident Investigation				5. Report Date	
				6. Performing Organization Report No.

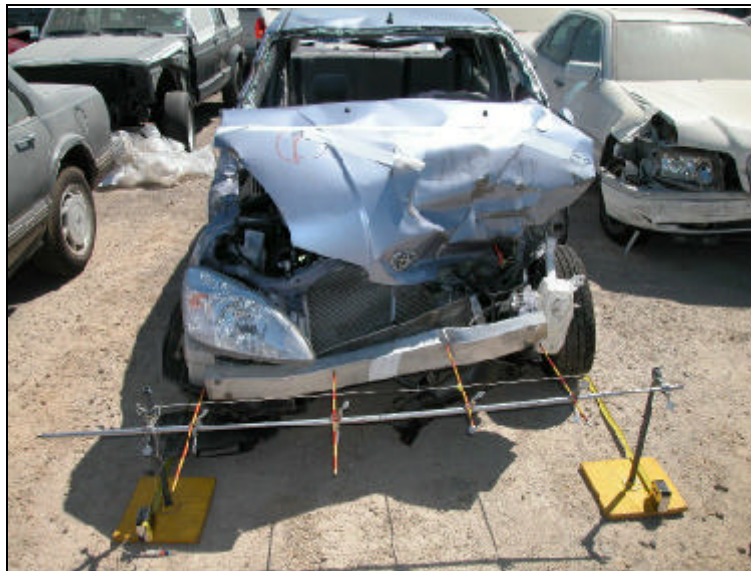
Figure 5. Front, case vehicle

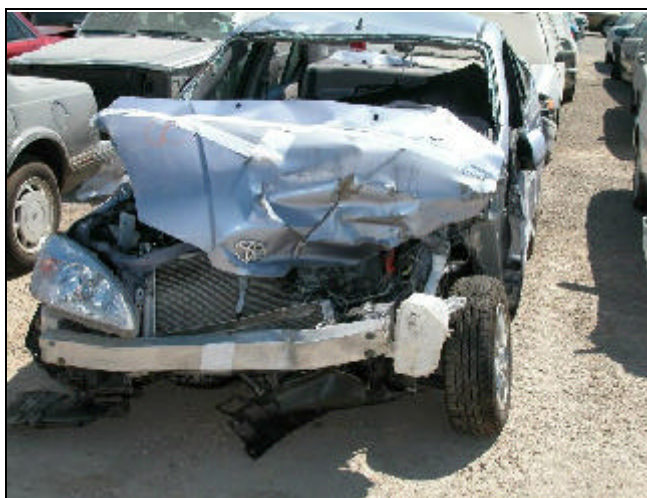
**Figure 7.** Front view, case vehicle

The case vehicle sustained 92.0 cm (36.2 in) of direct contact damage across the front end beginning at the left front bumper corner. The residual crush measured along the bumper reinforcement bar was as follows: C1=24.0 cm (9.4 in), C2=17 cm (6.7 in), C3=6 cm (2.4 in), C4=2.0 cm (0.8 in). The maximum crush was located at C1. The principle direction of force was within the 11 o'clock sector and was an estimated 340 degrees. The impact energy was managed by the forward structures of the vehicle. The damaged components for this impact included the bumper fascia and reinforcement bar, upper and lower radiator supports, and hood. The vehicle also sustained damage to the roof, left side, and right side as a result of the rollover and a non-horizontal impact with a private residence. The wheelbase was shortened by 5 cm (1.9 in) on the left side. The left rear door was jammed shut. The windshield was fractured and was likely removed by EMS personnel. The glazing at the left front, left rear, backlight, and right rear locations was disintegrated.

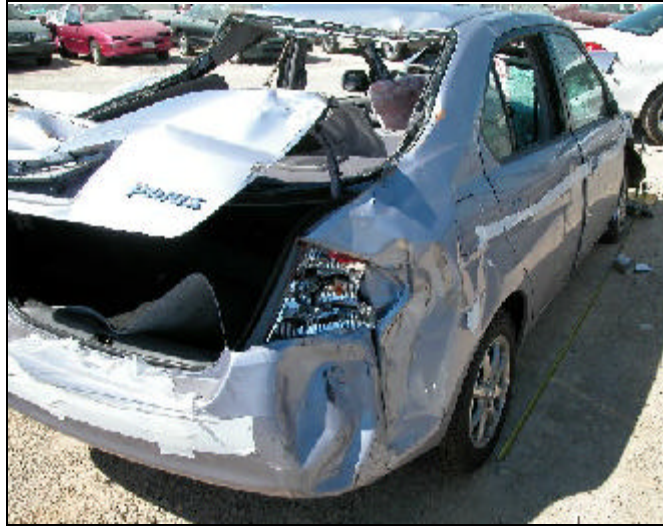
Figure 8. Right rear, case vehicle

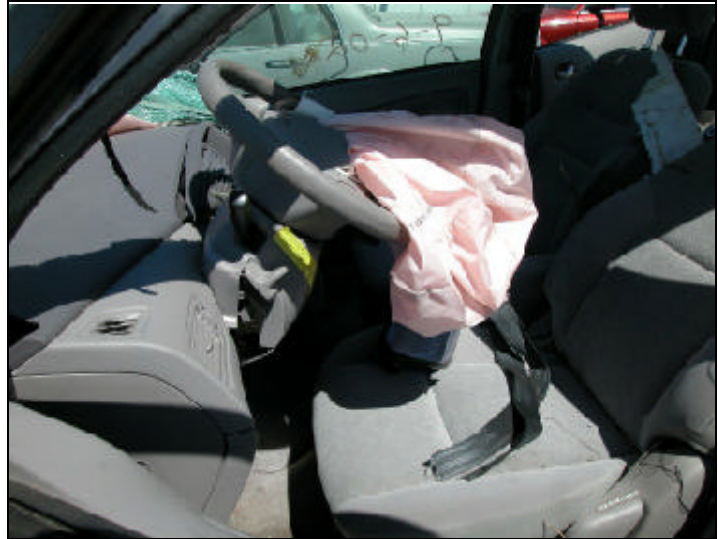
Figure 9. Steering column deformation/air bag

Both front air bags deployed during the crash. The circular driver's front air bag was mounted in the steering wheel hub and measured 52 cm (20.5 in) in diameter. The air bag was equipped with two vents ports--located at the 10 and 2 o'clock positions-- and one tether. The "Y" type module cover opened at the designed tear points and there was no damage to the cover.

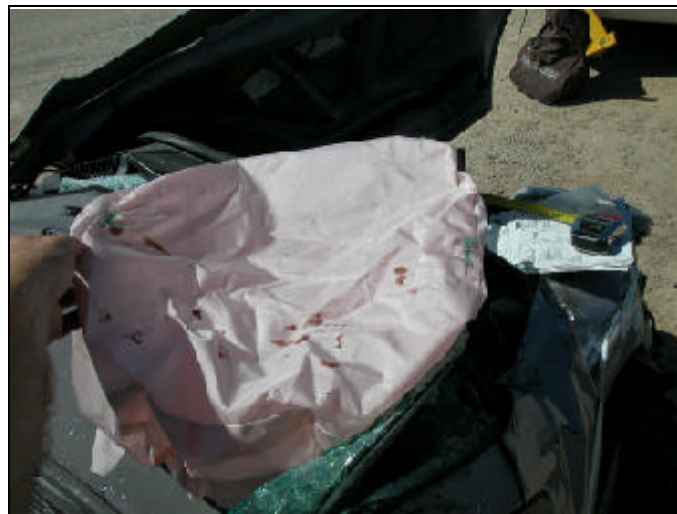
Figure 10. Front right passenger's air bag

There was no damage to the air bag nor any occupant contacts found. The rectangular front right air bag was mounted in the top of the instrument panel and measured 45 cm (17.7 in) wide seam to seam. The air bag was equipped with two vents--located at the 3 and 9 o'clock positions. The single module cover flap opened at the designed tear point and there was no damage to the cover. There was no damage to the air bag nor any occupant contacts found.

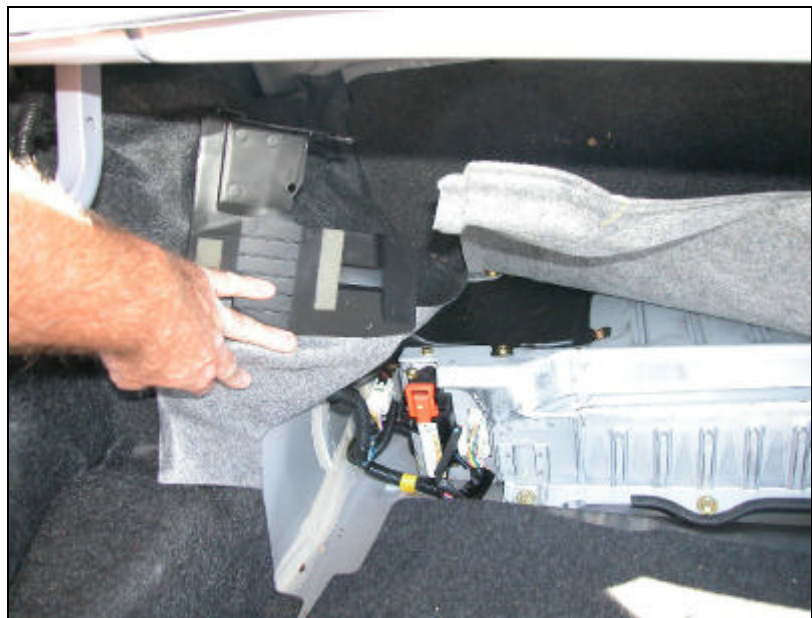
1. There were no indications of electrolyte spillage from the propulsion battery.
2. There was no movement of the battery module.
3. The electrical isolation test was attempted; however, there was no power present in the traction battery. It was physically possible to conduct the isolation tests for the service plug found in the rear trunk area (Item A in Attachment 1) and the battery power cable (Item B), and the results were understandably positive for isolation. The isolation test for Items C and D could not be conducted because the crush to the front of the vehicle had pushed the converter/inverter module into a location that could not be accessed. There were no indications of any arcing, fire, or component meltdown.

Figure 11. Service plug (located in trunk)

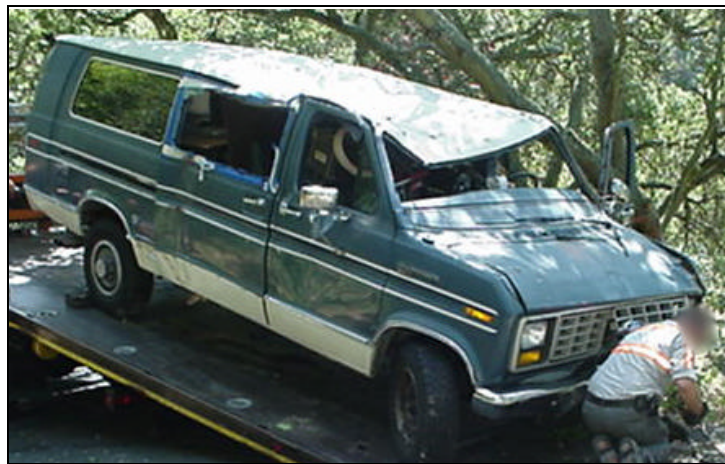
Figure 14. Front right, other vehicle

The other vehicle sustained direct contact damage beginning at the left front bumper corner and extending 2/3 the way across the bumper. The principle direction of force was within the 12 o'clock sector and was an estimated 355 degrees. The impact energy was managed by the forward structures of the vehicle. The damaged components for this impact included the bumper, grille, and likely the lower radiator support. The vehicle also sustained damage to the left, right, and top side of the vehicle due to the rollover. There was additional damage to the right side due to contact with a tree as it came to final rest. There was substantial intrusion to the roof and windshield header on the left side. The windshield glazing was out of place. The side glass at the front left, front right, and rear right was disintegrated.

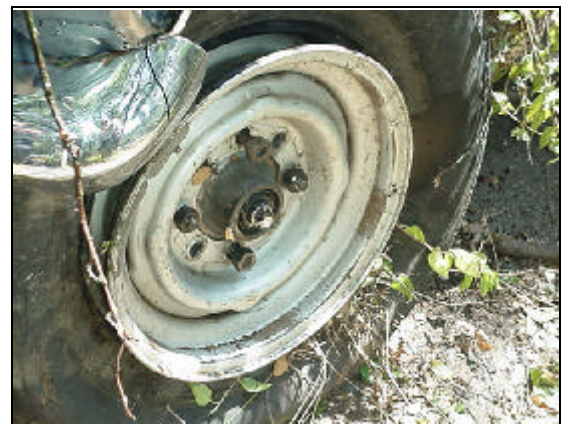
Reported Defects: None reported by police. Police photos, however, reveal that several tire rims were improperly secured to the vehicle axles. Nuts missing and/or not tightened.

Figure 16. Left front rim (loose and missing lug nuts)

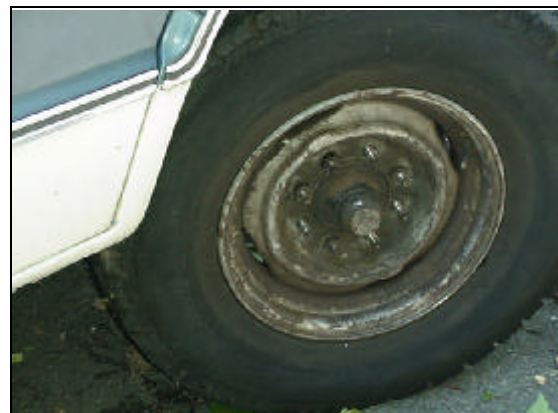
Figure 17. Front right rim (missing and loose lug nuts)

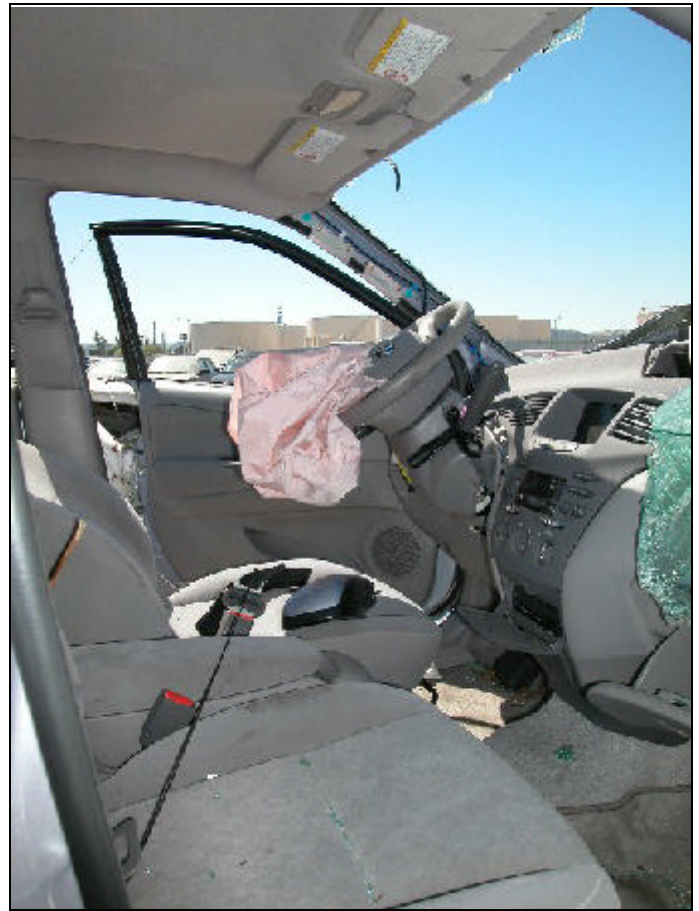
Figure 18. Driver's seated area—note upward loading to steering column (possibly due to extrication)

The case vehicle was redirected to the right after the initial impact and began overturning as it traveled down the embankment. The vehicle overturned five quarter turns before striking a private residence and coming to rest on its right side. During the second quarter turn onto the roof, the driver may have loaded the steering wheel to some degree and assisted in moving it upward. However, a more likely explanation is that the movement was as a result of extrication activities by EMS personnel.

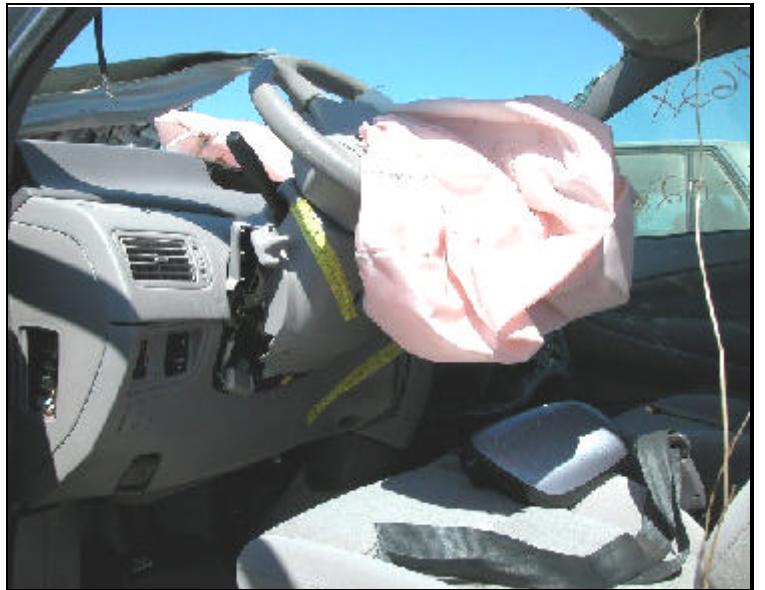
Figure 19. Damage and contact to left side of steering column

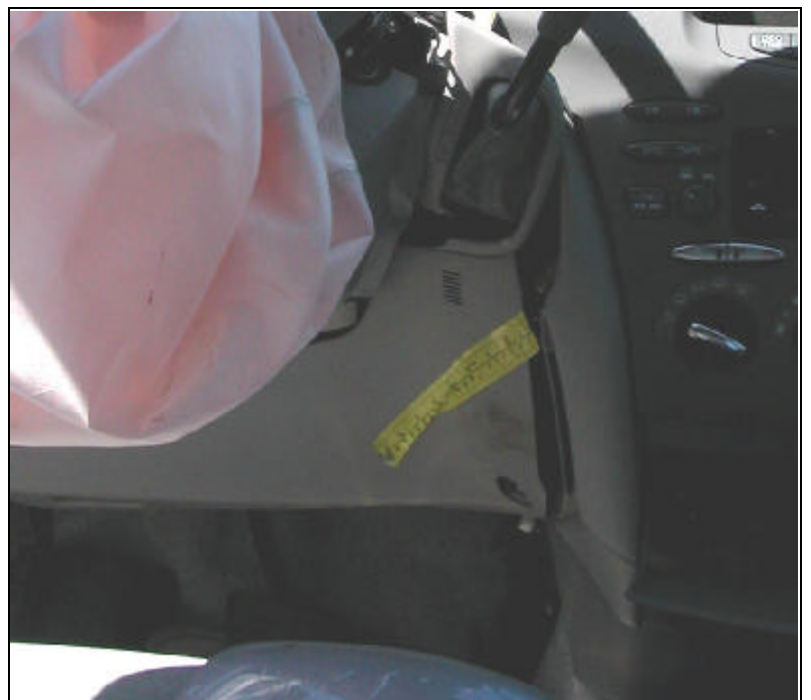
Figure 20. Right knee contact to lower instrument panel
