ON-SITE CHILD AIR BAG-RELATED SERIOUS INJURY INVESTIGATION

CASE NUMBER - IN-02-021
LOCATION - MINNESOTA
VEHICLE - 1995 VOLKSWAGEN JETTA III GL
CRASH DATE - December 2002

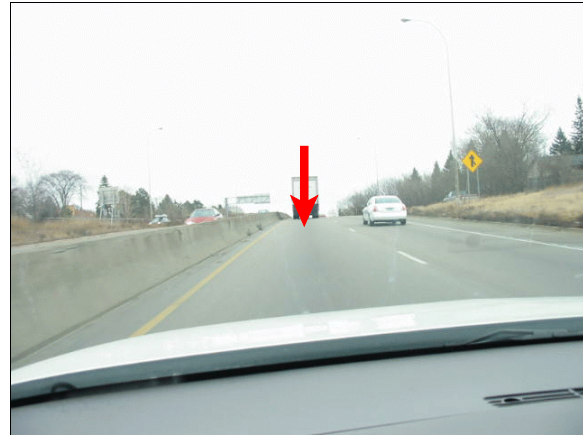
Crash Environment: The trafficway on which both vehicles were traveling was a four-lane, divided, state highway, traversing in an east-west direction (**Figure 1**). Both the east and west roadways had two through lanes. The state highway was straight and had a 4.0% grade positive to the east, at the area of impact (i.e., an upgrade in the case vehicle's and Honda's directions of travel—**Figure 1**). The pavement was bituminous, but traveled, and the width of the inside eastbound travel lane—for both vehicles, was approximately 3.7 meters (12 feet) and was most likely the same for the outside eastbound lane.

Figure 1: Case vehicle's eastward travel path in inside eastbound lane; Note: arrow indicates approximate impact location (case photo #03)

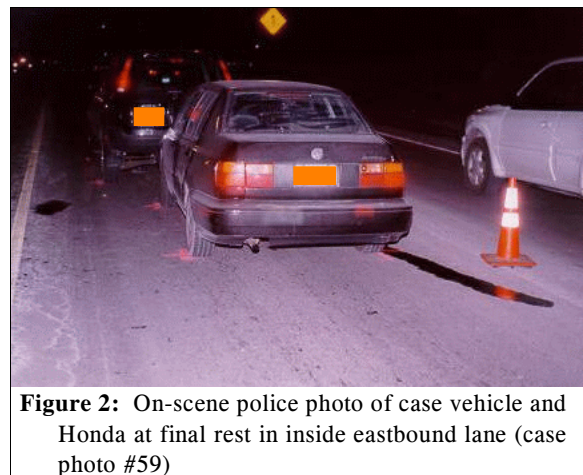
Figure 2: On-scene police photo of case vehicle and Honda at final rest in inside eastbound lane (case photo #59)

Post-Crash: According to the case vehicle's driver, the case vehicle came to rest at impact (Figure 2 above). Based on the available information, the case vehicle and the Honda both moved slightly forward before coming to rest in the inside eastbound lane, heading east.

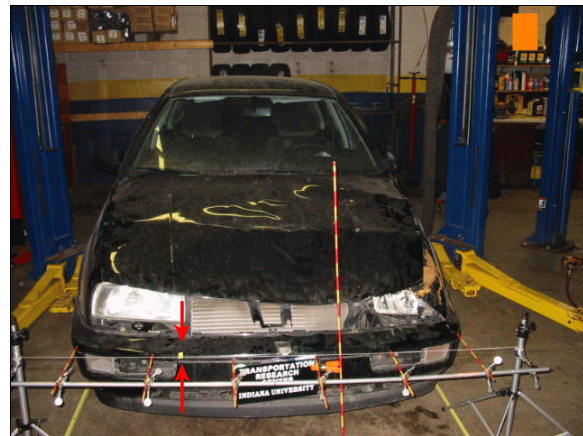
Crash: The front (Figure 3) of the case vehicle impacted the back of the Honda, causing the case vehicle's driver and front right passenger supplemental restraints (air bags) to deploy.

Figure 3: Elevated view of case vehicle's frontal damage with contour gauge present at bumper level; Note: yellow tape (arrows) indicates width of direct damage on bumper (case photo #07)

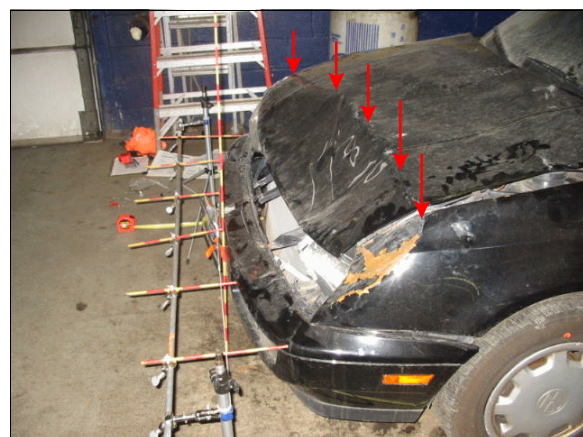
Figure 4: Case vehicle's frontal damage viewed along reference line from left with contour gauge present at bumper level; Note: ridge line (arrows) on hood shows above bumper deformation (case photo #09)

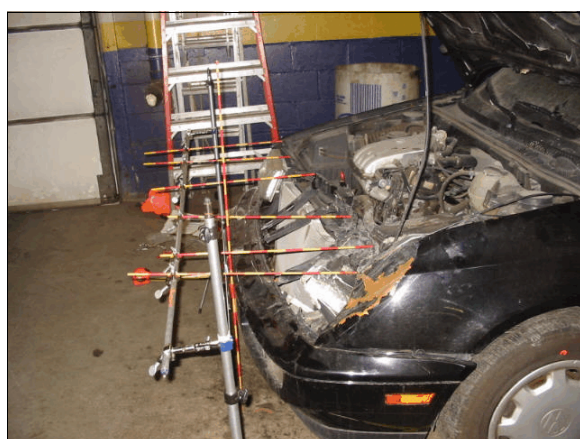
Figure 5: Case vehicle’s frontal damage viewed along reference line from left with contour gauge positioned above bumper at upper radiator support brackets (case photo #12)

The case vehicle’s wheelbase was unaltered from the crash. The case vehicle’s front bumper, bumper fascia, grille, hood, radiator, and left fender and headlight assembly were directly damaged and crushed rearward. Both the right and left headlight and turn signal assemblies sustained induced damage as well as the hood and both the right and left fenders. No obvious

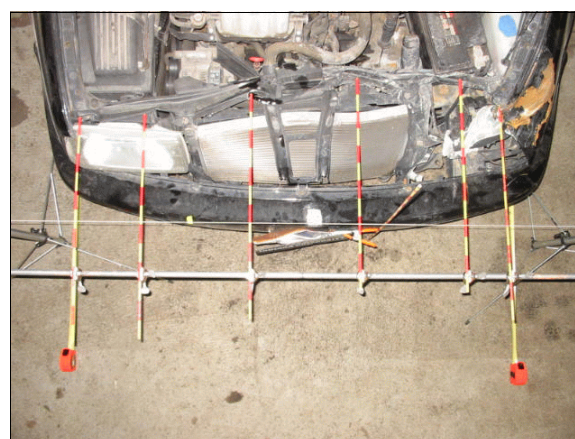
Exterior Damage: The case vehicle’s contact with the Honda involved the entire front with the damage distributed all the way across. Direct damage began at the front left bumper corner and extended 108 centimeters (42.5 inches) inward along the front bumper (**Figure 3** above). Crush measurements were taken at the bumper level (**Figure 4** above) and at the top of the radiator support (**Figure 5**), and values were averaged where appropriate. Residual maximum crush along the bumper was measured as 2 centimeters (0.8 inches) at all six “C” locations. Above the bumper (i.e., along the radiator support) the residual maximum crush was measured as 21 centimeters (8.3 inches) at C₃. The average residual maximum crush at C₃ was 12 centimeters (4.7 inches). The table below shows the case vehicle’s crush profile (**Figure 6**).

Figure 6: Overhead view of case vehicle’s frontal damage with hood raised and contour gauge position above bumper along radiator support (case photo #13)

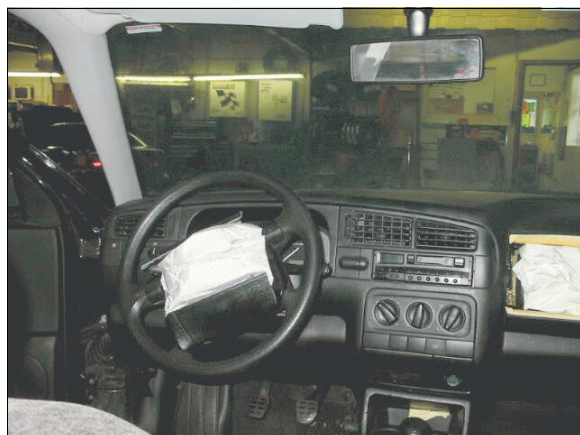
Vehicle Interior: Inspection of the case vehicle’s interior (**Figures 7 and 8**) revealed that there was no evidence of occupant contact on the interior surfaces of the case vehicle. Furthermore, there was no evidence of intrusion to the case vehicle’s interior, no evidence of compression to the energy absorbing shear capsules in the steering column, and no deformation to the steering wheel rim.

Figure 7: Case vehicle’s driver seating area showing deployed driver air bag and no apparent evidence of occupant contact to steering wheel, instrument panel, or greenhouse areas (case photo #30)

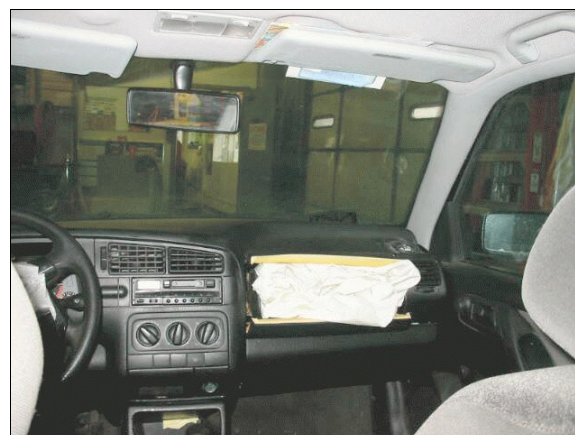
Figure 8: Case vehicle’s front right passenger seating area showing deployed front right passenger air bag and no apparent occupant contact evidence to mid and right instrument panels or greenhouse areas (case photo #32)

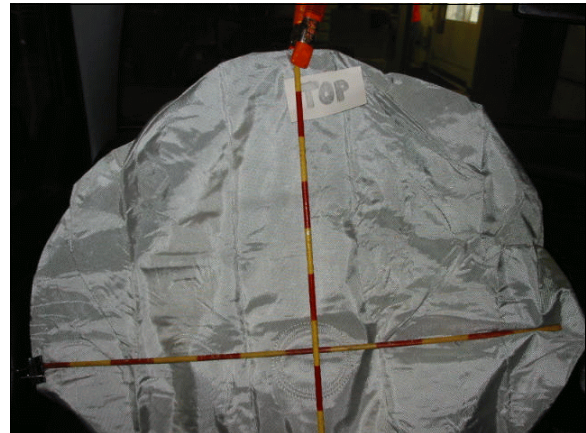
The case vehicle was equipped with a Supplemental Restraint System (SRS) that contained frontal air bags at the driver and front right passenger positions. Both frontal air bags deployed as a result of the frontal impact with the Honda. The case vehicle's driver air bag was located in the steering wheel hub. An inspection of the air bag module's cover flaps and the air bag's fabric revealed that the cover flaps opened at the designated tear points, and there was no evidence of damage during the deployment to the air bag or the cover flaps. The driver's air bag was designed with four tethers, each approximately 7 centimeters (2.8 inches) in width. The driver's air bag had two vent ports, approximately 3.5 centimeters (1.4 inches) in diameter, located at the 10 and 2 o'clock positions. The deployed driver's air bag was round with a diameter of 66 centimeters (26.0 inches). An inspection of the driver's air bag fabric revealed no contact evidence readily apparent on the air bag's fabric (**Figure 9**).

Figure 9: Case vehicle's deployed driver air bag showing no apparent evidence of occupant contact (case photo #44)

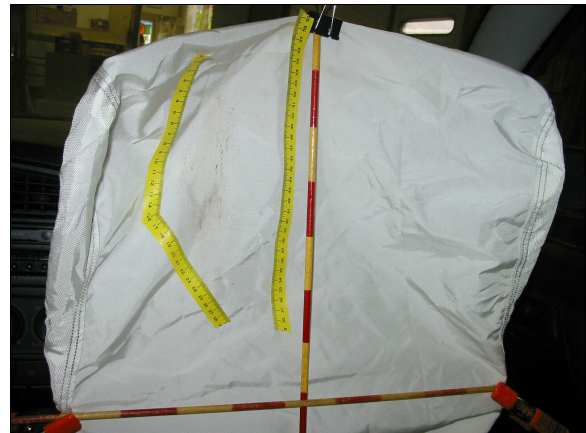
The front right passenger's air bag was located in the middle of the instrument panel. An inspection of the front right air bag module's cover flaps and the air bag's fabric revealed that the cover flaps opened at the designated tear points, and there was no evidence of damage during the deployment to the air bag or the cover flaps. The front right passenger's air bag was designed without any tethers. The front right air bag had no vent ports. The deployed front right air bag was rectangular with a height of approximately 72 centimeters (28.3 inches) and a width of approximately 45 centimeters (17.7 inches). An inspection of the front right passenger's air bag fabric revealed obvious contact evidence on the front surface. Specifically, on the front surface there was large vertically oriented skin transfer measuring 8 x 21 centimeters (3.1 x 8.3 inches) near the middle of the left upper quadrant (**Figure 10**). The transfer was located 7 centimeters (2.8 inches) to the right

Figure 10: Front surface of case vehicle's deployed front right passenger air bag showing vertically oriented contact area approximately midline within left upper quadrant (case photo #48)

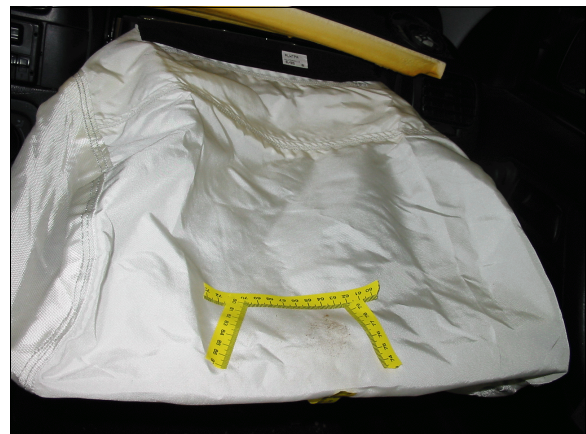
Figure 11: Top surface of case vehicle's deployed front right passenger air bag showing occupant contact evidence near 6 o'clock position (case photo #50a)

of the bag's left edge and 4 centimeters (1.6 inches) below the top edge. In addition, on the top surface there was a round skin transfer measuring approximately 5 centimeters (2.0 inches) in diameter located near the 6 o'clock position (**Figure 11** above). This transfer was located 18 centimeters (7.1 inches) from the left edge and 22 centimeters (8.7 inches) from the right edge of the air bag's top surface.

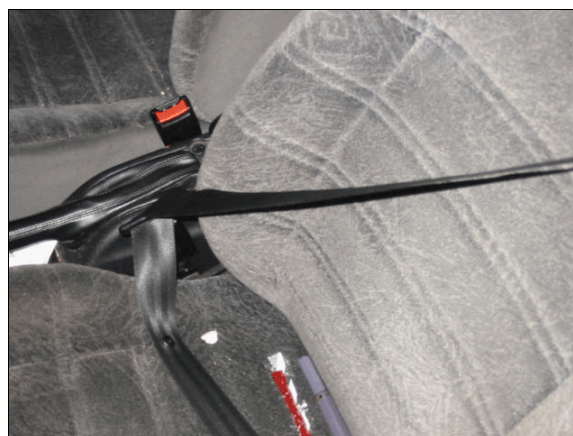
Based on this contractor's vehicle inspection, the case vehicle's driver was most likely restrained by her available, active, three-point, lap-and-shoulder, safety belt system. Furthermore, there were no reports of belt pattern bruising and/or abrasions to the driver's body, but the inspection of the driver's seat belt webbing, "D"-ring, and latch plate showed trace evidence of loading (i.e., slight waving on the belt's webbing—**Figure 12**).

Figure 12: Case vehicle's driver safety belt showing slight waving in the lap portion of the belt indicating probable restraint use (case photo #33)
