ON-SITE SIDE IMPACT OCCUPANT PROTECTION INVESTIGATION

VEHICLE: 1999 AUDI A6

CASE NO: CA02-023

CRASH DATE: JUNE 2002

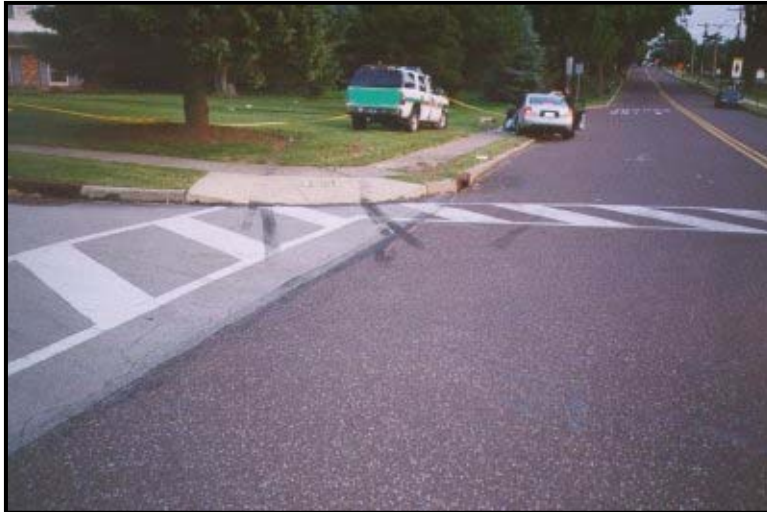
Figure 2: Southward view through the intersection toward the final rest positions of the vehicles.

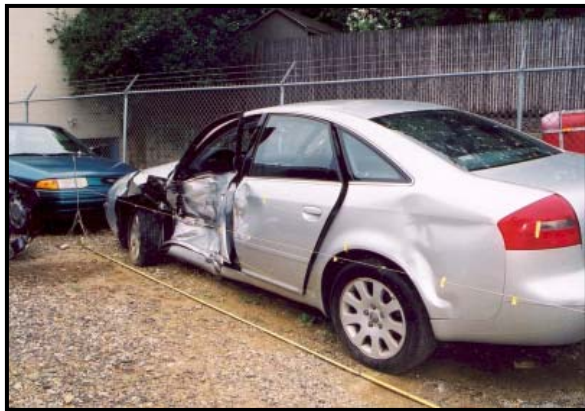
The left side of the Audi sustained two separate regions of contact damage as a result of the impact and subsequent side slap with the Chevrolet Tahoe. **Figures 5 and 6** are a left rear view and an overhead view of the damaged vehicle. The initial impact with the Chevrolet resulted in a combined length of direct contact and induced damage that measured 198 cm (78 in). The direct contact damage began on the mid aspect of the left rear door, 86 cm (34 in) forward of the left rear axle and extended forward 150 cm (59 in) to the left A-pillar location. Direct contact extended vertically 20 cm (8 in) above the belt line. The induced damage extended forward of the left A-pillar onto the left front fender and ended 14.0 cm (5.5 in) forward of the left front axle. The impact force in the 7 o’clock sector separated the trailing edge of the left front fender from the body of the vehicle. The fender was displaced laterally outboard with respect to the

The left rear quarterpanel sustained 96.5 cm (38.0 in) of direct contact damage as a result of the side slap impact. The direct contact began 16.5 cm (6.5 in) forward of the left rear axle and ended 31.5 rearward of the left rear axle. The maximum deformation within the contact pattern measured 6.3 cm (2.5 in). The CDC of this minor impact was 09-LBEW-1.

Figure 5: Left rear view of the Audi.

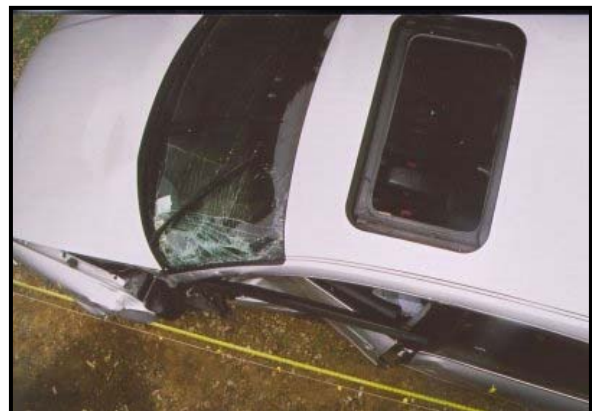
vehicle. The crush profile at the mid door elevation was as follows: C1 = 0, C2 = 5.0 cm (2.0 in), C3 = 9.1 cm (3.6 in), C4 = 29.2 cm (11.5 in), C5 = 36.3 cm (14.3 in), C6 = 15.2 cm (6.0 in). The left aspect of the windshield was fractured and left front window glazing had disintegrated as a result of the exterior crash forces. The left front door was jammed shut by the deformation. The left rear door was restricted by the B-pillar deformation. There was no change in the wheelbase dimensions. The delta V calculated by the Damage Algorithm of the WINSMASH model was 23.0 km/h (14.3 mph). The longitudinal and lateral delta V components were 17.6 km/h (10.9 mph) and 14.8 km/h (9.2 mph), respectively. The Collision Deformation Classification (CDC) was 07-LYAW-2.

Figure 6: Overhead view of the left side damage.

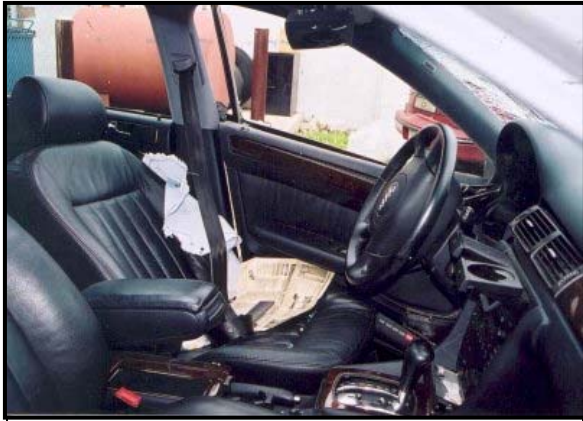
The interior vehicle damage to the 1999 Audi A6, **Figures 7 and 8**, was attributed to intrusion, and the deployment of the side impact air bag system. The forward aspect of the Audi's left front door sustained the highest magnitude of intrusion. The footwell intrusion measured 25 cm (10 in). The left B-pillar intrusion measured 3.8 cm (1.5 in). The intruding left door panel contacted the steering wheel rim and fractured the tilt mechanism due to the lateral displacement of the column. The lateral intrusion of the left A-pillar measured 10.7 cm (4.2 in) at the left aspect of the instrument panel.

A probable left upper extremity contact was identified on the upper center aspect of the front door interior trim panel. The trim was scuffed and fractured in the area of the contact. This contact measured 7.0 cm (2.8 in) in length. The center hub of the steering wheel exhibited blood evidence consistent with the driver's nasal fracture. There were no other identified occupant contacts.

Figure 7: View of the driver's interior.

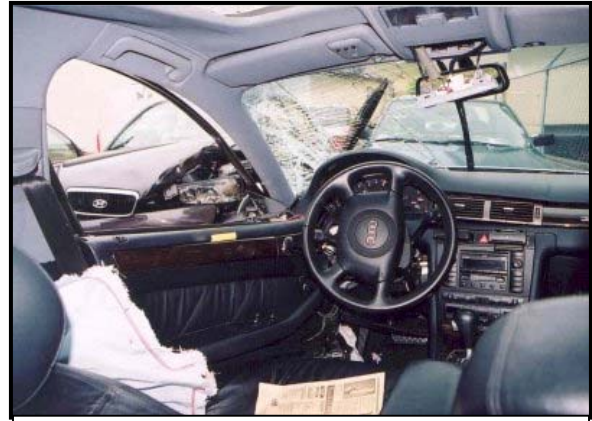
Figure 8: View of the front left intrusion.

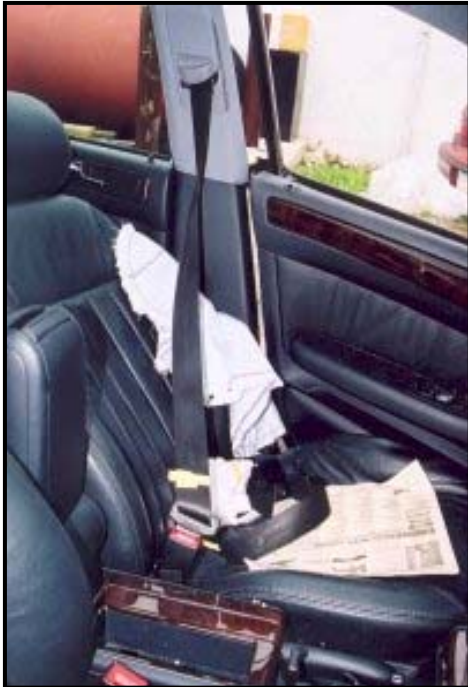
Upon inspection, the webbing of the driver's restraint (**Figure 11**) was exposed and the retractor was locked. The retractor was inoperable. It was probable the retractor was locked due to the left side deformation. The pretensioner was not designed to fire in this type of crash configuration. The D-ring was adjusted to a mid-position. Examination of the latch plate revealed evidence of historical use. Usage indicators were also identified on the frictional surface of the latch plate consisting of a full width abrasion to the plastic surface. A corresponding transfer was identified on a 5 cm (2 in) section of the webbing located at the latch plate with the restraint in the buckled condition, **Figure 12**. The webbing transfer began 71.6 cm (28.2 in) from the floor anchor. The inspection of the driver's belt system indicated he was restrained at the time of the crash.

Figure 9: View of the driver's restraint.

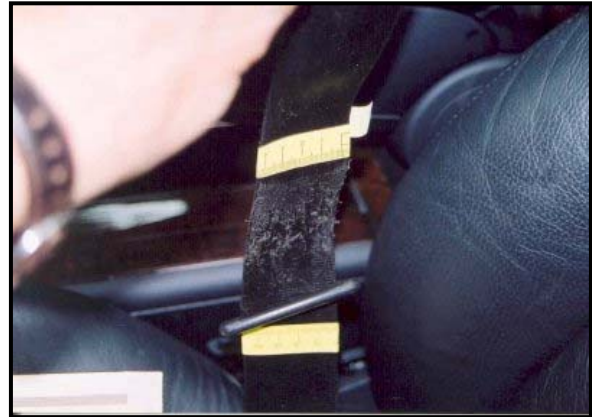
Figure 10: Close-up of the webbing transfer at the latch plate.

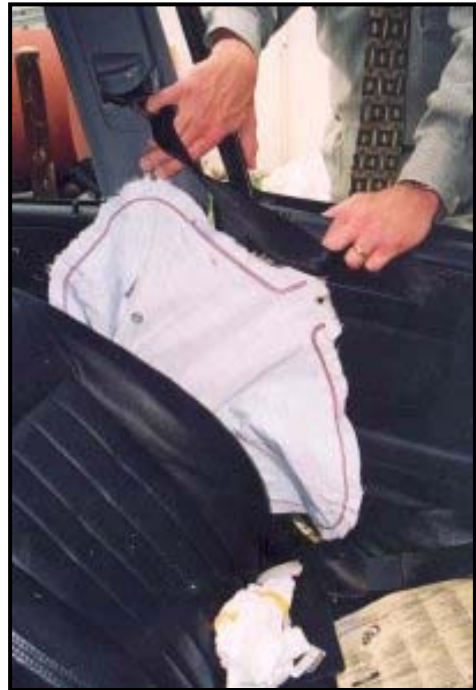
The side impact air bag deployed from the outboard aspect of the seat back along a 38 cm (15 in) seam, **Figure 11**. The bag expanded forward and offered thorax protection to the driver. The deflated air bag was approximately rectangular in shape and measured 20 cm x 58 cm (8 in x 23 in), width by height, respectively. It was not tethered. The air bag was vented by an opening in the stitching on the center forward aspect of the bag. Several post-crash blood spatters were located on the bag's inboard surface. There was no direct evidence of occupant contact to the bag. The following manufacturer's data was embossed onto the air bag's fabric:

Figure 11: View of the deployed side impact air bag.

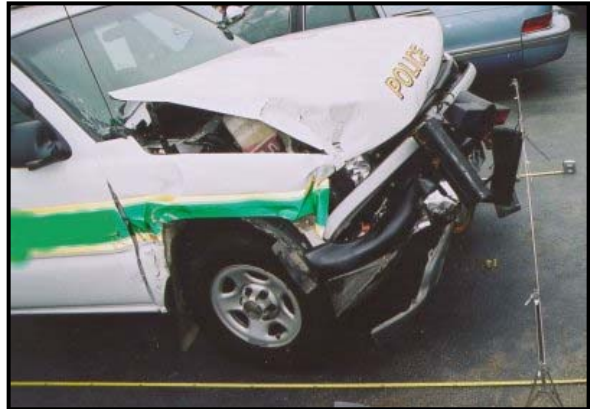
The Chevrolet sustained 87.6 cm (34.5 in) of direct contact damage began 7.6 cm (3.0 in) left of center and extended to the right corner of the front bumper. The combined direct and induced damage to the frontal plane that extended across the entire 160 cm (63 in) frontal end width of the vehicle. The direct contact pattern wrapped 175 cm (69 in) onto the right front fender due to the clockwise rotation of the Audi. The frontal impact damaged the OEM front bumper, aftermarket push bumper, grille, right headlamp assembly, hood and right front fender. An insurance repair estimate indicated the frame was deformed and would have to be replaced. The rearward shift of the hood and right front fender fractured the lower right aspect of the windshield. The operation of the right front door was restricted by the deformed front fender. The right wheelbase was foreshortened 10.7 cm (4.2 in). The crush profile measured along the front bumper was as follows: C1 = 1.3 cm (0.5 in), C2 = 4.6 cm (1.8 in), C3 = 9.9 cm (3.9 in), C4 = 12.4 cm (4.9 in), C5 = 11.4 cm (4.5 in), C6 = 21.3 cm (8.4 in). **Figure 12** is a right lateral view across the front plane. The delta V calculated by the Damage Algorithm of the WINSMASH model was 14.0 km/h (8.7 mph). The longitudinal and lateral delta V components were -13.8 km/h (-8.6 mph) and -2.4 km/h (-1.5 mph), respectively. The Collision Deformation Classification (CDC) was 12-FZEW-2.

Figure 12: Right lateral view of the Tahoe.

The right side of the Chevrolet sustained minor buckling and abrasions in the region of the right rear door as a result of the side slap. The length of the contact pattern measured 109 cm (43 in). The direct contact began 152 cm (60 in) forward of the right rear axle and extended rearward to the trailing edge of the right rear door. The maximum lateral deformation measured 5 cm (2 in). The CDC of this minor impact was 03-RPEW-1.
