Remote Investigation / Vehicle to Vehicle  
Dynamic Science, Inc. / Case Number: DS02023  
1993 Cadillac DeVille four door sedan  
California  
September, 2001

**Dynamic Science, Inc.**  
**Accident Investigation**  
**Case Number: DS02023**

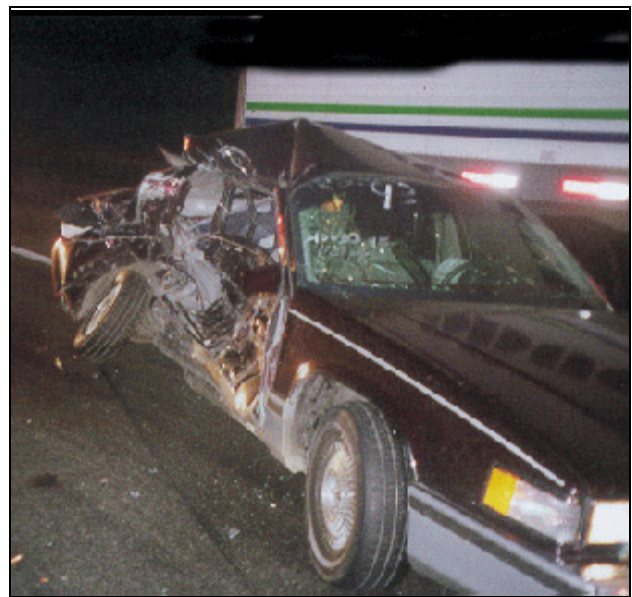
**Figure 1.** Final rest, case vehicle (northwest)

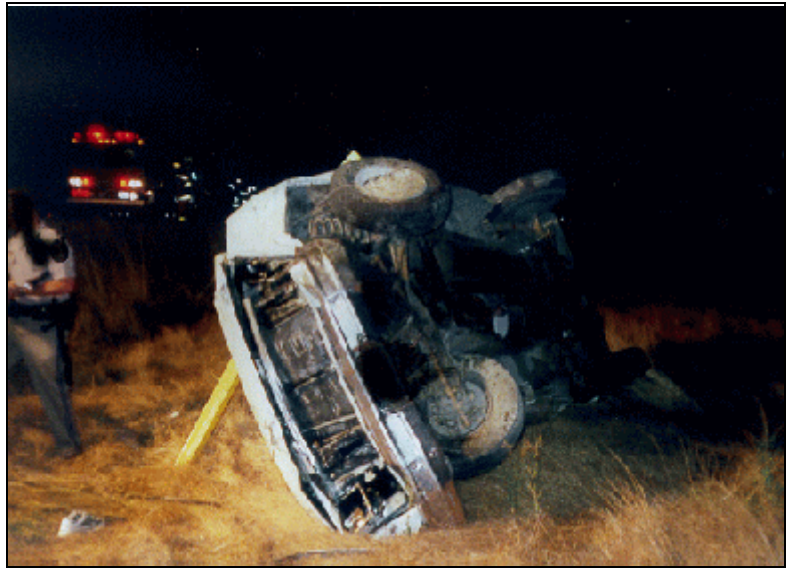
**Figure 2.** Final rest, other vehicle (south)

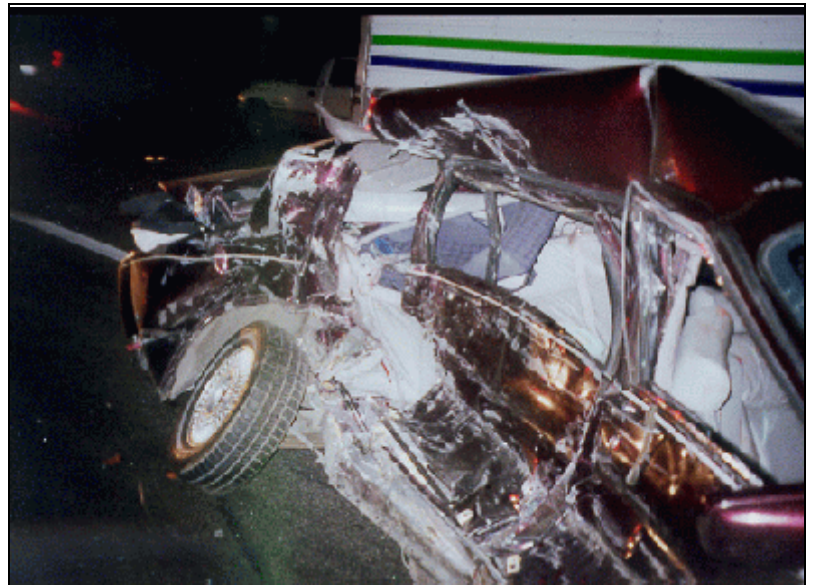
**Figure 3.** Right side damage, case vehicle

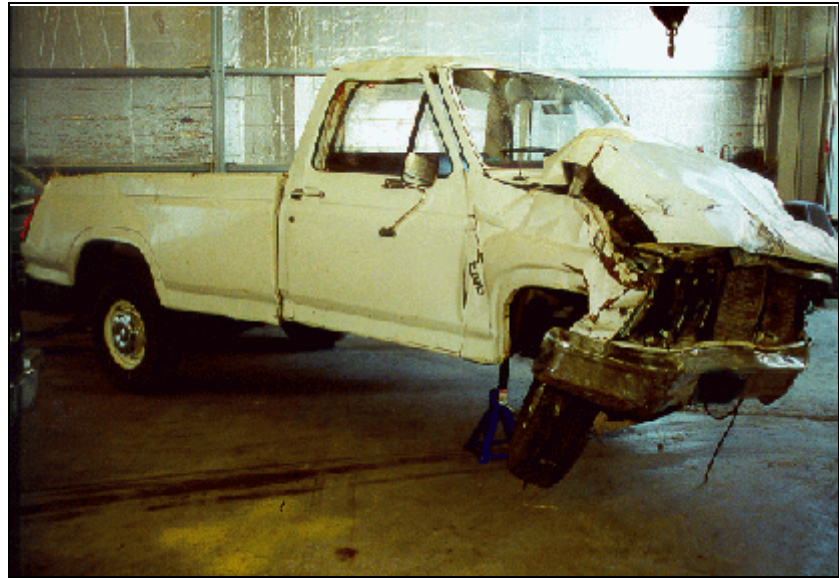
**Figure 4.** Front right, other vehicle

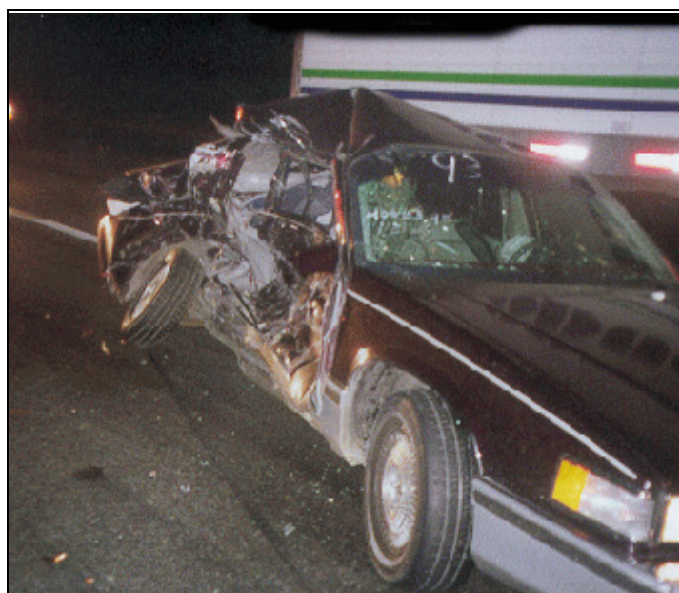
Description:	1993 Cadillac DeVille four-door sedan	
VIN:	Unknown	
Odometer:	Unknown	
Engine:	4.9 L (300 CID)/ 8 cylinder	
Reported Defects:	None noted	
Cargo:	Child seat, unknown additional items	
Damage Description:	Major damage through right side. Intrusion through both right doors. Vehicle towed due to damage.	
CDC (based on photos):	01RZAW3	
Delta V:	Total	35 km/h (22 mph)
	Longitudinal	-27 km/h (-17 mph)
	Latitudinal	-23 km/h (-14 mph)
	Energy	35,560 joules (26,228 ft-lbs)

**Figure 6.** Right side damage, case vehicle

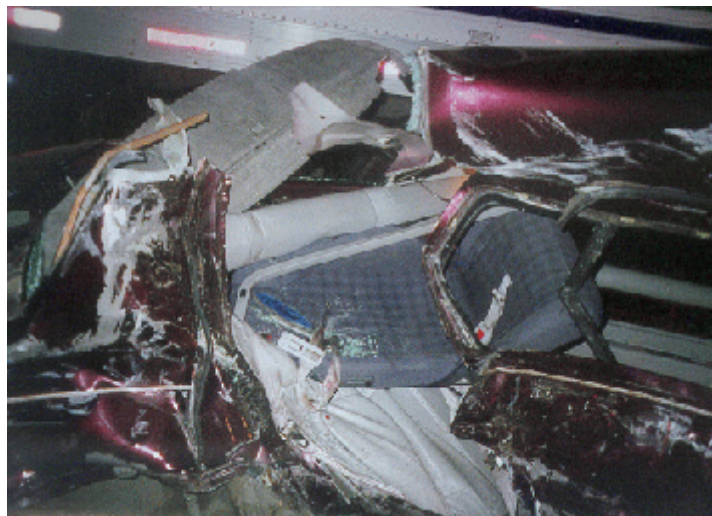
The 10-month-old female rear right occupant was seated in what appears to be an older model Cosco Highback Booster seat. The manufacturer's recommendations for use of this seat are: between 10- 18 kg (22 and 40 lbs) use 5-point harness and for 14-32 kg (30-70 lbs) remove harness and use as a belt-positioning booster. This seat is designed to have a 5-point harness, however, the hip straps were not present. This is likely due to mis-threading of the harness. According to police, this occupant was "properly secured in a child restraint seat." Based on the location of the vehicle shoulder belt in the photos, it would appear that the belt was being used with the child seat. The photos represent the position of the seat after emergency personnel had extricated and transported the child.

**Figure 7.** Child safety seat as it was found in vehicle

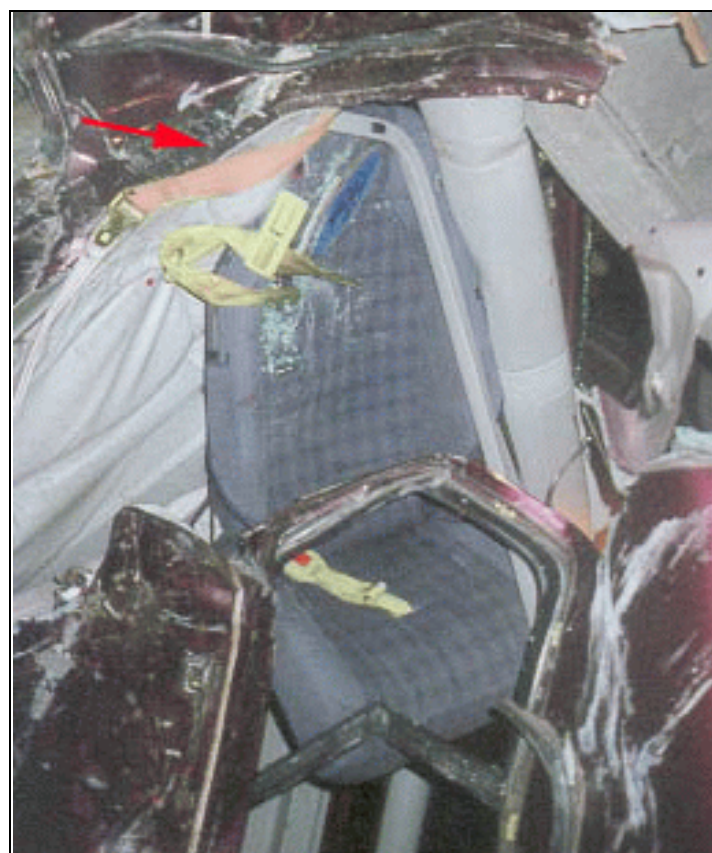
**Figure 8,** Child safety seat, image rotated and webbing enhanced

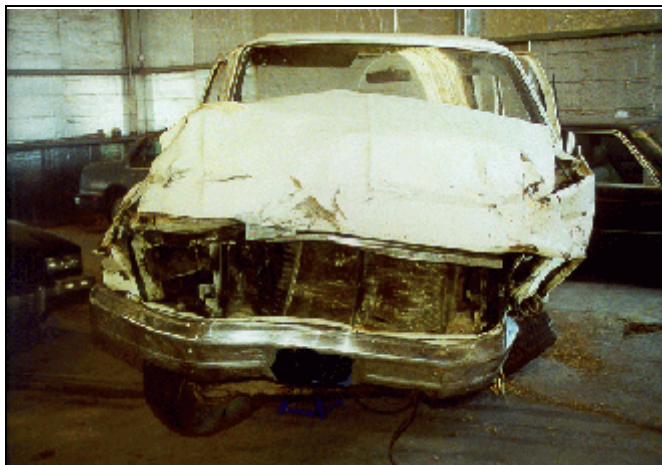
Damage Description: Major front end damage. Bumper, hood, grille, and fenders damage.

**Figure 9.** Front of other vehicle (1985 Ford F150 pickup)

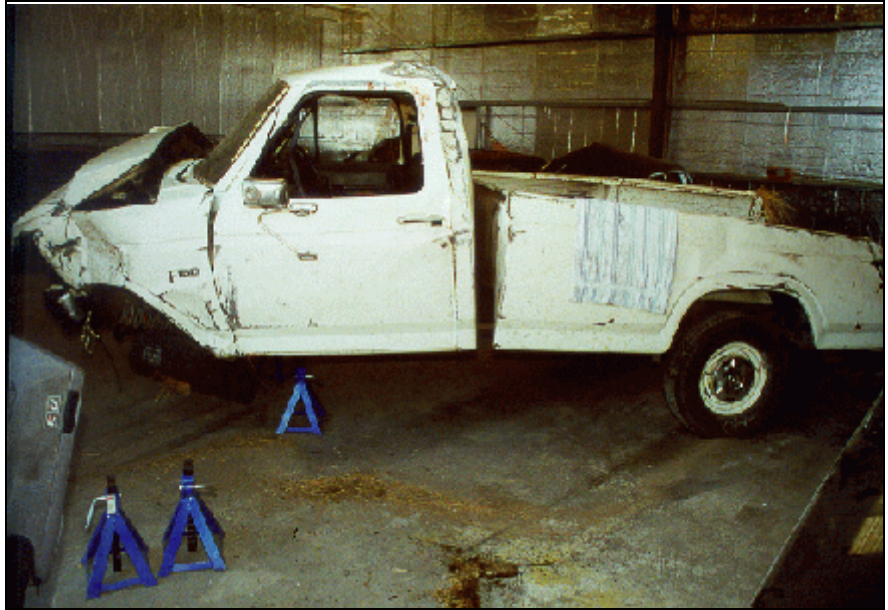
**Figure 10.** Left side, other vehicle

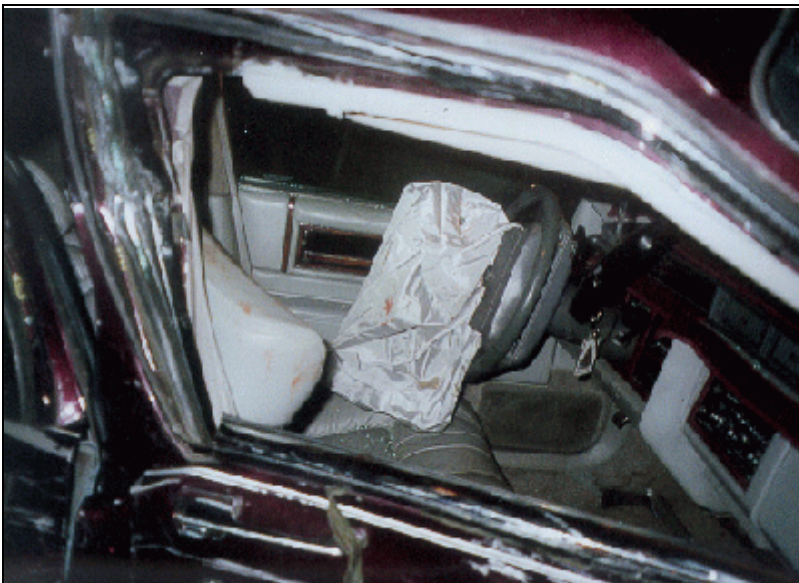
The 29-year-old male driver of the case vehicle was seated in a forward facing position. He was wearing the available lap and shoulder belt. It is believed that his right foot was on the accelerator and his left was on the floor. At impact, he was projected forward and to the right. He loaded the lap and shoulder belt and engaged the deployed air bag. He sustained lacerations to his face and head from an unknown source.

**Figure 11.** Driver's air bag

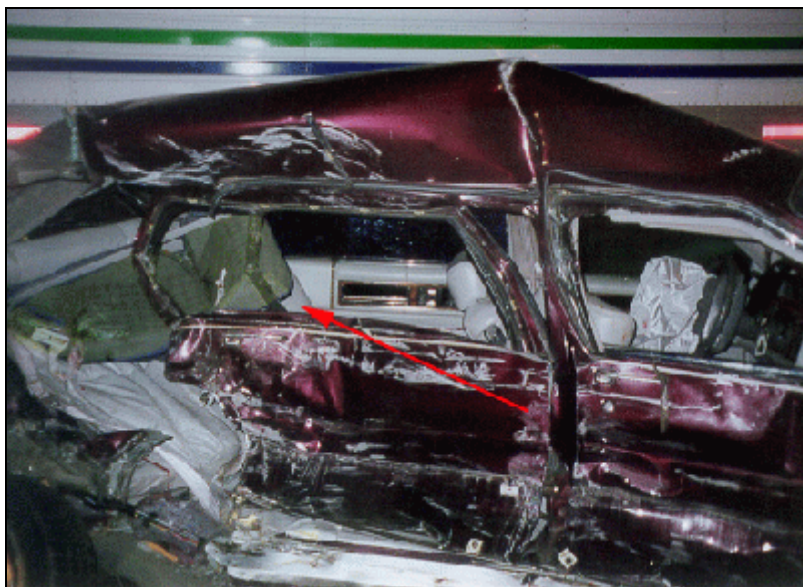
**Figure 12.** Rear right seat

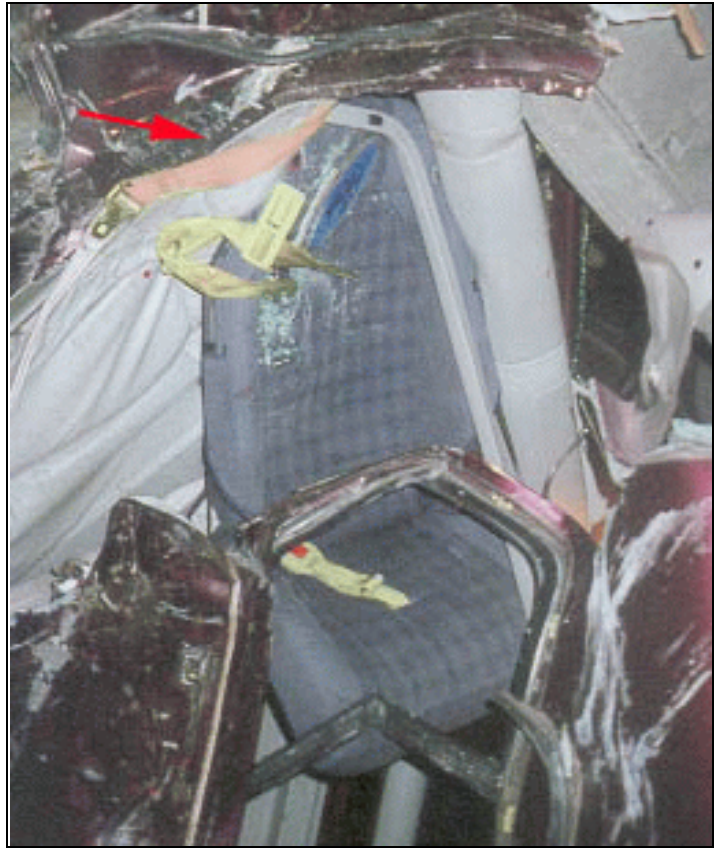
The 10-month-old female rear right occupant was seated in a forward facing/booster seat with what appears to be a modified harness system. The seat was designed with a 5-point harness, however there was no visual sign of the hip straps being available and/or used. It is believed that the seat was anchored to the vehicle and the child was strapped into the seat. The hip straps were not being used and do not appear to be available at the time of the crash. At impact, the child's initial motion would have been forward and to the right. As the right rear door intruded into the passenger compartment, this occupant engaged the door panel and side glass frame. The facial injuries were most likely related to the frame, while the abdominal injuries were related to the door panel.

**Figure 13**, Child safety seat, image rotated and webbing enhanced
