**VERIDIAN ON-SITE AIR BAG DEPLOYMENT INVESTIGATION  
SCI TECHNICAL SUMMARY REPORT**

**VERIDIAN CASE NO. CA02-031**

**VEHICLE - 1997 HONDA CIVIC**

**CRASH DATE - JULY 2002**

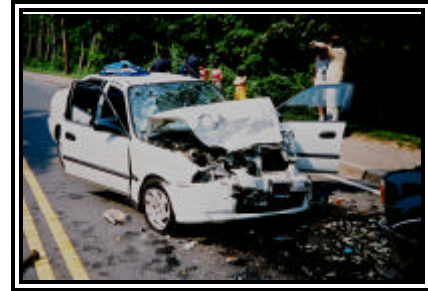
**Figure 1. On-scene photograph of the damaged 1997 Honda Civic**

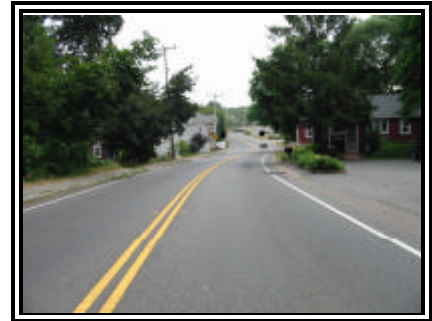
**Figure 2. Southbound approach for the Honda Civic**

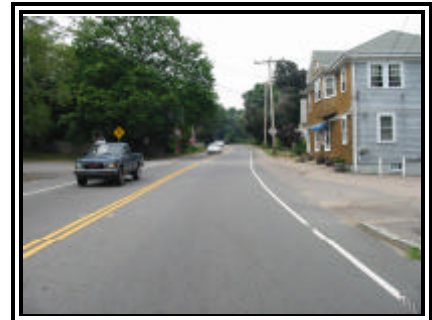
**Figure 3. Northbound approach for the Toyota Tacoma**

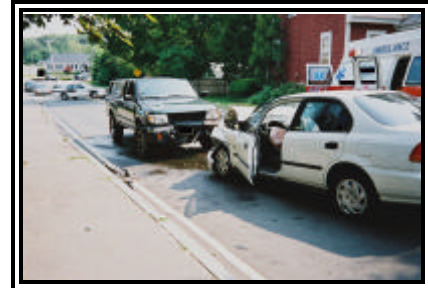
The Honda Civic came to rest facing south in the northbound lane and the Toyota Tacoma came to rest facing north in the northbound lane (**Figure 4**). A witness to the crash stated that passers-by attempted to stabilize the driver of the 1997 Honda Civic in the vehicle until rescue personnel arrived. Rescue personnel indicated that they found the driver of the Civic “under the dash” on the left side. The driver was removed from the vehicle by rescue personnel and transported by ambulance to a local hospital. Paramedics reported that the driver exhibited chest trauma, had a pulse and was breathing on his own at the time he was removed from the vehicle. The driver expired shortly after arrival at the hospital. The driver of the Toyota Tacoma was removed from the vehicle by rescue personnel and transported to a local hospital. His admission status was not known.

**Figure 4. Post-crash view showing final rest positions**

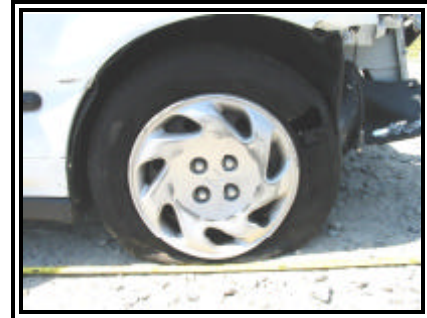
The 1997 Honda Civic sustained minor right side damage as a result of the pre-crash sideswipe impact with the guardrail. The impact resulted in longitudinal abrasions that began on the right front corner and extended rearward 166.4 cm (65.5") along the right side plane. Minor lateral crush was noted on the right front fender and measured 4.4 cm (1.8") at the rear aspect of the fender. The right front corner of the bumper fascia sustained heavy abrasions as a result of the contact with the guardrail. The guardrail contact also resulted in a laceration and hole in the sidewall of the right front tire that measured 8.9 cm (3.5") in width and 6.4 cm (2.5") in height (**Figure 5**). The right front wheel cover was abraded and deformed from the direct contact. An abrasion that measured 27.9 cm (11.0") in length was also present on the right rear quarter panel above the right rear wheel. The Collision Deformation Classification (CDC) for the guardrail impact was 12-FRES-1.

**Figure 5. View of abraded right front wheel cover and sidewall laceration**

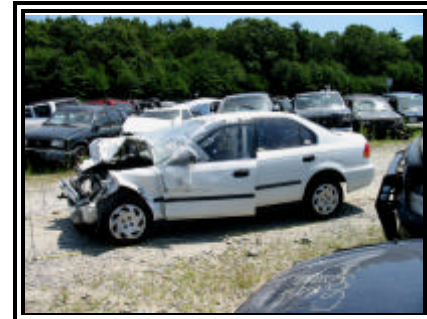
The Honda Civic also sustained minor left side damage (**Figure 6**) which resulted from the sideswipe with the 1993 Saturn. The left front fender and left front door were abraded longitudinally from direct contact with the Saturn. The initial direct contact and lateral deformation could not be accurately determined due to masking damage from the frontal impact. The abrasions extended rearward along the left side plane 52.1 cm (20.5") aft of the leading edge of the left front door. The left front wheel cover was abraded. Three linear abrasions were located on the left side aspect of the bumper fascia, but it was not known if they were crash-related.

**Figure 6. Left side view of 1997 Honda Civic**

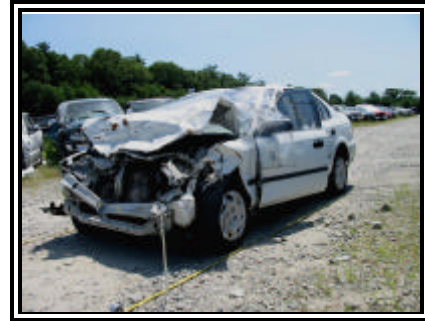
The frontal impact with the Toyota Tacoma pickup truck resulted in moderate frontal damage to the 1997 Honda Civic (**Figures 7 and 8**). The direct damage began 50.8 cm (20.0") right of center on the bumper fascia and extended laterally to the front left corner. The Civic underrode the Tacoma which allowed the grille area and hood to sustain direct contact damage evidenced by buckling, longitudinal abrasions and rearward crush. The bottom aspect of the bumper fascia was heavily abraded longitudinally from contact with the roadway surface and the fascia was fractured in four places from the impact. The entire bumper fascia was separated at the time of the vehicle inspection. The sheet metal and left corner of the upper radiator support were torn and crushed from direct contact. The protruding frame rails of the pickup truck penetrated the right aspect of the radiator core and components to the left of the left aspect of the radiator core. The upper and lower radiator supports and bumper beam were crushed rearward. The styrofoam filler was separated from the bumper beam at the time of the vehicle inspection. The left front wheel was displaced rearward and the left wheelbase was shortened 9.4 cm (3.7"). The right front wheel sustained minor rearward displacement and the right wheelbase was shortened 2.5 cm (1.0"). Both front fenders sustained induced buckling. The CDC for the frontal impact with the Toyota Tacoma was 12-FDEW-2. Six crush measurements were taken along the front bumper beam and were as follows: C1 = 22.2 cm (8.8"), C2 = 34.9 cm (13.8"), C3 = 37.4 cm (14.8"), C4 = 37.4 cm (14.8"), C5 = 34.2 cm (13.5"), C6 = 3.2 cm (1.3").

**Figure 7. View of frontal damage to the Honda Civic**

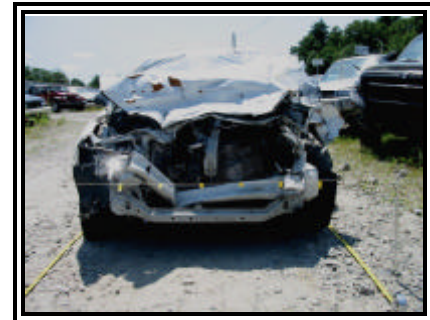
**Figure 8. Frontal view of damage to the Honda Civic**

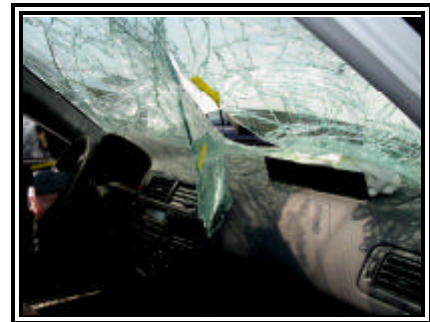
Interior damage to the 1997 Honda Civic was moderate and attributed to occupant contact and passenger compartment intrusion. The entire windshield was fractured from impact forces. A vertical laceration in the windshield laminate that measured 33.0 cm (13.0") in length was located 15.2 cm (6.0") left of center and 6.4 cm (2.5") below the windshield header. The windshield was also holed on the right aspect (**Figure 9**). The hole measured 38.1 cm (15.5") in height and 15.2 cm (6.0") in width and was located 33.7 cm (13.3") right of center and began 11.4 cm (4.5") below the windshield header. A light strand of hair was present in the fractured laminate, and a small clump of dark hair measuring 1.0 cm (0.4") was present on the inboard side of the hole on the outer aspect on the laminate 31.8 cm (12.5") below the header. The source of the hair was unknown, and the color of the small clump of hair was inconsistent with the driver's hair color. The left front window was

**Figure 9. View of holed windshield**

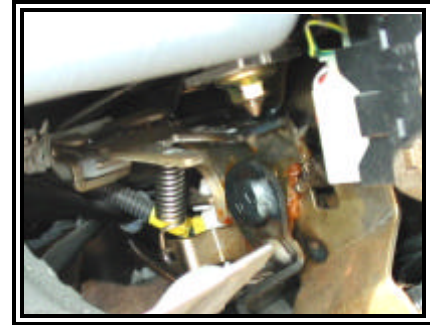
The entire steering wheel rim was deformed forward from occupant contact, and the all of the spokes were partially separated. The steering column was compressed forward with complete separation of the shear brackets (**Figure 10**).

**Figure 10. View of separated left shear bracket**

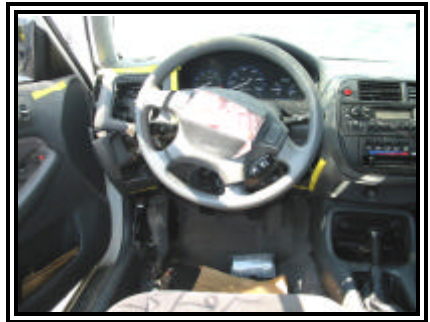
**Figure 11. View of steering wheel and contact points**

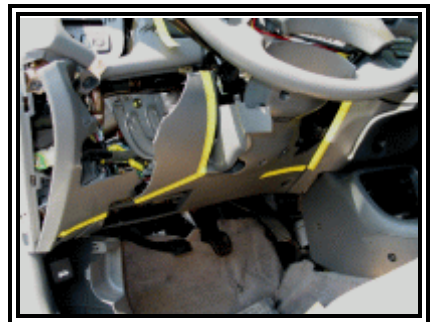
The interior surface of the left front door was abraded in a triangular fashion 20.3 cm (8.0") aft of the leading door edge and 2.5 cm (1.0") below the belt line and measured 7.0 cm (2.5") in length. The knee bolster and left instrument panel were fractured and holed on both sides of the steering column from contact with the driver's knees and lower legs (**Figures 11 and 12**). The fracture on the left side of the column measured 12.7 cm (5.0") in width and the fracture on the right side of the column measured 10.2 cm (4.0") in width. The brake pedal was displaced slightly to the right. The rear view mirror was separated from the windshield. The glove box door was open at the time of the vehicle inspection, and would not close due to induced damage from the crash. A thin longitudinal abrasion that measured 7.0 cm (2.8") in length was present on the head liner 17.1 (6.8") left of center and 31.8 cm (12.5") rear of the windshield header. Small amounts of body fluid (blood) were present on both front seat cushions and on the front aspect of the front right seat back. The front left seat back was rotated in a slight counterclockwise (CCW) direction. Longitudinal intrusions into the driver's seating position included the left toe pan and the left instrument panel. The right toe pan intruded into the front right occupant space.

**Figure 12. Close-up of damaged knee bolster and instrument panel**

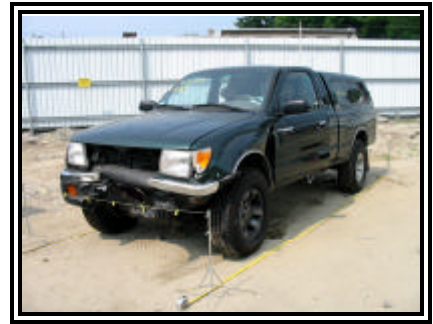
The 1999 Toyota Tacoma sustained moderate frontal damage as a result of the impact with the Honda Civic (**Figure 13**). The direct damage was concentrated on the front bumper and began 52.1 cm (20.5") right of center and extended 128.3 cm (50.5") along the bumper to the front left corner. The bumper sustained longitudinal abrasions and the bottom aspect was deflected rearward and upward due to the underride of the Civic. The bumper crush allowed both frame rails to protrude through the lower aspect of the bumper. The left frame rail was protruded 19.1 cm (7.5") and the right frame rail protruded 28.6 cm (11.3"). The right corner of the bumper was pulled inward slightly from induced damage. There was no direct contact damage above the bumper of the Toyota Tacoma. The direct and induced damage involved the entire frontal width of the pickup truck. The grille was separated from the Tacoma, the left head lamp was slightly displaced, and the right bumper corner was pulled inward slightly from induced damage. The left front wheel was displaced rearward and restricted against the left front fender which resulted in the shortening of the left wheelbase by 4.2 cm (1.7"). Both front fenders were buckled from induced damage. The CDC for the frontal impact with the Honda Civic was 12-FDEW-2. Six crush measurements were taken along the front bumper of the Toyota Tacoma and were as follows: C1 = 14.0 cm (5.5"), C2 = 16.5 cm (6.5"), C3 = 22.2 cm (8.8"), C4 = 24.8 cm (9.8"), C5 = 17.1 cm (6.8"), C6 = 3.8 cm (1.5").

**Figure 13. View of frontal damage to the Toyota Tacoma**

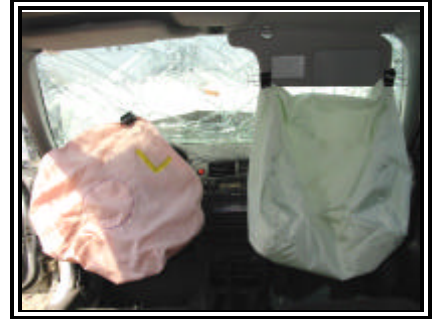
The 1997 Honda Civic was equipped with frontal air bags for the driver and front right passenger positions that deployed as a result of the impact with the Toyota Tacoma pickup truck (**Figure 14**). The driver's air bag was housed in the steering wheel hub with asymmetrical H-configuration cover flaps. The top flap measured 10.2 cm (4.0") in width at the top aspect, 7.6 cm (3.0") in height, and 14.6 cm (5.8") in width at the tear seam. The bottom flap measured 8.3 cm (3.3") in width at the bottom aspect and 5.1 cm (2.0") in height. The driver's air bag was circular in shape and measured 61.0 cm (24.0") in diameter in its deflated state. The air bag was vented by two circular ports that measured 3.8 cm (1.5") in diameter and were located at the 11 and 1 o'clock positions on the rear aspect. The air bag was also tethered by two internal straps that measured 7.0 cm (2.8") in width and were located at the 12 and 6 o'clock positions. A faint abrasion was present on the top right quadrant of the air bag membrane located 19.1 cm (7.5") from the center of the air bag and measured 7.0 cm (2.8") in length and 3.8 cm (1.5") in width. A body fluid (blood) transfer was located on the bottom aspect of the air bag adjacent to the tear seam. The body fluid transfer measured 3.0 cm (1.2") in length and 0.8 cm (0.3") in height. Faint green/blue fabric transfers were located adjacent to the body fluid transfer along the bottom aspect of the air bag on the air bag seam (**Figure 15**). The transfers measured 8.9 cm (3.5") in length. Thin diagonal green fabric transfers/striations were located along the outboard air bag seam on the left lower quadrant. The transfers measured 14.0 cm (5.5") in length along the air bag seam.

**Figure 14. Deployed frontal air bags in the Honda Civic**

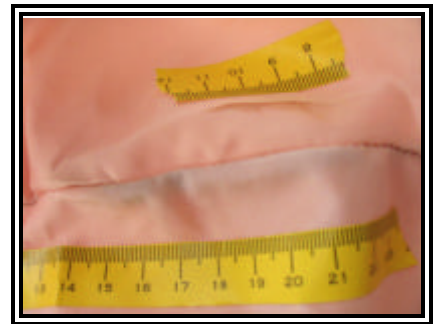
**Figure 15. Body fluid transfer and fabric transfer on bottom aspect of the driver's air bag**

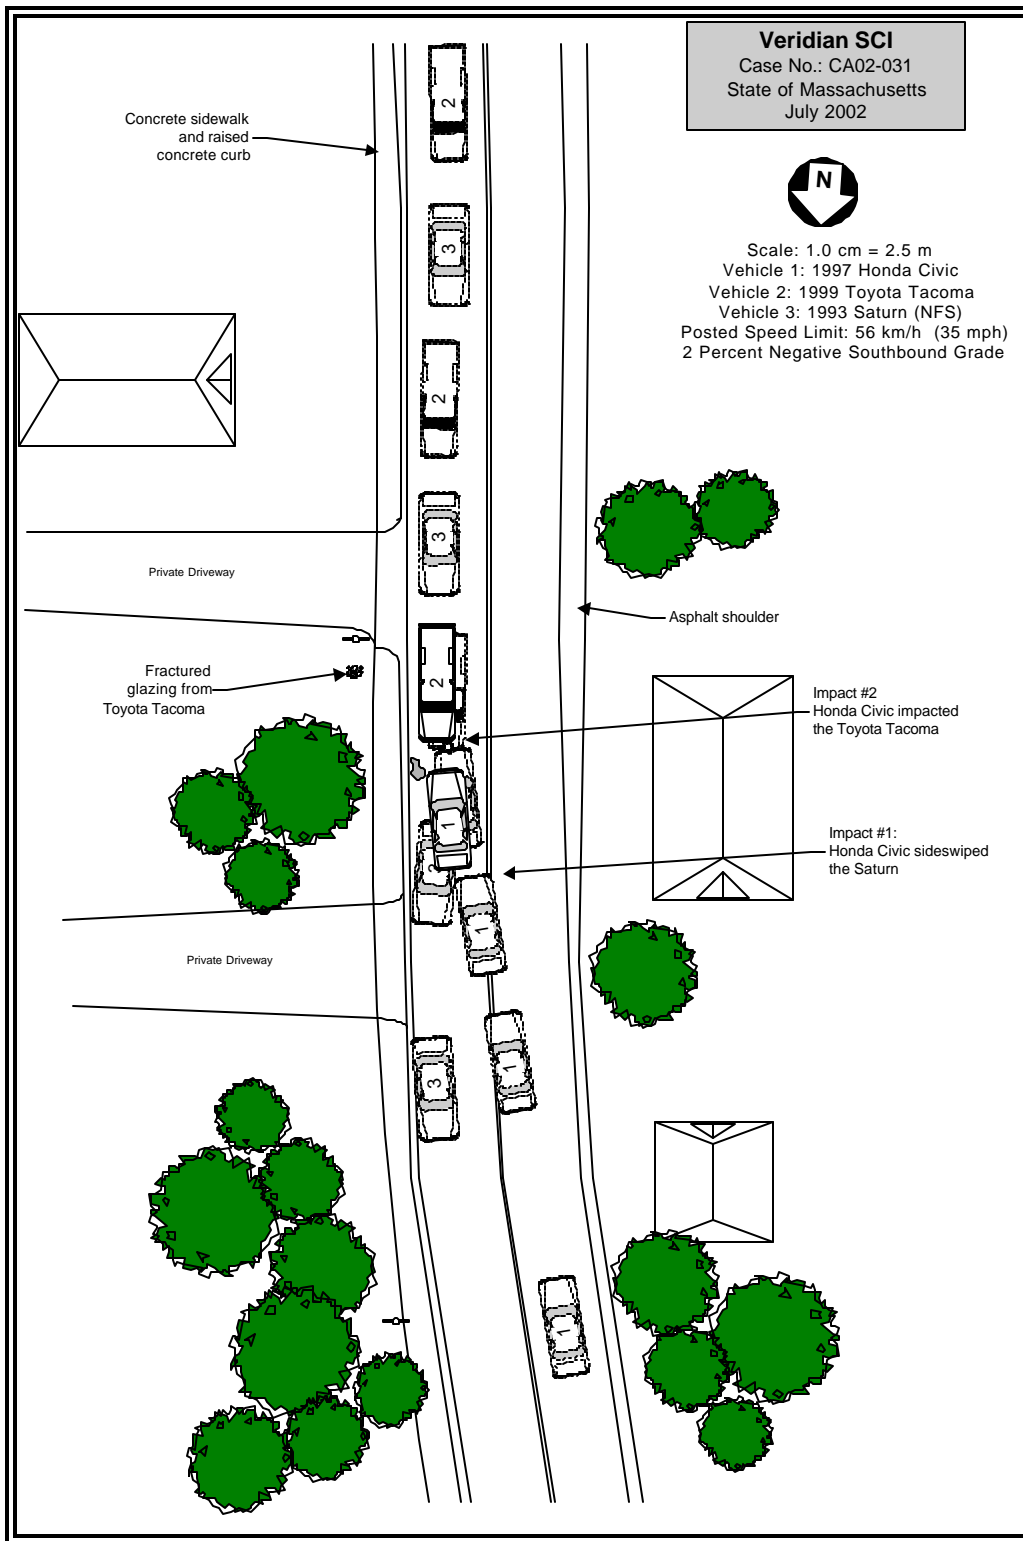
Figure 16. Scene schematic

This three-vehicle crash occurred on a two-lane undivided roadway during daylight hours of July 2002. At the time of the crash, the weather was clear and the asphalt roadway surface was dry. The north/south roadway consisted of two travel lanes separated by a double-yellow centerline. The roadway was bordered by a concrete curb and concrete sidewalk on the east side and by asphalt shoulders on the west side. The crash occurred on a straight segment of the roadway with a two percent negative southbound grade. Opposing curves were present north and south of the crash site which created an “S” curve configuration. There was no traffic control present at the scene and the posted speed limit for the roadway was 56 km/h (35 mph). The scene schematic is included as **Figure 16** of this report.
