**OFFICE OF DEFECTS INVESTIGATION
1998 FORD CROWN VICTORIA POLICE INTERCEPTOR REAR IMPACT CRASH**

VERIDIAN CASE NO: CA02-034

<p>15. <i>Sponsoring Agency Code</i></p>	
<p>16. <i>Supplementary Notes:</i> On-site investigation of a rear impact crash of a 1998 Ford Crown Victoria resulting in a fire.</p>			
<p>17. <i>Abstract</i></p> <p>This investigation focused on identifying the cause of a crash induced fire in a 1998 Ford Crown Victoria Police Interceptor and the identification of any associated potential mechanical defect(s). The Ford Crown Victoria was involved in a rear-end crash with a 2002 Chevrolet K2500 pick-up truck towing a 5th wheel gooseneck cattle trailer. The Ford Crown Victoria was stopped on the road straddling the fog line at the time of the crash with his emergency lights illuminated. The 78 year old driver of the Chevrolet failed to recognize that the police vehicle was stopped and braked too late to avoid the crash. The New York State Trooper seated in the Ford struck the posterior aspect of his head on the intruding rear sheet metal and was incapacitated. He was removed from the vehicle by some witnesses to the crash. The Ford Crown Victoria was then consumed

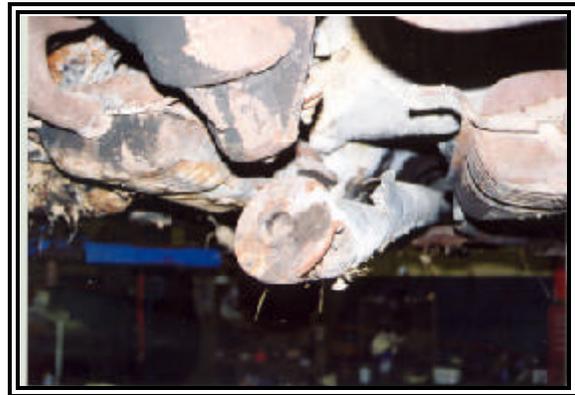
A pattern of gouge marks attributed to the front and rear suspensions of both vehicles identified the point of impact. The post-crash trajectory of the Ford was identified by rear tire skid marks and a long gouge located centrally between the rear tire skids. As a result of the impact, the differential input shaft and the drive shaft of the Ford fractured, **Figure 4**. The gouge mark was attributed to contact from the steel flange at the end of the drive shaft, as the Ford was forced down by the override. This contact was the probable source of the fire's ignition. The outer diameter at the end of the drive shaft was ground down from the contact.

Figure 4: Drive shaft deformation.

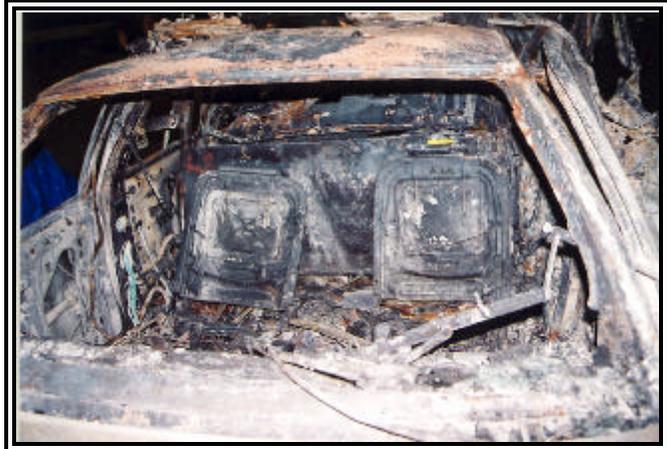
The rear plane of the vehicle sustained severe impact damage that extended across its entire 142.2 cm (56.0 in) end-width. The damage was indicative of an override with the above bumper damage biased to the left side and extending longitudinally forward to the left B-pillar. The left rear door was crushed against the B-pillar and the left C-pillar was crushed forward within 18 cm (7 in) of the left B-pillar. The left front door was jammed shut. The right rear door was fully intact and was jammed shut due to the deformation of the vehicle's frame. The right front door was operational and was used to remove the injured Trooper. The trunk space collapsed and its contents crushed forward due to the impact. The deformation extended forward through the rear occupant space, forward to approximately the front seat backs. The fire consumed everything that was combustible in the vehicle and it was a total burn, **Figure 6**.

Figure 6: View through the windshield opening of the front interior.

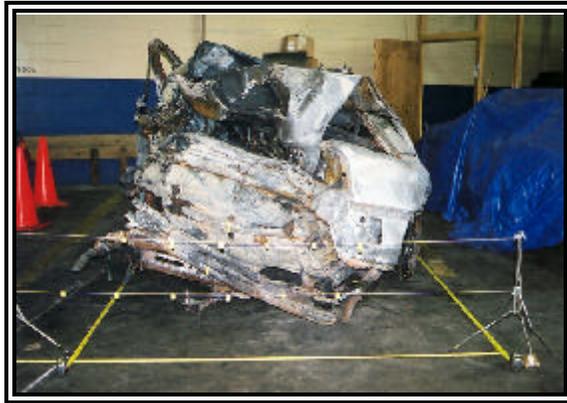
The residual crush profile of the Ford was measured along the rear bumper and along the trunk line in order to document the override damage. The crush values at these respective elevations were then averaged to develop a composite profile used for analysis. The averaged residual crush profile was as follows: C1 = 118 cm (46 in), C2 = 97 cm (38 in), C3 = 88 cm (35 in), C4 = 72 cm (28 in), C5 = 41 cm (16 in), C6 = 19 cm (7.5 in). The maximum crush at the left rear bumper corner measured 99 cm (39 in). The maximum above-bumper damage (at the location of the left rear tail light) measured 138 cm (54 in). The Collision Deformation Classification (CDC) was 06-BDEW-6. The total Delta V of the Ford calculated by the Damage Algorithm of the WINSMASH model was 45 km/h (28 mph). The longitudinal and lateral components were +45 km/h (+28 mph) and 0 km/h, respectively. The crash configuration was beyond the scope of the WINSMASH model due to the unknown loaded weight of the trailer, however, the results appear reasonable. A Conservation of Momentum and Energy analysis indicated the vehicle's delta V was in the range of +45 to 58 km/h (+28 to +36 mph), based on the Chevrolet's impact speed of 64 to 80 km/h (40 to 50 mph). The WINSMASH analysis was consistent with the analysis by the Conservation Principles. **Figures 7 through 9** are views of the Ford's exterior damage.

Figure 7: Rear view of the Ford.

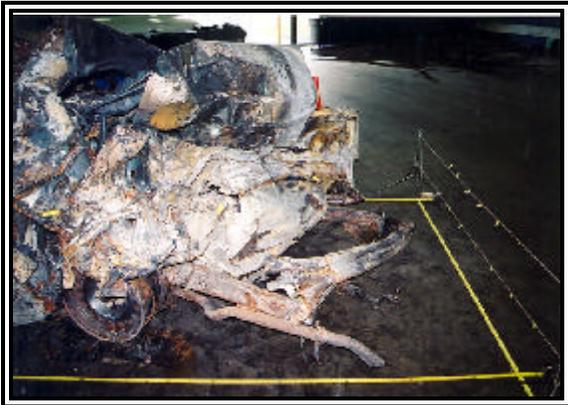
The left rear and right rear body mounts separated from their respective frame locations. The residual location of the left rear mount was 42.0 cm (16.5 in) forward and 36 cm (14 in) above the deformed frame. The right rear mount was located 41 cm (16 in) forward and 29.0 cm (11.5 in) above the deformed frame. The left wheelbase was foreshortened 46 cm (18 in). The right wheelbase lengthened 18 cm (7 in) due frame distortion and rotation of the rear axle.

Figure 8: Left lateral view depicting the maximum deformation.

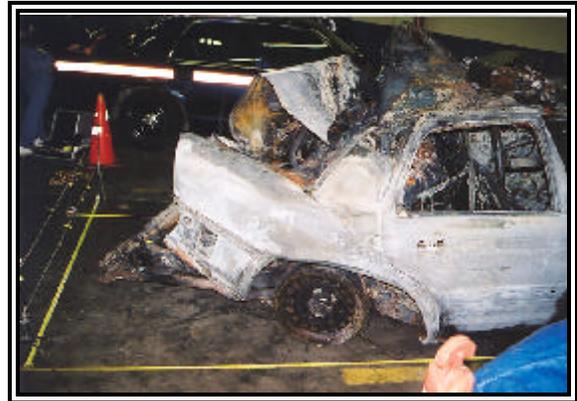
Figure 9: Right rear deformation.

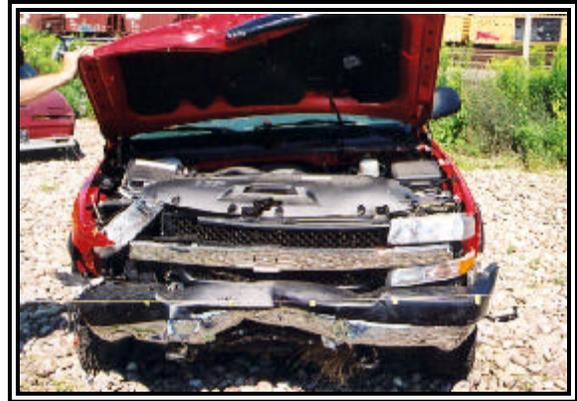
The front plane of the Chevrolet sustained 136.0 cm (53.5 in) of direct contact damage that began 53 cm (21 in) left of the vehicle's center line and extended to the right front bumper corner, **Figure 11**. The combined width of the direct and induced damage extended across the entire 165 cm (65 in) frontal end width. The residual crush profile was as follows: C1 = 0, C2 = 9.0 cm (3.4 in), C3 = 22.0 cm (8.8 in), C4 = 32.0 cm (12.5 in), C5 = 24.0 cm (9.5 in), C6 = 28.0 cm (11 in). The Collision Deformation Classification (CDC) was 12-FDEW-2.

Figure 11: Front view of the Chevrolet.

The energy of the impact was primarily managed by the vehicle's structures forward of the radiator support plane and engine cradle. The damaged components included the front bumper, grille, right headlamp assembly, engine cradle and right front suspension. There was a right side bias to the damage pattern due to the slight offset impact orientation of the vehicles. The right wheelbase was reduced 14.7 cm (5.8 in). There was earth and grass embedded in the undercarriage as a result of an impact with the ground during the road side departure. The total Delta V of the Chevrolet calculated by the Damage Algorithm of the WINSMASH model was 22.0 km/h (13.7 mph). The longitudinal and lateral components were -22 km/h (-13.7 mph) and 0 km/h, respectively. The impact speed calculated by the Trajectory Algorithm was 63.0 km/h (39.2 mph). The crash configuration was beyond the scope of the WINSMASH model due to the unknown loaded weight of the trailer, however, the results appear reasonable. This calculated speed was consistent with the 64 to 80 km/h (40 to 50 mph) speed range calculated by the Conservation of Momentum and Energy Principles.

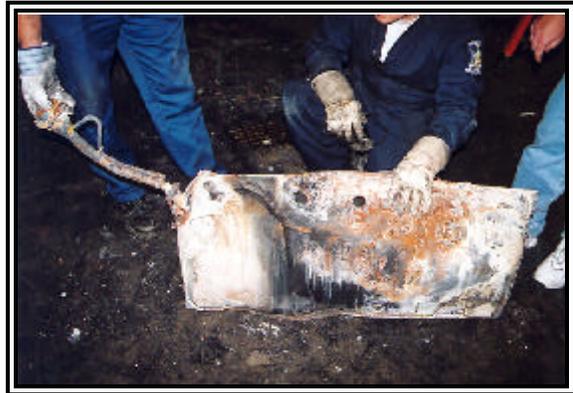
filler door was displaced forward 50.3 cm (19.8 in). The residual location of the filler door was 12.5 cm (5.0 in) forward of the post-crash left rear axle location. There was no separation of the filler neck from the tank during the crash, **Figure 14**. Approximately 14.7 cm (5.8 in) of the filler neck remained within the tank. The non-combustible portion of the filler cap was threaded into the neck at the time of the inspection.

Figure 14: Filler neck and fuel tank after removal from the vehicle.

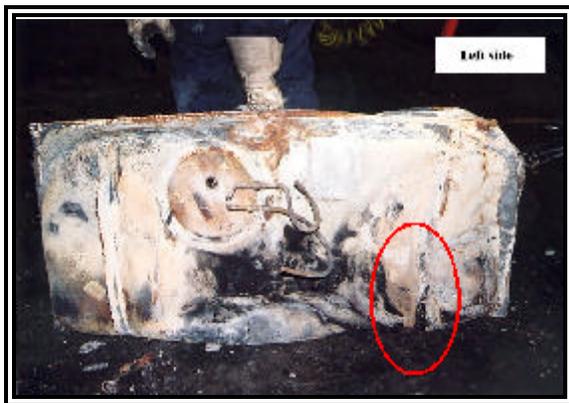
The deformation of the fuel tank was biased to its left side. The damaged tank did not have a large reduction in its volume. Two large creases were noted on the left forward side of the tank from direct contact with the left lower shock absorber mount. The creases measured approximately 11.4 cm (4.5 in) in length. No punctures in the tank were identified prior to its removal.

Figures 15 and 16 are overall views of the tank after its removal from the vehicle. A distinct burn pattern was noted on the rear side of the tank (refer to Figure 15). Close inspection of the tank identified a small vertically oriented puncture/cut in the area of the left tank strap on the forward side of the tank. The area in question is highlighted in red in Figure 14. The hole measured 11.1 mm (0.43 in) long by 1.5 mm (0.06 in) wide. **Figures 17 and 18** are progressively closer views of the puncture/cut.

Figure 15: View of the forward side of the tank.

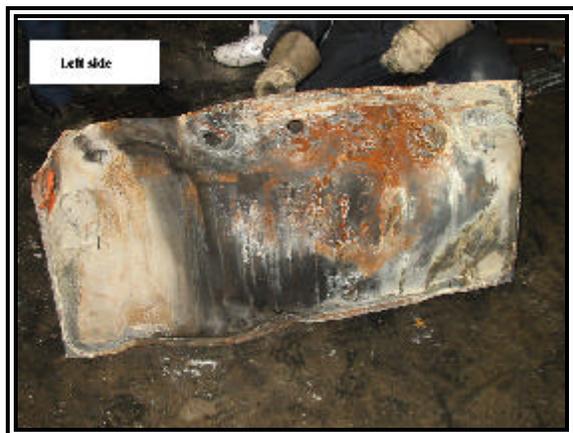
Figure 16: View of the rear side of the tank.

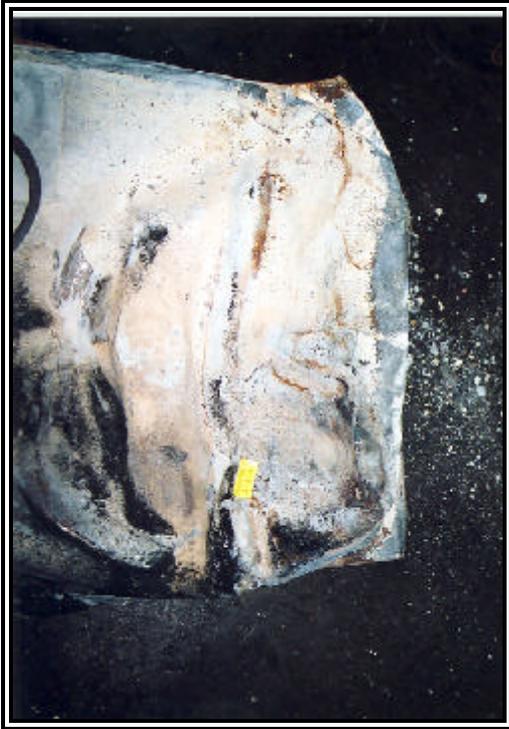
Figure 17: View depicting the location of the puncture/cut on the left side of the tank.

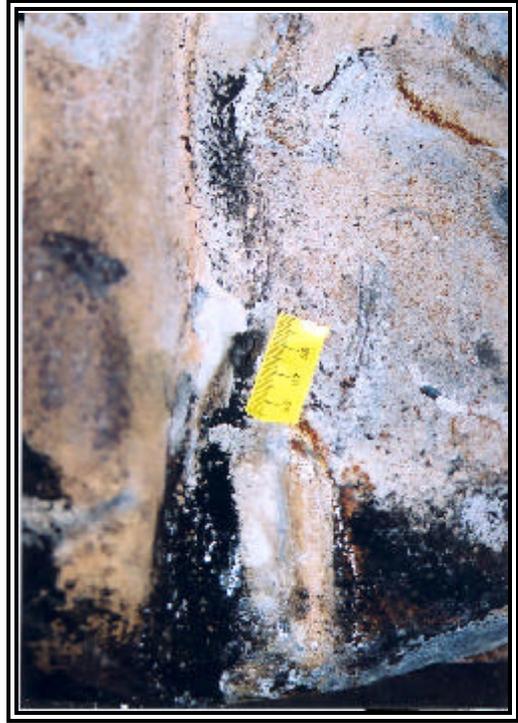
Figure 18: Close-up view of the puncture/cut.

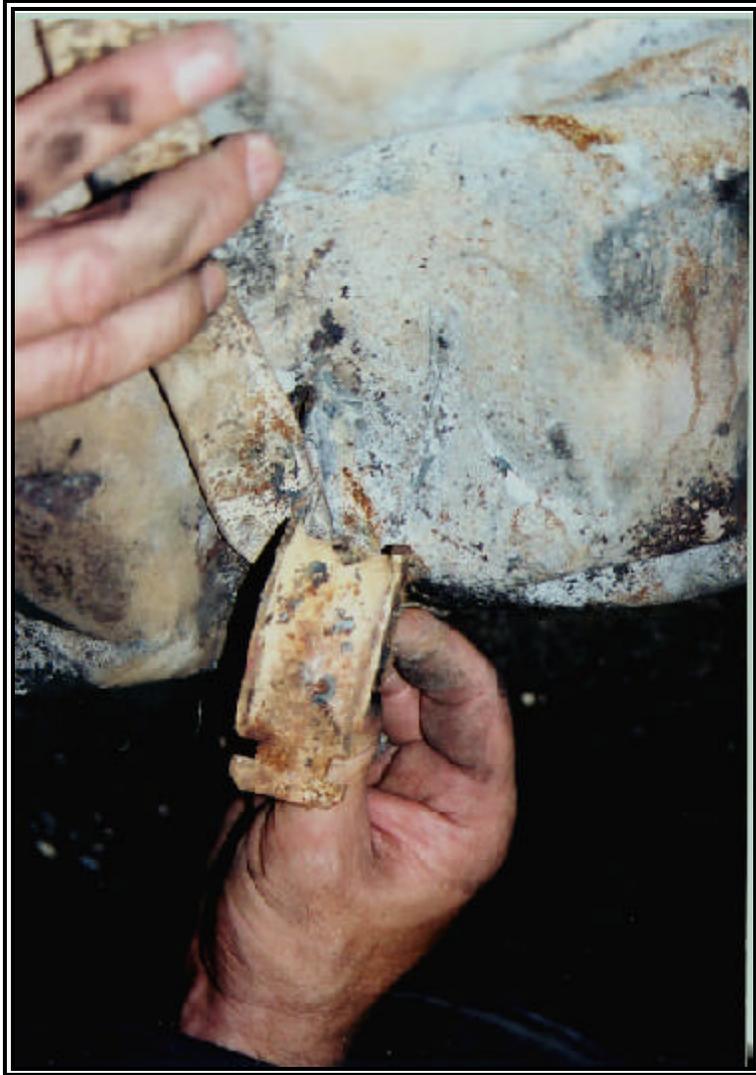
During the deformation of the vehicle, the forward side of the tank contacted the rear axle and left rear sway bar bracket and shock absorber mount. The mechanism that caused the puncture of the fuel tank was contact between the fuel tank, the tank's left carry strap and the left sway bar bracket. Refer to **Figure 19**. Two impressions from the outer edges of the bracket were visible in the tank as a result of the contact. Additionally, the edge of the carry strap in the area of the hole was rolled over and there was a sharp burr. It should be noted, the inboard side (right edge) of the bracket caused the tank puncture. The Technical Safety Bulletin (TSB) issued by Ford on October 21, 2001 addressed grinding the tabs on the outboard (left side) of the bracket (relative to the vehicle). This service was performed on the subject vehicle. The evidence of compliance with the TSB can be seen on the left edge of the bracket in Figure 19.

Figure 19: View of the contact between the tank, carry strap and left rear sway bar bracket.
