**GENERAL DYNAMICS ON-SITE ADVANCED OCCUPANT PROTECTION (AOPS)
INVESTIGATION
SCI TECHNICAL SUMMARY REPORT**

CASE NO. CA02-040

VEHICLE – 2001 HONDA ACCORD

CRASH DATE – AUGUST 2002

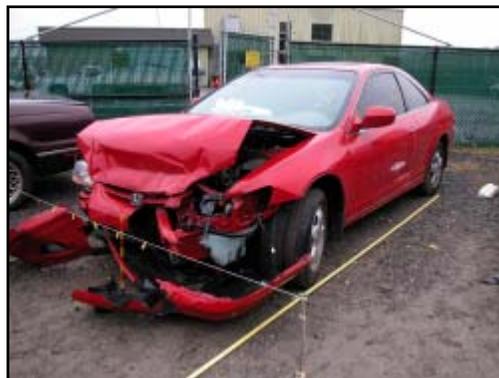
This on-site investigation focused on the performance of the Advanced Occupant Protection System (AOPS) that was present in a 2001 Honda Accord (**Figure 1**). The AOPS consisted of dual-stage frontal air bags and seat belt retractor pretensioners. The Honda Accord was involved in an intersection collision with a 2002 Mazda 626 that resulted in the deployment of the AOPS in the Accord. A 24-year-old female driver and a 21-year-old male front right passenger were reported by police to have been restrained by the manual 3-point lap and shoulder belts, although based on the visual inspection of the belts it appeared both occupants were unrestrained. At impact, the safety belt pretensioners fired and the frontal air bag system deployed. The occupants initiated forward trajectories in response to the frontal crash force and loaded the deployed frontal air bags. The driver sustained a right third finger contusion, knee contusion, and neck and lumbar strains. She was transported to a local hospital where she was treated for her injuries and released. The front right passenger was not injured.

Figure 1. Damaged 2001 Honda Accord

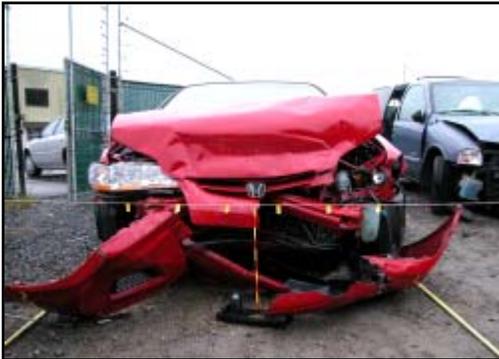
The 2001 Honda Accord sustained moderate frontal damage as a result of the impact with the Mazda 626. The front bumper fascia was partially separated, fractured in multiple locations and sustained abrasions from direct contact with the Mazda (**Figure 4**). The direct contact damage began at the front left bumper corner and extended 127.0 cm (50.0") across the bumper fascia to the front right bumper corner. The combined direct and induced damage involved the entire frontal width of the Accord and measured 102.9 cm (40.5") across the front bumper beam.

Figure 4. Frontal damage to the 2001 Honda Accord

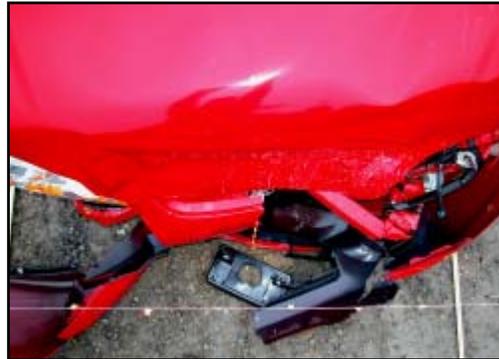
The maximum crush on the front bumper beam was located 2.5 cm (1.0") left of the centerline and measured 43.2 cm (17.0") (Figure 5).

Figure 5. View showing crushed bumper beam

The Styrofoam filler was separated from the bumper beam. The forward aspect of the left frame rail was displaced inboard 4.4 cm (1.8") and the forward aspect of the right frame rail was displaced inboard 7.0 cm (2.8"). The hood was buckled rearward and direct contact abrasions extended 20.3 cm (8.0") rearward from the leading edge of the hood. The upper radiator support was crushed rearward. The left head lamp assembly was separated and the right head lamp assembly was displaced. Six crush measurements were taken along the front bumper beam and were as follows: C1 = 8.3 cm (3.3"), C2 = 19.4 cm (7.6"), C3 = 33.7 cm (13.3"), C4 = 31.1 cm (12.3"), C5 = 21.9 cm (8.7"), C6 = 12.1 cm (4.8"). The Collision Deformation Classification (CDC) for the impact with the Mazda 626 was 12-FDEW-2.

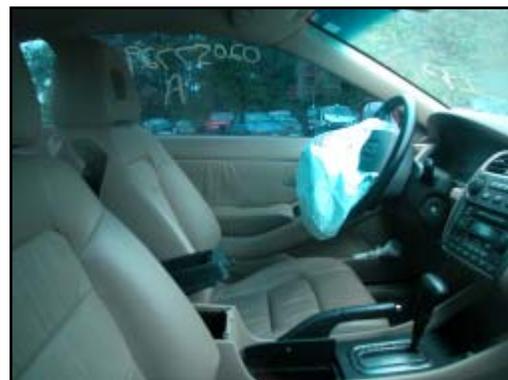
Interior damage to the 2001 Honda Accord appeared to be minor. The interior of the vehicle could not be accessed for inspection and interior damage was based on inspection through the vehicle windows (Figure 6). The windshield and remaining glazing did not sustain damage. There did not appear to be any intrusion into the passenger compartment. There were no apparent occupant contacts.

Figure 6. Interior view of the 2001 Honda Accord

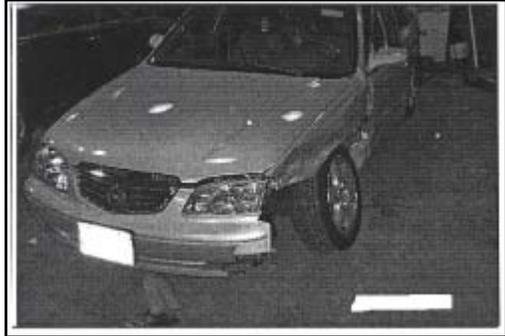
The exterior damage to the 2002 Mazda 626 was based on damage photographs obtained from a repair facility (**Figure 7**). The direct contact damage began slightly aft of the left front corner and extended rearward along the left front door. The combined direct and induced damage began at the left front corner and extended rearward to the middle aspect of the left rear door. The left front fender was crushed laterally and the left front aspect of the front bumper fascia was fractured. The left front wheel was displaced laterally against the suspension components. Six crush measurements were estimated from the repair photographs and were as follows: C1 = 0 cm, C2 = 5 cm (2”), C3 = 10 cm (4”), C4 = 8 cm (3”), C5 = 13 cm (5”), C6 = 0 cm. The CDC for the impact with the Honda Accord was 11-LYEW-2.

Figure 7. Damaged 2002 Mazda 626

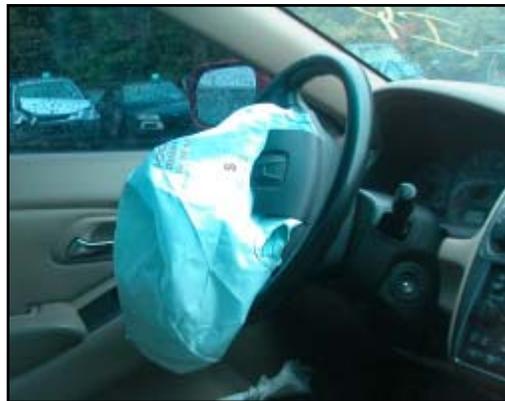
The 2001 Honda Accord was equipped with dual-stage frontal air bags for the driver and front right passenger positions that deployed as a result of the impact with the Mazda 626. The driver's air bag was housed in the center of the steering wheel with asymmetrical H-configuration module cover flaps (**Figure 8**). There was no contact evidence visible on the driver's air bag.

Figure 8. View of deployed driver's air bag
