ON-SITE AIR BAG RELATED CHILD FATALITY INVESTIGATION

VEHICLE: 1996 CHEVROLET CAVALIER

CASE NO: CA02-041

CRASH DATE: SEPTEMBER, 2002

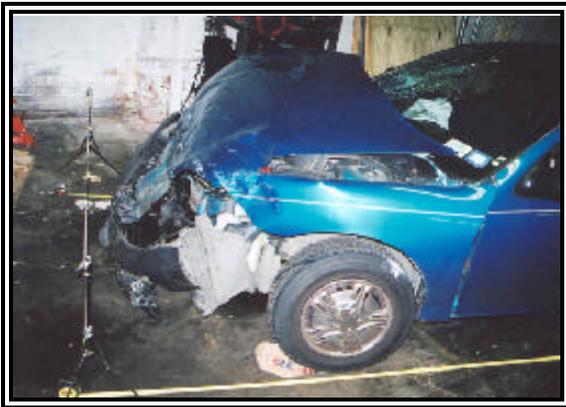
Figures 5 and 6 are a left lateral and an overhead frontal view of the vehicle's exterior damage. The frontal plane of the Chevrolet sustained moderate direct contact damage that extended across its entire 142 cm (56 in) end width. The lateral momentum of the Volvo during the impact phase caused a 30 cm (12 in) right lateral deformation of the Chevrolet's bumper structure. The crash damage extended longitudinally rearward to approximately the radiator support plane. The residual frontal crush profile measured along the bumper reinforcement was as follows: C1 = 14.1 cm (5.5 in), C2 = 31.4 cm (12.4 in), C3 = 35.3 cm (13.9 in), C4 = 34.9 cm (13.8 in), C5 = 29.5 cm (11.6 in), C6 = 29.3 cm (11.6 in). The right front fender shifted rearward and restricted the operation of the right door. The right wheelbase was reduced 6.5 cm (2.6 in) and the right front tire was restricted. The left wheelbase dimension was unchanged. The total delta V calculated by the Damage algorithm of the WINSMASH model was 25.1 km/h (15.6 mph). The longitudinal and lateral components of the delta V were -19.3 km/h (-12.0 mph) and 16.2 km/h (10.1 mph), respectively. The impact's principle direction of force (PDOF) was in the vehicle's 11 o'clock sector estimated to be 320 degrees. The Collision Deformation Classification (CDC) was 11-FDEW-2.

Figure 5: Left lateral view.

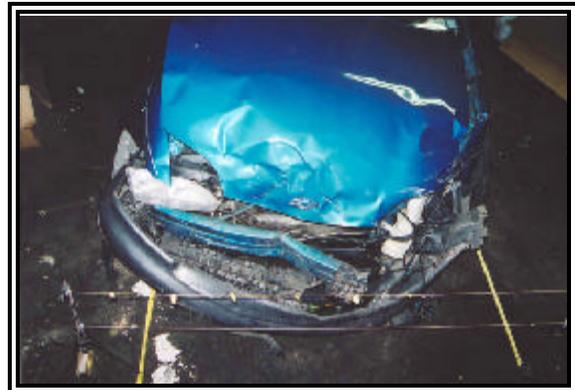
Figure 6: View of the frontal damage.

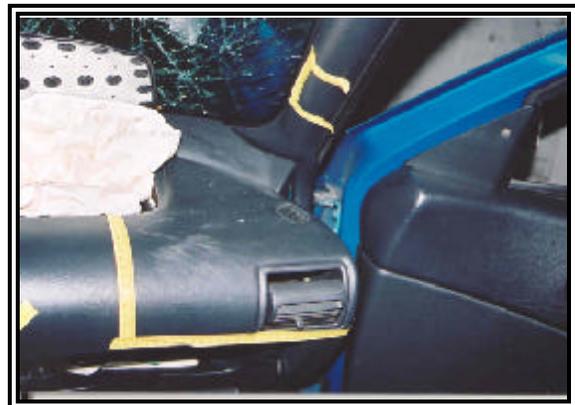
Figure 7 is an overall view of the Chevrolet's interior. Multiple areas of contact evidence were identified on the upper surface of the instrument panel's right aspect. These contacts were attributed to contact from the impeded expansion of the front right passenger air bag due to the forward position of the lap seated child passenger. A 25 cm x 18 cm (10 in x 7 in), width by height, area of air bag scuffing was located on the right corner of the instrument panel, **Figure 8**. This contact pattern measured 13 cm (5 in) on the vertical face of the panel and wrapped 5 cm (2 in) onto its horizontal surface. The heating vent louvers were fractured by this contact. A 10 cm x 8 cm (4 in x 3 in) air bag scuff was identified on the vertical face of the instrument panel in its right center aspect. This scuff began 36.8 cm (14.5 in) left of the panel's outboard edge. An 8.0 cm (3.0 in) air bag scuff was located on the trim panel covering the right A-pillar. This scuff began 15 cm (6 in) above the instrument panel. The right door interior trim panel exhibited a 14.0 cm (5.5 in) air bag scuff on its upper aspect at the intersection with the glazing. The pattern began 24.1 cm (9.5 in) rear of the forward edge of the glazing. The trim panel was fractured within this pattern from probable occupant contact.

Figure 8: Air bag transfers to the right aspect of the IP.

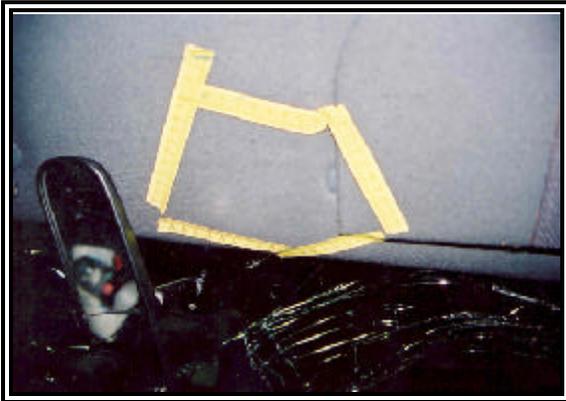
A head contact was identified on the center forward aspect of the headliner, **Figure 9**. The contact measured 15 cm x 10 cm (6 in x 4 in), width by length and was located 5 cm (2 in) right of the vehicle's centerline. The center mirror adjacent to this location rotated and fractured. A 13 cm x 13 cm (5 in x 5 in) body fluid spray was identified on the left aspect of the instrument panel brow located above the instrument cluster, **Figure 10**. The contact pattern began 72.4 cm (28.5 in) left of the instrument panel right outboard edge and extended left to approximately the steering column center line. Several strands of hair were located on the brow within a probable head contact in this contact pattern (identified by the arrow in Figure 10). These contacts were both associated to the child passenger due to their relative location and orientation.

Figure 9: Contact evidence to the headliner.

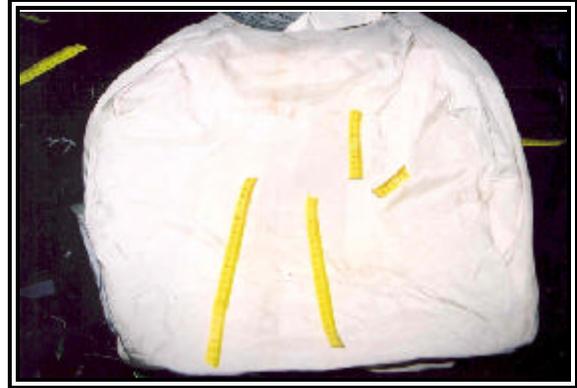
The top surface of the air bag, **Figure 11**, exhibited multiple patterns of contact evidence. A 25 cm x 15 cm (10 in x 6 in) region of vinyl transfers was located on the forward aspect of the top surface and began 15 cm (6 in) from the aft edge of the module. This pattern was attributed to contact with the cover flap during its impeded deployment. A 5 cm x 11.4 cm (2 in x 4.5 in) area of the air bag was yellowed from probable heating during the deployment. This pattern began 18 cm (7 in) from the module edge and was centered 18.5 cm (7.3 in) right of the inboard edge of the bag. A 14.0 cm (5.5 in) long by 3.8 cm (1.5 in) wide black vinyl transfer was located 14.0 cm (5.5 in) left of the right outboard edge of the bag. A secondary pattern linked to the former transfer measured 10 cm (4 in) long and was located on the outboard edge of the bag extending onto the outboard side panel. These transfers resulted from their contact with the right A-pillar trim. A 8 cm x 20 cm (3 in x 8 in), width by length, tissue transfer was located within the center aspect of the air bag's top surface, **Figure 12**. The transfer began 41 cm (16 in) from the module and extended rearward ending 61 cm (24 in) from the module. This transfer resulted from direct contact with the child occupant.

Figure 11: Passenger air bag top surface.

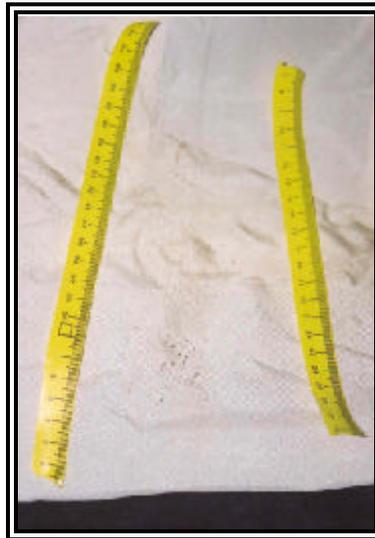
Figure 12: Close-up of the tissue transfer.

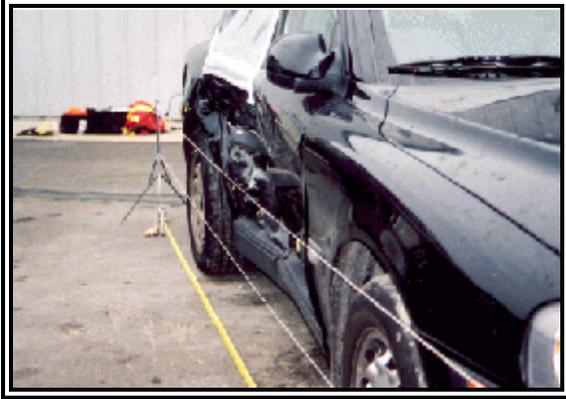
Figures 14 and 15 are the right front and right rear views of the damage. The right side plane of the Volvo sustained a combined 218.7 cm (86.1 in) of direct and induced damage as a result of the impact. The induced damage began 49.3 cm (19.4 in) aft of the right front axle at the leading edge of the right front door. The width of the direct damage measured 174.2 cm (68.6 in) and began 96.3 cm (37.4 in) aft of the right front axle on the center aspect of the right front door. The end of the direct and induced damage was located 81 cm (3.2 in) forward of the right rear axle immediately aft of the right rear door. The door panels were crushed laterally and right rear glazing disintegrated in the impact. The maximum lateral deformation measured 24.4 cm (9.6 in). The residual crush profile was as follows: C1 = 0, C2 = 19.3 cm (7.6 in), C3 = 23.1 cm (9.1 in), C4 = 24.3 cm (9.6 in), C5 = 19.8 cm (7.8 in), C6 = 0. The total delta V calculated by the Damage algorithm of the WINSMASH model was 19.8 km/h (12.3 mph). The longitudinal and lateral delta V components were -12.7 km/h (-7.9 mph) and -15.2 km/h (-9.4 mph), respectively. The principle direction of the impact was within the 2 o'clock sector estimated at 50 degrees. The Collision Deformation Classification was 02-RPEW-2.

Figure 14: Right front close-up of the damage.

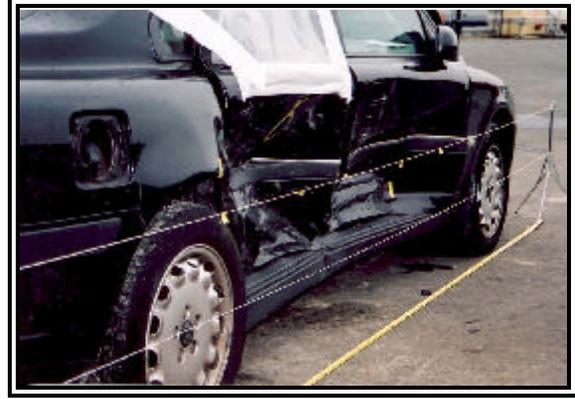
Figure 15: Right rear close-up of the damage.

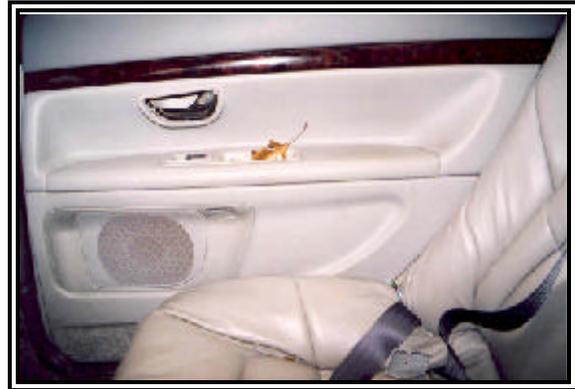
The right front and right rear interior door panels intruded laterally into the occupant compartment and were in contact with outboard aspect of the front right and rear right seat. **Figure 16** is a view of the intrusion and rear right seat compression. The seat cushions were compressed laterally. The intrusion of the central aspect of the right front door measured immediately above the grab handle was 6.1 cm (2.4 in). The right B-pillar intrusion measured at the elevation of the front seat backs was 4.6 cm (1.8 in). The intrusion of the central aspect of the right rear door measured immediately above the grab handle was 5.8 cm (2.3 in).

Figure 16: View of the rear right intrusion and seat compression.

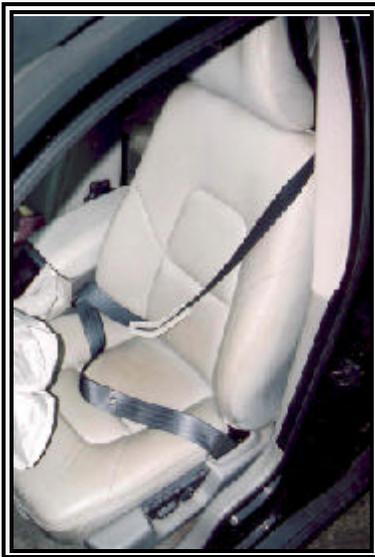
At the time of the inspection, the driver's restraint was extended from the retractor and laying on the seat, **Figure 17**. The retractor was locked. The exposed webbing section measured 168 cm (66 in) from the outboard anchor to the spool of the locked retractor located in the upper B-pillar. The trim that guided and

surrounded the belt path at the upper aspect of the left B-pillar separated and was laying on the seat. The trim separated due to the belt tensioning caused by the fired retractor pretensioner. Examination of the webbing revealed a 8 cm (3 in) section of stretched webbing located at the latch plate with the restraint in the buckled condition. Examination of the latch plate revealed evidence of historical use consistent with the age of the vehicle. All the evidence gathered during the inspection indicated the driver was restrained at the time of the crash.

Figure 17: Driver's restraint.

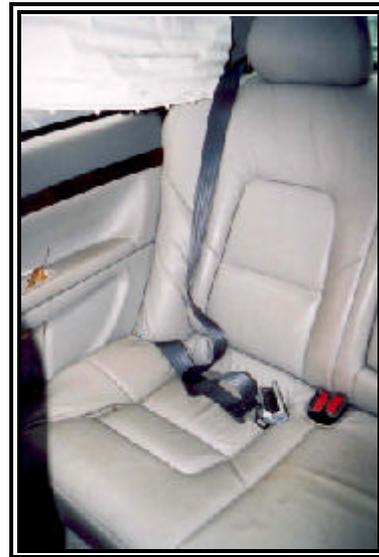
The rear right restraint was extended from its retractor and laying on the rear bench seat, **Figure 18**. The retractor was locked. The retractor was locked by the fired pretensioner. The exposed webbing section measured 141.0 cm (55.5 in) measured from the seat bight to the upper belt guide. Examination of the webbing did not reveal any evidence of loading. However, given the relative mass of the occupant (as compared to the driver) and the principle direction of force in this crash loading evidence would not be expected. Latch plate examination revealed sign historical usage indicators. The evidence gathered during the inspection indicated the rear right occupant was restrained in this crash.

Figure 18: Rear right restraint.

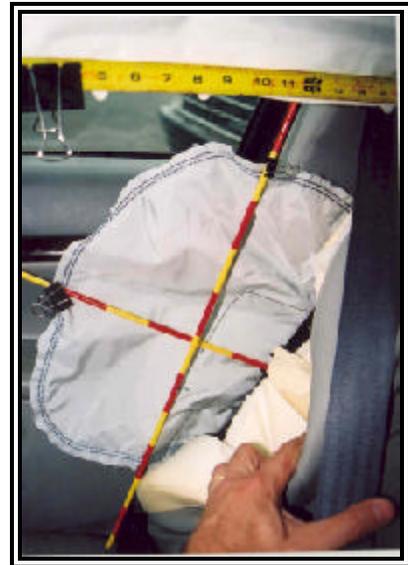
The right side impact air bag, **Figure 19**, was housed in a vertically oriented module housed in the outboard bolster of the right front seat back. The bolster seam stitching separated vertically allowing the forward expansion of the air bag. The side impact air bag was elliptical in shape and was designed to offer thorax protection. The air bag measured 39.4 cm x 25 cm (15.5 in x 10 in), vertically by longitudinally with respect to the vehicle. The air bag was not tethered and was vented by a single 2.5 cm (1.0 in) diameter port located on the upper aspect of the bag's outboard side. The air bag inflated to an estimated thickness of approximately 5 to 8 cm (2 to 3 in). There was no contact evidence noted on the air bag.

Figure 19: View of the deployed right side impact air bag.

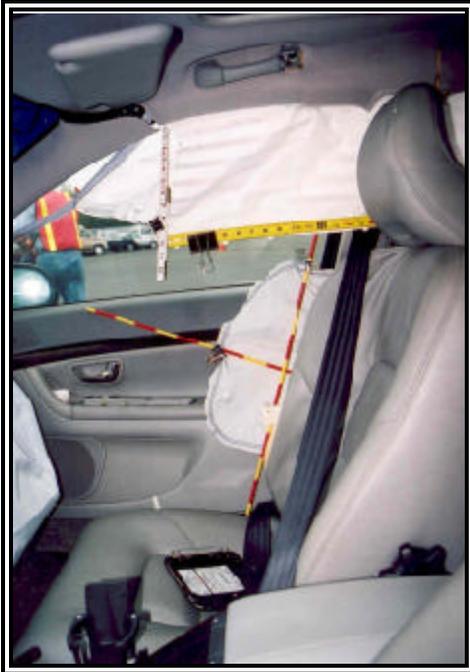
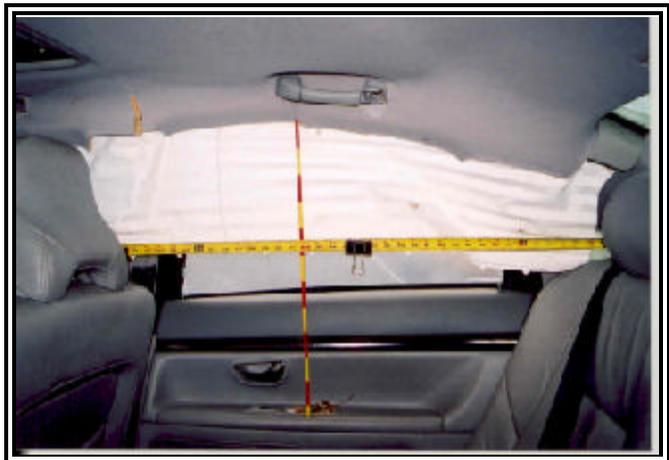
Figures 20 and 21 are left side views of the deployed right inflatable side curtain. The inflatable curtain deployed downward from the right roof rail. The curtain was rectangular in shape and measured 25 cm x 137 cm (10 in x 54 in) overall. The estimated thickness of the inflated curtain was approximately 5 cm (2 in). The headliner separated, along its length, from the upper interior trim allowing the curtain to deploy vertically down. The curtain provided approximately 137 cm (54 in) of coverage across the vehicle's right side glass. This coverage measured approximately 38 cm (15 in) forward of the B-pillar extending forward across approximately two thirds (2/3) of the right front glazing. The coverage extended approximately 86 cm (34 in) rearward of the B-pillar, across the left rear glazing and ending adjacent to the right rear seat back. The forward aspect of the curtain was fastened to the mid aspect of the A-pillar by a 47.0 cm (18.5 in) long tether strap. The strap was attached to the A-pillar 30 cm (12 in) above the instrument panel. The rear aspect of the curtain was fastened to the left roof rail at the C-pillar. The vertical dimension of the deflated curtain measured 25 cm (10 in). The curtain was designed with a distinct chambered pattern. There were 12 chambers with nominal dimensions that measured 8.9 cm x 21.6 cm (3.5 in x 8.5 in) This pattern provided the occupant protection when inflated, as well as providing some

Figure 20: Left interior view depicting the deployed right side impact protection.

Figure 21: Left interior view of the deployed inflatable curtain at the rear right position.
