**VERIDIAN ON-SITE LOW-SPEED FRONTAL AIR BAG DEPLOYMENT
INVESTIGATION**

VERIDIAN CASE NO. CA02-046

VEHICLE: 2001 FORD FOCUS

CRASH DATE: SEPTEMBER 2002

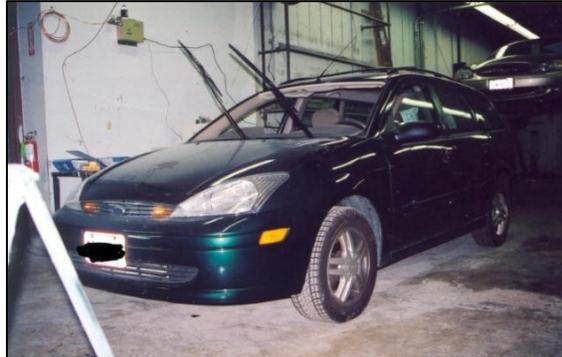
This on-site investigation resulted from an attorney notification to the Veridian SCI team of an alleged low-speed crash that resulted in the deployment of the frontal air bag system in a 2001 Ford Focus (**Figure 1**) and deployment induced thermal burns to the driver's right wrist/forearm. The Ford Focus that was involved in a minor severity front-to-rear crash with a stopped 1999 Ford E150 conversion van. The 29-year old female driver of the Ford Focus was restrained by the manual 3-point lap and shoulder belt system. She sustained a first-degree thermal burn of the anterior aspect of the right forearm and wrist from the exhaust gases venting onto her cotton sweatshirt. A 5-year old female rear right passenger was restrained by the 3-point belt system and was not injured in the crash. Although the Focus did not sustain disabling damage, the vehicle was towed from the scene of the crash. The Ford van sustained minor rear bumper damage and was driven from the scene.

Figure 1 - Subject 2001 Ford Focus

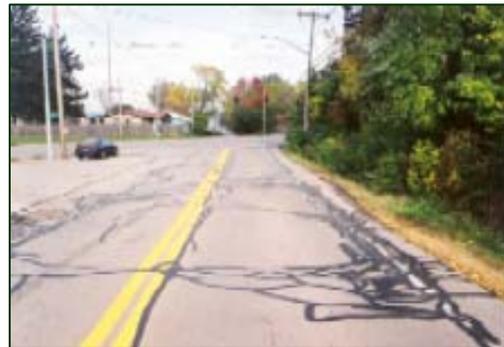
Figure 2. Overall view of the crash site from a northerly direction.

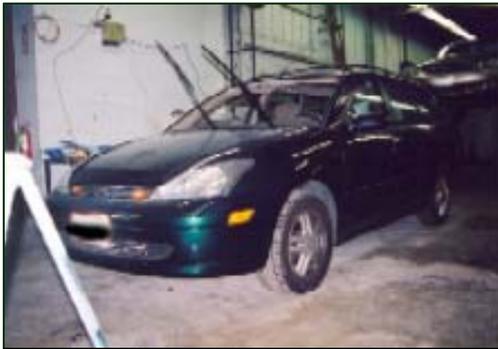
inspection of the underlying bumper beam and frame components. No damage was found and the fascia was replaced. Superficial abrasions to the fascia were repaired and the component was repainted. Superficial scratches were reported to the hood of the Focus. Although no direct contact damage occurred to the hood, these scratches possibly resulted from the fractured windshield glazing due to the deployment of the front right passenger air bag. The hood was also repainted. All body damage was repaired prior to the SCI inspection. There was no crush reported to the Focus. Based on the reported damage by the insurance company and the body repair shop, a Collision Deformation Classification (CDC) of 12-FZEW-1 was estimated for this impact event. **Figures 3 and 4** are frontal views of the repaired exterior of the Ford Focus.

Figure 3. Front left three-quarter view of the repaired Ford Focus.

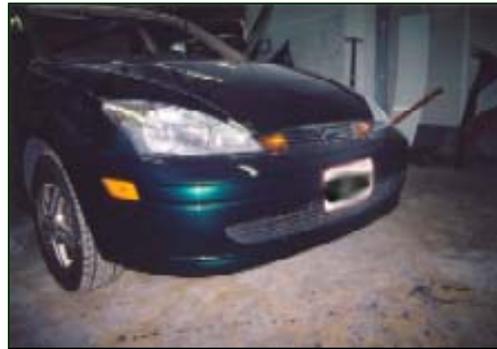
Figure 4. Front right view of the bumper fascia.

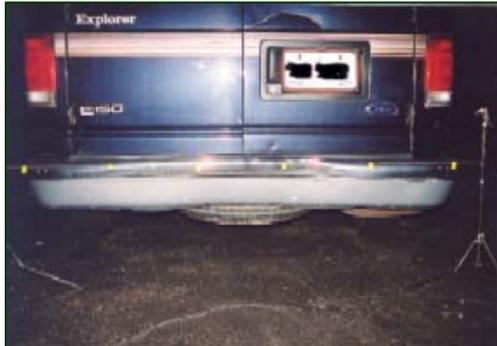
The front right corner area of the Focus impacted the center aspect of the van's rear bumper (**Figure 5**). The direct contact damage on the chromed bumper involved superficial abrasions and wipe marks (removal of road film). The contact damage began 26.4 cm (10.4") left of the vehicle's centerline and extended 71.8 cm (28.25") to the right. The impact crushed the mid point of the bumper between the frame rails that were

Figure 5. Rear bumper damage to the conversion van.

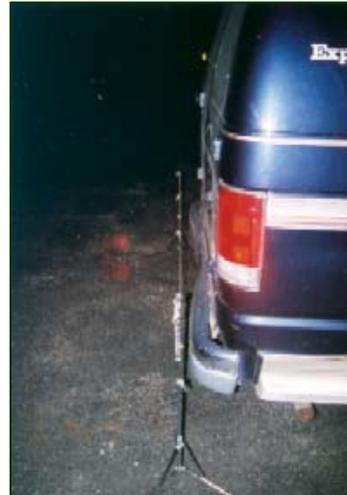
spaced on 71.1 cm (28.0") centers. Maximum crush was 7.0 cm (2.75"), located (7.0") right of center (**Figure 6**). The crush at bumper level was as follows: C1 = 1.6 cm (0.625"), C2 = 2.5 cm (1.0"), C3 = 5.3 cm (2.1"), C4 = 7.0 cm (2.75"), C5 = 0.3 cm (0.1"), C6 = 0.6 cm (0.25"). The CDC for this impact damage was 06-BZEW-1.

Figure 6. Extent of crush to the mid point of the rear bumper.

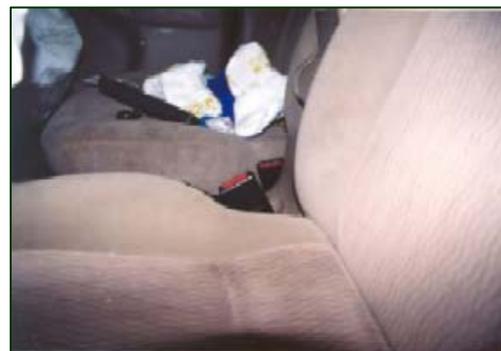
Figure 7. Fired front right buckle pretensioner.

fired (**Figure 7**). Post-crash, the cable protruded 2.5 cm (1.0”) from the end of the pretensioner barrel.

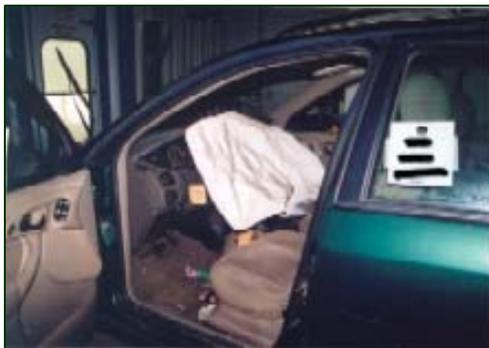
The driver air bag was concealed within H-configuration module cover flaps that opened at the designated tear seams (**Figure 8**). The upper flap was 17.8 cm (7.0”) wide at the horizontal tear seam with a maximum width of 19.7 cm (7.75”) and a height of 4.8 cm (1.875”). The top hinge of the upper flap was 11.7 cm (4.6”) in width. The lower module cover flap was 17.8 cm (7.0”) wide at the horizontal tear seam and reduced in width to 6.0 cm (2.375”) at the bottom hinge. The vertical height of the flap was 7.9 cm (3.125”). The cover flaps are illustrated in **Figure 9**.

Figure 8. Deployed front left air bag.

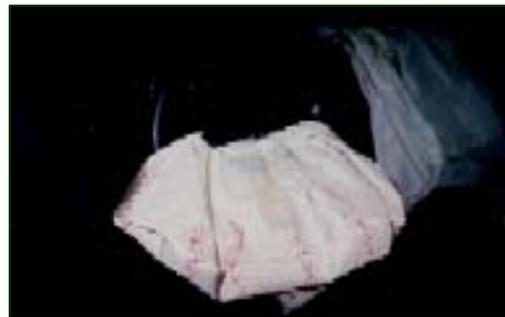
Figure 9. Cover flaps and rip-stitch pattern.

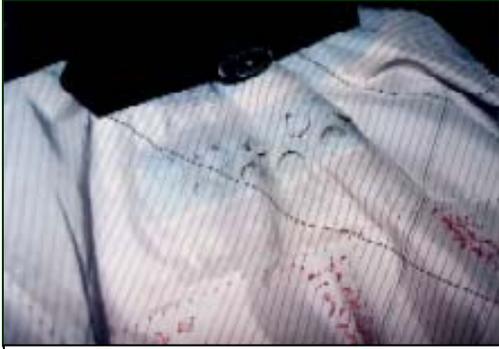
Figure 10. Petal vents and the rip-stitch patterns.

The bag was vented by a series of nine petal vents (**Figure 10**) that were located on the backside of the bag membrane away from the driver, ranging from the 11:30-12:30 o'clock positions. The petal vents were semi-circular (gill-shaped) cuts in the bag membrane that were positioned in two rows, five on the bottom (closest to the inflator) with four on top, 15.9 cm (6.25") from the peripheral seam (**Figure 11**). The open aspect of the two rows of vents were opposed to one-another. The vents measured 15.9 mm (0.625") in width at the hinge and 9.5 mm (0.375") in height. The exterior surface of the inboard vent ports contained a black soot-like substance. The interior surface of the vent ports was clean of any soot-like material. It should be noted that the petal vent system was designed to dissipate the exhaust gases over a larger area, thus eliminating the possibility of thermal issues (burns) to clothing and tissue. There was no trace evidence of exhaust gas residue to the headliner, sun visors, steering wheel, or the instrument panel (**Figure 12**). It should be noted that the interior of the Focus was extremely dirty, due to poor maintenance.

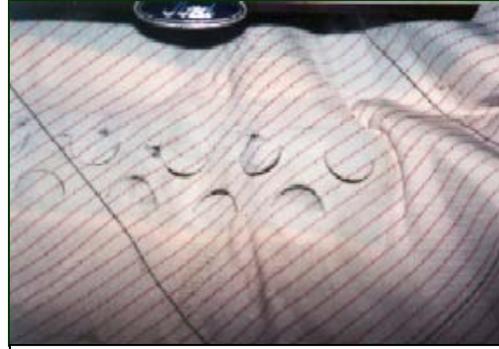
Figure 11. Close-up view of the petal vents.

Based on the location of the burn to the driver’s sweatshirt and forearm, the burn probably resulted from the hot exhaust gases and/or particulates that exhausted from the petal vents located on the backside of the front left air bag. A black soot-like substance was noted to the exterior surface of the inboard vents.

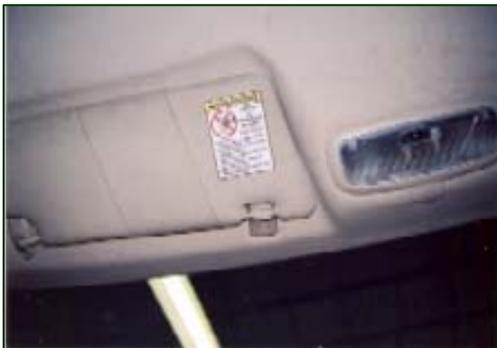
Figure 12. Sun visor/headliner area over the driver's position.

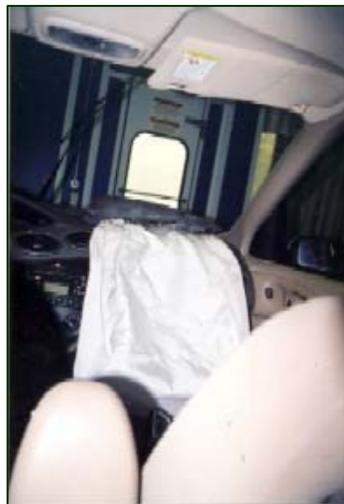
Figure 13. Deployed front right passenger air bag.

The front right air bag module was mounted in the top aspect of the right instrument panel. The module was concealed by a single cover flap that measured 40.6 cm (16.0”) at the leading edge tear seam and 44.5 cm (17.5”) at the top hinge point. The cover flap was deformed (creased) laterally at the mid point from the deployment event. Although the windshield had been removed prior to the SCI investigation, the cover flap opened against the laminated windshield and fractured the glazing. **Figure 13** is a view of the deployed front right air bag.

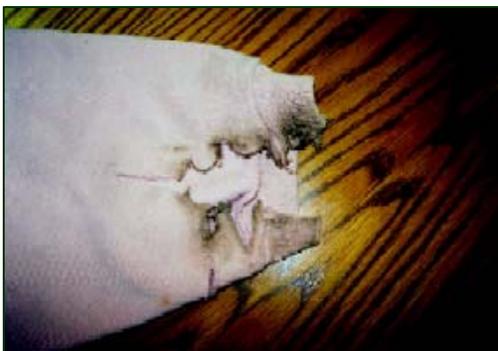
The 29-year old female driver of the Ford Focus was dressed in a washed-out pink 100 percent cotton pullover, long-sleeved sweatshirt and stretch pants. She stated that at impact, her hands were positioned on the steering wheel at the 3 and 9 o’clock sectors. The deployment of the frontal air bag system resulted in a discharge of hot exhaust gases that ignited the inboard aspect of her right sleeve at the cuff (**Figures 14 and 15**). Immediately following the crash, the driver observed the flame on her sleeve. She wiped her sleeve against her right thigh to extinguish the flame. The driver subsequently noted that she sustained a thermal burn of the anterior aspect of her right forearm and wrist.

Figure 14. Burned left anterior sleeve of the driver’s sweatshirt.

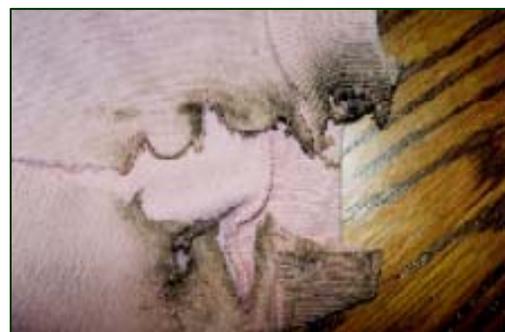
Figure 15. Close-up view of the burned sleeve.

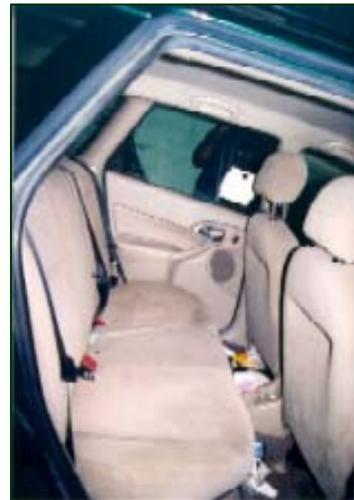
The 5-year old child passenger was seated in the right rear position of the Ford Focus and was reported by the driver as restrained with the 3-point lap and shoulder belt system. A child safety seat was not available for the child. At impact, the child passenger probably initiated a forward trajectory and loaded the manual belt system. There were no occupant contact points in the rear seat area of the Focus or loading evidence on the belt system (Figure 16). The child passenger was not injured in the crash.

Figure 16. Rear right seat position.
