**GENERAL DYNAMICS ON-SITE AIR BAG RELATED CHILD FATALITY
INVESTIGATION
SCI TECHNICAL SUMMARY REPORT**

CASE NO. CA02-055

VEHICLE – 1995 PLYMOUTH VOYAGER

CRASH DATE – NOVEMBER 2002

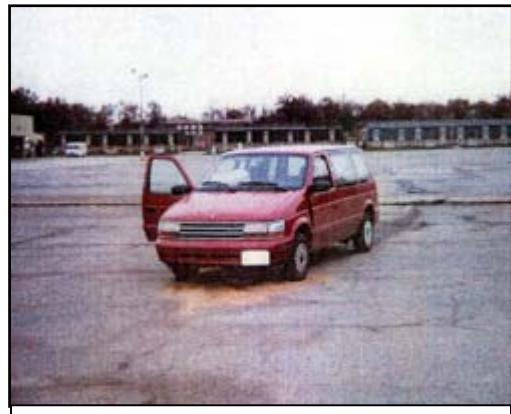
Figure 1. 1995 Plymouth Voyager at final rest

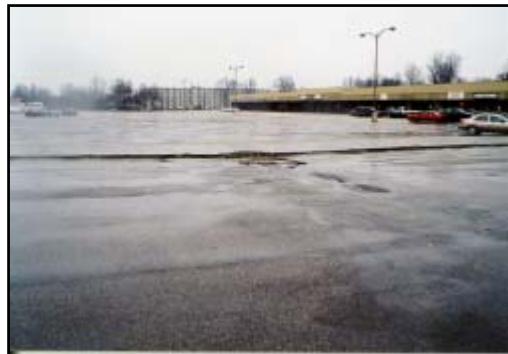
This single-vehicle crash occurred during the daylight hours of November 2002. At the time of the crash, the weather was cloudy and the asphalt surface of the parking lot was dry. The crash occurred in the center of a large asphalt parking lot adjacent to retail stores. The store fronts were located along the east aspect of the parking lot. A long concrete sidewalk extended laterally in an east-to-west direction through the parking lot. There were no warning signs or devices present that identified the presence of the sidewalk. The police noted that vehicles drove over the sidewalk on a regular basis. The sidewalk began 10.7 m (35.1') west of the store fronts and extended 100.7 m (330.4') across the parking lot (**Figure 2**). It measured 3.8 m (12.5') in width and the curb height averaged 10.2 cm (4.0") along the outboard edges. A storm drain was present adjacent to the south aspect of the sidewalk and was located 47.8 m (156.8') west of the east edge of the sidewalk (**Figure 3**). The square grate measured 0.8 x 0.8 m (2.6 x 2.6') and was bordered by concrete that measured 0.4 m (1.3') in width. The outboard aspect of the concrete border was located 0.4 m (1.3') from the south curb edge. The center grate was contoured downward in the center aspect to allow for drainage and

Figure 2. View of parking lot and concrete sidewalk

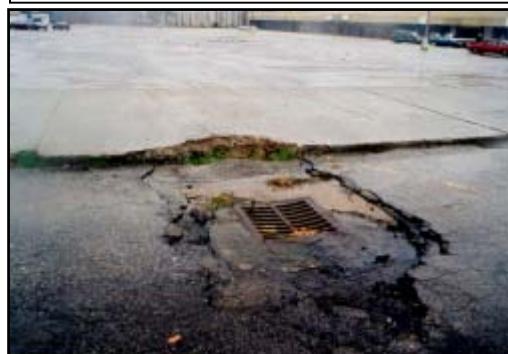
Figure 3. Close up of the depressed sewer collector

was located 6.4 cm (2.5") below the asphalt grade of the parking lot. The parking lot exhibited a level grade, pitched slightly negative around the storm drain to allow for drainage. The storm drain was the lowest point in the parking lot. The outboard perimeter of the storm drain measured 2.5 cm (1.0") below the adjacent parking lot grade. Fragments of asphalt had been displaced around the collector due to erosion.

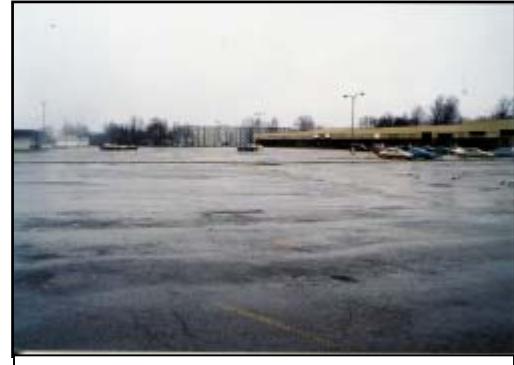
The 47-year-old female driver was operating the 1995 Plymouth Voyager northbound through the large parking lot (**Figure 4**). The driver stated she had not driven in the lot for a number of years. She had entered the parking lot through the south entrance adjacent to the north/south roadway. After entering the driveway, she proceeded to turn left and traveled in a northeast direction diagonally across the parking lot. As the Plymouth Voyager was crossing the lot, the front right child passenger inquired if they were close to their destination. The driver told her that they were almost to the destination, at which time the 5-year-old released the buckle on the safety belt and removed the manual restraint. The driver did not detect the concrete sidewalk, which was present in the parking lot. The Voyager traveled over the depression leading into the storm drain and the left wheel traveled over the left aspect of the storm drain grate. The driver stated that the vehicle hit a "hole" prior to impact and denied pre-crash braking. Based on the direct contact damage to the lower radiator support and the Voyager's exemplar distance of 19.1 cm (7.5") between the lower radiator support and the ground compared to the combined vertical distance of 16.5 cm (6.5") between the top of the curb and the center of the storm drain, it was possible that she applied the brakes prior to impact. Pre-crash braking would have allowed the front of the vehicle to pitch farther downward as the Voyager traveled over the storm collector. The increased downward pitch compressed the front suspension and exposed the lower aspect of the bumper fascia and lower radiator support to the curb edge. Based on the driver's post-impact stopping distance, the pre-crash speed was estimated to be between 32 - 48 km/h (20 – 30 mph). In addition, the trajectory algorithm of the WinSMASH program computed a pre-impact vehicle speed of 40.2 km/h (25.0 mph) based on the impact location and the documented final rest position.

Figure 4. Northbound trajectory of Voyager through parking lot

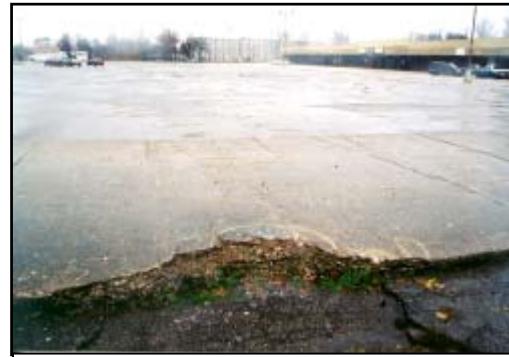
A pre-existing semi-circular gouge was present on the south aspect of the concrete sidewalk curb at the point of impact. The gouge measured 2.0 m (6.5') in width and 0.5 m (1.6') in depth at the center aspect. A second pre-existing gouge was present on the north aspect of the sidewalk, opposite the south pre-existing gouge. The faces of both concrete curbs in the gouged areas were crumbling away. The scene schematic is included as **Figure 17** of this report.

The 1995 Plymouth Voyager impacted the concrete sidewalk curb (**Figure 5**). The principal direction of force was in the 12 o'clock sector and approximately 350 degrees. Initial engagement with the concrete curb began at the front left aspect of the lower bumper fascia and lower radiator support and continued across the lower radiator support as the Voyager continued to engage the curb. The impact-induced deceleration from the impact to the lower radiator support was sufficient to deploy the frontal air bag system in the Voyager. The damage algorithm of the WinSMASH program computed a total delta-V of 18.0 km/h (11.2 mph) based on the documented frontal crush profile. Additional undercarriage contact resulted as the Voyager continued forward. The oil pan, transmission oil pan, and steering components impacted the curb as the vehicle continued forward. The left front wheel struck the edge of the curb face, evidenced by minor deformation to the left front wheel rim and both front wheels rolled over the curb edge and onto the sidewalk. The vehicle traveled over the concrete sidewalk and the north curb edge. The driver stated that she brought the vehicle to a controlled stop after the vehicle cleared the sidewalk. Based on post-crash measurements from the police, the Voyager came to rest 18.5 m (60.1') north of the point of impact and 14.7 m (48.2') north of the north curb edge. **Figure 6** is an on-scene view of the Voyager's final rest position in relation to the struck curb.

Figure 5. Close-up of concrete curb edge at impact point

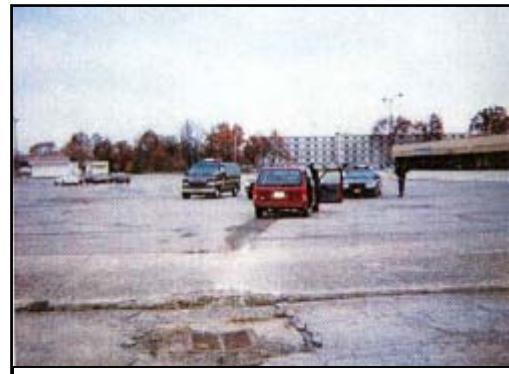
Figure 6. Final rest position of the Voyager

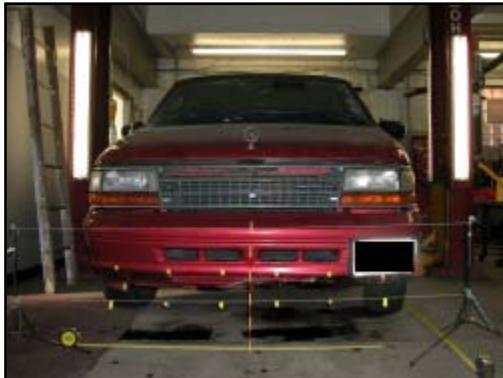
The 1995 Plymouth Voyager sustained moderate damage as a result of the sidewalk impact. Direct contact damage began on the lower aspect of the front bumper fascia at the front left corner and extended laterally across the bottom aspect (**Figure 7**). The lower aspect of the bumper fascia was fractured from direct contact, which began 64.8 cm (25.5") left of the centerline and extended 143.5 cm (56.5") laterally to the front right corner. The lower radiator

Figure 7. Frontal view of the Plymouth Voyager

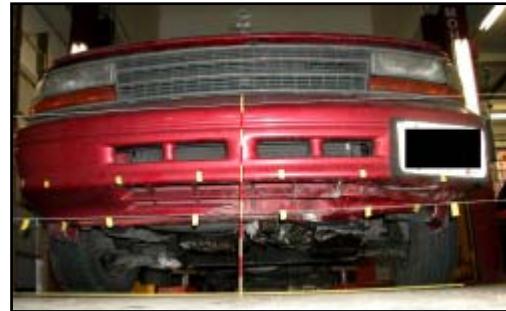
Figure 8. Frontal view of damage to bumper and lower radiator support

support sustained longitudinal crush and direct contact abrasions from the concrete curb edge (**Figure 8**). The direct damage on the lower radiator support began 20.2 cm (8.0") to the right of the centerline and extended laterally 82.6 cm (32.5") to the front left corner. The combined direct and induced damage measured 118.1 cm (46.5") across the entire lower radiator support. The maximum crush on the lower radiator support measured 12.3 cm (4.9") and was located 22.3 cm (8.8") to the left of the centerline. Six crush measurements were documented along the lower radiator support and were as follows: C1 = 0.6 cm (0.3"), C2 = 10.8 cm (4.3"), C3 = 8.9 cm (3.5"), C4 = 6.4 cm (2.5"), C5 = 3.8 cm (1.5"), C6 = 0.0 cm. There was no measurable crush to the front bumper beam.

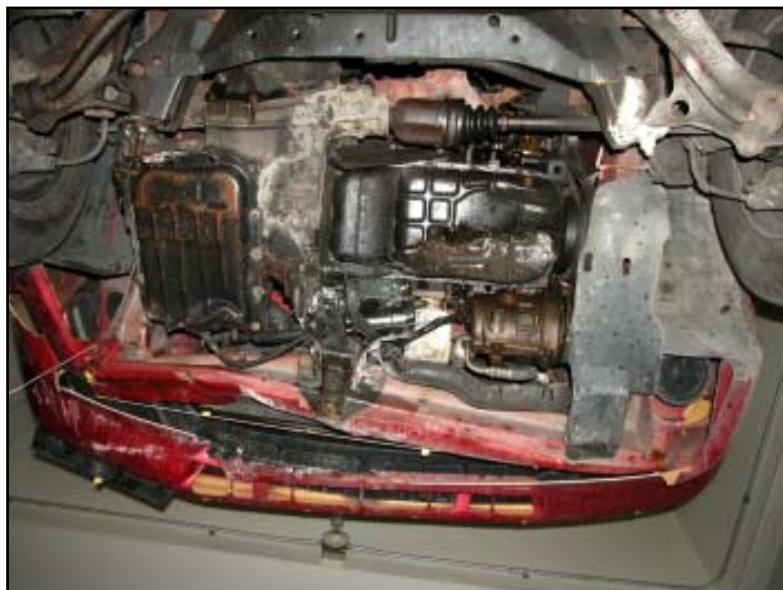
Undercarriage components also sustained direct contact damage as they impacted the concrete curb edge (**Figure 9**). The transmission oil pan was abraded, crushed and dented. The entire frontal width of the transmission oil pan was abraded. The front right corner of the oil pan sustained an area of crush that measured 7.6 cm (3.0") in width and 6.4 cm (2.5") in height. The maximum longitudinal crush to the transmission oil pan measured 4.5 cm (1.8"). The rear left aspect of the transmission oil pan was split at the seam from contact with the leading edge of the front cross member. The opening measured 4.5 cm (1.8") in width and 2.5 cm (1.0") in height. The engine oil pan also sustained lateral abrasions along the entire frontal width. The engine oil pan deformation began at the front right corner and extended 24.8 cm (9.8") laterally. The crush depth to the front lower aspect of the engine oil pan was 7.6 cm (3.0"). The right lower control arm was abraded and exhibited a moderate amount of concrete dust from direct contact with the concrete curb. The front engine mount that was located on the center aspect of the vehicle was

crushed rearward. The rear aspect of the right side fractured at the bolt and separated from the engine. The forward aspect of the left side showed deformation to the bracket around the bolt head which illustrated rearward displacement with some restitution. The rear aspect of the right lower control arm was crushed rearward which resulted in a weld separation located 33.0 cm (13.0") outboard of the centerline.

Figure 9. Undercarriage view showing damaged components and crushed lower radiator support

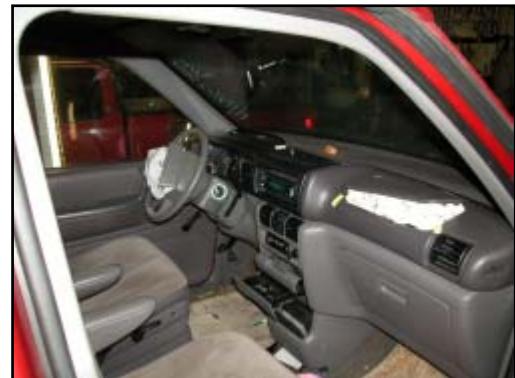
Interior damage to the 1995 Plymouth Voyager was minor (**Figure 10**) and attributed to occupant contact. There was no damage to the laminated windshield or vehicle glazing. There was no passenger compartment intrusion. There were no identifiable occupant contacts with the exception of the frontal air bags. A scuff mark was identified on the right front door handle, however, it appeared to be pre-existing.

Figure 10. Interior view

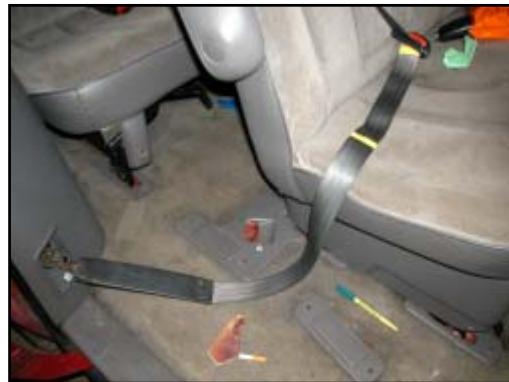
The second row right safety belt was used by the 3-year-old male child who was positioned in a high-back belt-positioning booster CSS. Minor stretch marks were present on the lap and shoulder belt webbing, although it could not be confirmed if they were pre-existing at the time of the crash.

Figure 11. View of second row right safety belt anchor

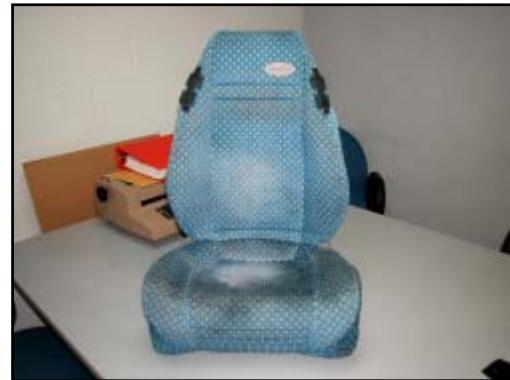
The 3-year-old child in the second seat right position was restrained in a Gerry Guardian high back belt-positioning booster CSS (**Figure 12**). The CSS was purchased used by the family from a second-hand store. The owner of the vehicle stated that they did not know the history of the CSS, nor did it come equipped with an owner's manual. There was no model number found on the CSS, and the manufacture date was July 27, 1996. The CSS was configured with two plastic shoulder belt positioners that were located on the top outboard aspects. The CSS was not configured for use with a harness system.

Figure 12. Gerry Guardian High Back Belt Positioning Booster CSS

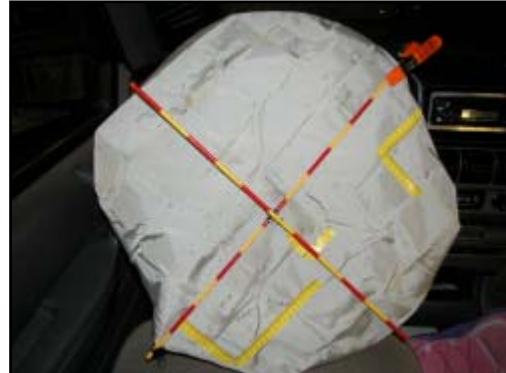
The driver's air bag was housed in the center of the steering wheel. The air bag was circular in shape and measured 63.5 cm (25.0") in diameter in its deflated state (**Figure 13**). The H-configuration vinyl cover flaps were symmetrical in shape and measured 16.5 cm (6.5") in width at the top and bottom aspects, 6.7 cm (2.6") in height, and 17.1 cm (6.8") in width at the tear seam. The air bag was not tethered and was vented by two circular ports located at the 12 o'clock position on the rear aspect of the air bag 6.4 cm (2.5") aft of the peripheral seam. Each vent port measured 2.5 cm (1.0") in diameter.

Figure 13. Driver's air bag

The air bag exhibited minor body fluid spatter on the upper right and lower right quadrants of the face of the air bag. The upper right quadrant body fluid contacts measured an area of 10.2 cm (4.0") in height and 8.9 cm (3.5") in width and the lower right quadrant body fluid contacts measured an area of 16.5 cm (6.5") in height and 10.2 cm (4.0") in width. A small body fluid transfer was present 2.5 cm (1.0") to the right of the centerline and vertically located at the center aspect of the air bag.

Linear faint orange-colored transfers were located along the outboard fold points of the air bag, on the face and rear aspects. It appeared that they may have resulted from contact with the interior surface of the air bag module within the steering wheel as it deployed.

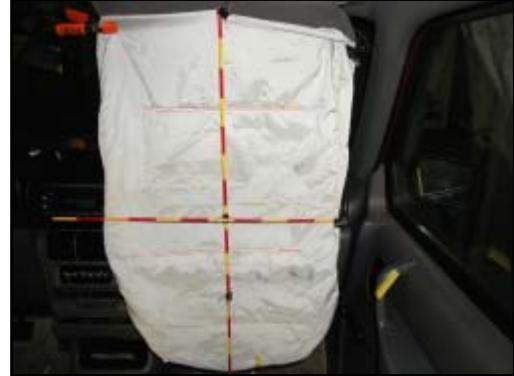
The front right passenger's air bag (**Figure 14**) deployed from a top-mount module configured with a rectangular cover flap hinged at the forward aspect. The vinyl cover flap measured 32.4 cm (12.8") in width, 14.6 cm (5.8") in height on the left aspect and 14.3 cm (5.6") in height on the right aspect. "SRS Airbag" was embossed on the lower right corner of the air bag cover flap (**Figure 15**). The air bag measured 45.7 cm (18.0") in width and 66.0 cm (26.0") in height. The air bag was vented back through the module and exhibited two lateral stitch seams on the face of the air bag that measured 29.8 cm (11.8") in width.

The top aspect of the front right passenger's air bag exhibited a black vinyl transfer from contact with the cover flap that measured 12.7 cm (5.0") in width and 6.4 cm (2.5") in height. The transfer was located 20.3 cm (8.0") inboard of the left side seam and 16.5 cm (6.5") rearward of the forward-most lateral stitching on the top of the air bag. An area of body fluid (blood) transfers was present on the bottom aspect of the air bag. The transfers began 11.4 cm (4.5") inboard of the left side seam of the air bag and measured 15.2 cm (6.0") in width and 17.8 cm (7.0") in height. The transfers were vertically located on the bottom aspect of the air bag 30.5 cm (12.0") from the inflator and 16.5 cm (6.5") above the lower-most lateral stitching.

The face of the air bag did not exhibit any transfers or damage.

Figure 14. Front right passenger's air bag

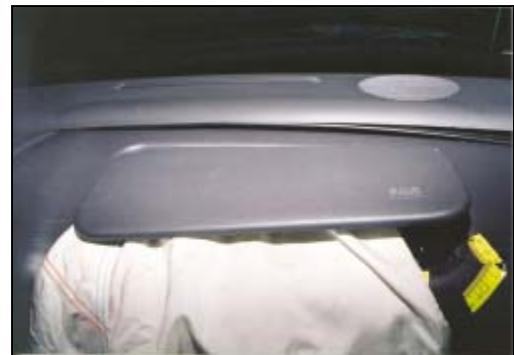
Figure 15. Front right passenger's air bag cover flap

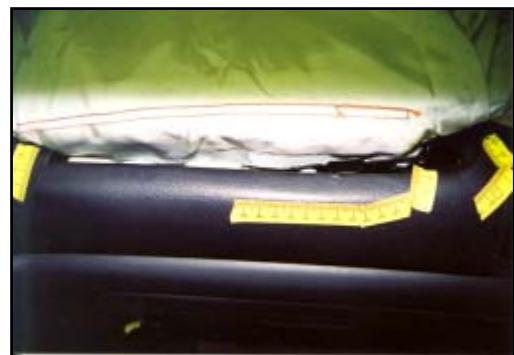
There was no damage or occupant contact noted on the air bag cover flap, however, the outboard corners of the module perimeter near the face of the instrument panel were torn diagonally as a result of the air bag deployment. The left corner tear measured 3.0 cm (1.2") in length and the right corner tear measured 1.0 cm (0.4") in length. A faint transfer was present on the right aspect of the top instrument panel adjacent to the leading edge of the cover flap from interaction with the deploying air bag (**Figure 16**). The air bag module housing did not sustain damage.

Figure 16. View of corner tears and faint transfer on the instrument panel adjacent to the leading edge of the cover flap
