SIDE IMPACT OCCUPANT PROTECTION NON-DEPLOYMENT INVESTIGATION

VERIDIAN CASE NO: CA02-060

VEHICLE: 2002 HYUNDAI SONATA

CRASH DATE: DECEMBER 2002

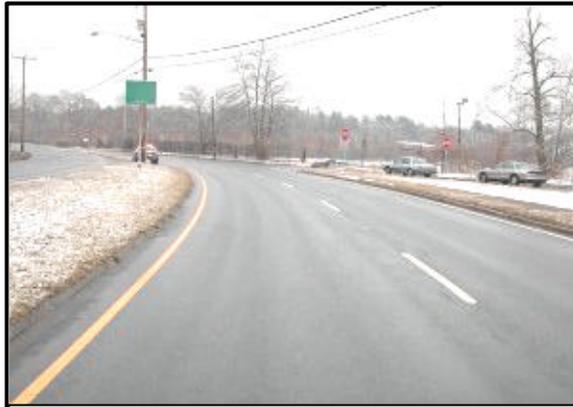
The crash occurred on an east/west, two-lane divided state highway. There was a left curve for eastbound traffic. At the scene, a one-way road intersects the state highway from the southwest at an acute angle forming a Y-type intersection. The intersecting traffic could merge and continue eastbound or turn sharply left into a cross-over for westbound travel. The intersection was controlled by a stop sign for the intersecting traffic. There were no obstructions in the intersection that would have impaired either driver's visibility. The speed limit in the area of the crash was 56 km/h (35 mph). **Figure 1** is an eastbound trajectory view approaching the intersection. A schematic of the crash sequence and the configuration of the intersection is depicted on **Figure 16** attached to the end of this report.

Figure 1: Eastbound trajectory view approaching the intersection.

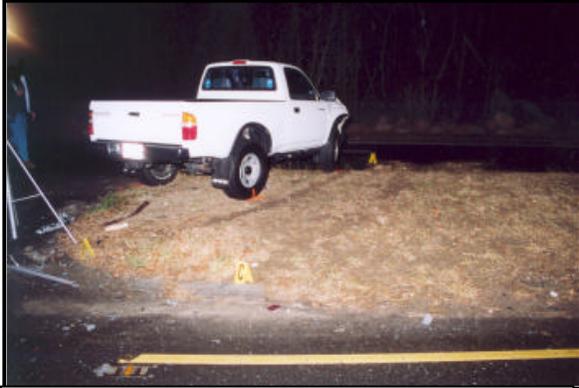
The lateral momentum of the Hyundai, coupled with probable left steering by the Toyota, re-directed both vehicles into the center median. The Toyota came to rest facing northward approximately 12 m (40 ft) northeast of the impact. The Hyundai was accelerated forward by the impact and remained engaged with the Toyota as the vehicles entered the median. As the vehicle approached the same eastbound velocity, the Hyundai then rotated counterclockwise across the front of the Toyota, and through the median evidenced by tire marks documented during the police investigation. The Sonata then entered the westbound lanes facing northwestward, rolled across the westbound lanes and came to rest against a road sign on the north shoulder. **Figure 2** is a view looking northward at the Toyota's final rest location and depicting the Hyundai's tire marks through the median. **Figure 3** is a view of the final rest location of the Hyundai.

Figure 2: Toyota FRP and Hyundai's tire marks through the median

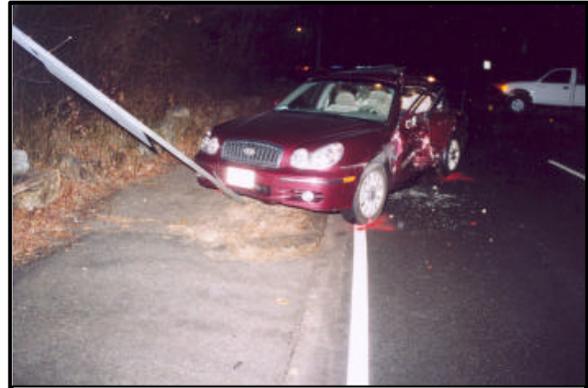
Figure 3: Hyundai FRP.

The front plane of the Hyundai contacted and deformed a road sign support post as it rolled to its final rest location (refer to Figure 3 above). There was no residual frontal crush as a result of this event. The sign contact was located 30 cm (12 in) right of vehicle center and the CDC was 12-FCLN-1.

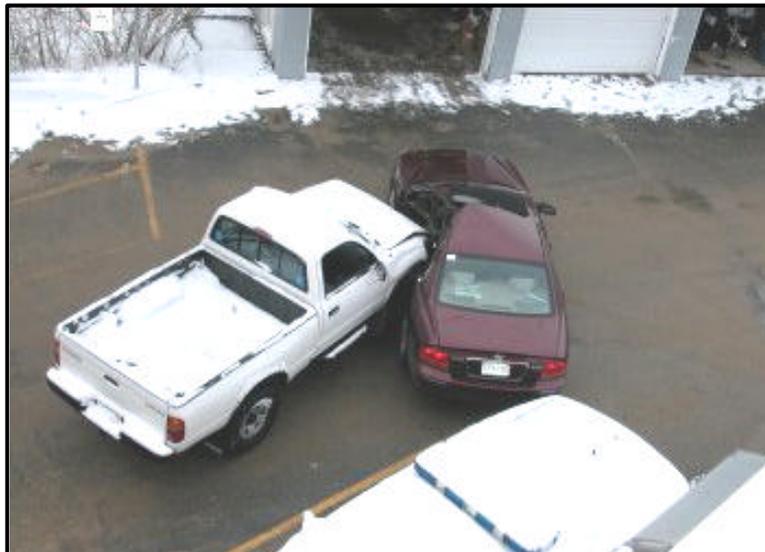
The impact's Principle Direction of Force (PDOF) was an estimated 220 directions with respect to the Hyundai. The PDOF was confirmed by a match-up of the vehicles during the SCI investigation, **Figure 4**. The right frame rail of the Toyota's front bumper system penetrated the left front door of the Hyundai. This damage pattern was used to align the vehicles during the match-up. The reconstructed impact configuration was consistent with the intersection configuration and the crash dynamics. In this contractor's opinion, the shallow PDOF relative to the vehicle's longitudinal axis resulted in an impact that was below the lateral threshold required to deploy the left side impact air bag.

Figure 4: Overhead view of the reconstructed crash configuration.

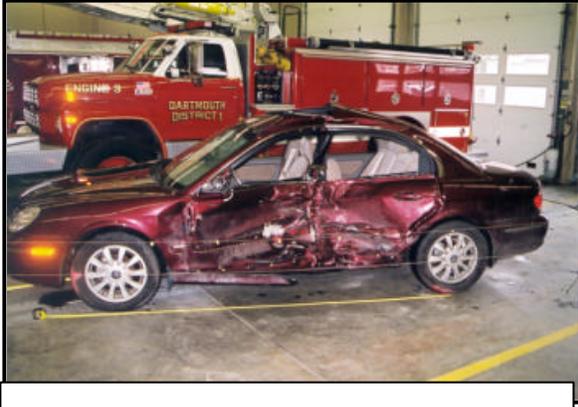
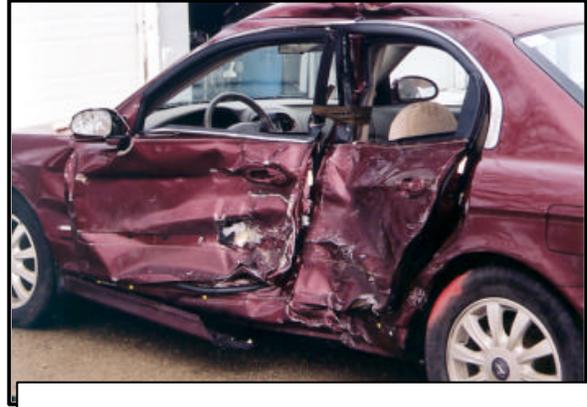
Figures 5 and 6 are views of the Hyundai's left side damage. The left side of the Hyundai sustained moderate damage as a result of the impact. The combined width of the direct contact and induced damage measured 232.4 cm (91.5 in). The pattern and flow of the damage was indicative of the 7 o'clock direction of the impact. The damage began 6.3 cm (2.5 in) forward of the left rear axle and extended forward onto the left front fender. The residual crush profile at the mid-door elevation was as follows: C1=0, C2=14.0 cm (5.5 in), C3=37.6 cm (14.8 in), C4=35.8 cm (14.1 in), C5=12.7 cm (5.0 in), C6=2.0 cm (0.8 in). The left doors were jammed shut due to deformation and the side glazing disintegrated. The left front door was opened by extrication. The right frame horn of the Toyota Tacoma contacted and penetrated left front door 24.1 cm (9.5 in) forward of its trailing edge during the impact. The roof buckled due to the lateral deformation. The left aspect of the windshield was fractured. The left wheelbase was reduced 6.6 cm (2.6 in) due to bending of the vehicle's unibody. The right wheelbase lengthened 1.0 cm (0.4 in). The Collision Deformation Classification was 07-LPAW-3. The total delta V calculated by the Damage Algorithm of the WINSMASH model was 24.0 km/h (14.9 mph). The longitudinal and lateral delta V components were +18.4 km/h (+11.4 mph) and +15.4 km/h (+9.6 mph), respectively.

Figure 6: Left side view of the Hyundai.

Figure 5: Left rear view of the damage along the PDOF.

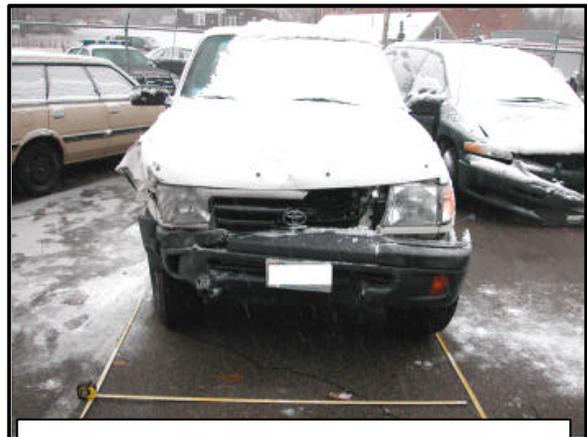
The front plane of the Toyota sustained direct contact damage that extended across the vehicle's entire 147 cm (58 in) end width, **Figure 7**. The damage pattern was biased to the vehicle's right side indicative of the angular impact configuration. The maximum crush was located at the right front bumper corner. The residual crush profile along the front bumper was as follows: C1=1.3 cm (0.5 in), C2=3.3 cm (1.3 in), C3=9.4 cm (3.7 in), C4=13.2 cm (5.2 in), C5=15.2 cm (6.0 in), C6=26.2 cm (10.3 in). The crush of the bumper exposed the end of the right frame rail. This component contacted and penetrated the exterior panel of the Hyundai's left front door. The deformation of the right front fender and wheelhouse contacted and restricted the right front tire. The right wheelbase was shortened 5.8 cm (2.3 in). The left wheelbase was unchanged. There was no cab to bed contact. The Collision Deformation Classification was 12-FDEW-2. The total delta V calculated by the Damage Algorithm of the WINSMASH model was 32.0 km/h (19.9 mph). The longitudinal and

Figure 7: Front view of the Toyota.

lateral components were -32.0 km/h (-19.9 mph) and 0, respectively. The WINSMASH calculation overestimated the Toyota's delta V based on SCI field experience. An estimated 24 km/h (15 mph) delta V was more consistent with the magnitude of the Toyota's damage and the crash dynamics.

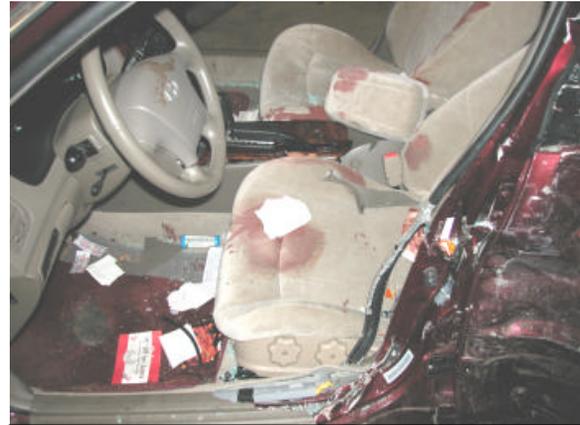
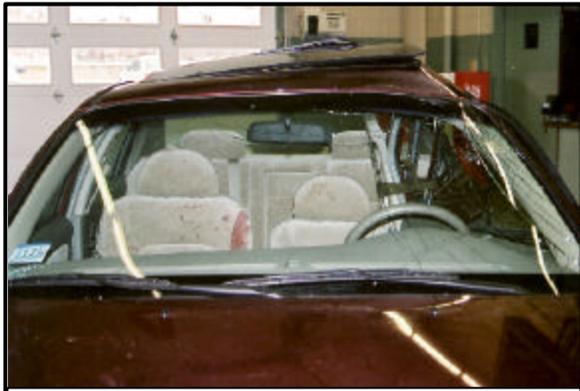
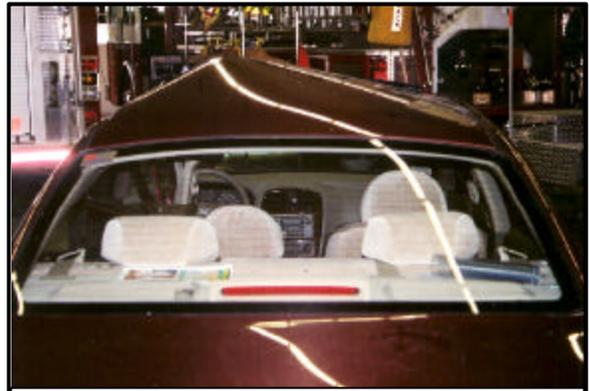
The front left and rear left occupant spaces sustained moderate intrusion as a result of the exterior crash forces. **Figure 8** is a view of the driver's interior. **Figures 9 and 10** are front and rear views into the occupant compartment depicting the extent of the intrusion. The lateral intrusion of the left front door measured at the center aspect of the arm rest was 16.5 cm (6.5 in). The lateral intrusion of the left rear door measured at its center aspect was 22.9 cm (9.0 in). The intrusion of the left B-pillar measured at the D-ring was 36.8 cm (14.5 in). The left B-pillar was in contact with the driver's seat back and had compressed the seat back approximately 15 cm (6 in) laterally. The center console was deformed to the right due to contact from the driver's right hip.

Figure 8: Left front interior view.

Figure 9: Front view into the occupant compartment.

Figure 10: Rear view into the occupant compartment.

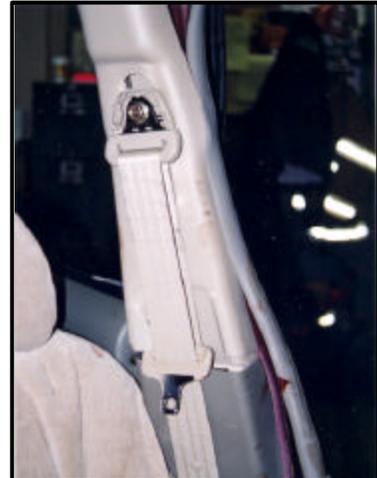
The driver's manual restraint was stowed in its retractor at the time of the inspection and the retractor was locked. The stowed webbing was captured between the left B-pillar and the outboard aspect of the driver's seat. The retracted and captured position of the restraint indicated the driver was unrestrained at the time of the crash. Inspection of the latch plate identified minimal historical usage evidence. The plastic trim covering the D-ring fastener was fractured by a contact from the driver's head during the crash sequence, **Figure 11**.

Figure 11: Driver's 3-point restraint.

The left posterior aspect of the driver's head impacted the D-ring and left B-pillar. This contact fractured the molded plastic trim covering the fastener and lacerated the driver's scalp. The force of this impact resulted in the identified severe acute subarachnoid brain hemorrhages. The lateral intrusion contacted the left flank of the driver resulting in multiple left rib fractures and the deep laceration of the lower lobe of the left lung. The force of the intrusion then displaced the driver to the right. The driver's right hip contacted and deformed the center console. The anterior aspect of the driver's thighs contacted the lower sector of the steering wheel rim and became contused. It was probable the driver contacted the front right passenger during the later stages of the crash sequence. He reportedly came to rest within his seat and had to be extricated from the vehicle.

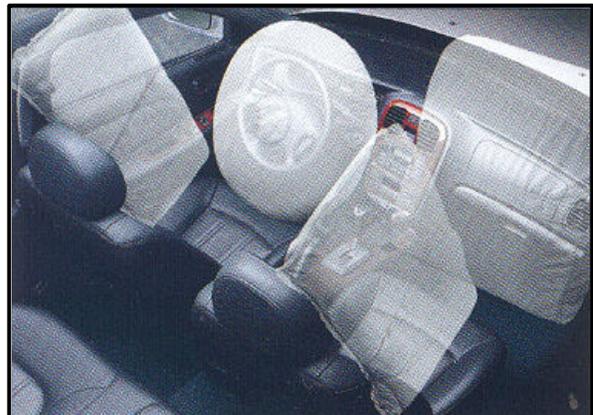
The SRS in the Hyundai Sonata consisted of frontal air bags and seat-mounted side impact air bags for the driver and front right passenger. The side impact air bags were designed to offer head and thorax protection. **Figure 12** is a depiction of the vehicle's deployed SRS taken from a 2002 Hyundai publication.

Figure 12: 2002 Hyundai Sonata SRS.

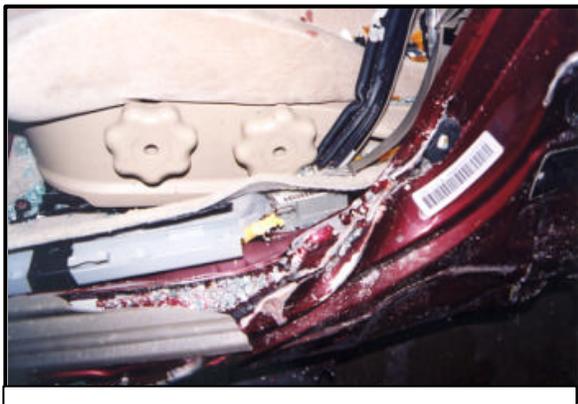
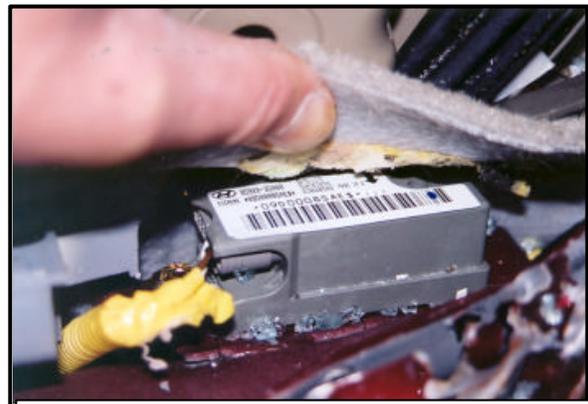
The left side impact sensor was physically inspected; refer to **Figures 13 and 14**. The following manufacturer's nomenclature identified the sensor:

A blue dot was located on the label and reportedly indicated that this sensor was a recall replacement. The wiring to the sensor was intact and it was not damaged. To ensure the side impact circuitry was operational, the electrical connector was removed from the sensor with the ignition key in the ON position. The SRS warning immediately illuminated indicating a fault in the circuit. The ignition key was then cycled OFF and back ON. The warning lamp flashed 6 times during the diagnostic sequence and then remained on, flagging the open side impact circuit.

Figure 13: View of the left sill and side impact sensor location.

Figure 14: Left side impact sensor.

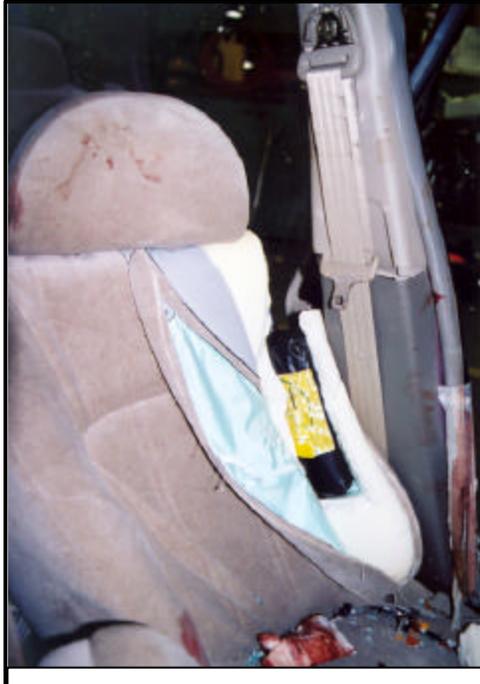
The cloth covering and foam of the driver seat bolster was removed to assess and inspect the left side impact module. Examination found the module and wiring intact. There were no apparent faults with the module, **Figure 15**.

Figure 15: Non-deployed left side impact air bag.
