**TRANSPORTATION SCIENCES
CRASH DATA RESEARCH CENTER**

**GENERAL DYNAMICS REMOTE CERTIFIED ADVANCED 208-COMPLIANT
VEHICLE CRASH INVESTIGATION
SCI TECHNICAL SUMMARY REPORT**

NASS/SCI COMBO CASE NO. 03-41-043B

**VEHICLE – 2003 CHEVROLET SILVERADO
LOCATION - STATE OF FLORIDA**

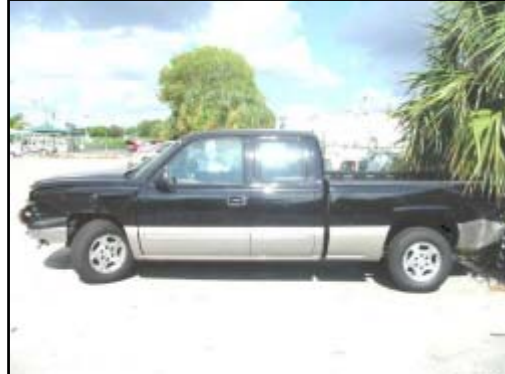
Figure 1. 2003 Chevrolet Silverado.

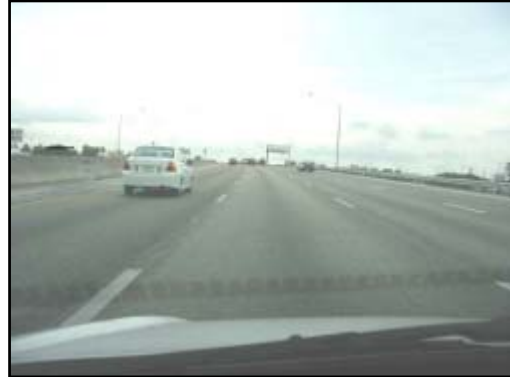
This three-vehicle crash occurred during the morning hours of February 2003 in the state of Florida. At the time of the crash, there were no adverse weather conditions and the asphalt road surface was wet. The crash occurred on the northbound lanes of a three-lane turnpike (Figure 2). The northbound roadway was configured with three through traffic lanes and a one-lane on-ramp. A painted gore with white lines divided the on-ramp and northbound roadway. The roadway was bordered with concrete shoulders on the east and west road edge. A concrete “Jersey” median divided the north/south roadway. The northbound lanes curved left at the crash site with a slight positive grade. The advisory speed for the on-ramp was 48 km/h (30 mph). The posted speed limit for the turnpike was 105 km/h (65 mph). The NASS scene schematic is included as Figure 11 of this report.

Figure 2. Crash site three-lane turnpike.

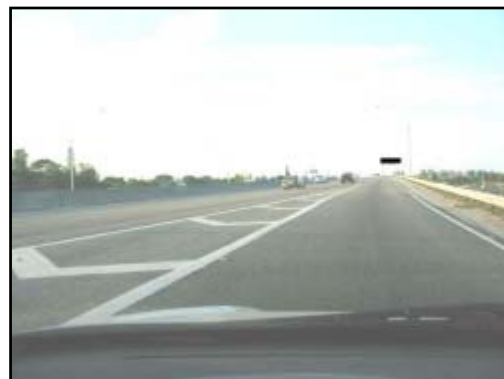
The 28-year-old male driver of the 2003 Chevrolet Silverado was operating the vehicle northbound on the on-ramp approaching the turnpike (**Figure 3**). The driver of the 1993 Oldsmobile was operating the vehicle northbound on the turnpike in the left lane approaching the end of the painted gore. The driver of the Hyundai was operating the vehicle northbound on the turnpike in the center lane approaching the on-ramp. The police reported that the Chevrolet was traveling at a high rate of speed on the on-ramp. As the Chevrolet approached the painted gore, the Chevrolet traversed the gore and onto the northbound

Figure 3. Chevrolet's approach to impact area.

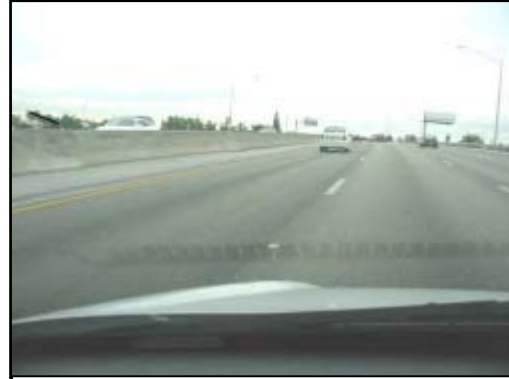
As the Chevrolet entered the center lane, the driver began to steer right in an attempt to maintain his lane. The vehicle drifted across the lane line into the outboard lane, impacting the rear of the Oldsmobile. The front left area of the Chevrolet impacted the rear right aspect of the Oldsmobile (**Figure 4**). The resultant directions of force were within the 11 o'clock sector for the Chevrolet and 5 o'clock for the Oldsmobile. The resultant damage was of sideswipe-type for the Chevrolet and severe override for the Oldsmobile. Based on the sideswipe-type engagement, a common velocity was not obtained; therefore the WINSMASH program was out of scope and not used to determine a delta V. This impact resulted in the frontal air bag deployment in the Chevrolet.

Figure 4. Area of impacts between Chevrolet, Oldsmobile, and Hyundai.

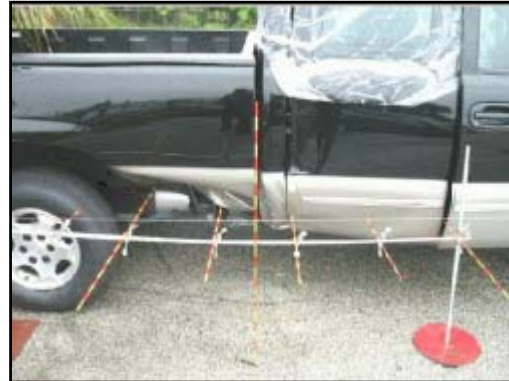
The third impact to the Chevrolet was the front of the Hyundai impacting the right side of the Chevrolet (**Figure 7**). The direct contact damage measured 146.0 cm (57.5”) and was located at the sill area of the right rear door and the forward aspect of the bed. The direct contact damage began 158.0 cm (62.2”) forward of the right rear bumper corner and extended 304.0 cm (120.0”) forward. Six crush measurements were documented along the sill level using a combined direct and induced damage width of 162.0 cm (63.8”) and were as follows: C1= 5.0 cm (2.0”), C2= 30.0 cm (11.8”), C3= 29.0 cm (11.4”), C4= 2.0 cm (0.8”), C5= 0.0, C6= 0.0. The CDC for this impact was 03-RZLW-3.

Figure 7. Damage from impact with the Hyundai.

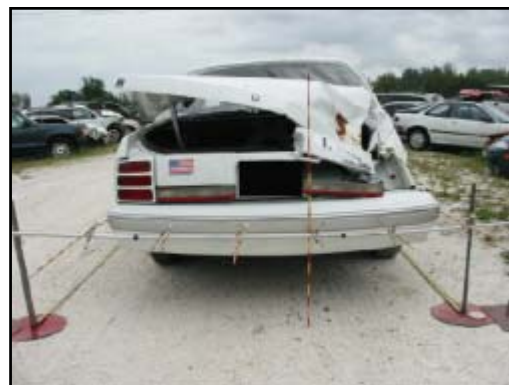
The 1993 Oldsmobile Cutlass Ciera sustained moderate severity rear damage as a result of the impact with the Chevrolet (**Figure 8**). The damage consisted of the right rear fender being longitudinally and vertical displaced from the Chevrolet overriding the rear of the Oldsmobile. The damage also consisted of the trunk being displaced downward and laterally left. In addition, the trunk was buckled forward and the forward left corner of the trunk contacted and disintegrated the rear glazing. The direct contact damage began at the right corner of the bumper and extended 22.0 cm (8.5”) left. Maximum crush was located at the rear right bumper corner and measured 13.0 cm (5.1”). Six crush measurements were documented at the bumper level and above bumper level using a combined direct and induced damage width of 164.0 cm (60.6”). The average crush for both levels was C1= 3.0 cm (1.2”), C2=

Figure 8. Damage area from impact with the Chevrolet.

4.0 cm (1.6”), C3= 0.0 cm, C4= 0.0, C5= 2.0 cm (0.8”), C6= 1.0 cm (0.4”). The CDC for this impact was 05-BREE-5.

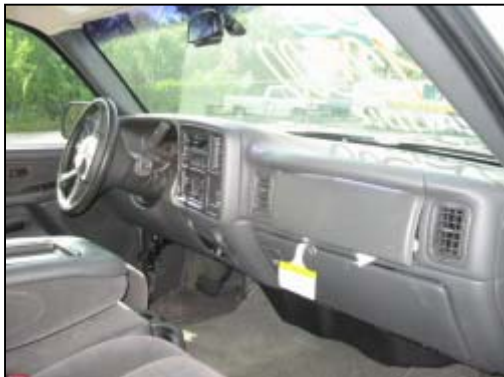
The 2003 Chevrolet Silverado was equipped with a Certified Advanced 208-Compliant safety system. The system consisted of dual stage frontal air bags, seat track position sensors for the front left and front right seats, and an occupant presence sensor for the front right seat. The system was controlled by a Sensing and Diagnostic Module (SDM). The SDM deploys the appropriate safety system dependant on crash severity, seat track position, and front right occupant presence. In this crash, the SDM commanded the deployment of the frontal air bags (**Figure 9**). The deployment stage was not known for this crash.

Figure 9. Overall view of the instrument panel and deployed air bags.

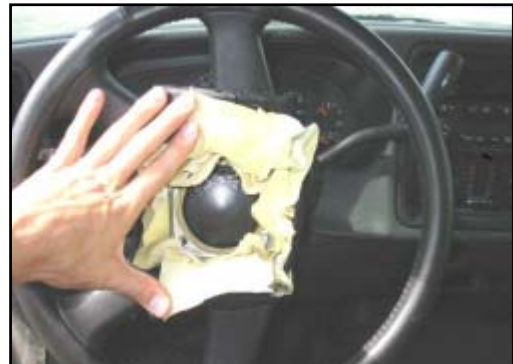
The front left air bag was located in the steering wheel hub (**Figure 10**). Two symmetrical I-configuration cover flaps that measured 6.0 cm (2.4”) in height and width concealed the front left air bag. The air bag membrane was cut out of the vehicle prior to the inspection by the NASS researcher; therefore the air bag size, tethers, occupant contacts, and vent ports were unknown.

Figure 10. Driver's air bag module. Note air bag was cut out prior to inspection.

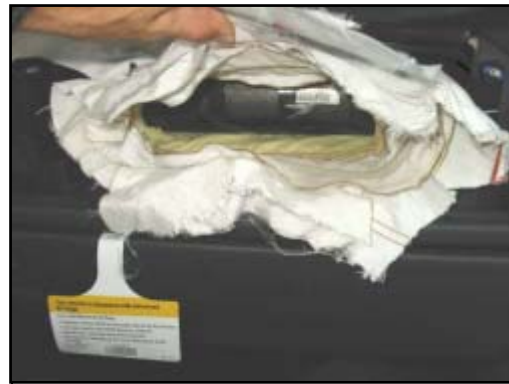
The front right air bag was mid-mounted in the right instrument panel (**Figure 11**). The air bag was concealed by a single cover flap that measured 19.0 cm (7.5”) in height and 39.0 cm (15.4”) width. The air bag membrane was cut out of the vehicle prior to the inspection by the NASS researcher; therefore the air bag size, tethers, and vent ports were unknown. Additionally, no occupant contact evidence could be determined.

Figure 11. Front right air bag module. Note air bag was cut out prior to inspection.

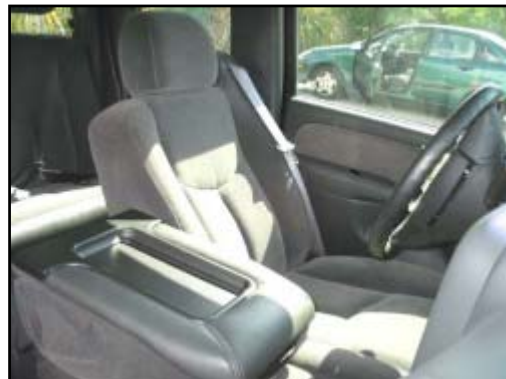
The 2003 Chevrolet Silverado was equipped with manual 3-point lap and shoulder belts for the outboard seating positions. The front center and rear center seats were configured with manual 2-point lap belts. The front left safety belt was integrated into the seat back (**Figure 12**) and configured with a sliding latch plate and an Emergency Locking Retractor (ELR). The front center safety belt was configured with a locking latch plate and no retractor. The front right safety belt was integrated into the seat back and configured with a sliding latch plate and switchable ELR/Automatic Locking Retractor (ALR).

Figure 12. Front left integrated safety belt.
