**VERIDIAN REMOTE SIDE IMPACT INFLATABLE OCCUPANT PROTECTION
INVESTIGATION
SCI TECHNICAL SUMMARY REPORT**

NASS/SCI COMBO CASE NO. 03-41-128F

**VEHICLE – 2003 MERCEDES-BENZ C240
LOCATION - STATE OF FLORIDA**

CRASH DATE – JULY 2003

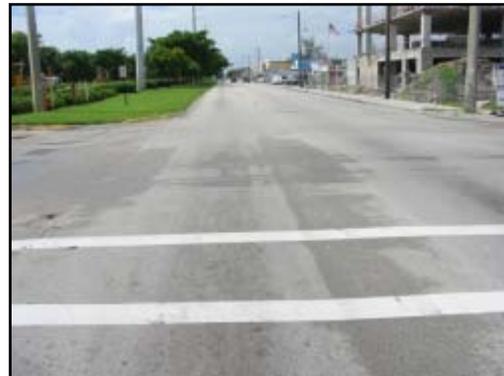
The frontal area of the BWM impacted the forward aspect of the Mercedes-Benz's left side (**Figure 4**). The resultant directions of force were within the 10 o'clock sector for the Mercedes-Benz and 1 o'clock for the BMW. This impact was sufficient to deploy the front left and rear left door panel mounted side air bags and left side curtain air bag in the Mercedes-Benz. The impact resulted in the BMW's driver's frontal air bag deployment. The missing vehicle algorithm of the WinSMASH program computed a total velocity change of 13.0 km/h (8.1 mph) for the Mercedes-Benz. The longitudinal and lateral components were -11.0 km/h (-6.8 mph) and 7.0 km/h (4.3 mph) respectively. The total velocity change for the BMW was 16.0 km/h (9.9 mph). The longitudinal and lateral components were -13.9 km/h (-8.6 mph) and -8.0 km/h (-5.0 mph) respectively.

Figure 4. Area of impact from the Mercedes-Benz approach.

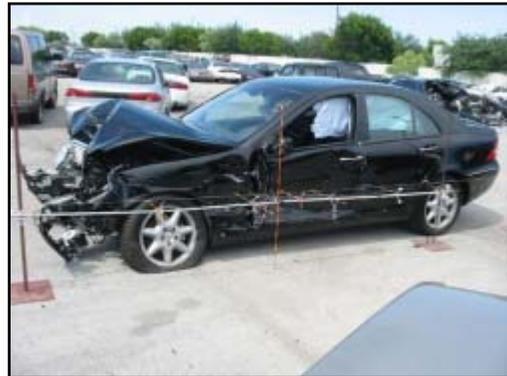
The 2003 Mercedes-Benz C240 sustained moderate left side damage (**Figure 5**) as a result of the impact with the 1995 BMW 325i. The direct contact damage width measured 274.0 cm (107.8") and began 83.0 cm (32.6") forward of the left rear axle and extended rearward where it terminated beyond the forward edge of the left rear door. The maximum crush was 12.0 cm (4.7") and was located 179.0 cm (70.5") forward of the left rear axle. The damage from the impact with BMW consisted of lateral crush to the left front fender, left front door, and shattered left front glazing. The researcher noted that the left wheelbase was reduced 4.0 cm (1.6"). Six crush measurements were documented along the mid-door level using a combined direct and induced damaged width of 329.0 cm (129.5") and were as follows: C1 = 0.0 cm, C2 = 4.0 cm (1.6"), C3 = 10.0 cm (3.9"), C4 = 10.0 cm (3.9"), C5 = 12.0 cm (4.7"), C6 = 5.0 cm (1.9"). The Collision Deformation Classification (CDC) for the impact with the BWM was 10-LYEW-1.

Figure 5. Left side damage from impact with the BMW.

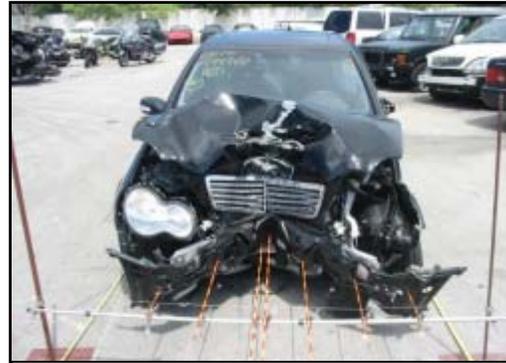
The Mercedes-Benz impacted a utility pole with its front and sustained moderate damage (**Figure 6**). The direct contact damage began 36.0 cm (14.2") inboard of the front right bumper corner and measured 33.0 cm (13.0") in length. The maximum crush from this impact was located 49.0 cm (19.3") inboard of the front right bumper corner and measured 44.0 cm (17.3"). Six crush measurements were documented on the front bumper using a combined direct and induced damage width of 111.0 cm (43.7") and were as follows: C1 = 0.0, C2 = 0.0, C3 = 23.0 cm (9.1"), C4 = 37.0 cm (14.6"), C5 = 11.0 cm (4.3"), C6 = 0.0. The CDC for this impact was 12-FZEN-2.

Figure 6. Pole impact damage to the front center area of the Mercedes-Benz.

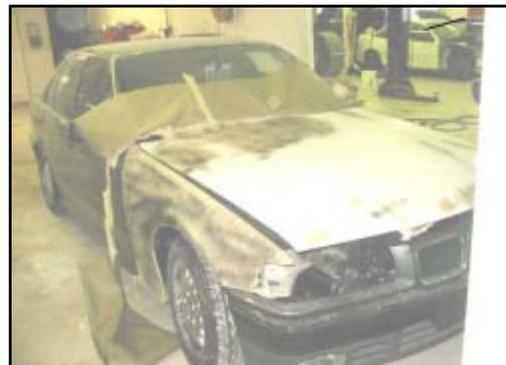
The 1995 BMW 325i sustained moderate severity damage as a result of the impact with Mercedes-Benz. The BMW was under repair at the time of the inspection (**Figure 7**). The damage involved the front left and right fenders, hood, grille, and bumper fascia. Due to the repair status, a crush profile could not be obtained. The Collision Deformation Classification for this impact was 01-F999-99.

Figure 7. Under repaired section of BMW.

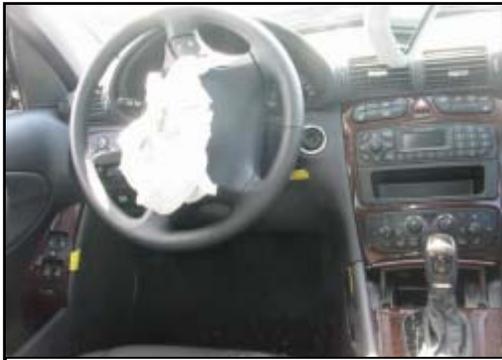
The 2003 Mercedes-Benz sustained minor interior damage (**Figures 8 and 9**) as a result of air bag deployment and occupant contacts. No intrusions were present in the Mercedes-Benz. At impact, the driver initiated a left and forward trajectory. The driver's left hip contacted the door panel armrest resulting in a scuff to the armrest. The driver's left knee contacted the lower portion of the door panel resulting in a crack to the lower door panel. The driver's right knee scuffed the knee bolster, his right hand contacted the rear view mirror and detached it from its mounting point. His right knee dented the center console. The driver's face contact to the frontal air bag resulted in the skin oil transfer to the air bag, and the driver's left arm contacted the door panel mounted side air bag resulting in a skin oil transfer. The steering wheel was deformed 1.0 cm (0.4") from the driver's loading of the air bag against the steering wheel.

Figure 8. Driver contact to the knee bolster.

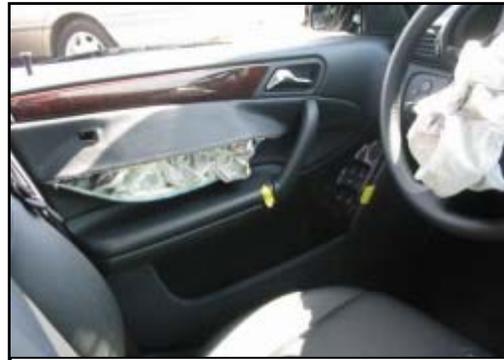
Figure 9. Driver contacts to the front left door panel and armrest.

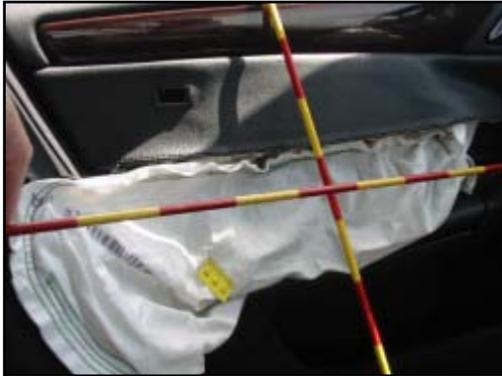
The 2003 Mercedes-Benz was equipped with side impact air bags that consisted of door panel mounted side air bags and curtain air bags for the four outboard seating positions. The front left and rear left door panel air bags and left side curtain air bag deployed as result of the crash with the BMW. The air bag module contained a single cover flap that consisted of the leather door panel cover and measured 43.0 cm (16.9") in width. The front left door panel air bag measured 20.0 cm (7.9") in height and 43.0 cm (16.9") in width (**Figure 11**). The researcher documented a skin oil transfer on the front lower right aspect of the air bag and a bloodstain on the rear top right aspect of the air bag. The air was not tethered and was vented internally. The air bag module contained a single cover flap that consisted of the leather door panel cover and measured 48.0 cm (18.9") in width. The rear left door panel side air bag measured 20.0 cm (7.9") in height and 44.0 cm (17.3") width (**Figure 12**). The air bag was not tethered and was vented internally.

Figure 11. Driver's door panel mounted side impact air bag (not fully extended).

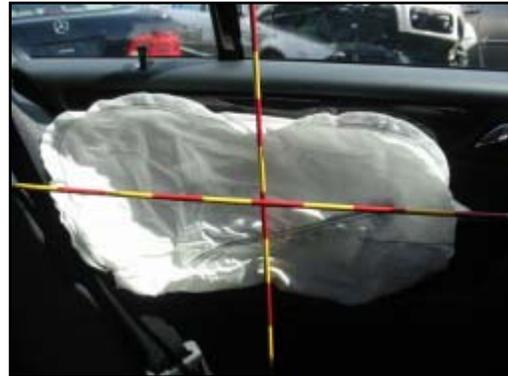
Figure 12. Rear left door panel mounted side air bag.

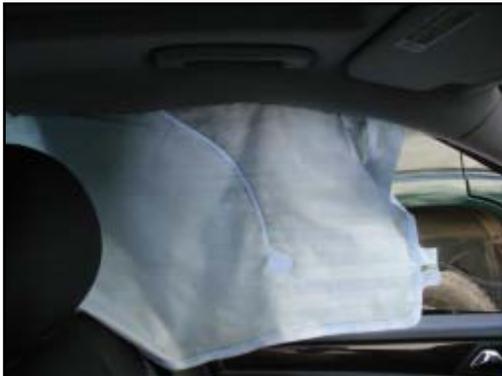
The left side curtain air bag deployed from the roof side rail and extended from the A-pillar to the C-pillar protecting both front and rear outboard seated positions (**Figures 13 and 14**). The air bag measured 29.0 cm (11.4") in height and 128.0 cm (50.4") length. The air bag was tensioned by two tethers that were connected to the left A-pillar and left C-pillar. The air bag fabric was fused to form a series of chambers and was internally vented. No contact evidence was noted to the curtain air bag. The right curtain and side air bags did not deploy during the crash.

Figure 13. Front left section of the inflatable curtain.

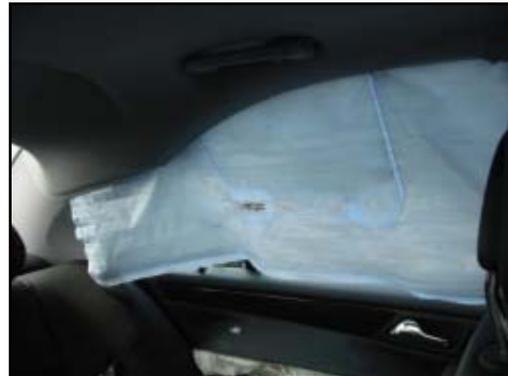
Figure 14. Rear left section of the inflatable curtain.

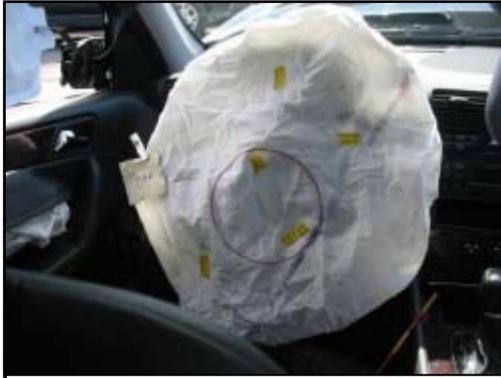
The 2003 Mercedes-Benz C240 was equipped with dual-stage frontal air bags. The driver's frontal air bag deployed as result of the crash. The air bag module contained two cover flaps. The top cover flap was 8.0 cm (3.1) in height and 17.0 cm (6.7") in width and the lower flap was 7.0 cm (2.8") in height and 17.0 cm (6.7") in width. The air bag was 53.0 cm (20.9") in diameter (**Figure 16**). The researcher noted skin oil transfers. The air bag contained two tethers and a single vent port at the 12 o'clock position on the rear aspect of the air bag. The front right air bag did not deploy (**Figure 17**) due to the front right seat not being occupied at the time of the crash.

Figure 16. Deployed driver's frontal air bag.

and impacted a utility pole with its front bumper. At impact with the pole, the driver's frontal air bag deployed and the driver's safety belt pretensioner fired. The driver's forearms were contacted by the deploying frontal air bag, resulting in the 5.1 cm x 5.1 cm (2.0" x 2.0") bilateral forearm abrasions. The driver initiated a forward trajectory in response to the 12 o'clock impact force. The combination of safety belt usage and frontal air bag deployment protected the driver from contact with frontal components, thus preventing possible injury. The driver was reported by the police as not injured and was not transported.

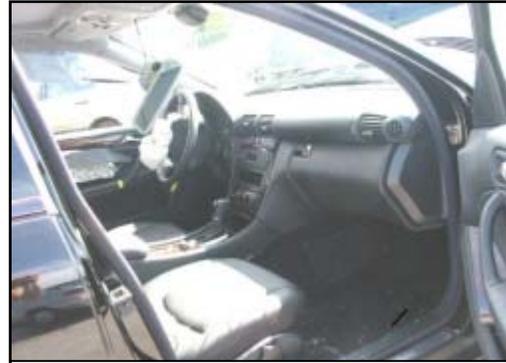
Figure 17. Non-deployed front right frontal air bag.
