**SCI 1 REMOTE CERTIFIED ADVANCED 208-COMPLAIANT VEHICLE CRASH
INVESTIGATION**

SCI 1 TECHNICAL SUMMARY REPORT

NASS/SCI COMBO CASE NO. 03-43-022G

VEHICLE – 2003 CHEVROLET SILVERADO

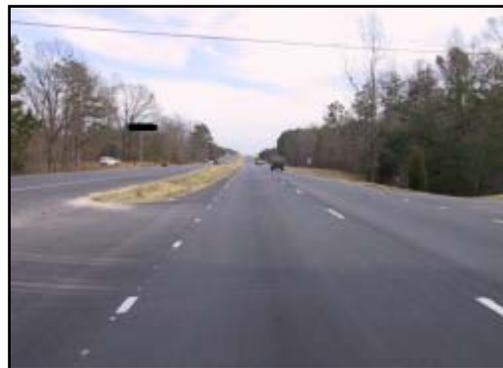
The front left aspect of the Chevrolet impacted the rear left side aspect of the Freightliner (**Figure 4**) in the intersection. The impact resulted in minor severity damage to the front aspect of the Chevrolet and was not sufficient to deploy the frontal air bags. The WINSMASH program was used to calculate a barrier equivalent speed for this impact due to the Freightliner being out of scope for the WINSMASH program. The barrier equivalent speed for the Chevrolet was 10.0 km/h (6.2 mph). The EDR data recorded a maximum velocity change of -7.99 km/h (-4.97 mph).

Figure 4. Area of impact from Chevrolet's approach.

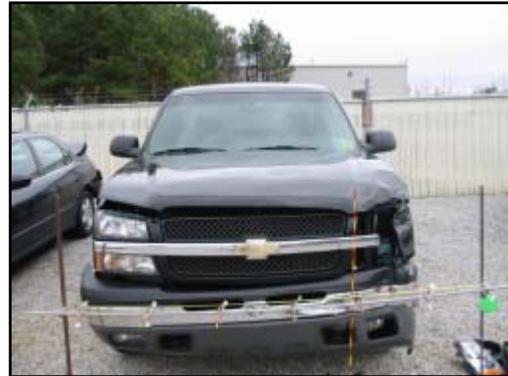
The 2003 Chevrolet Silverado sustained minor severity frontal damage as a result of the intersection type crash with the Freightliner (Figure 5). The direct contact damage began on the front left bumper corner and extended left 25.0 cm (9.8”). The damage consisted of a longitudinally displaced bumper, hood and front left fender and a disintegrated front left headlight assembly. Six crush measurements were documented along the front bumper using a combined direct and induced damage with of 168.0 cm (66.1”) and were as follows: C1 = 7.0 cm (2.8”), C2 = 5.0 cm (2.0”), C3 = 2.0 cm (0.8”), C4 = 0.0 cm, C5 = 0.0 cm, C6 = 0.0 cm.

Figure 5. Chevrolet's crush profile.

The Collision Deformation Classification for this impact was 12-FLEE-1. The four doors remained closed and operational and all glazing remained intact.

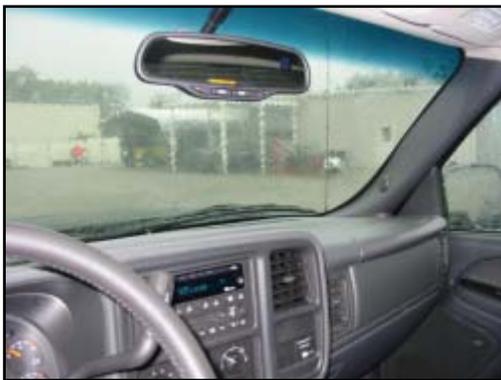
The 2003 Chevrolet Silverado sustained no interior damage (Figure 6 and 7) as a result of the crash.

Figure 7. Across instrument panel from left. No interior damage.

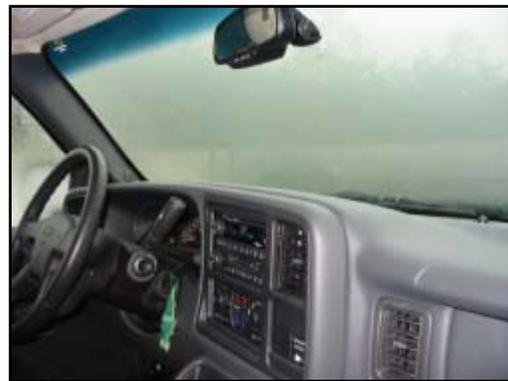
Figure 6. Across instrument panel from right. No interior damage.

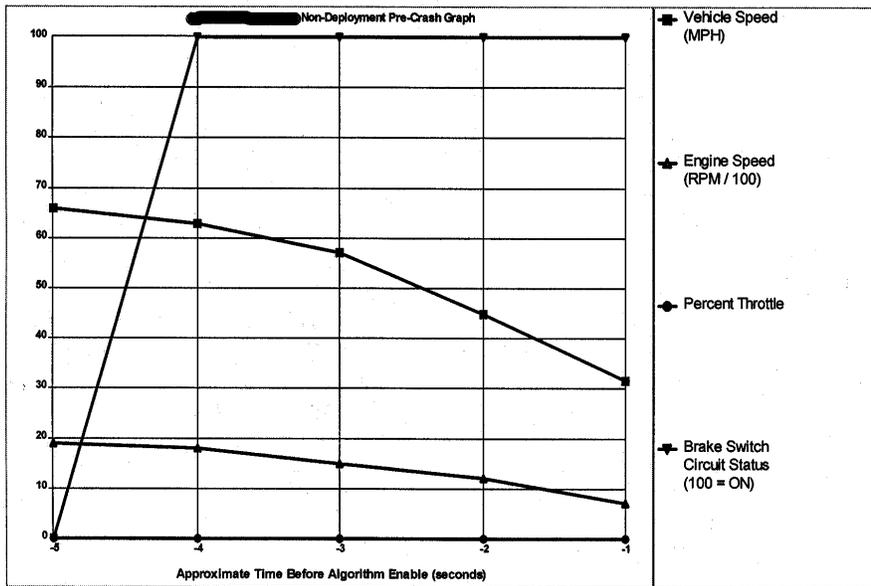
SIR Warning Lamp Status	OFF
Driver's Belt Switch Circuit Status	BUCKLED
Ignition Cycles At Non-Deployment	678
Ignition Cycles At Investigation	684
Maximum SDM Recorded Velocity Change (MPH)	-4.97
Algorithm Enable to Maximum SDM Recorded Velocity Change (msec)	215
Event Recording Complete	Yes
Multiple Events Associated With This Record	No
One Or More Associated Events Not Recorded	No

Seconds Before AE	Vehicle Speed (MPH)	Engine Speed (RPM)	Percent Throttle	Brake Switch Circuit Status
-5	66	1856	0	OFF
-4	63	1792	0	ON
-3	57	1536	0	ON
-2	45	1152	0	ON
-1	32	704	0	ON

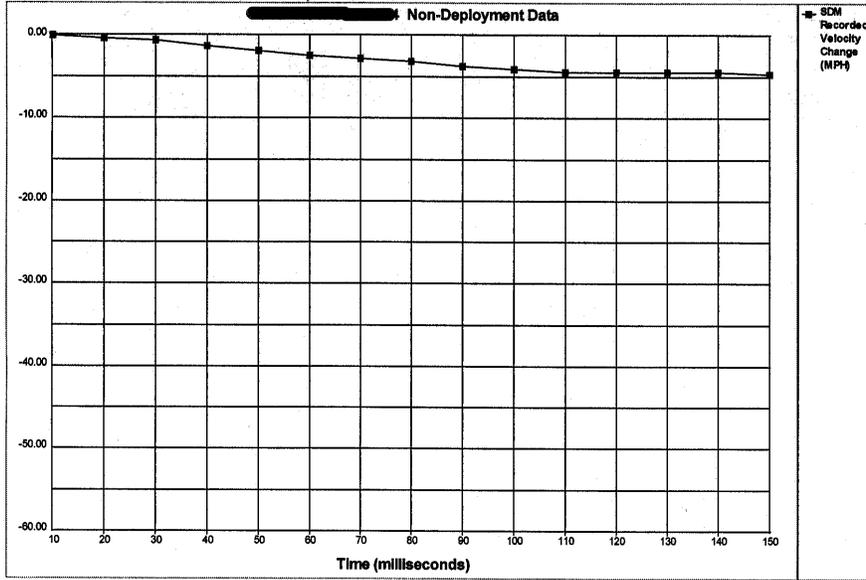
Time (milliseconds)	10	20	30	40	50	60	70	80	90	100	110	120	130	140	150
Recorded Velocity Change (MPH)	0.00	-0.31	-0.62	-1.24	-1.86	-2.48	-2.79	-3.10	-3.72	-4.03	-4.34	-4.34	-4.34	-4.34	-4.65
