**GENERAL DYNAMICS REMOTE SIDE IMPACT INFLATABLE OCCUPANT
PROTECTION SYSTEM CRASH INVESTIGATION**

SCI TECHNICAL SUMMARY REPORT

NASS/SCI COMBO CASE NO. 03-43-270A

VEHICLE – 2001 BMW 325i

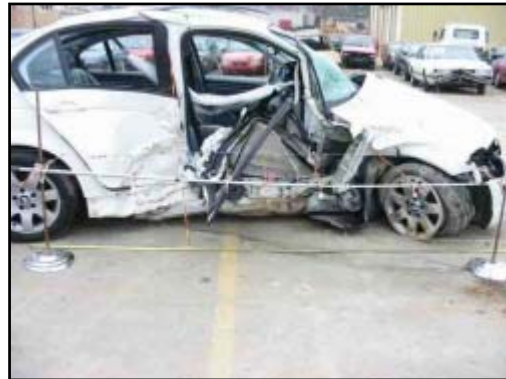
The 2001 BMW 325i sustained severe right side damage as a result of the collision with the Honda (**Figure 4**). The direct contact damage measured 180.0 cm (70.9”) and began 56.0 cm forward of the right rear axle and extended forward. The maximum crush was located near of the B-pillar and measured 45.0 cm (17.7”). The damaged components involved the right front fender, A-pillar, right doors, sill, B-pillar, roof side rail, and the right side glazing. Six crush measurements were documented along the mid-door level using a combined direct and induced damage width of 245.0 cm (96.5”) and were as follows: C1 = 8.0 cm (3.1”), C2 = 41.0 cm (16.1”), C3 = 16.0 cm (6.3”), C4 = 21.0 cm (8.3”), C5 = 43.0 cm (16.9”), C6 = 3.0 cm (1.2”).

Figure 4. Right side crush profile.

The Collision Deformation Classification (CDC) for this impact was 02-RYEW-3. The right side and left rear doors were jammed closed by deformation and the left front door remained closed and operational post-crash. The windshield was fractured from the lateral deformation. The right front and right rear glazing were disintegrated at impact. The left side, backlight, and right rear quarter glazing remained intact.

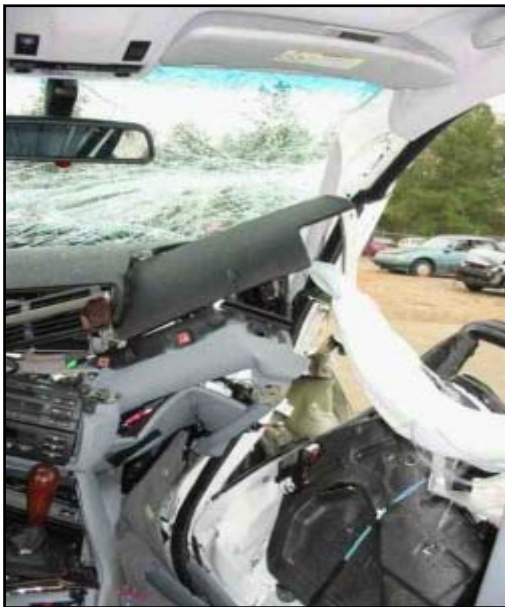
The 2001 BMW 325i sustained severe interior damage (**Figure 5, 6 and 7**) as a result of intrusion and occupant contacts. As a result of the impact, the driver initiated a right trajectory and the driver’s right hip contact the center console, which deformed by the occupant contact. The driver’s right thigh contacted the center console mounted parking brake handle, which was evidenced by lateral deformation. The driver’s left knee

contacted the knee bolster that was evidenced by deformation to the knee bolster. As the driver rebounded, her back contacted and deformed the seatback. As a result of the impact forces, the front right passenger initiated a right trajectory and her right hip and flank contacted the intruded right front door panel. The NASS researcher noted that the door panel was deformed and fractured from the occupant contact. The passenger's head contacted the right B-pillar and right front door panel. The NASS researcher noted probable occupant contact points from the front right occupant to the following objects, floor, seatback, right side impact air bag, and right side HPS air bag. However, no occupant contact related evidence was noted to the objects. The documented intrusions were as follows:

Figure 5. Right front passenger area.

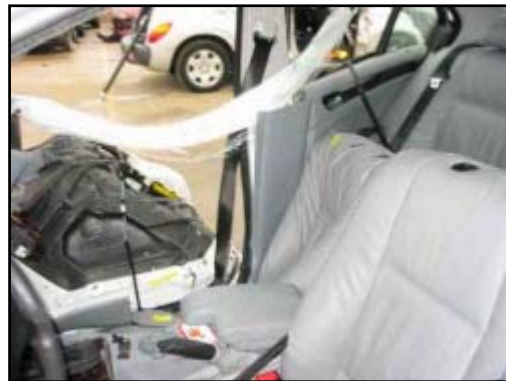
Figure 6. Front right seat.

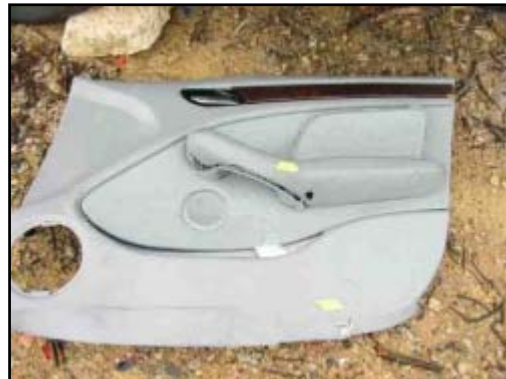
Figure 7. Removed right front door panel.

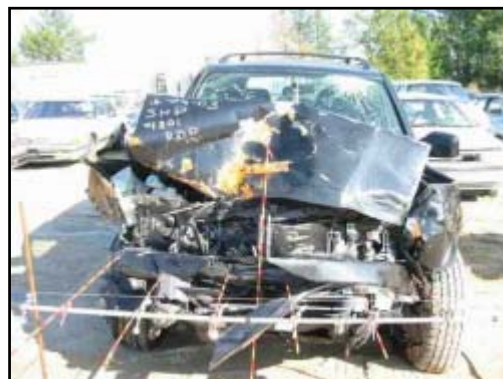
The 1999 Honda Passport sustained severe damage as result of the collision with the BMW (Figure 8). The direct damage measured 140.0 cm (55.1") and extended the full width of the vehicle. Maximum crush was located at the front right bumper corner and measured 49.0 cm (19.3"). The damage involved longitudinal deformation to the frontal structure. The NASS researcher utilized six crush measurements using a combined direct and induced damage width of 140.0 cm (55.1") to document the residual crush. The crush measurements were as follows: C1 = 38.0 cm (14.9"), C2 = 22.0 cm (8.6"), C3 = 26.0 cm (10.2"), C4 = 35.0 cm (13.7"), C5 = 35.0 cm (13.7"), C6 = 49.0 cm (19.3"). The CDC for this impact was 11-FDEW-3.

Figure 8. Damaged 1999 Honda Passport.

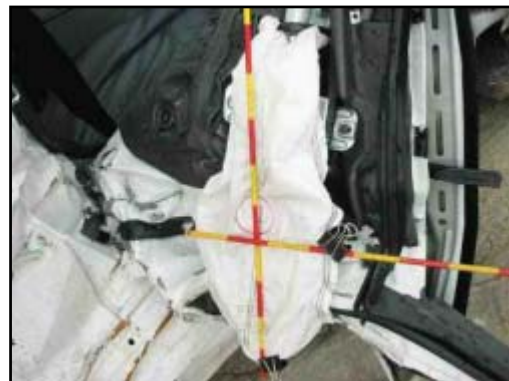
The 2001 BMW 325i was equipped with door panel mounted side impact air bags for the front seating positions. In the subject crash, the front right door panel side impact air bag deployed (**Figure 9**). The air bag was concealed by a leather cover flap that measured 11.0 cm (4.3") in height and 25.0 cm (9.8") in width. The air bag membrane measured 10.0 cm (3.9") in height at the forward aspect and 20.0 cm (7.8") at the rear aspect and 45.0 cm (17.7") in width. The NASS researcher noted no vent ports or tethers on the air bag. Although, a circular stitch pattern was present on the outboard panel of the air bag, which may have been consistent of a lateral tether. The NASS researcher documented a possible occupant contact to the air bag from the front right occupant, however; no contact related evidence was cited. No damage or failure was noted to the air bag.

Figure 9. Deployed right side impact air bag.

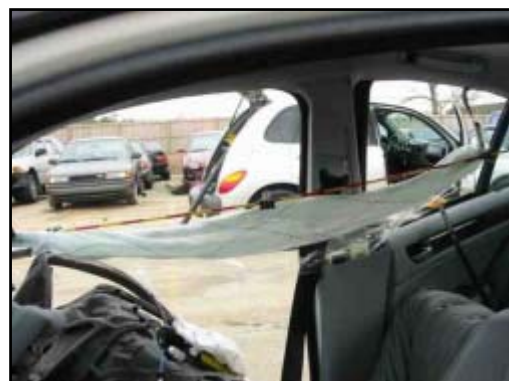
The 2001 BMW 325i was equipped with a Head Protection System (HPS) for the front seating positions. The system included two tubular air bags that deploy from the roof side rails and were designed to protect the occupants in the event of a side impact. In subject crash, the right side HPS deployed (**Figure 10**) from the right roof side rail. The air bag membrane measured 16.0 cm (6.3") diameter (deflated)

Figure 10. Deployed right side HPS air bag.

and 111.0 cm (43.7”) in length. The HPS was tethered at the right A- and C-pillars and was tensioned by inflation. The NASS researcher documented probable contact to the right HPS air bag; however, no contact related evidence was found. The NASS researcher noted no failures or damage to the air bag. The vehicle did not sustain a left side impact, therefore the left side HPS did not deploy.
