**GENERAL DYNAMICS REMOTE CERTIFIED ADVANCED 208-COMPLIANT
VEHICLE CRASH INVESTIGATION**

SCI TECHNICAL SUMMARY REPORT

NASS/SCI COMBO CASE NO. 03-43-285H

VEHICLE – 2004 LEXUS RX330

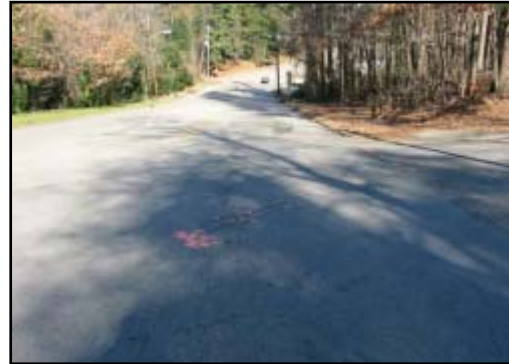
The front left aspect of the Lexus impacted the front right aspect of the Ford in the intersection. The NASS researchers' derived resultant directions of force were within the 11 o'clock sector (340 degrees) for the Lexus and 2 o'clock sector (70 degrees) for the Ford, which was used to calculate a delta V. Based on the SCI evaluation of the vehicle damage, the directions of force were revised to 11 o'clock (320 degrees) for the Lexus and 2 o'clock (50 degrees) for the Ford. This change warranted the delta V to be recalculated. The delta V was calculated using the missing vehicle algorithm of the WINSMASH program due to the Lexus

Figure 4. Northbound view of the initial point of impact.

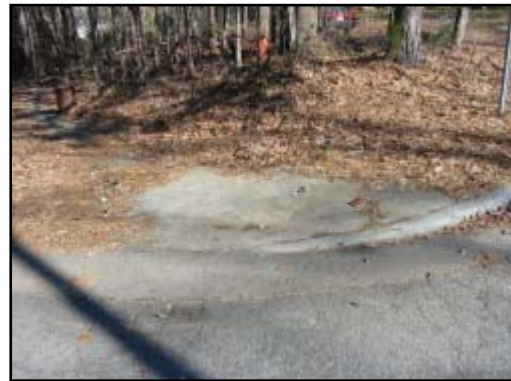
The Lexus continued its northeast trajectory and departed the northeast quadrant of the intersection at the location of the curb ramp for the sidewalk. The Lexus traveled off-road and impacted a fire hydrant with its frontal aspect (**Figure 5**). The resultant direction of force was within the 12 o'clock sector. The damage for this impact could not be located on the Lexus due to a subsequent frontal impact to a tree; therefore, a delta V could not be calculated.

The Lexus traveled an additional 2.8 meters (9.2 feet) and impacted a 30.0 cm (11.2") diameter tree with its front (**Figure 5**). The resultant direction of force for this impact was within the 12 o'clock sector. The WINSMASH barrier equivalent algorithm was used to calculate a delta V for this impact. The barrier equivalent delta V was 26.0 km/h (16.2 mph). It should be noted that this damage pattern was a result of the fire hydrant and tree impact damage. The Lexus came to rest against the tree facing in a northeast direction.

Figure 5. Area of impact with the fire hydrant and the tree.

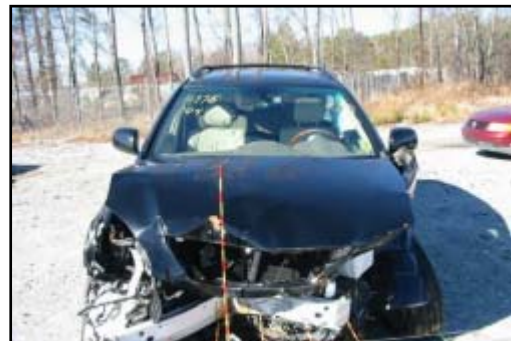
The 2004 Lexus RX330 sustained severe damage as a result of the multiple event crash. The damage from the initial impact with the Ford consisted of longitudinal and lateral displacement of the frontal components (**Figure 6**). Due to the multiple overlapping impacts to the frontal aspect, a crush profile was not documented for this impact. The NASS researcher documented a Collision Deformation Classification (CDC) for this impact of 11-FL99-9 (9's represent unknown values). Based on the SCI evaluation of the damage the CDC was revised for this report as follows: 12-FLEW-1.

Figure 6. Frontal damage from the initial impact with the Ford.

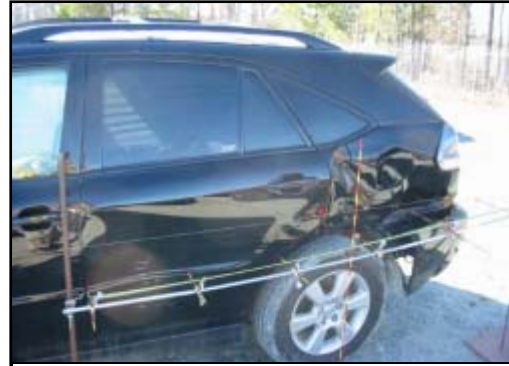
The Lexus sustained minor severity damage as a result of the secondary sideslap impact with the Ford (**Figure 7**). The damage consisted of lateral displacement of the left rear door and left rear quarter panel. The direct contact damage measured 203.0 cm (79.9”), which began at the left rear bumper corner and extended forward. The maximum crush measured 13.0 cm (5.1”) and was located at the mid point of the left rear quarter panel. Six equidistant crush measurements were documented along the mid-door level using a combined direct and induced damage width of 203.0 cm (79.9”) and were as follows: C1 = 3.0 cm (1.2”), C2 = 13.0 cm (5.1”), C3 = 12.0 cm (4.7”), C4 = 0.0 cm, C5 = 2.0 cm (0.8”), C6 = 0.0 cm. The CDC for this impact was 09-LZEW-1.

Figure 7. Left side damage from the secondary impact with the Ford.

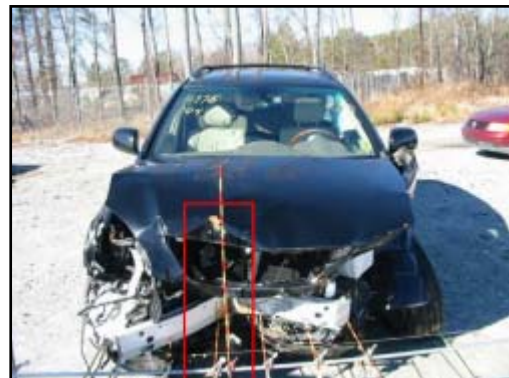
The Lexus sustained moderate severity damage as a result of the impact with the 30.0 cm (11.8”) diameter tree (**Figure 8**). The damage from this impact resulted in the longitudinal displacement of the frontal structure of the Lexus. The direct contact damage measured 30.0 cm (11.8”). This impact yielded a maximum crush depth of 35.0 cm (13.8”) which was located 55.0 cm (21.7”) inboard of the front left bumper support corner. Six crush measurements were documented along the bumper support using a combined direct and induced damage width of 100.0 cm (39.3”) and were as follows: C1 = 0.0 cm, C2 = 16.0 cm (6.3”), C3 = 29.0 cm (11.4”), C4 = 27.0 cm (10.6”), C5 = 8.0 cm (3.1”), C6 = 0.0 cm. The NASS researcher documented CDC for this impact was 12-FLEN-2. Based on the SCI evaluation of the damage, the CDC was revised for this report as follows: 12-FZEN-1.

Figure 8. Damage from the impact with the tree.

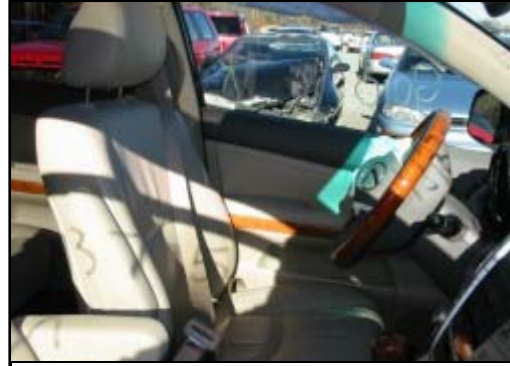
The 2004 Lexus RX330 sustained minor interior damage (**Figure 9**) as a result of occupant contacts. There were no intrusions into the passenger compartment. The NASS researcher documented a scuff to the lap portion of the safety belt webbing from the driver's abdomen. The NASS researcher also documented two scuffs to the knee bolster air bag from contact by the driver's knees.

Figure 9. Overall view of the driver's area.

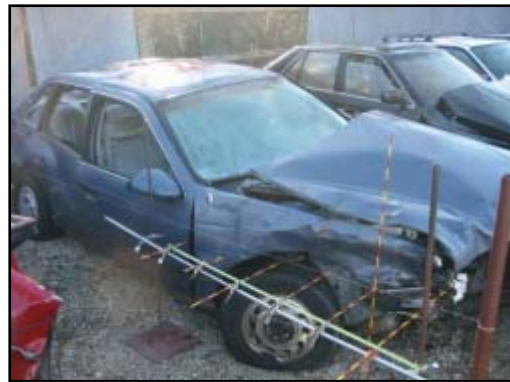
The 1991 Ford Taurus sustained moderate right side damage as a result of the initial impact with the Lexus (**Figure 10**). The direct damage measured 49.0 cm (19.3") and began at the front right corner and extended rearward. The maximum crush was 57.0 cm (22.4") and was located at forward edge of the front right fender. The damage involved lateral displacement of the right side and frontal components. Six crush measurements were documented at the mid-door level using a combined direct and induced damage width of 113.0 cm (44.5"), and were as follows: C1 = 0.0 cm, C2 = 10.0 cm (3.9"), C3 = 24.0 cm (9.5"), C4 = 37.0 cm (14.6"), C5= 37.0 cm (14.6"), C6= 57.0 cm (22.4"). The CDC for this impact was 02-RFEW-4.

Figure 10. Right side damage from the initial impact with the Lexus.

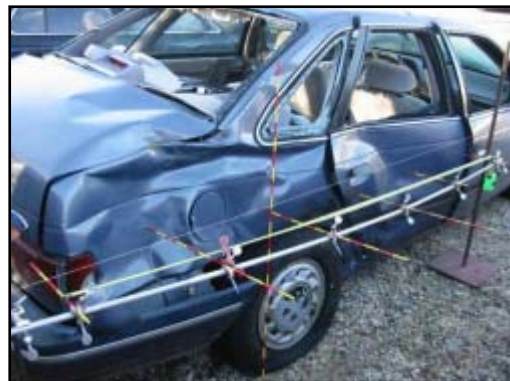
The secondary sideslap impact with the Lexus resulted in moderate damage to the right rear aspect of the Ford (**Figure 11**). The direct contact damage began at the right rear corner and extended forward 214.0 cm (84.3"). The resultant damage consisted of lateral displacement of the right rear door, right rear quarter panel, and disintegrated right rear door, right rear, and rear glazing. Six crush measurements were documented at the mid-door level using a combined direct and induced damage width of 214.0 cm (84.3") and were as follows: C1 = 5.0 cm (2.0"), C2 = 24.0 cm (9.5"), C3 = 22.0 cm (8.7"), C4 = 11.0 cm (4.3"), C5 = 12.0 cm (4.7"), C6 = 1.0 cm (0.4"). The CDC for this impact was 03-RZEW-2.

Figure 11. Right side damage from the secondary impact with the Lexus.

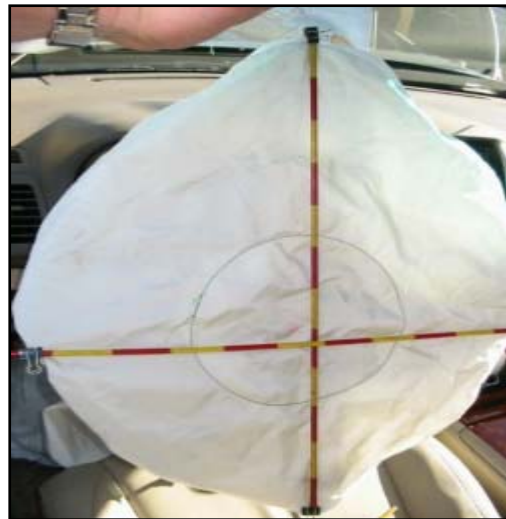
The driver’s frontal air bag deployed from the center of the steering wheel hub (**Figure 12**). The air bag was configured with a triangular cover flap design. The top flap measured 8.0 cm (3.1”) in height and 12.0 cm (4.7”) in width. The lower flaps measured 8.0 cm (3.1”) in height and 7.0 cm (2.8”) in width. The air bag measured 66.0 cm (26.0”) in diameter in its deflated state. The air bag contained two tethers and two vent ports. The vent ports were located at the 11 and 1 o’clock positions on the rear aspect. No occupant contacts were noted to the air bag.

Figure 12. Deployed driver's frontal air bag.

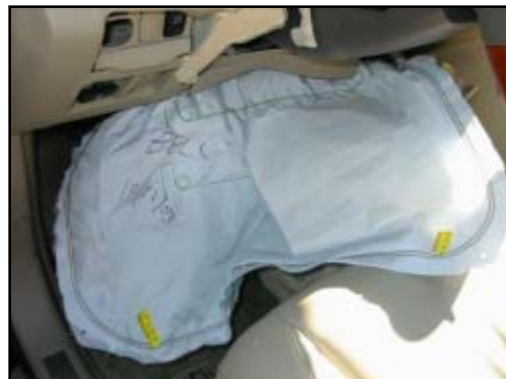
The driver’s knee bolster air bag deployed from the left side knee bolster (**Figure 13**). The air bag was configured with H-configuration cover flaps. The top flap measured 3.0 cm (1.2”) in height and 25.0 cm (9.8”) in width. The lower flap measured 5.0 cm (2.0”) in height and 25.0 cm (9.8”) in width. The knee bolster air bag measured 38.0 cm (15.0”) in height and 56.0 cm (22.0”) in width in its deflated state and contained two tethers and no vent ports. The NASS researcher documented two occupant contacts to the face of the knee bolster air bag. The occupant contacts consisted of two scuffmarks on the left and right aspects from the driver’s knees. The NASS researcher also noted that the upper section of the plastic knee bolster panel was displaced from the deploying knee bolster air bag. The section of the knee bolster was mounted below the

Figure 13. Deployed driver's knee bolster air bag.

steering column and measured 12.0 cm in (4.7”) height and 36.0 cm (14.2”) in width. No occupant contact points were noted to the displaced panel.

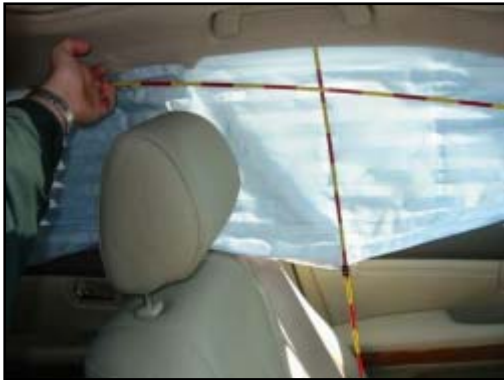
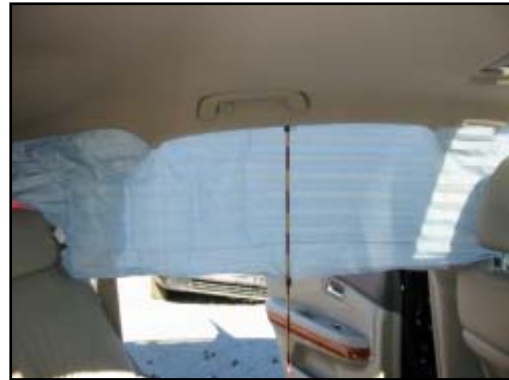
The 2004 Lexus RX330 was equipped inflatable curtain air bags for the outboard seating positions. The inflatable curtains are Roll-Sensing Curtain Air Bags (RSCA) and are designed to deploy at a severe tilt degree, roll or lateral G-force from side impacts. In the subject crash, the left side RSCA deployed (**Figures 14 and 15**). The air bag measured 38.0 cm (15.0”) in height and 167.0 cm (65.7”) in width. The RSCA contained two tethers and no vent ports. No occupant contacts were noted to the RSCA. The right RSCA did not deploy in this crash.

Figure 14. Deployed left side RSCA.

Figure 15. Deployed left side RSCA
