**GENERAL DYNAMICS REMOTE CHILD SAFETY SEAT INVESTIGATION**

**NASS/SCI COMBO CASE NO. 03-45-065K**

**VEHICLE – 1999 CHEVROLET SILVERADO**

**CRASH DATE – APRIL 2003**

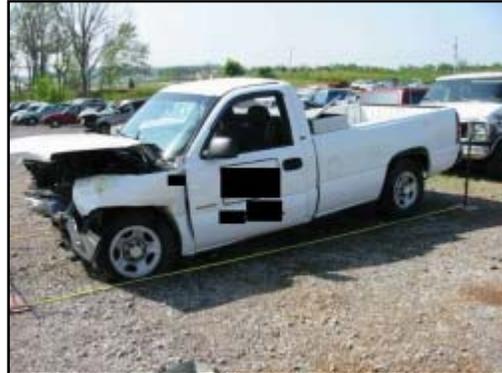
**Figure 1. 1999 Chevrolet Silverado.**

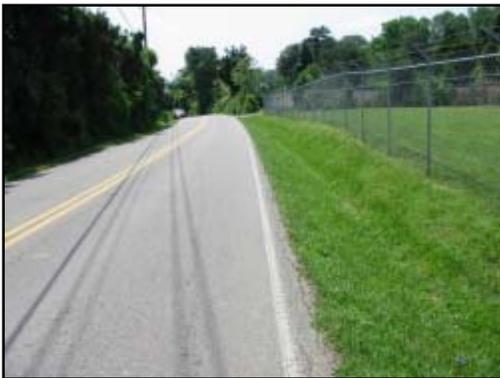
The restrained 26-year-old male driver of the Chevrolet was operating the vehicle northbound (**Figure 2**) on the two-lane road negotiating the left curve. The unrestrained driver of the Mazda was operating the vehicle southbound on the same roadway negotiating the right curve. The driver of the Mazda relinquished control of the vehicle and entered the northbound lane. As the driver of the Chevrolet observed the Mazda enter his lane, he began to brake and steer right towards the east road edge. The driver of the Mazda applied the brakes and left approximately 33.9 meters (111.2') of pre-impact right front skid mark and approximately 12.4 meters (40.7') of a left front pre-impact skid mark (**Figure 3**). The equivalent velocity loss due to braking was calculated at 80 km/h (50 mph). The NASS scene schematic is included as **Figure 15** of this report.

**Figure 2. Chevrolet's approach to the crash site.**

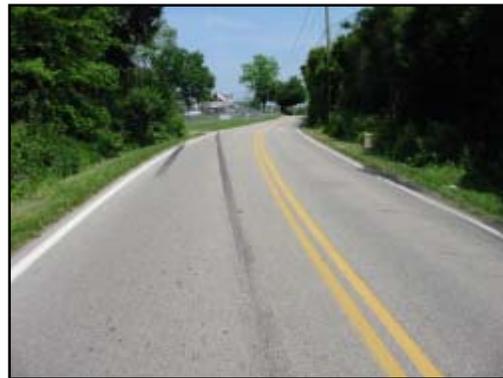
**Figure 3. Mazda's approach to crash site. Note pre-impact skid marks.**

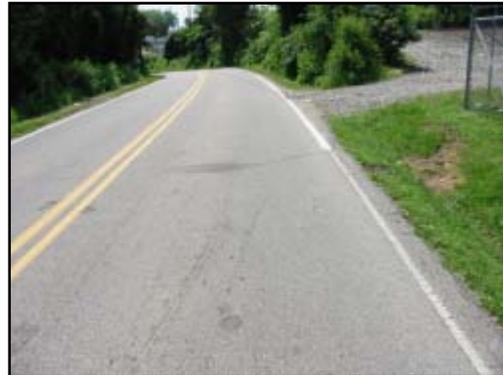
The full frontal aspect of the Mazda impacted the full frontal area of the Chevrolet in the northbound travel lane (**Figure 4**). At impact, the Chevrolet was straddling the east fog line. The impact speed for the Mazda was computed at approximately 105 km/h (65 mph). The resultant directions of force were within the 11 o'clock sector for the Chevrolet and 12 o'clock for the Mazda. The impact resulted in severe frontal damage to both vehicles. The impact resulted in the deployment of the Chevrolet's driver's frontal air bag. The front right air bag did not deploy due to the OEM on/off switch keyed to the off-position. The damage algorithm of the WINSMASH program was used to calculate a total delta-V for both vehicles. The total delta-V for the Chevrolet was 54 km/h (34 mph). The total delta-V for the Mazda was 67 km/h (42 mph). The longitudinal and lateral components for the Chevrolet were -51 km/h (32 mph) and 19 km/h (12 mph) respectively. The longitudinal and lateral components for the Mazda were -66 km/h (-41 mph) and -12 km/h (-8 mph) respectively.

**Figure 4. Northbound view of area of impact.**

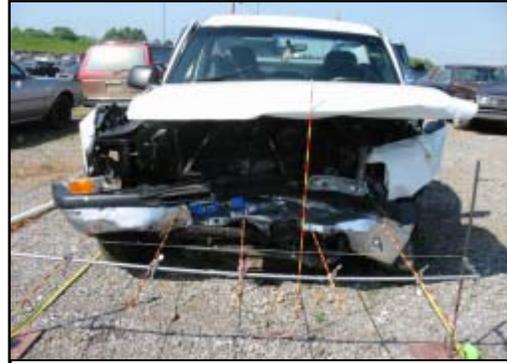
The 1999 Chevrolet Silverado sustained severe frontal damage as a result of the head-on crash with the 1994 Mazda B2300 (**Figure 5**). The direct contact damage width was 162.0 cm (63.7") and extended from bumper corner-to-bumper corner. Maximum crush was located at C3 and was 78.0 cm (30.7"). The left side wheelbase was reduced 8.0 cm (3.1") and the right wheelbase was reduced 24.0 cm (9.5"). Six crush measurements were documented along the front bumper fascia using a combined direct and induced damage width of 179.0 cm (70.5") and were as follows: C1 = 56.0 cm (22.1"), C2 = 71.0 cm (28.0"), C3 = 78.0 cm (30.7"), C4 = 66.0 cm (26.0"), C5 = 55.0 cm (21.7"), C6 = 52.0

cm (20.5”). The Collision Deformation Classification (CDC) for this impact was 71-FDEW3 with incremented lateral shift to the right. Both doors remained closed and operational post crash. The windshield was cracked from impact forces and the rear backlight was disintegrated from the bed moving forward at impact and contacting the back wall of the cab.

**Figure 5. Damage profile to the front of the Chevrolet.**

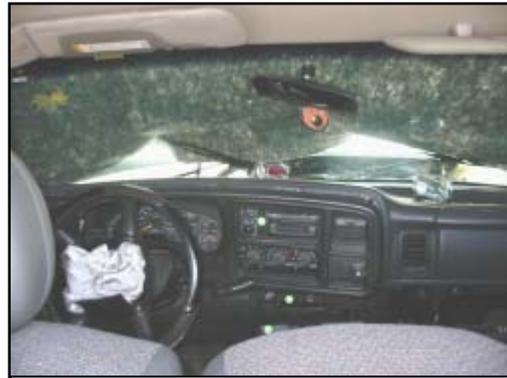
The 1999 Chevrolet Silverado sustained minor interior damage as a result of the crash. The damage consisted of intrusion and occupant contacts to the interior (**Figures 6**). The occupant contacts from the driver consisted of his left hand fracturing the left outside rearview mirror, the driver’s lower left arm fracturing the left A-pillar trim, a scuff from the driver’s left knee to the knee bolster, and a scuff mark from the driver’s face to the air bag. The contact points from the front center occupant consisted of fractured trim on the lower center instrument panel from her left knee, a fracture to the center instrument panel trim from the occupant’s lower left arm, deformed center instrument panel trim from the occupant’s face. Two scuffs were noted to the right door panel from possible contact with either the front right occupant or the shield booster seat. The intrusions are listed in the following table:

**Figure 6. View of occupant contacts to the instrument panel.**

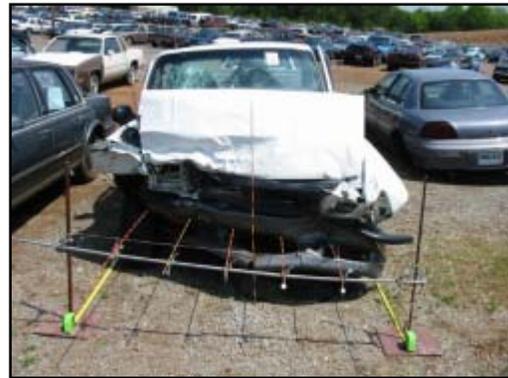
The 1994 Mazda B2300 sustained severe frontal damage (**Figure 7**) as result of the impact with the Chevrolet. The direct contact damage width was 160.0 cm (62.9”) and extended from bumper corner-to-bumper corner. The left side wheelbase was reduced 6.0 cm (2.4”) and the right side was reduced 12.0 cm (4.7”). Maximum crush was located at C6 and was 61.0 cm (24.0”). Six crush measurements were documented along the bumper profile using a combined and direct damage width of 142.0 cm (55.9”) and were as follows: C1 = 38.0 cm (15.0”), C2 = 47.0 cm (18.5”), C3 = 44.0 cm (17.3”), C4 = 49.0 cm (19.3”), C5 = 57.0 cm (22.4”), C6 = 61.0 cm (24.0”). The left front door remained closed and operational post-crash and the front right door was jammed shut. The front left and front right glazings were not damaged. The windshield was cracked from deformation and occupant contact. The backlight was disintegrated from contact by an occupant who was riding in the cargo bed of the vehicle.

**Figure 7. Frontal damage to the 1994 Mazda B2300.**

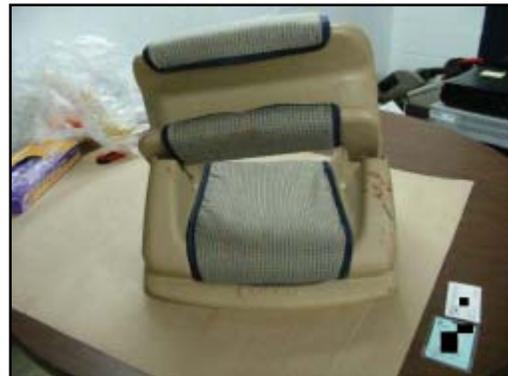
The 16-month old front right child occupant was seated in a Cosco Grand Explorer shield booster seat. The seat was identified by Model No. 02-424 TCD GEIC (**Figure 8**) and was manufactured on 08/01/02. The shield booster seat was installed in the front right seat the vehicle’s lap portion of the 3-point lap and shoulder belt system. Manufacturer recommends use of the restraint with the shield for children 13.6-18.1 kgs (30-40 lbs); without the shield for 18.1-36.3 kgs (40-80 lbs). The subject occupant was not within the manufacturers’ guidelines.

**Figure 8. Frontal view of the Cosco shield booster.**

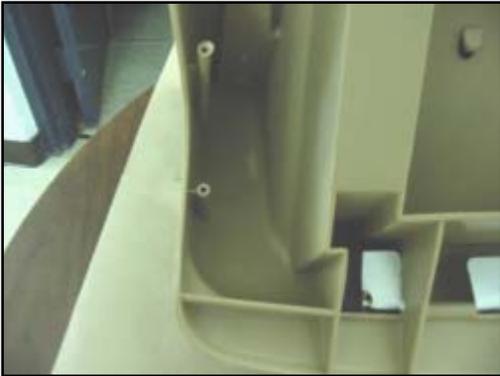
At impact, the child responded to the 11 o’clock impact force and initiated a forward and left trajectory. The abdominal and lower torso area of the 16-month-old female loaded the shield of the booster seat resulting in a Grade III spleen laceration and bilateral lung contusions. Her head flexed over the shield resulting in the C1/C2 dislocation with spinal cord injury and a closed head injury. The researcher documented loading marks on the bottom aspect of the seat at the left and right sides of the seat’s integrated frame (**Figures 9 and 10**).

**Figure 9. Bottom left side view depicting the loading marks.**

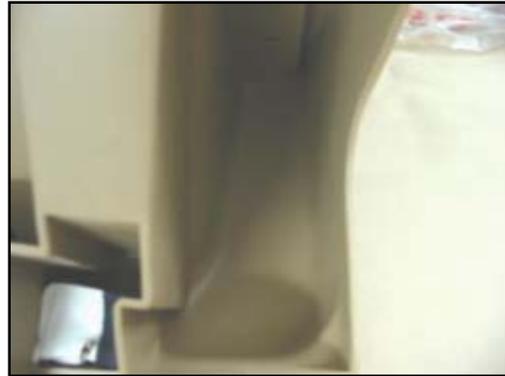
**Figure 10. Bottom right side view depicting the loading marks.**

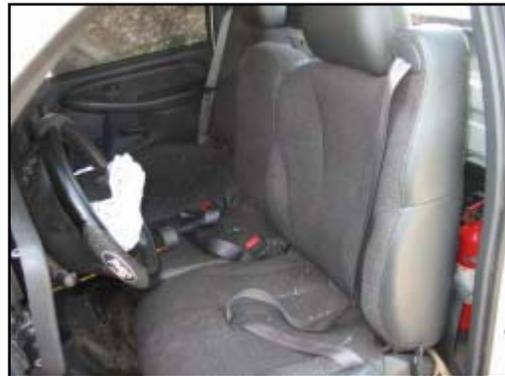
The 1999 Chevrolet Silverado was equipped with integrated manual 3-point lap and shoulder belts for the outboard seating positions and a lap belt for the front center position. The driver's safety belt was configured with a sliding latch plate and a belt-sensitive Emergency Locking Retractor (ELR). The driver's safety belt was restricted in the used position indicating that he utilized the safety belt in the crash. The front center safety belt was configured with a locking latch plate and no retractor. The front right safety belt was an integrated 3-point lap and shoulder belt with a sliding latch plate and a switchable ELR/Automatic Locking Retractor (ALR). The driver and front center passenger utilized their safety belts. The lap portion of the 3-point lap and shoulder belt of the front right safety belt was used to install the shield booster seat that was occupied by the 16-month-old female. It was unknown if the safety belt retractor was engaged in the ALR position at the time of the crash.

**Figure 11. Driver's safety belt restricted in the used position.**

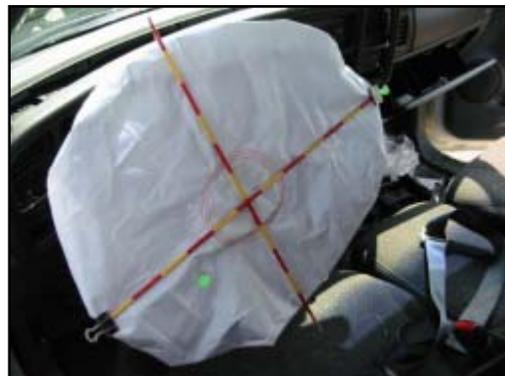
The 1999 Chevrolet Silverado was equipped with a redesigned frontal air bags system for the driver and front right passenger positions. The force of the impact with the Mazda resulted in the deployment of the driver's frontal air bag. The front left air bag deployed from the center of the steering wheel hub. The front left air bag module was designed with "T" configuration symmetrical cover flaps. The cover flaps were

**Figure 12. Deployed driver's air bag.**

measured as 6.5 cm (2.6”) in width and 10.0 cm (3.9”) in height. The front left air bag contained two vent ports on the rear aspect of the air bag at the 11 and 1 o’clock positions. The air bag was measured by the NASS researcher at 50.0 cm (19.7”) in diameter (**Figure 12**). A scuff was noted to the bottom left quadrant of the air bag from possible contact with the driver’s face.

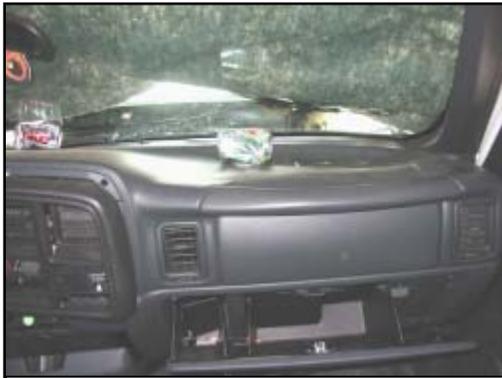
The mid mounted front right air bag was equipped with an OEM on/off switch was located at the lower right corner of the mid instrument panel. The switch was in the off-position at the time of the crash and the front right air bag did not deploy (**Figures 13 and 14**).

**Figure 13. Non-deployed front right air bag.**

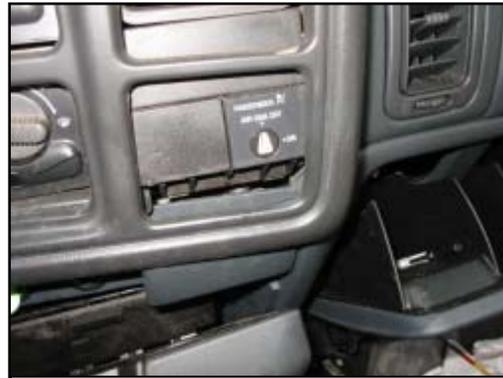
**Figure 14. OEM on/off switch in off position.**
