**GENERAL DYNAMICS REMOTE SIDE IMPACT INFLATABLE OCCUPANT
PROTECTION SYSTEM CRASH INVESTIGATION**

SCI TECHNICAL SUMMARY REPORT

NASS/SCI COMBO CASE NO. 03-45-150J

VEHICLE – 2002 BMW 325i

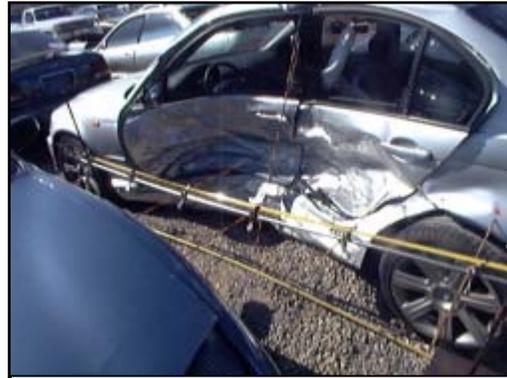
The 2002 BMW 325i sustained severe left side damage as a result of the collision with the Ford (Figure 6). The maximum crush was located at the mid-door level near the B-pillar and measured 48.0 cm (18.9"). The direct contact damage measured 192.0 cm (75.6") and began 4.0 cm (1.6") forward of the left rear axle and extended forward. The damage involved the left side doors, sill, left A-pillar, left B-pillar, roof, roof side rail, windshield, and left rear quarter panel. Six crush measurements were documented along the mid-door level using a combined direct and induced damage width of 212.0 cm (83.5") and were as follows: C1 = 4.0 cm (1.6"), C2 = 24.0 cm (9.5"), C3 = 48.0 cm (18.9"), C4 = 46.0 cm (18.1"), C5 = 38.0 cm (15.0"), C6 = 5.0 cm (2.0"). The Collision Deformation Classification (CDC) for this impact was 10-LPAW-3. The left side doors were jammed closed by deformation and the right side doors remained closed and operational post-crash. The windshield was fractured at the left A-pillar from the lateral deformation of the A-pillar and roof. The left front and left rear glazing were disintegrated from damage. The left quarter, backlight, and right side glazing remained intact.

Figure 6. 2002 BMW 325i damage profile.

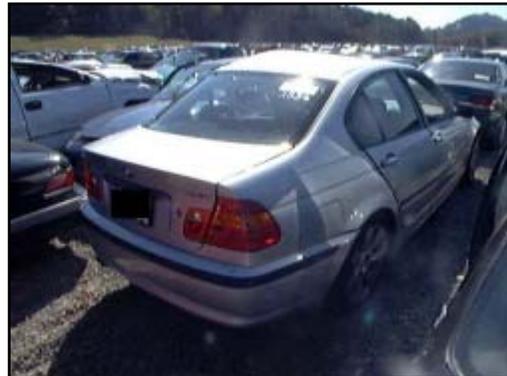
Figure 7. Rear area no residual damage from shrub impact.

The BMW sustained no damage from the back plane impact with the shrub (Figure 7). The CDC for this impact was 99-B999-9.

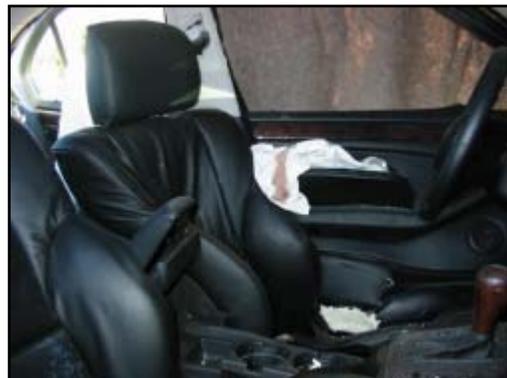
The 2002 BMW 325i sustained moderate interior damage (Figure 8) as a result of intrusion and occupant contacts. The maximum documented intrusion was the front of the Ford intruding approximately 40.0 cm (15.7") into the front left passenger compartment area. The occupant contacts consisted of the driver's left shoulder contacting the upper aspect of the left door that was evidenced by deformation to the door panel. A contact was noted to the lower aspect of the door panel from the driver's left leg that deformed the door panel. Also noted

Figure 8. Intrusion into driver's position.

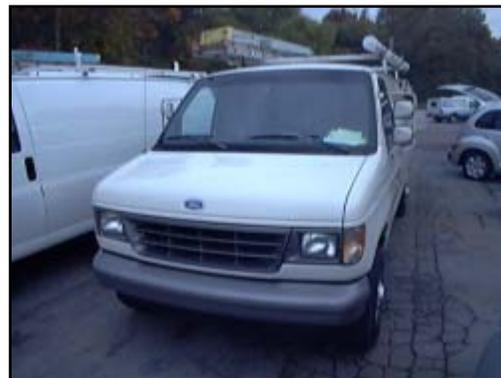
The 1995 Ford Econoline was repaired prior to the NASS inspection; therefore the damage severity was unknown for the frontal impact with the BMW (Figure 9). The CDC for this impact was 99-F999-9.

Figure 9. Repaired 1995 Ford Econoline.

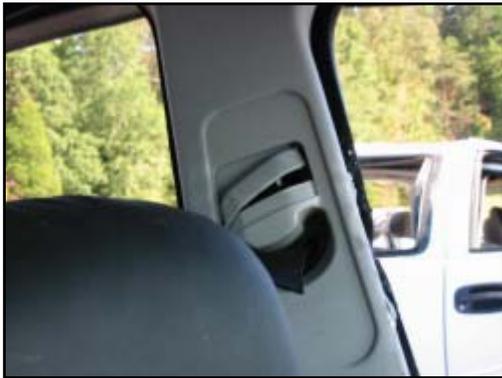
Figure 10. Shoulder belt portion retracted in B-pillar cut by rescue

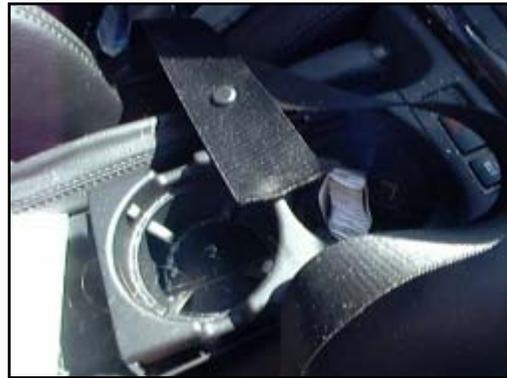
Figure 11. Cut lap belt portion remained buckled.

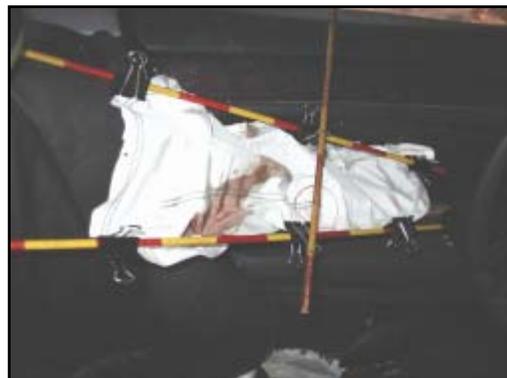
The 2002 BMW 325i was equipped with door panel mounted side impact air bags for the front seating positions. In this crash, the driver's door panel side impact air bag deployed (**Figure 12**). The air bag was concealed by a leather cover flap that measured 8.0 cm (3.2") in height and 34.0 cm (13.4") in width. The air bag membrane measured 12.0 cm (4.7") in height and 40.0 (15.7") in width at the top aspect and 30.0 cm (11.8") in width at the lower aspect. The air bag contained a single circular tether on the center aspect of the air bag. No vent ports were noted on the air bag. The NASS researcher documented a large area of body

Figure 12. Deployed driver's door panel mounted side impact air bag. Noted the blood on the air bag is from driver bleeding onto it at final rest not an occupant contact.

fluid that was located left of the tether. The body fluid appears to be from the driver bleeding onto the air bag and not as a result of contact. No damage or failure was noted to the air bag.

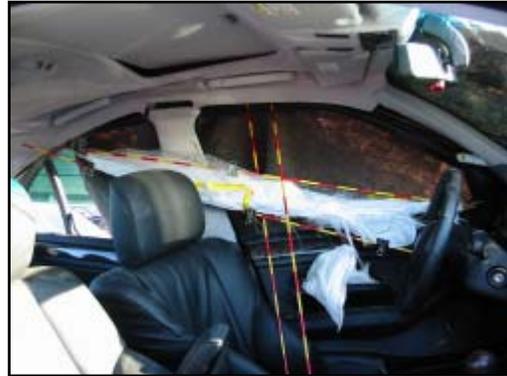
The 2002 BMW 325i was equipped with a Head Protection System (HPS) for the front seating positions. The system included two tubular air bags that deployed from the roof side rails and were designed to protect the occupants in the event of a side impact. As a result of the subject crash, the left side HPS deployed (**Figure 13 and 15**) from the left roof side rail. The air bag membrane was 12.7 cm (5.0”) diameter and 112.0 cm (44.1”) in width. The HPS was tethered at the left A- and C-pillars and was tensioned by inflation. The NASS researcher documented a transfer on the air bag, which was located near the front left head

Figure 13. Deployed driver's HPS air bag.

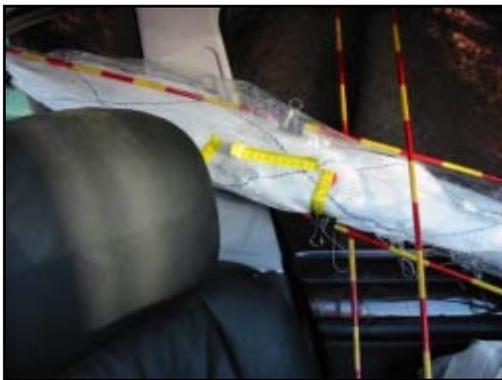
restraint. The transfer was black in color and consistent with contacting the head restraint, therefore it was not considered and occupant contact (**Figure 14**). Rescue personnel cut the air bag at the A-pillar tether during the removal of the driver (**Figure 16 and 17**). There also appears to be several small cuts and frayed air bag material from contact with glass and the front of the Ford. The NASS researcher noted no failures or damage to the air bag.

Figure 14. Head restraint contact to HPS air bag.

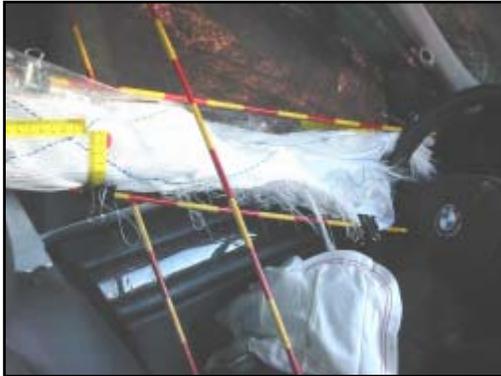
Figure 16. Damage from rescue personnel cutting the HPS air bag. Also, the air bag sustained minor cuts from contact with flying glass.

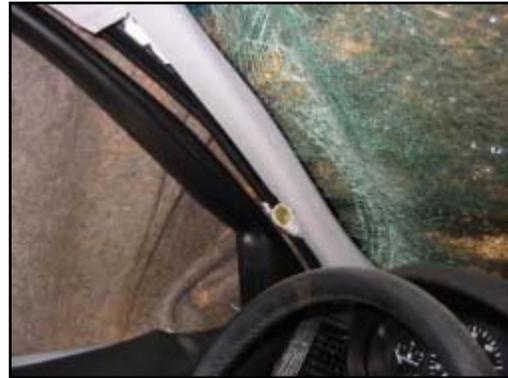
Figure 17. Area of HPS that rescue personnel cut.
