## SCI/NASS COMBINATION CASE REPORT

CASE NUMBER - NASS-2003-48-193C  
LOCATION - Alabama  
VEHICLE - 2001 BMW 525i  
CRASH DATE - September 2003

1. <i>Report No.</i> NASS-2003-48-193C		2. <i>Government Accession No.</i>		3. <i>Recipient's Catalog No.</i>	
4. <i>Title and Subtitle</i> SCI/NASS Combination Side Air Bag Investigation Vehicle - 2001 BMW 525i Location - Alabama			5. <i>Report Date:</i> April 2, 2004

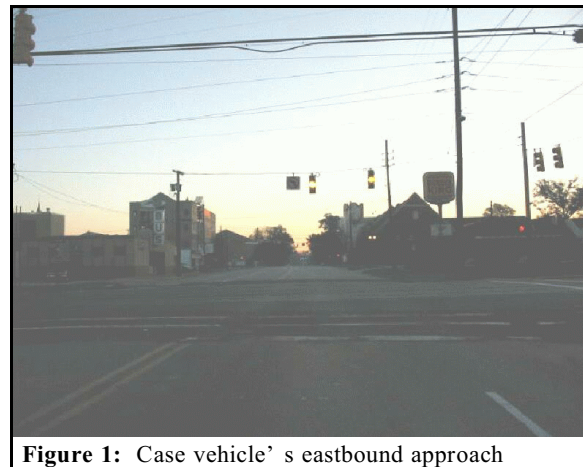
The case vehicle was traveling east in the outside eastbound lane of a four-lane city street, approaching a four-leg intersection controlled by automatic signals and intending to continue east (**Figure 1**). The other vehicle was traveling south in the leftmost southbound through lane on the intersecting five-lane, one-way city street, intending to continue south. It was dark but lighted, the weather was clear, both roads were straight and level, the asphalt surface was dry with no apparent defects and the speed limit on both roadways was 56 km.p.h. [35 m.p.h.]. The case vehicle entered the intersection across the path of the other vehicle.

**Figure 1:** Case vehicle's eastbound approach

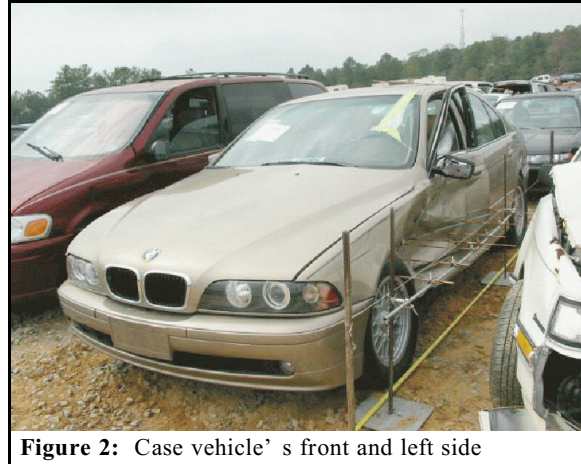
The case vehicle sustained direct contact damage on the left side from event #1, on the driver's door and extending forward of the left A-pillar to the left front wheel well (**Figures 2 and 3**). Direct damage was measured as 165 centimeters [64.9 inches], with maximum crush of 30 centimeters [11.8 inches] located at the leading edge of the driver's door (**Figure 3**). The driver's door window glazing was shattered, the windshield was cracked in the lower left area and there was no other glazing damage. None of the tires were damaged or restricted. The CDC was determined to be **10-LYEW-3 (290)**. This was the most severe impact for both vehicles. The WinSMASH reconstruction program, damage algorithm based on the measured crush profile of the case vehicle and CDC-only for the other vehicle (due to overlapping damage), was used on this impact. The Total, Longitudinal and Lateral delta Vs are, respectively: 31 km.p.h. [19.3 m.p.h.], -11 km.p.h. [-6.8 m.p.h.] and +29 km.p.h. [+18.0 m.p.h.]. These results appear reasonable. The first impact was of moderate severity (24-40 km.p.h. [15-25 m.p.h.]) for the case vehicle.

Figure 2: Case vehicle's front and left side

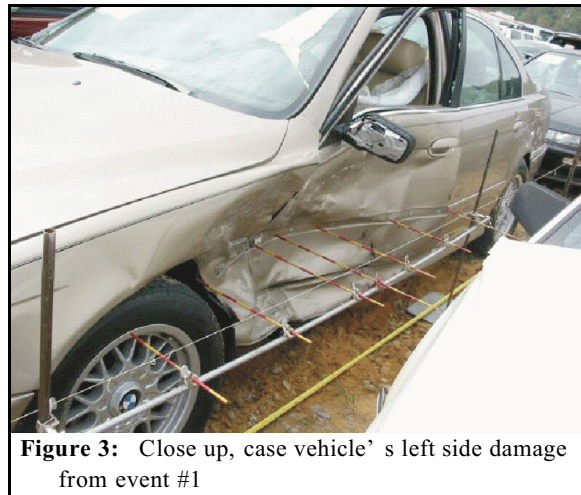
Figure 3: Close up, case vehicle's left side damage from event #1

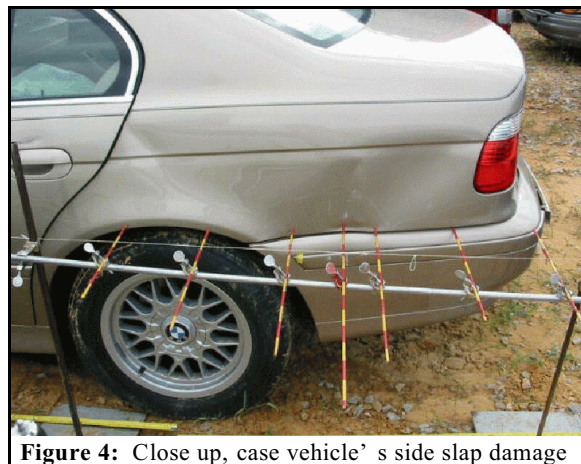
The case vehicle also sustained side-slap damage on the left rear area (event #2), with direct contact entirely on the rear overhang (**Figure 4**). Direct contact was measured as 61 centimeters [24.0 inches], with maximum crush of 8 centimeters [3.1 inches] located approximately midway from the rear axle to the rear end of the vehicle. The CDC was determined to be **09-LBEW-1 (270)**. The WinSMASH reconstruction program, damage algorithm based on the measured crush profiles of both vehicles, was used on this impact. The Total, Longitudinal and

Figure 4: Close up, case vehicle's side slap damage

Lateral delta Vs are, respectively: 6 km.p.h. [3.7 m.p.h.], 0 km.p.h. [0 m.p.h.] and + 6 km.p.h. [+ 3.7 m.p.h.]. These results appear reasonable. The second impact was of minor severity (1-13 km.p.h. [1-8 m.p.h.]) for the case vehicle.

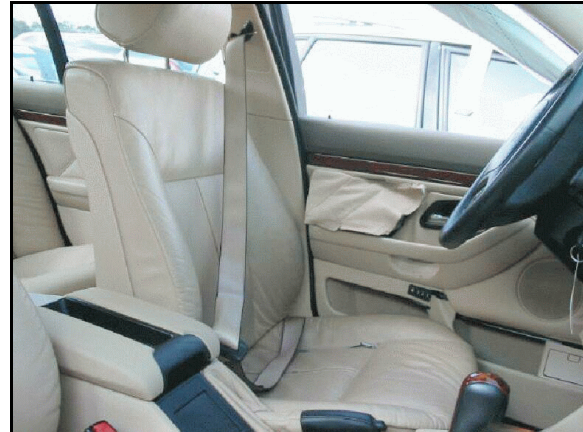
The driver's side impact air bag module was mounted behind a panel of pleated upholstery in the driver's door, immediately above the arm rest (**Figure 5**). The upholstery panel was approximately trapezoidal, measuring 19 centimeters [7.5 inches] horizontally and 12 centimeters [4.7 inches] vertically. The deployed air bag was an elongated oval, measuring 50 centimeters [19.7 inches] horizontally and 24 centimeters [9.4 inches] vertically (**Figure 6**). The air bag had no vent ports. It is not known if the air bag had internal tethers. There was no evidence of damage to the air bag, the upholstery cover flap or the surrounding structures.

**Figure 5:** Deployed driver's door-mounted side air bag tucked away, showing upholstery cover

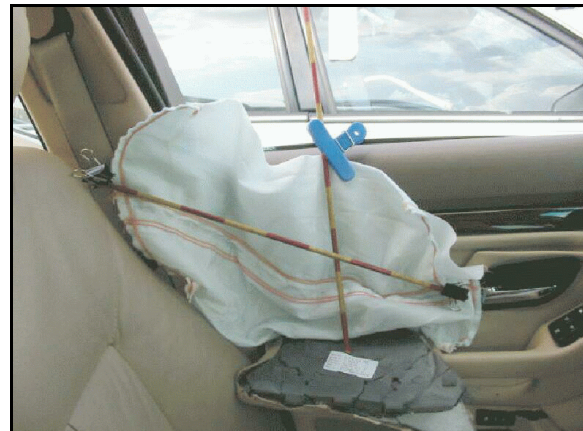
**Figure 6:** Inboard surface of the driver's door-mounted side air bag

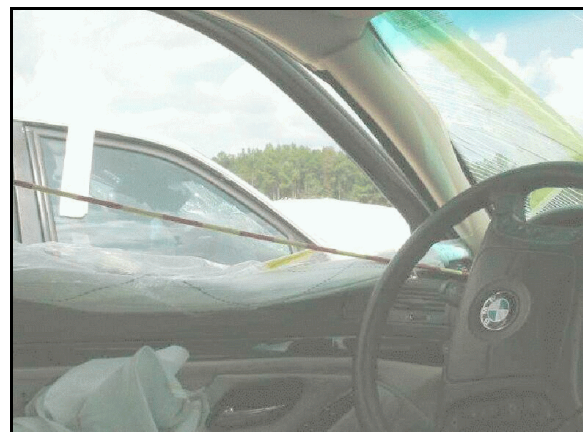
**Figure 7:** Forward portion of tubular air bag, tethered to the base of the upper A-pillar

The driver's tubular head protection air bag was mounted in the left roof rail, with a short tether to the base of the upper A-pillar and a long tether to the top of the upper C-pillar (**Figures 7, 8 and 9**). The deploying tubular air bag deploys through a seam along the roof rail and upper A-pillar, and there is no cover flap as such. The deployed air bag was a round tube measuring 113 centimeters [44.5 inches] long and with a diameter of 12 centimeters [4.7 inches]. The tubular air bag did not have any internal tethers or vent ports. There was no evidence of damage to the air bag or the surrounding structures, except the opening of the seam through which the air bag emerged.

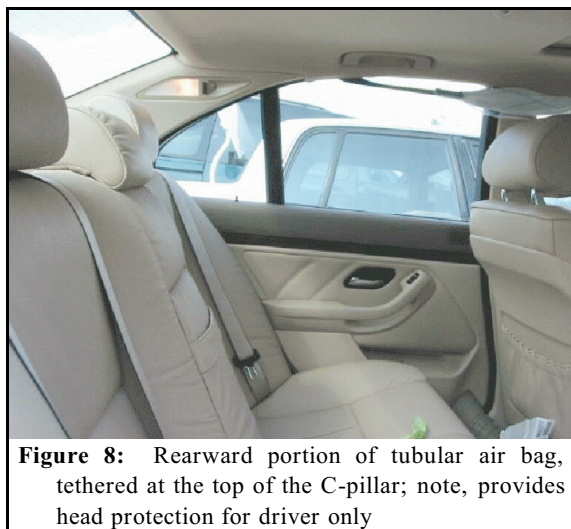
**Figure 8:** Rearward portion of tubular air bag, tethered at the top of the C-pillar; note, provides head protection for driver only

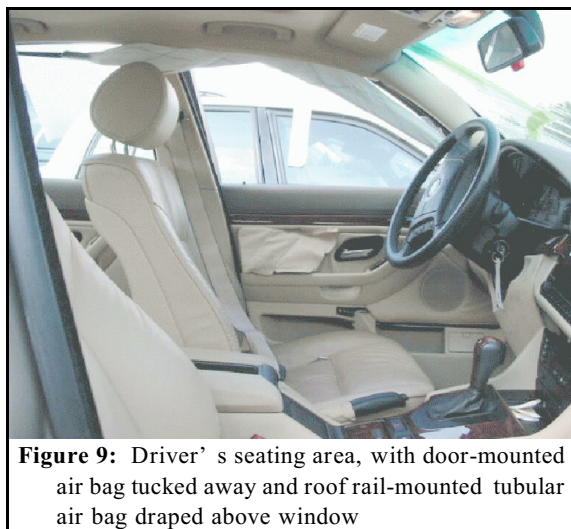
The case vehicle driver (47-year-old male, black, non-Hispanic, 178 centimeters, 94 kilograms [70 inches, 207 pounds]) was restrained by the available, manual, three-point lap-and-shoulder safety belt system. He was seated in a normal, upright driving posture, with the bucket seat back slightly reclined, the seat track adjusted between the middle and rear most positions and the tilt steering wheel adjusted at the full up position (**Figure 9**).

**Figure 9:** Driver's seating area, with door-mounted air bag tucked away and roof rail-mounted tubular air bag draped above window

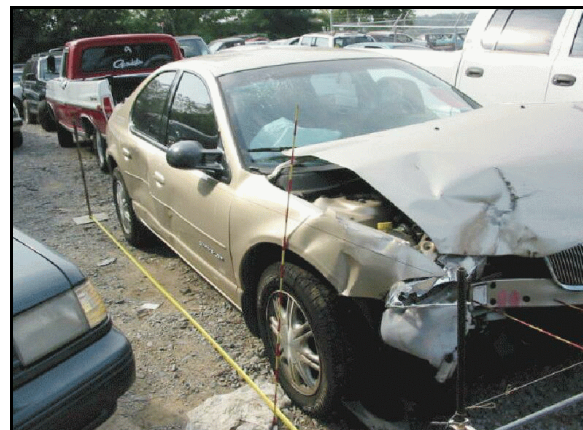
The Cirrus sustained direct contact damage across the full width of its front plane (**Figures 10 and 11**) due to its first impact with the case vehicle (event #1). The CDC for event #1 was determined to be **01-FDEW-2 (20)**. The Cirrus also sustained a second impact on the front plane from its impact with the traffic signal pole (event #3), causing overlapping damage near the front right corner. The CDC for event #3 was determined to be **12-FREN-? (0)** with the extent zone unknown due to the overlapping damage configuration. The WinSMASH reconstruction program, damage algorithm based on the measured crush profile of the case vehicle and CDC-only for the Cirrus, was used on event #1, which was the Cirrus’ most severe impact. The

**Figure 10:** Front right corner and right side of the Cirrus

Total, Longitudinal and Lateral Delta Vs are, respectively: 35 km.p.h. [21.7 m.p.h.], -33 km.p.h. [-20.5 m.p.h.] and -12 km.p.h. [-7.5 m.p.h.]. This is a borderline reconstruction for the Cirrus, but the results appear reasonable. This was an impact of moderate severity (24-40 km.p.h. [15-25 m.p.h.]) for the Cirrus.

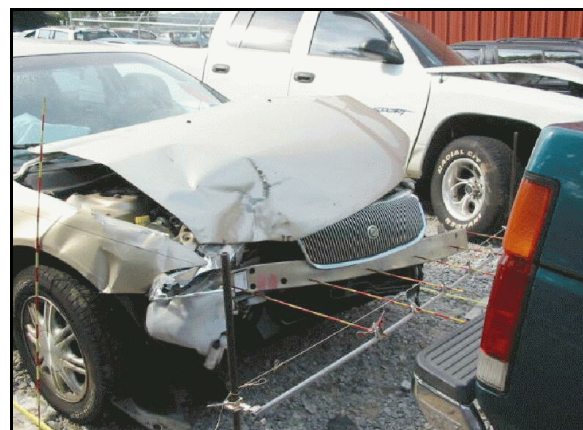
**Figure 11:** Front of Cirrus, showing overlapping damage from two impacts

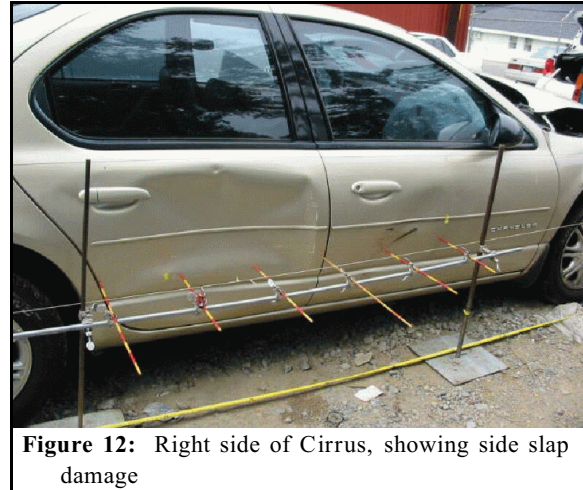
The Cirrus also sustained minor damage on the right side (**Figure 12**), primarily on the back door, from the side slap impact (event #2). The length of direct contact was measured as 106 centimeters [41.7 inches], centered approximately on the B-pillar door, with maximum crush 3 centimeters [1.2 inches]. The CDC for the side slap was determined to be **03-RPEW-1 (90)**. The WinSMASH reconstruction program, damage algorithm based on the measured crush profile of both vehicles, was used on event #2. The Total, Longitudinal and Lateral Delta Vs are, respectively: 7 km.p.h. [4.3 m.p.h.], 0 km.p.h. [0 m.p.h.] and -7 km.p.h. [-4.3 m.p.h.]. These results appear reasonable. This was an impact of minor severity (1-13 km.p.h. [1-8 m.p.h.]) for the Cirrus.

**Figure 12:** Right side of Cirrus, showing side slap damage
